# Tree Assessment and Compensation Strategy

**Lodge Road, Hurst**  
**04 June 2025**

| Project No: | Report No. | Date | Revision |
|---|---|---|---|
| 16452 | R05 | 04 June 2025 | a |

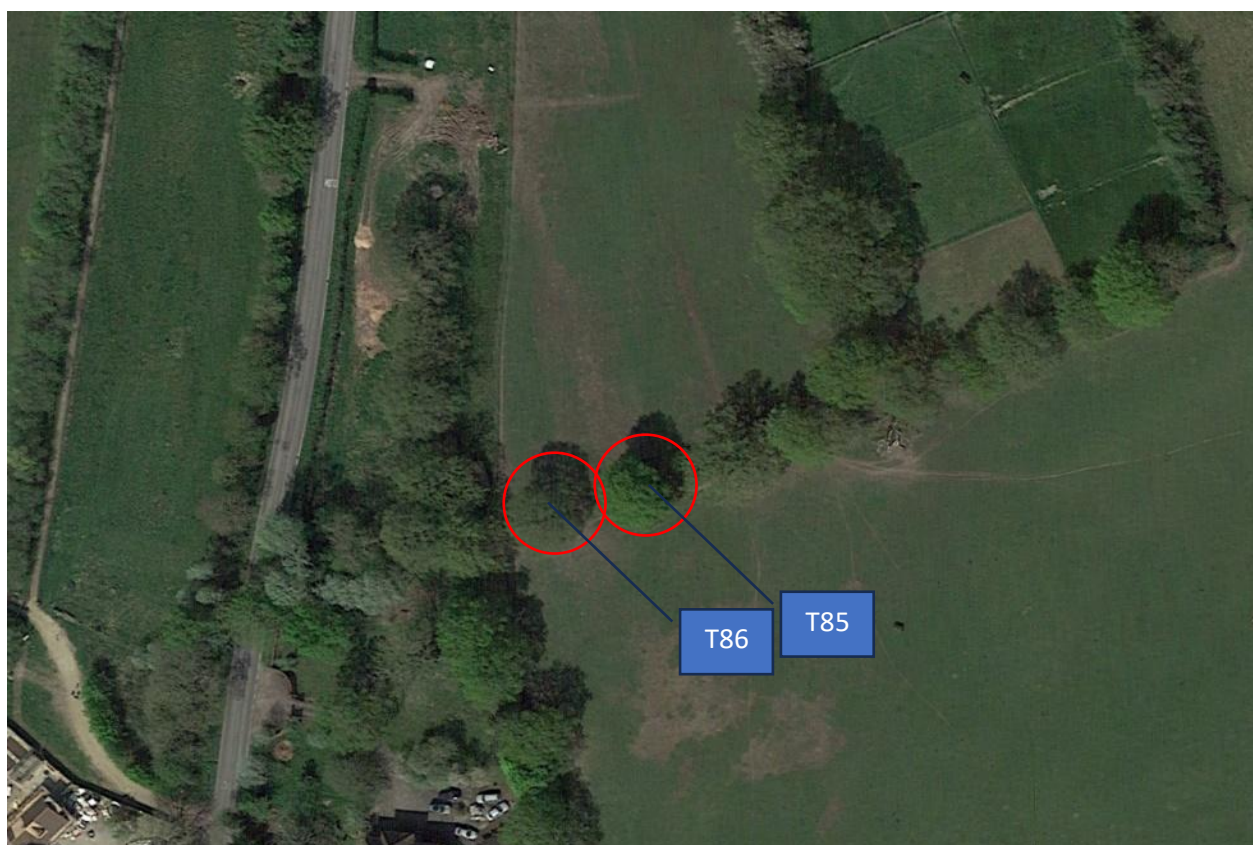
- 2.3. Figure 1 below shows the two trees standing on the site in 2020. They were located between trees T14 and tree T70 as recorded on the arboricultural (Report Ref. 16452 R01a dated 2<sup>nd</sup> July 2024) and ecology surveys (Report Ref. 16452 R02b dated 21<sup>st</sup> November 2024) submitted as part of the planning application. For the purposes of this report and the appeal, the trees have been recorded as trees T85 and T86.

Figure 1. Location of trees removed. Extract of Google Earth taken from 2020.

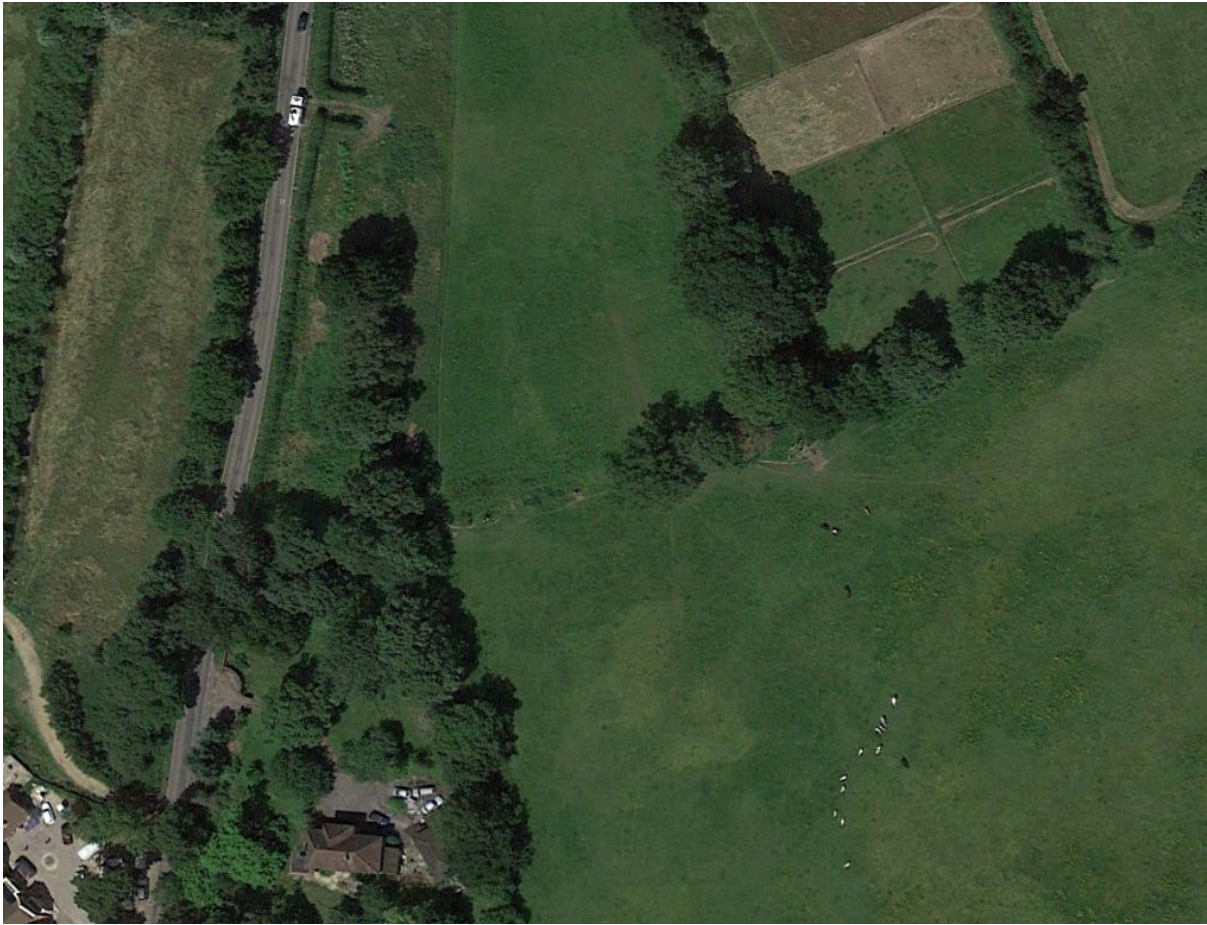
- 2.4. Figure 2 below shows the two trees having been removed in 2021. This occurred prior to TG's involvement in the project and before the ecology and tree surveys were undertaken by TG to inform the planning application that is subject to appeal.

Figure 2. Location of trees removed. Extract of Google Earth taken from 2021.

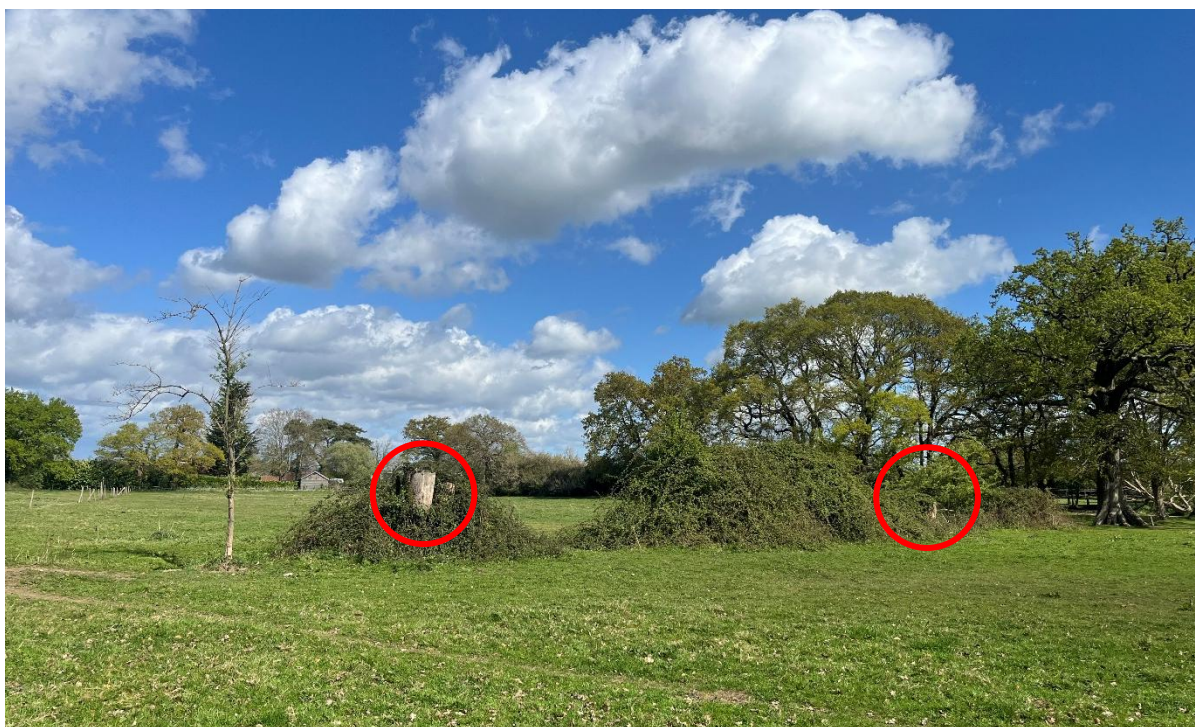
- 2.5. The remaining stumps from both trees remain on the site. The stumps are largely covered in bramble (See Figures 3-5 overleaf) and are approximately 1m in height from ground level. The bark on both trees suggest they are English oak *Quercus robur* species. The stumps were fully dead with no new growth observed.

Figure 3. Stumps from trees T85 and T86.

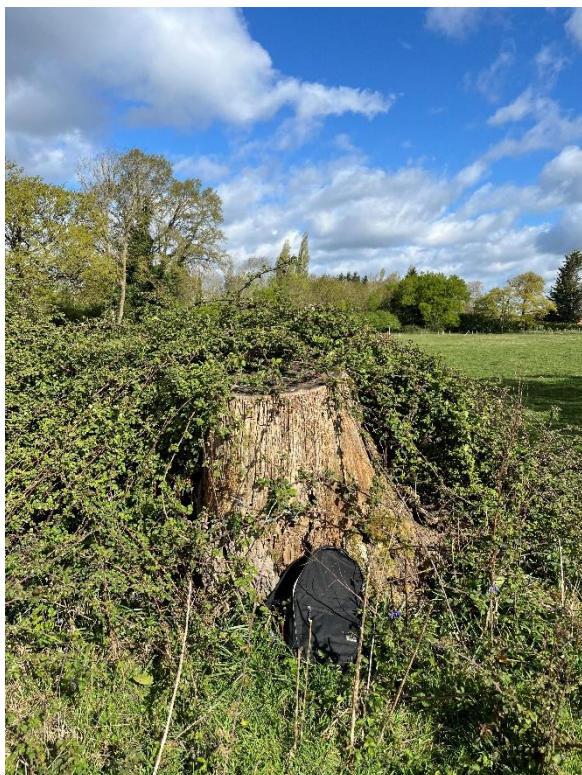
- 2.7. During a previous site visit on the 19<sup>th</sup> November 2024, the diameter of T85 could not be measured due to the bramble *Rubus fruticosus* agg. growth. As part of the latest site visit on 16th April 2025 it was possible to remove some of the bramble and measure the diameter of the remaining stems. Tree T85 had a single stem which measure at 700mm at 1m from ground level. There were no open cavities or internal hollowing observed in the base / remaining stump. There was some basal

decay however this appeared to be recently established and more likely a result of the removal of the tree which has exposed the remaining stump to decay.

Figure 5. Stump of tree T85

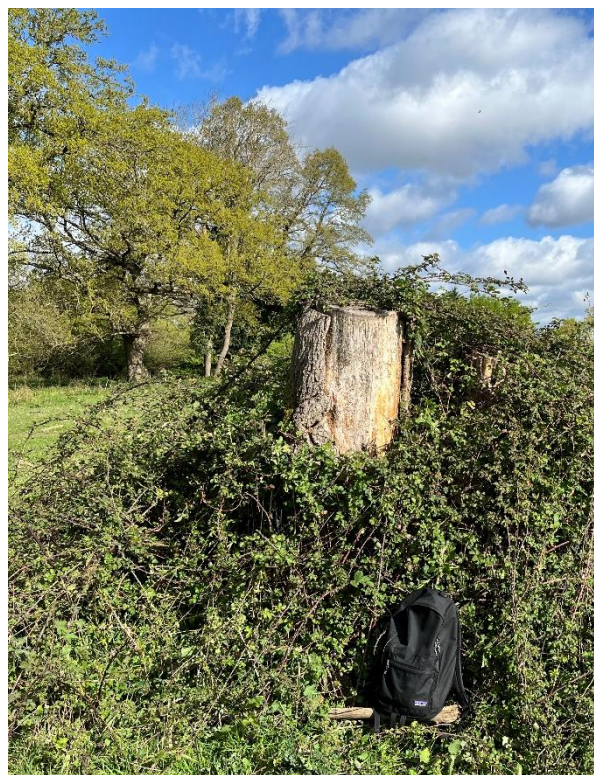
- 2.8. Tree T86 is multi-stemmed indicating it may have been historically 'copparded' within the former hedgerow. The has a combined stem diameter of 944mm, from three stems the measure 675mm, 560mm and 350mm in diameter (the ecology site visit on 19<sup>th</sup> November 2024 only measured the 560mm stem). Similarly, there were no open cavities or internal hollowing observed in the stump.

Figure 4. Stump of tree T86

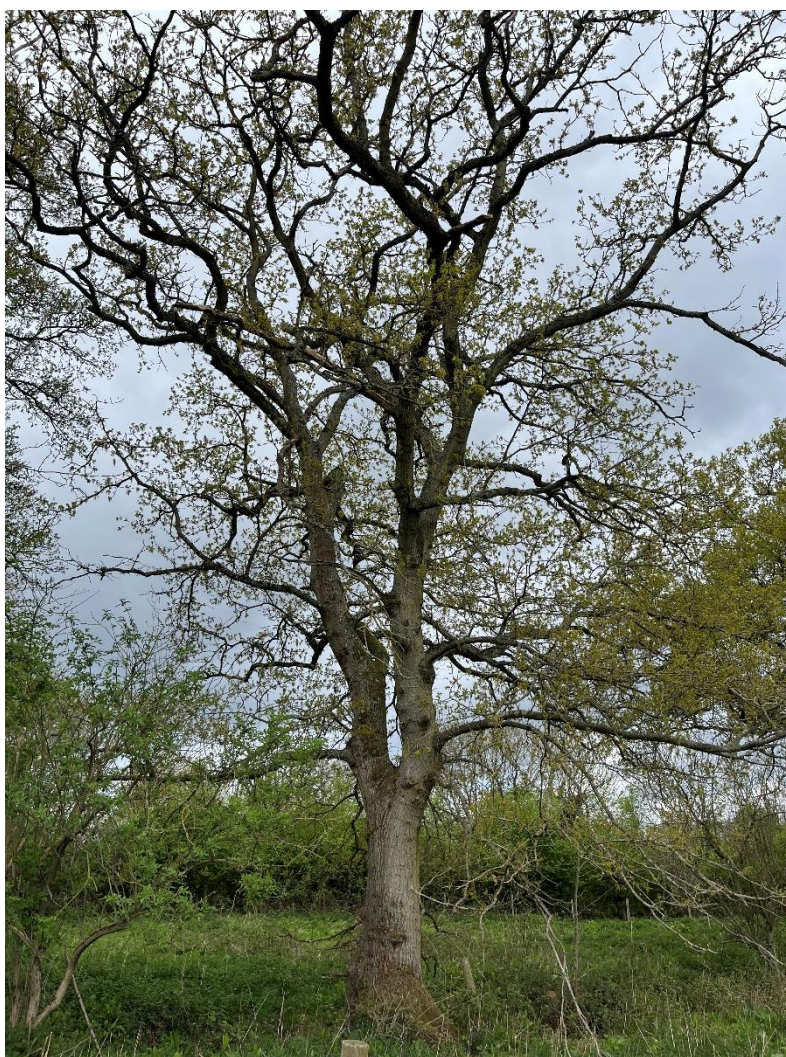
- 2.36. The image of tree T9 (See Figure 7 below) illustrates the form and characteristics of a typical mature English oak tree where features such as significant deadwood and advanced decay, as defined under the NPPF and the BNG Regulation, are yet to develop. There are some sections of deadwood present however this is not significant in terms of its size and proportion of the canopy. Tree T9 has the same stem diameter as tree T85.

**Figure 7. Photo of tree T9.**

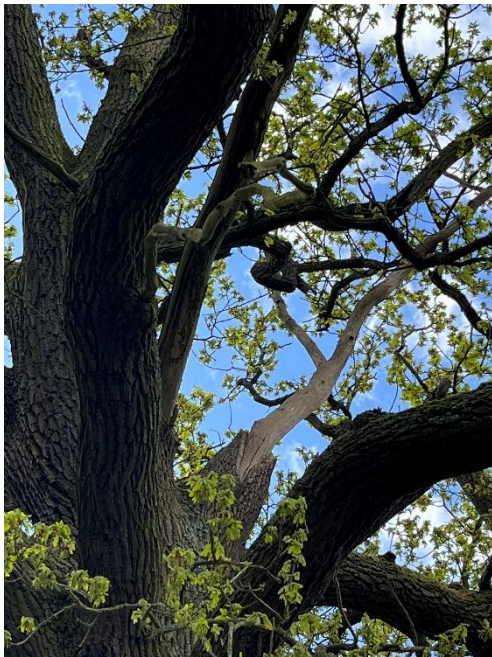
- 2.37. Tree T70 is located to the east of tree T85 and was recorded as a mature tree, however, a precautionary veteran tree buffer was applied as part of the planning application as it has potential to be veteran in the near future. The tree is not considered a 'true' veteran due to its size (1210mm stem diameter) and lack of primary veteran features. Features present on the tree included sections of deadwood in the crown, albeit not significant in term of size and proportion of the overall crown, some hollowing at the base of the tree (likely due to erosion of the former

hedge bank on which the tree is located), and small decay pocket holes. Image of these features are shown below.

**Figure 9. Largest section of deadwood within the crown of tree T70.**

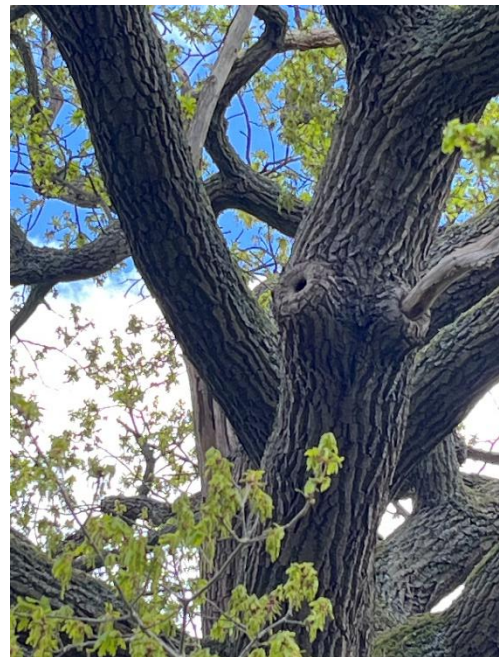
**Figure 8. Small decay holes within primary limb of tree T70.**

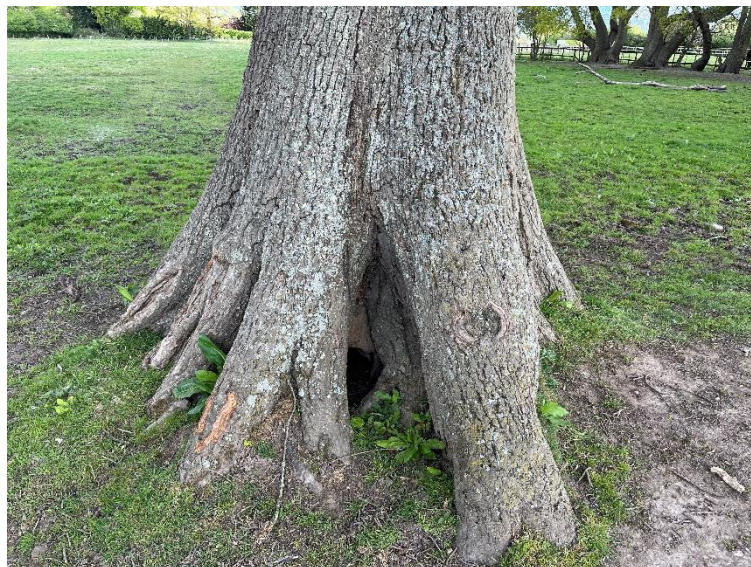
**Figure 10. Base of tree T70 showing eroded ground from buttress roots and moderate hollowing under centre of the stem**

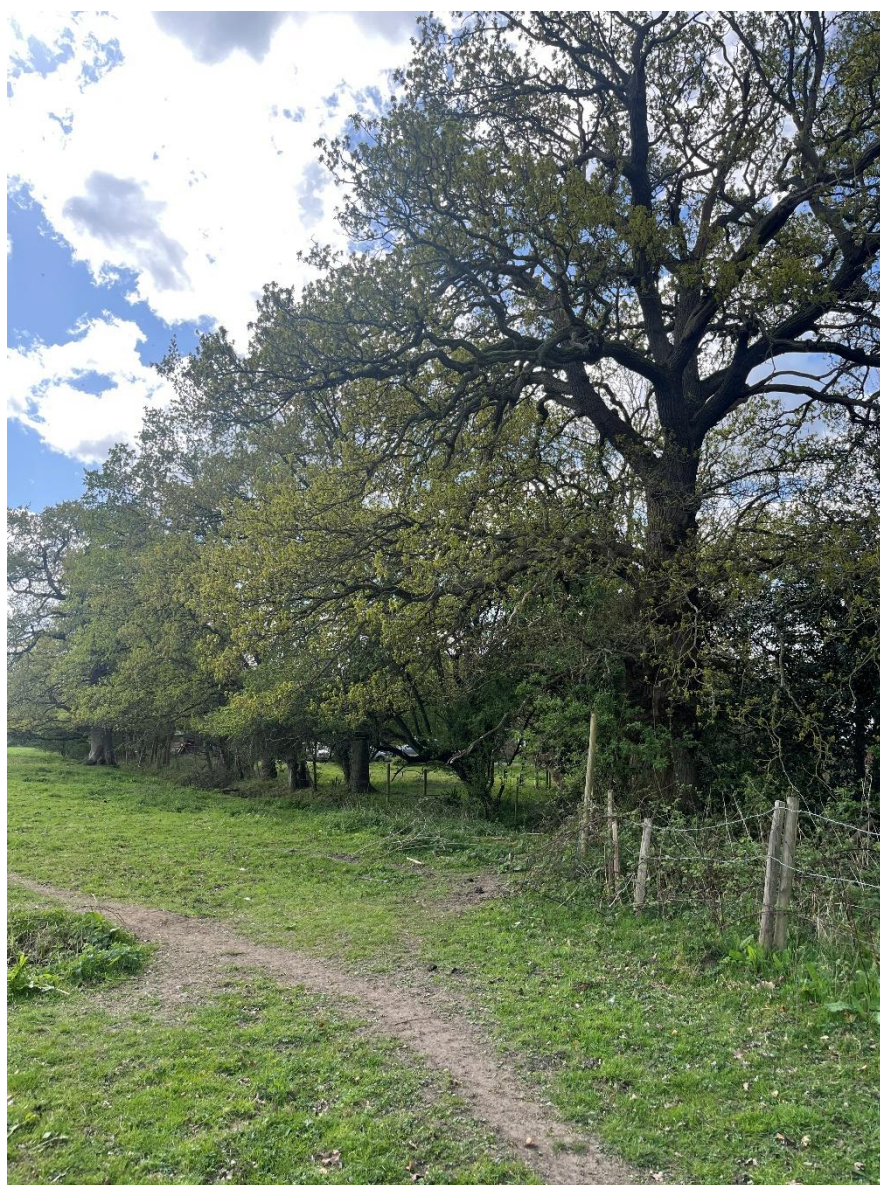
- 3.5. All veteran trees will be retained as part of the proposed development and have been afforded a buffer zone in accordance with government standing advice. The creation of the buffer zones offers an opportunity to remediate the ground conditions in the long-term, which are currently affected by compaction from farm vehicles and livestock trampling.

**Figure 112. Veteran tree T14 (right side of image) with compacted ground within rooting area from livestock paths and farm vehicles.**

- 3.7. Is it proposed that ground conditions are improved for all veteran trees surveyed as part of the future management plan. The measures for improvements to the ground will be addressed as a matter of detail and are envisaged to include targeted air spading and / or bio char applications.
- 3.8. The proposed masterplan also includes buffer zones around the veteran trees. Access to the buffer zones will be restricted using fencing as part of a proposed detailed landscape plan. This will prevent further compaction occurring in the rooting zones as part of the proposed residential use for the site.

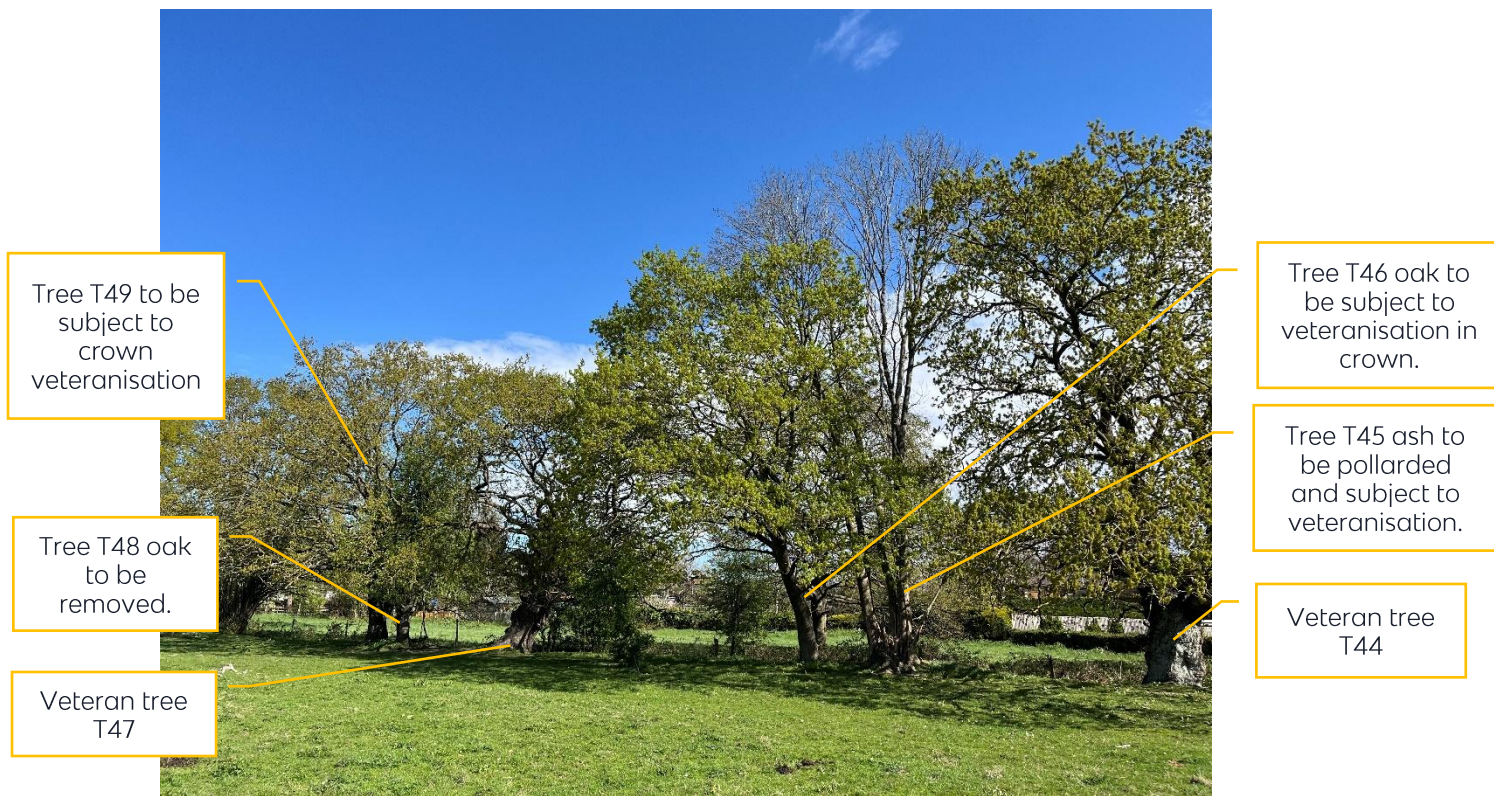
- 3.13. There are several trees growing in close proximity to veteran trees T44 and T47. The competing trees are likely to contributing to the stress observed in the trees T44 and T47 and therefore remedial work via management of the adjacent trees is recommended. The following remedial management works are recommended and are illustrated at Figure 12 overleaf:

**Figure 123. Proposed remedial tree works to improve condition of veteran trees T44 and T47 and encourage future veteran status of retained mature trees.**

- Pollard ash tree T45 to a height of approximately 5m and create artificial veteran features (veteranisation) on the retained stems. The tree is in poor condition and the pollarding will improve its structural integrity and light levels towards tree T47. The retained stems will also be retained to function as 'habitat poles' in the future, or used in log pyramids as appropriate.

- 3.14. Tree T46 and T49 are also likely to out-compete veteran trees T44 and T47. Rather than remove the trees, it is recommended that both are subject to veteranisation which will also serve to reduce their crown size and reduce competition towards trees T44 and T47.

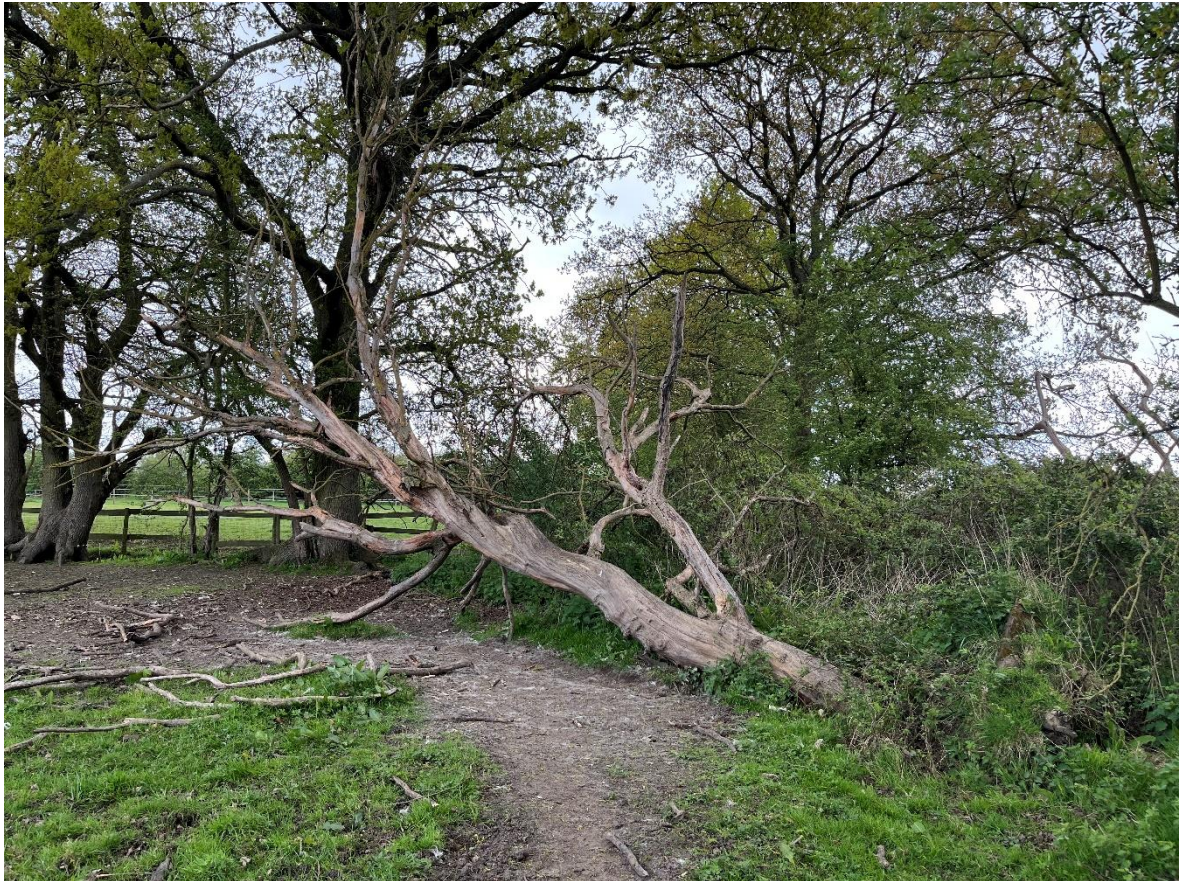
**Figure 156.** Fallen dead tree at ground level. Located approximately 30m east of removed tree T8

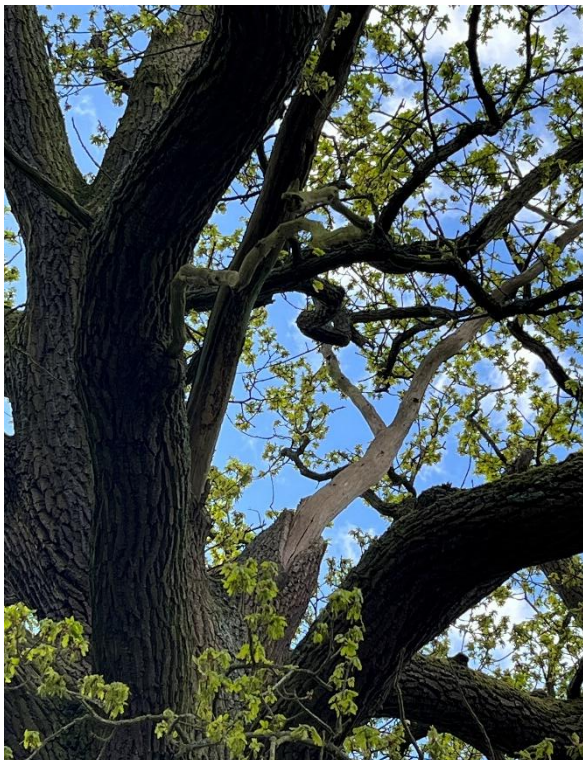
**Figure 145.** Section of aerial dead wood within veteran candidate tree T70.

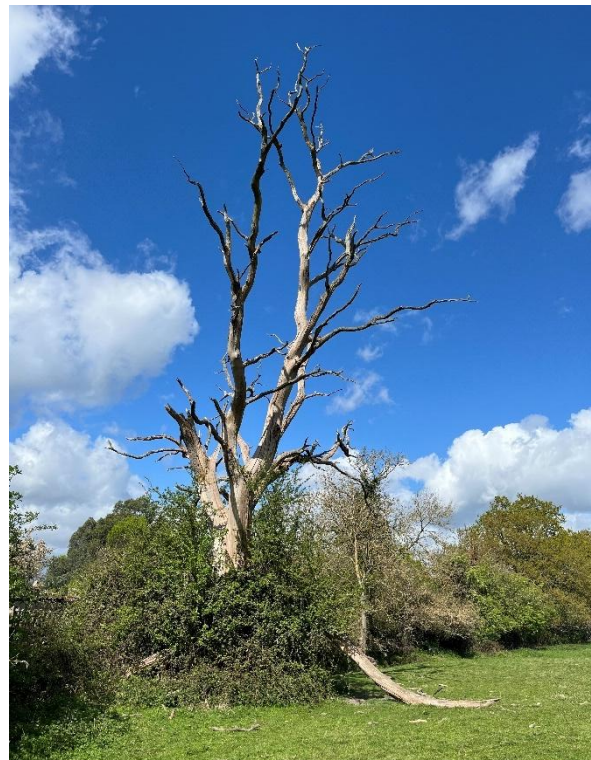
**Figure 134.** Tree T19 – large standing dead oak tree

- 3.21. Tree T19 is a large standing dead oak tree located at the eastern boundary of the site. The tree will be retained as part of the proposed development however the potential risks associated with the tree need to be managed for the residential context. As shown on Figure 14, one large scaffold limb has collapsed. It is recommended that the remaining two scaffold limbs are reduced to a height of approximately 8m (to the same height as the failed limb) to form a more contained dead crown and habitat pole. This is above the potential bat roost features identified, which would remain in-situ. This will reduce the risk of full tree collapse under windthrow, securing the longevity of standing dead wood, whilst managing tree risk. Removed sections of dead wood will be placed at ground level beneath the tree. This would be completed under the supervision of a suitably qualified ecologist, and where considered necessary, with a mitigation licence in place if bats are found to be present.
