# THAMESFIELD EXTENSION TO THE EXISTING RETIREMENT VILLAGE

## Arboricultural Impact Assessment

JSL4752\_770  
Thamesfield  
Arboricultural Impact  
Assessment  
V2  
Dec 2024

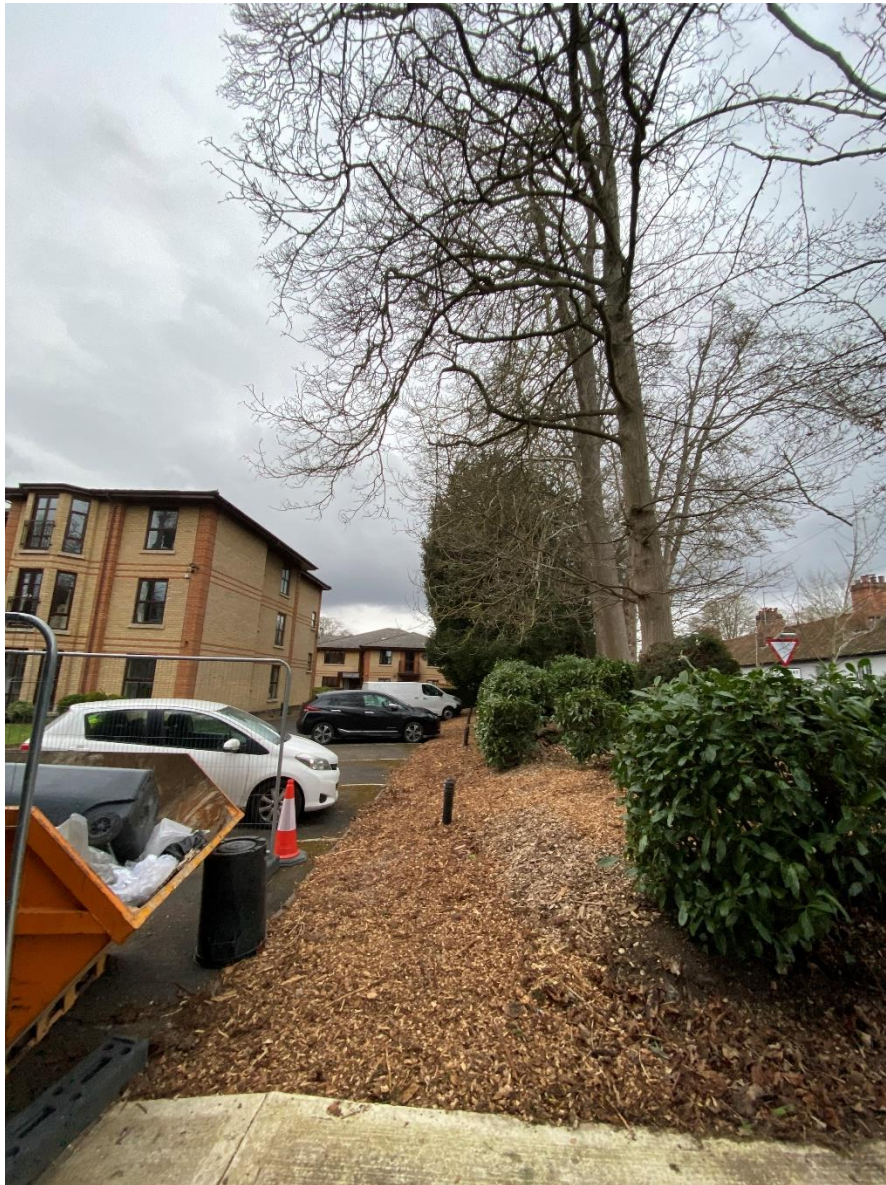
**An image taken from an existing concrete slab adjacent tool shed/container looking NNW along the boundary with Wargrave Road.**

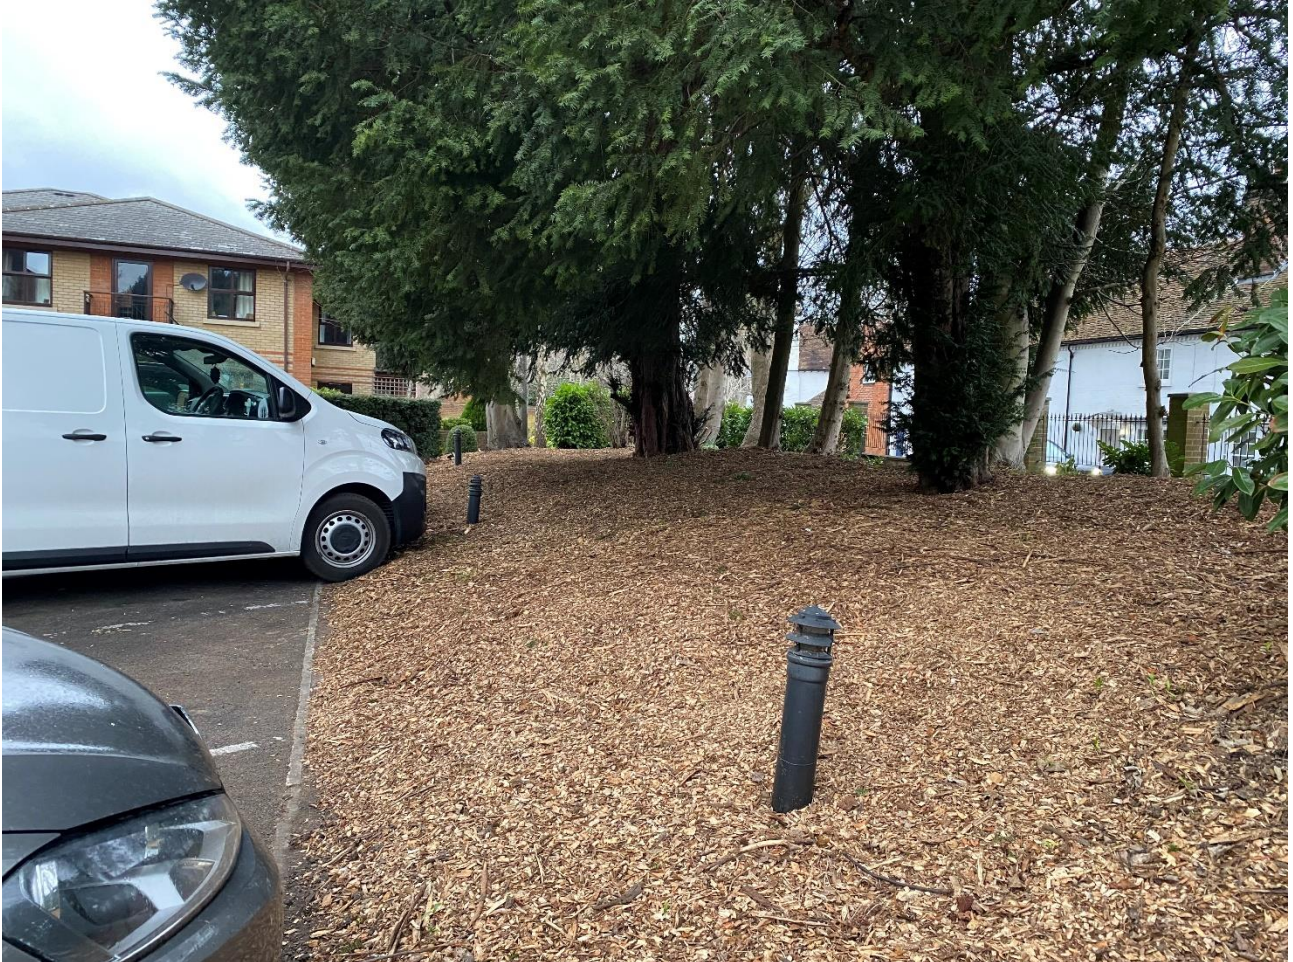
**Image of the norther section of the treed boundary adjacent Wargrave road. Looking north.**

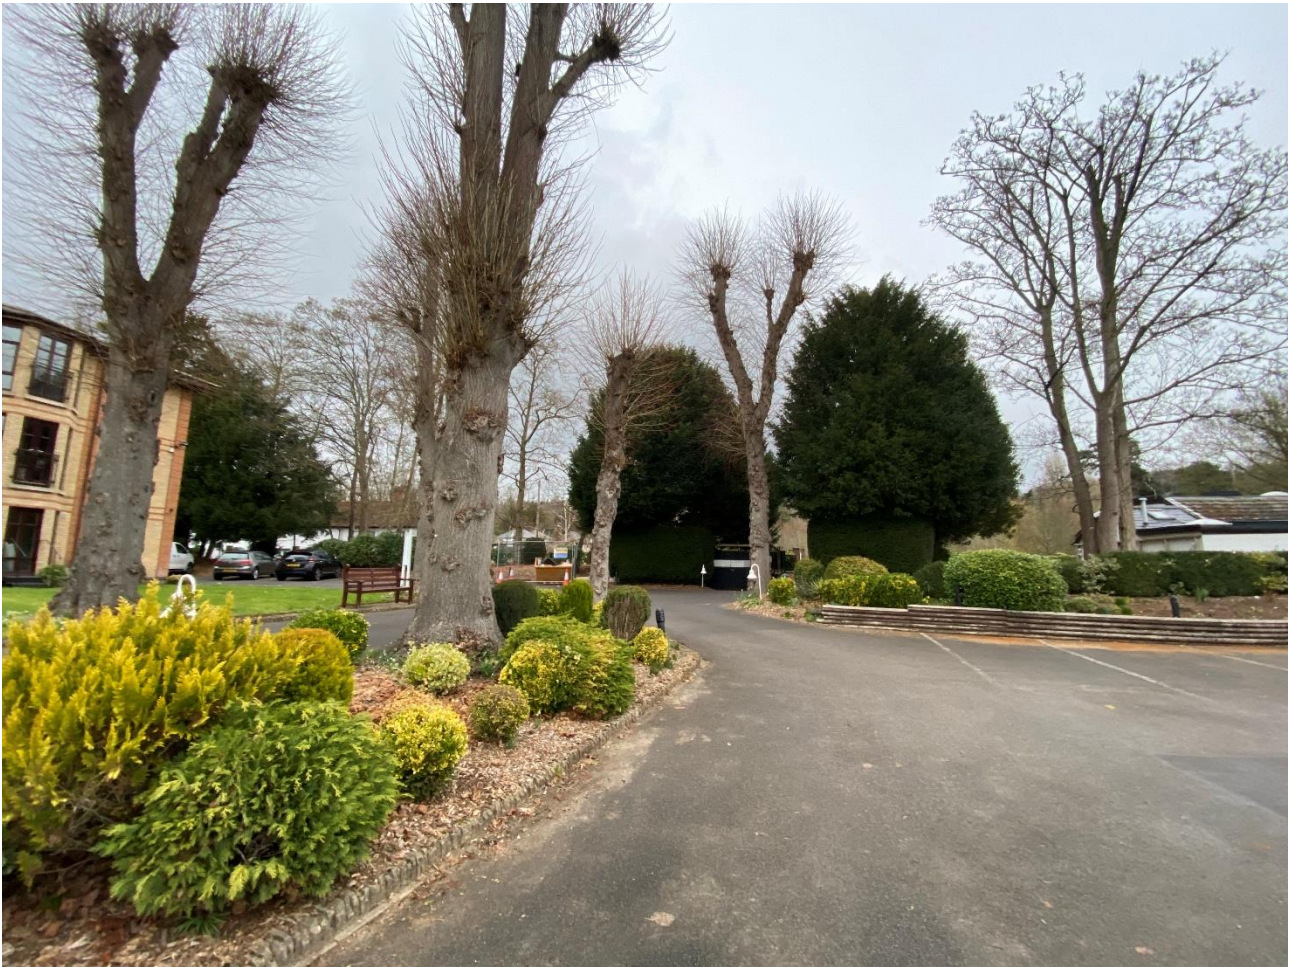
**Image taken looking northeast with T27, T61 & T28  
in center frame. Existing surfacing to be retained.**
