23 July 2026  
Our reference: ECO3668c

**Re: Discharge of planning condition 6 of planning application number 242712: Little Gables, Sindlesham Road, Arborfield, Arborfield Cross, Reading, RG2 9JH.**

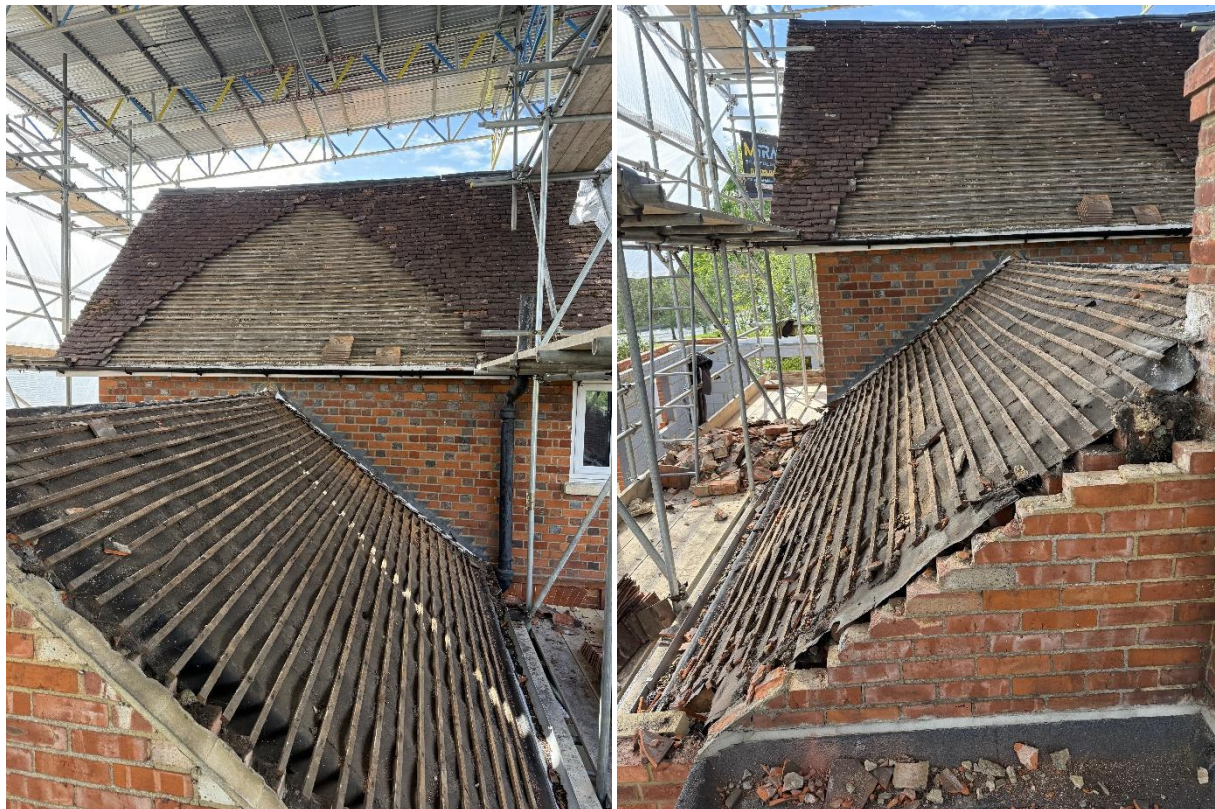
- 3.5 The tiles and roof lining from the single-storey roof and rear elevation of the main roof were removed by hand. No bats or signs of bats were found during the works.

Photos 1 and 2 – Tiles from the single-storey roof and rear elevation of main roof removed

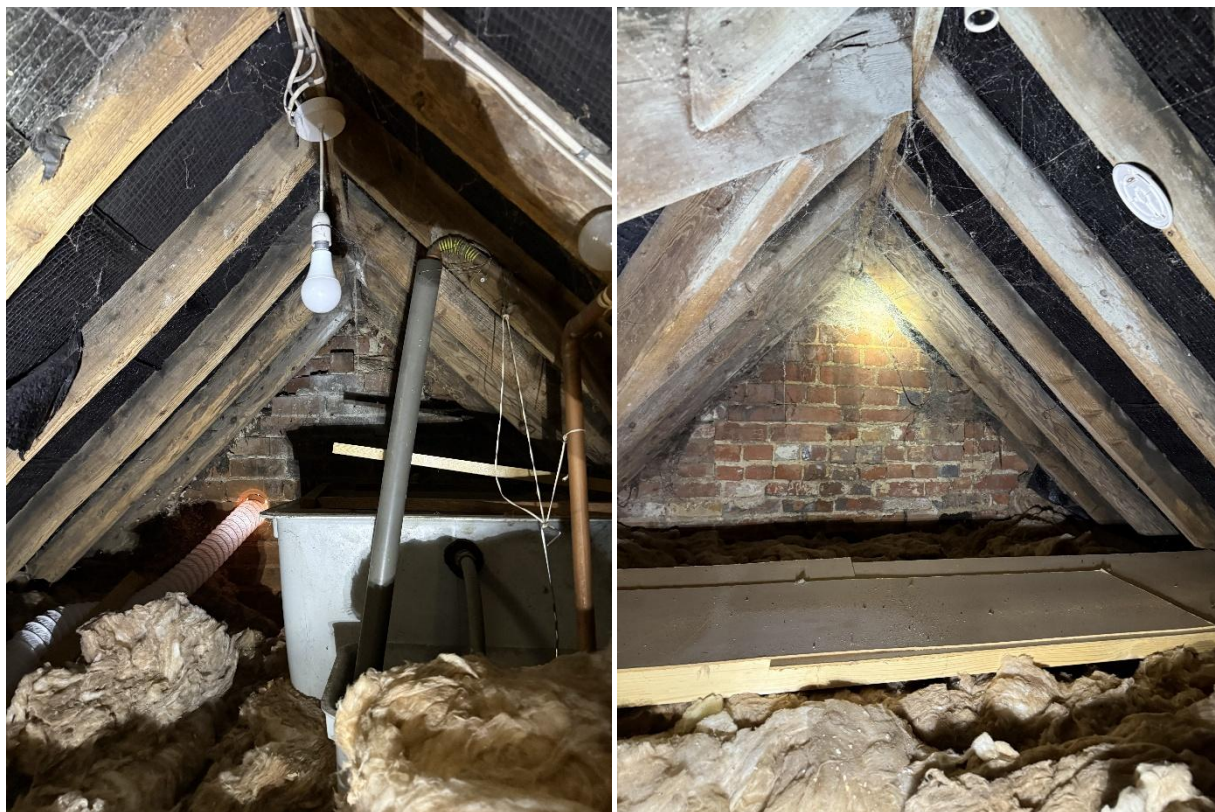
- 3.3 A pre-commencement inspection of the loft space and the roof was carried out. No bats or signs of bats were found.
- 3.4 Prior to the commencement of works, the contractors were given a “tool box talk” which included: background legislation in relation to bats; the most likely areas to expect bats; and, details of what to do if bats were discovered.

Photos 3 and 4 – Pre-commencement check of loft

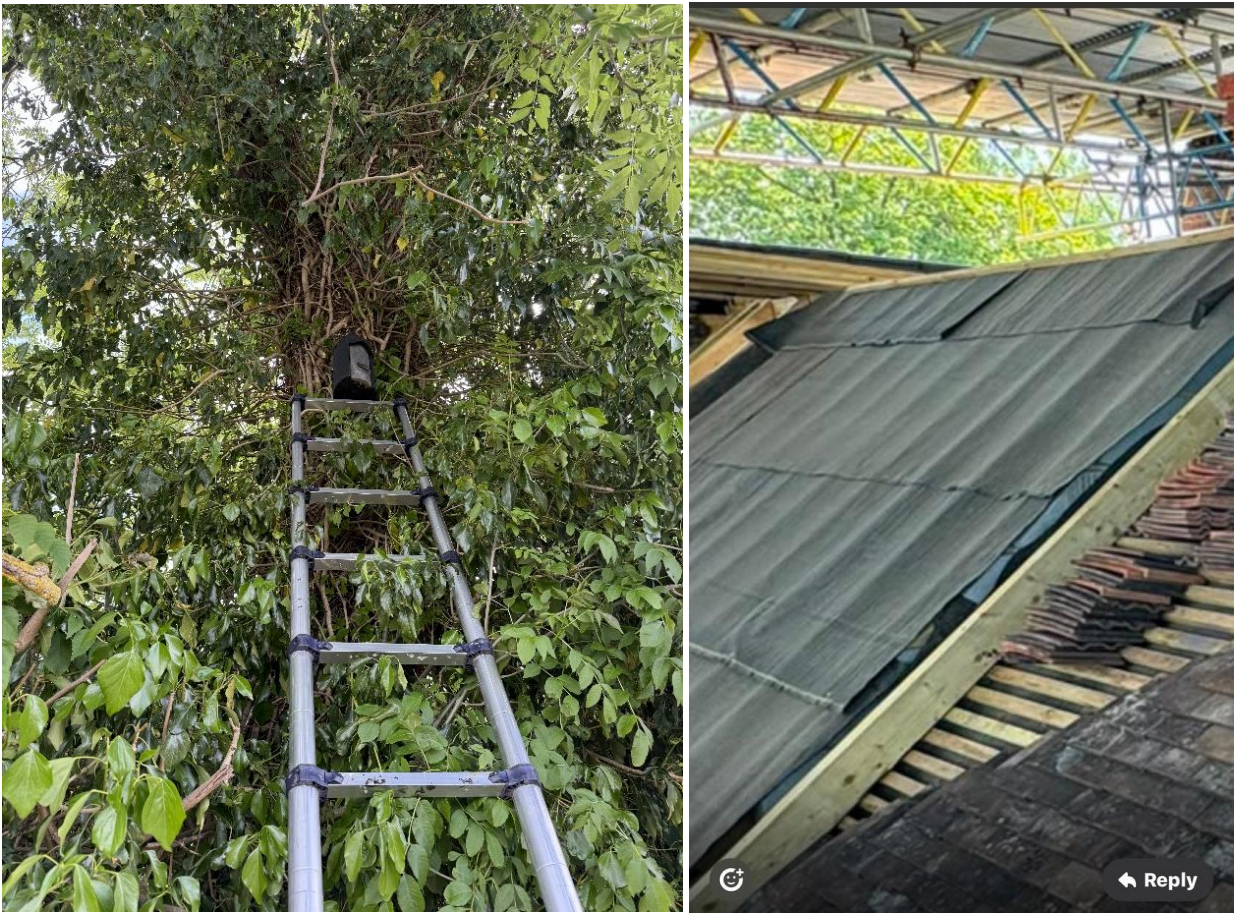
- 3.1 On 18 May 2026, I attended the site to act as ECoW and to directly supervise the roof works. I am an experienced bat surveyor, an associate member of the Chartered Institute of Ecology and Environmental Management and hold a Natural England WML A34 Level 2 bat survey licence.
- 3.2 Prior to the commencement of works a Schwegler 2F bat box was installed on a tree in the rear garden.

- 3.6 The contractors were then left to carry out the remainder of the works. The contractor has provided us with photos showing that a TLX BatSafe membrane had been used to line the new roof.

Photo 5 – A Schwegler 2f bat box installed on a tree in the rear garden, and Photo 6 – TLX BatSafe roof membrane
