Document viewer window titled 'FDA1351\_Mill Green London plane assessme...' showing Page 4 of 11. The text on the page reads: 'The rooting zone of the tree has been damaged by repeated vehicle movements over the grass, compacting and capping the soil. This removes air spaces from between the soil particles and prevents rain water from percolating into the soil, which in turn suffocates the roots and reduces available water. The usual symptoms of such root damage is declining vigour and thinning at the top of a tree's crown.'

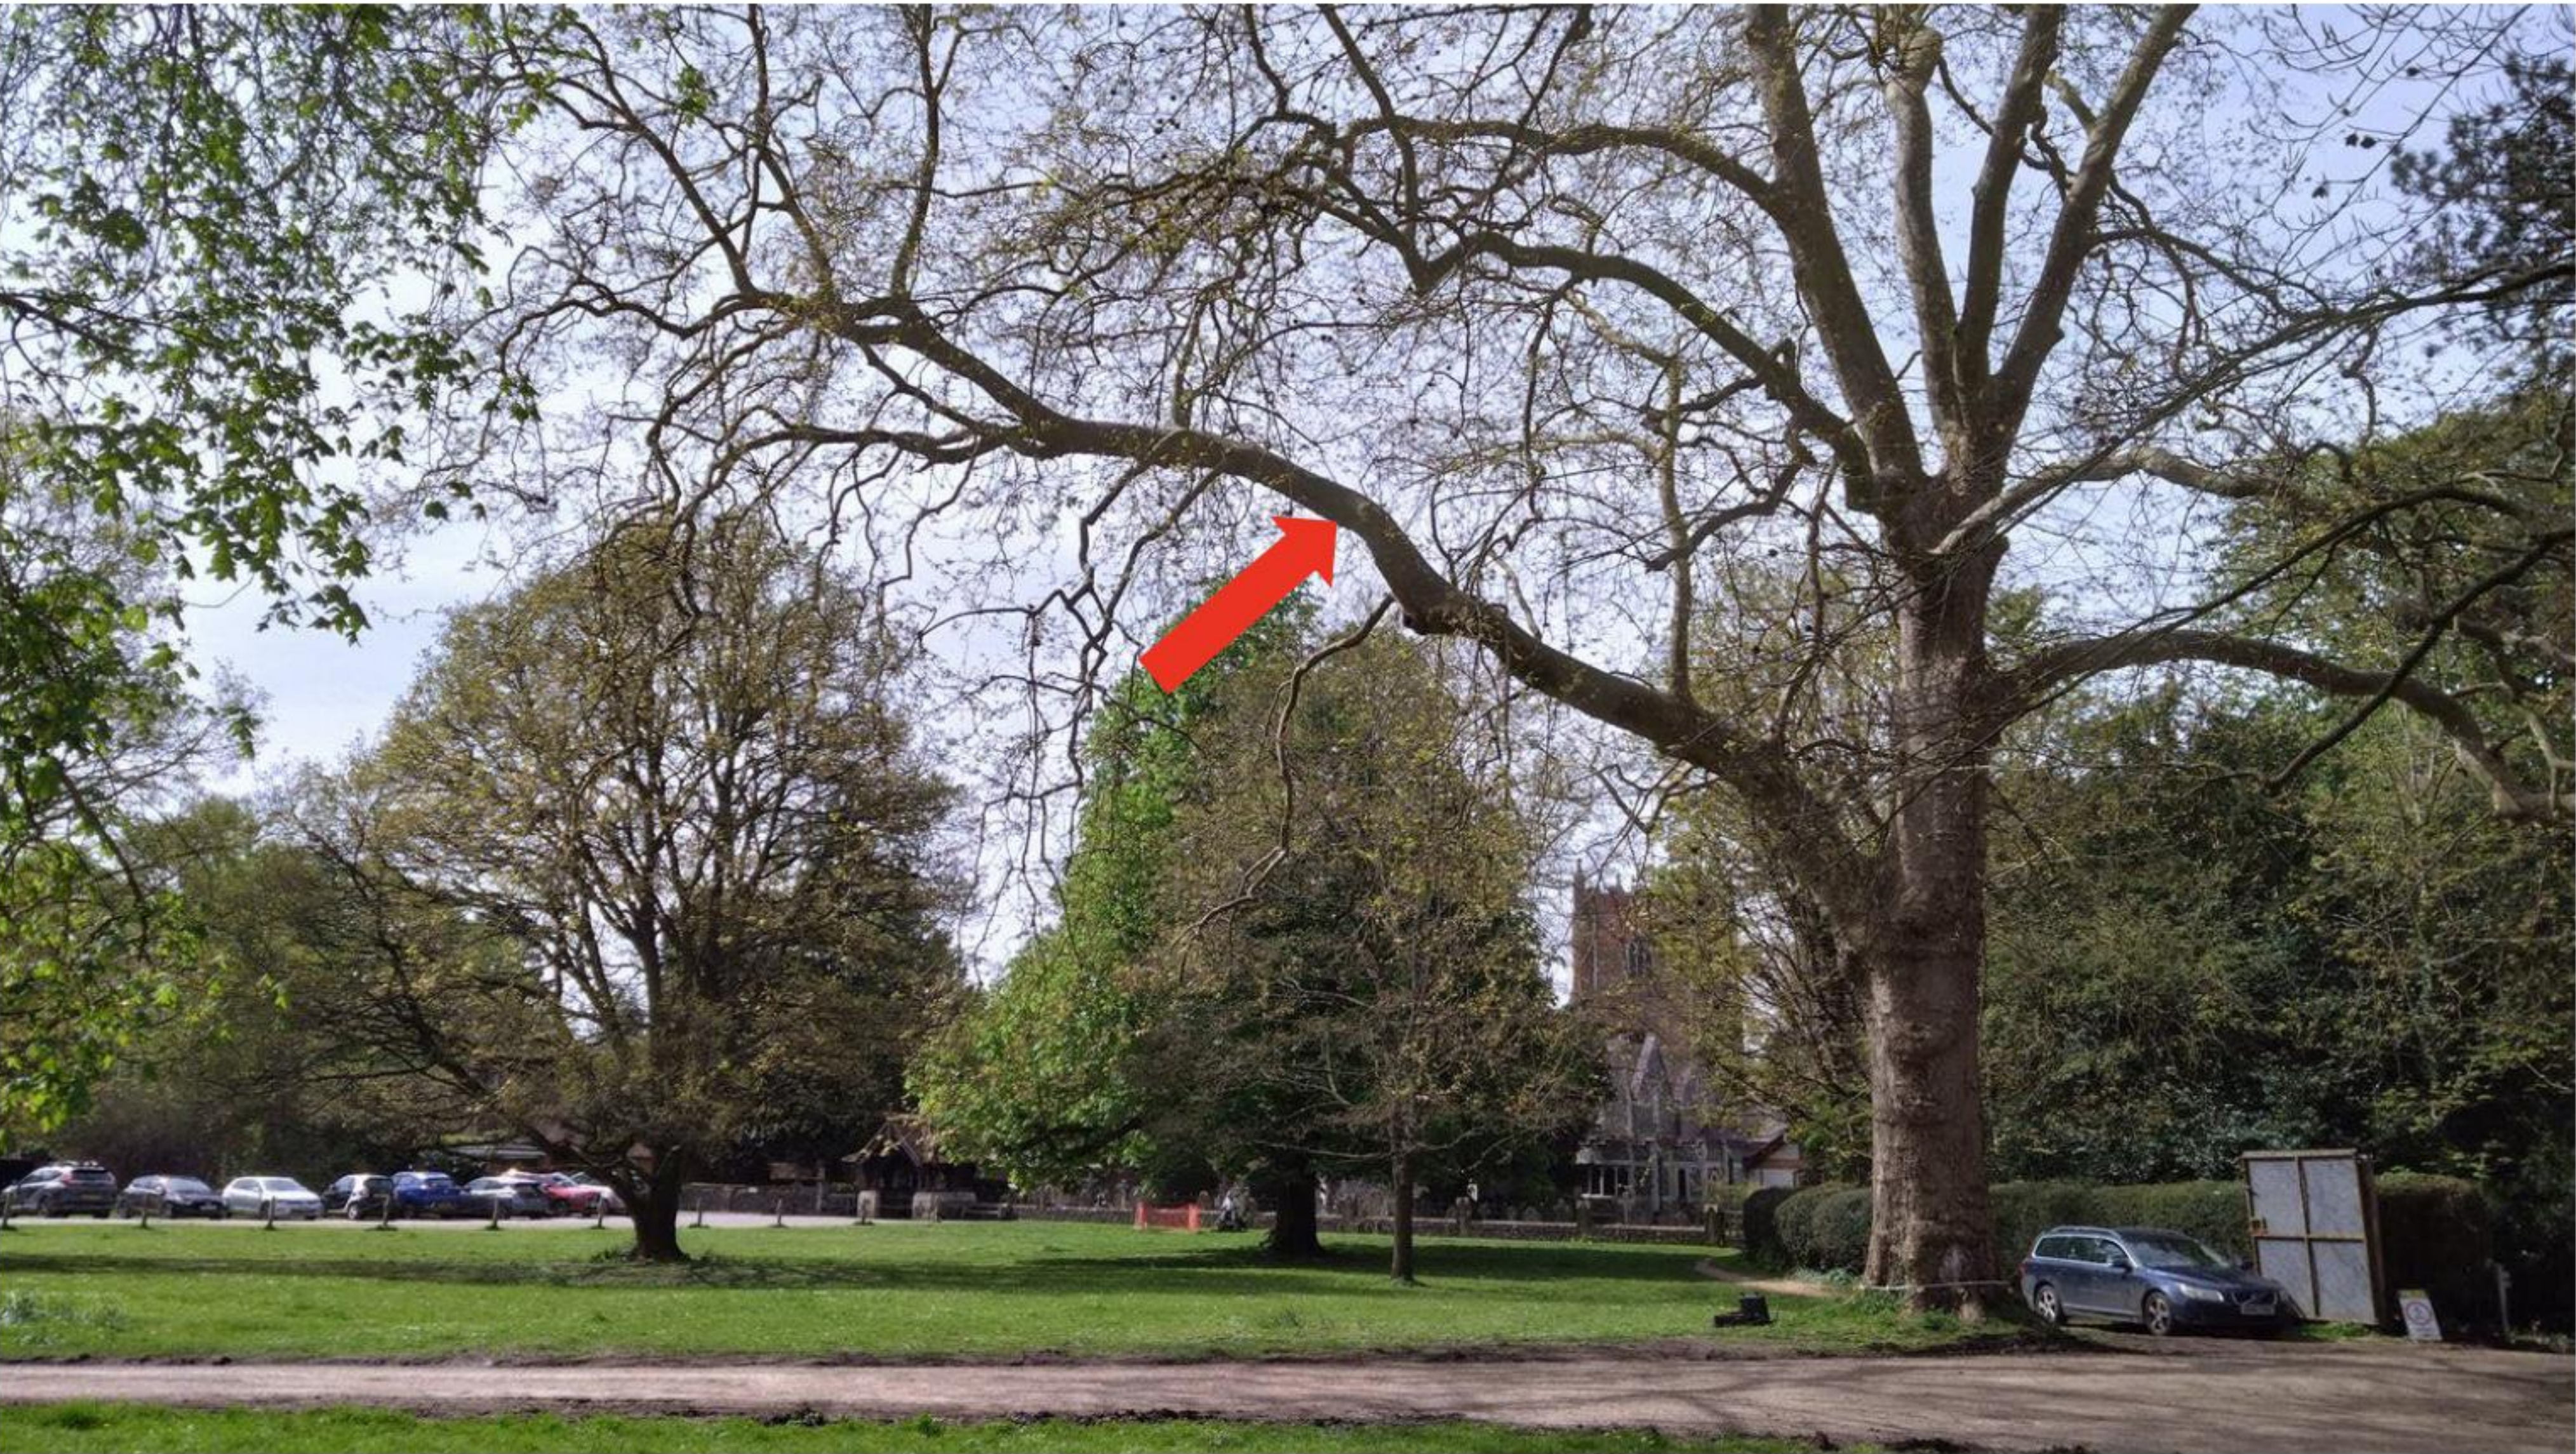
Figure 1: View of the tree from the east – large southern branch highlighted
