**Merewood**  
*Arboricultural Consultancy Services*

**Arboricultural Implications  
Assessment  
for a proposed development  
at  
The Old Thatch  
Lower Sandhurst Road  
Finchampstead  
RG40 3TH  
Rev A**

**Client: Robert & Lucy Westell  
The Old Thatch  
Lower Sandhurst Road  
Finchampstead  
RG40 3TH**

**Date**  
09/10/2025

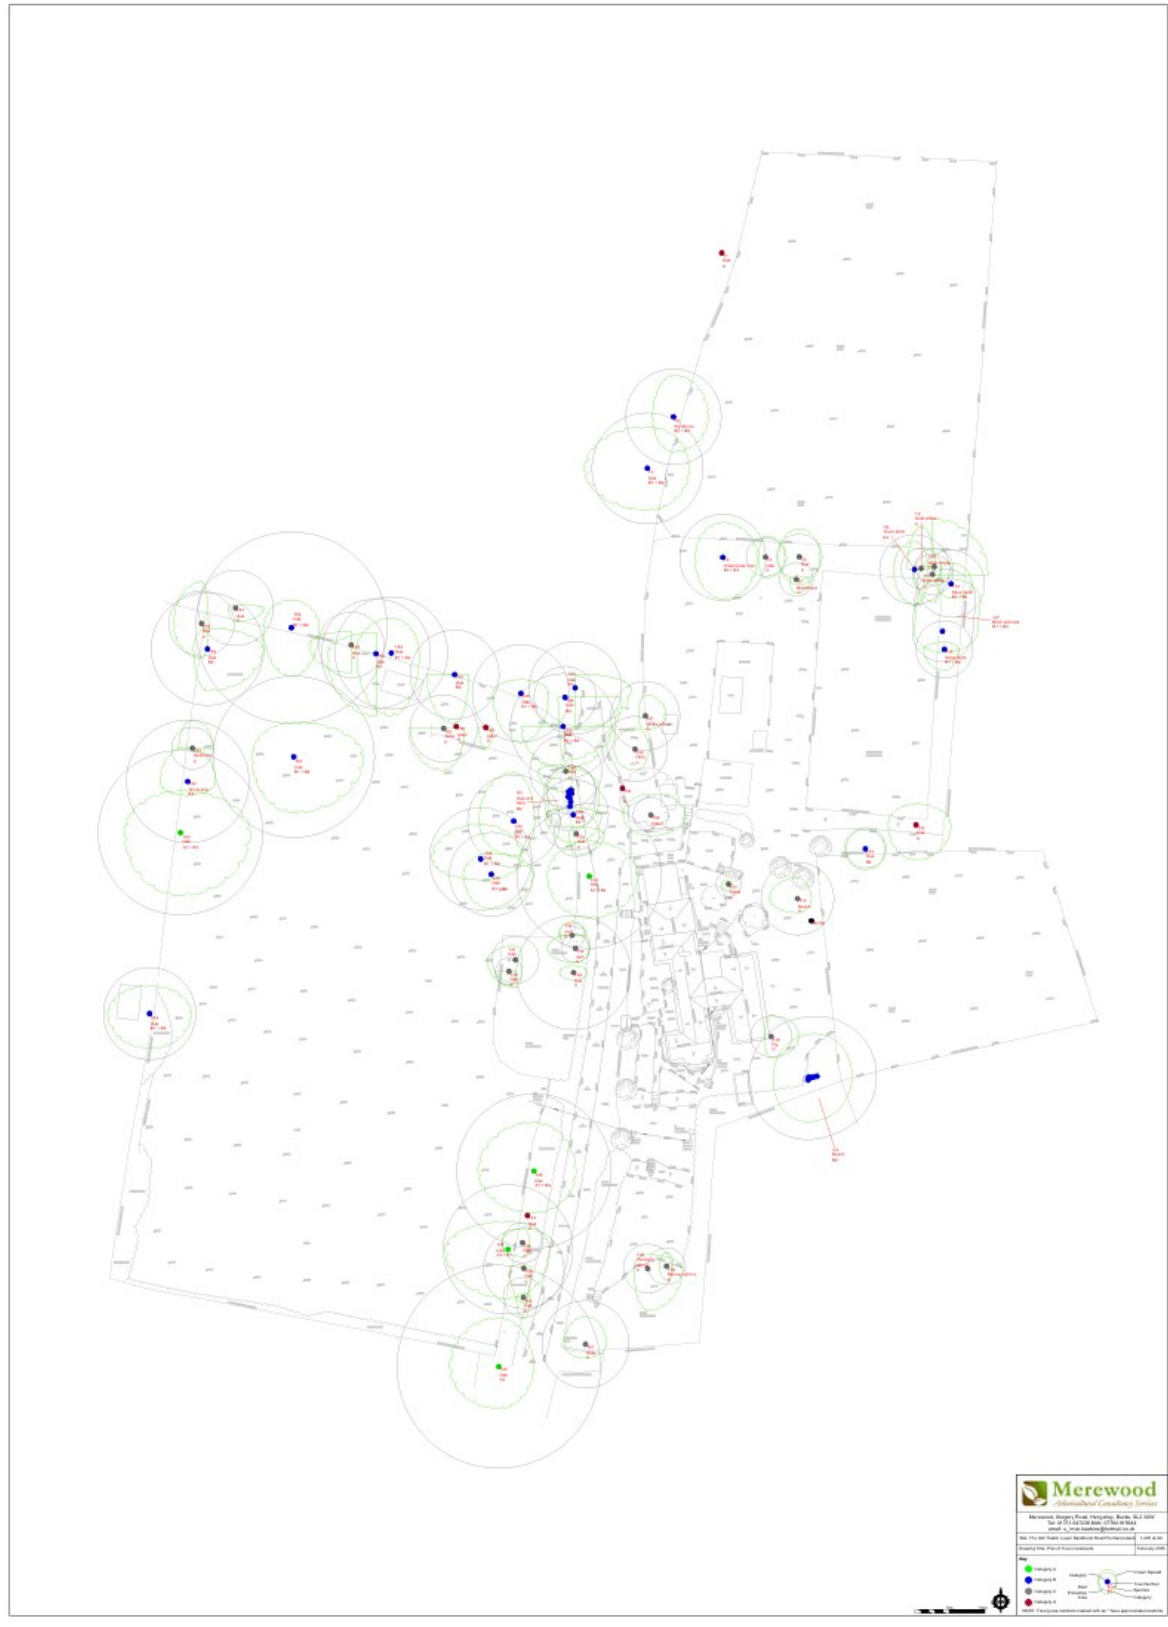
### Plan of Tree Constraints

2.1.2 The survey has revealed that that of the 64 trees and 3 groups of trees surveyed, 5 are category 'A'; 23 are category 'B' plus 3 category 'B' groups; 30 are category 'C' and 6 are category 'U'.

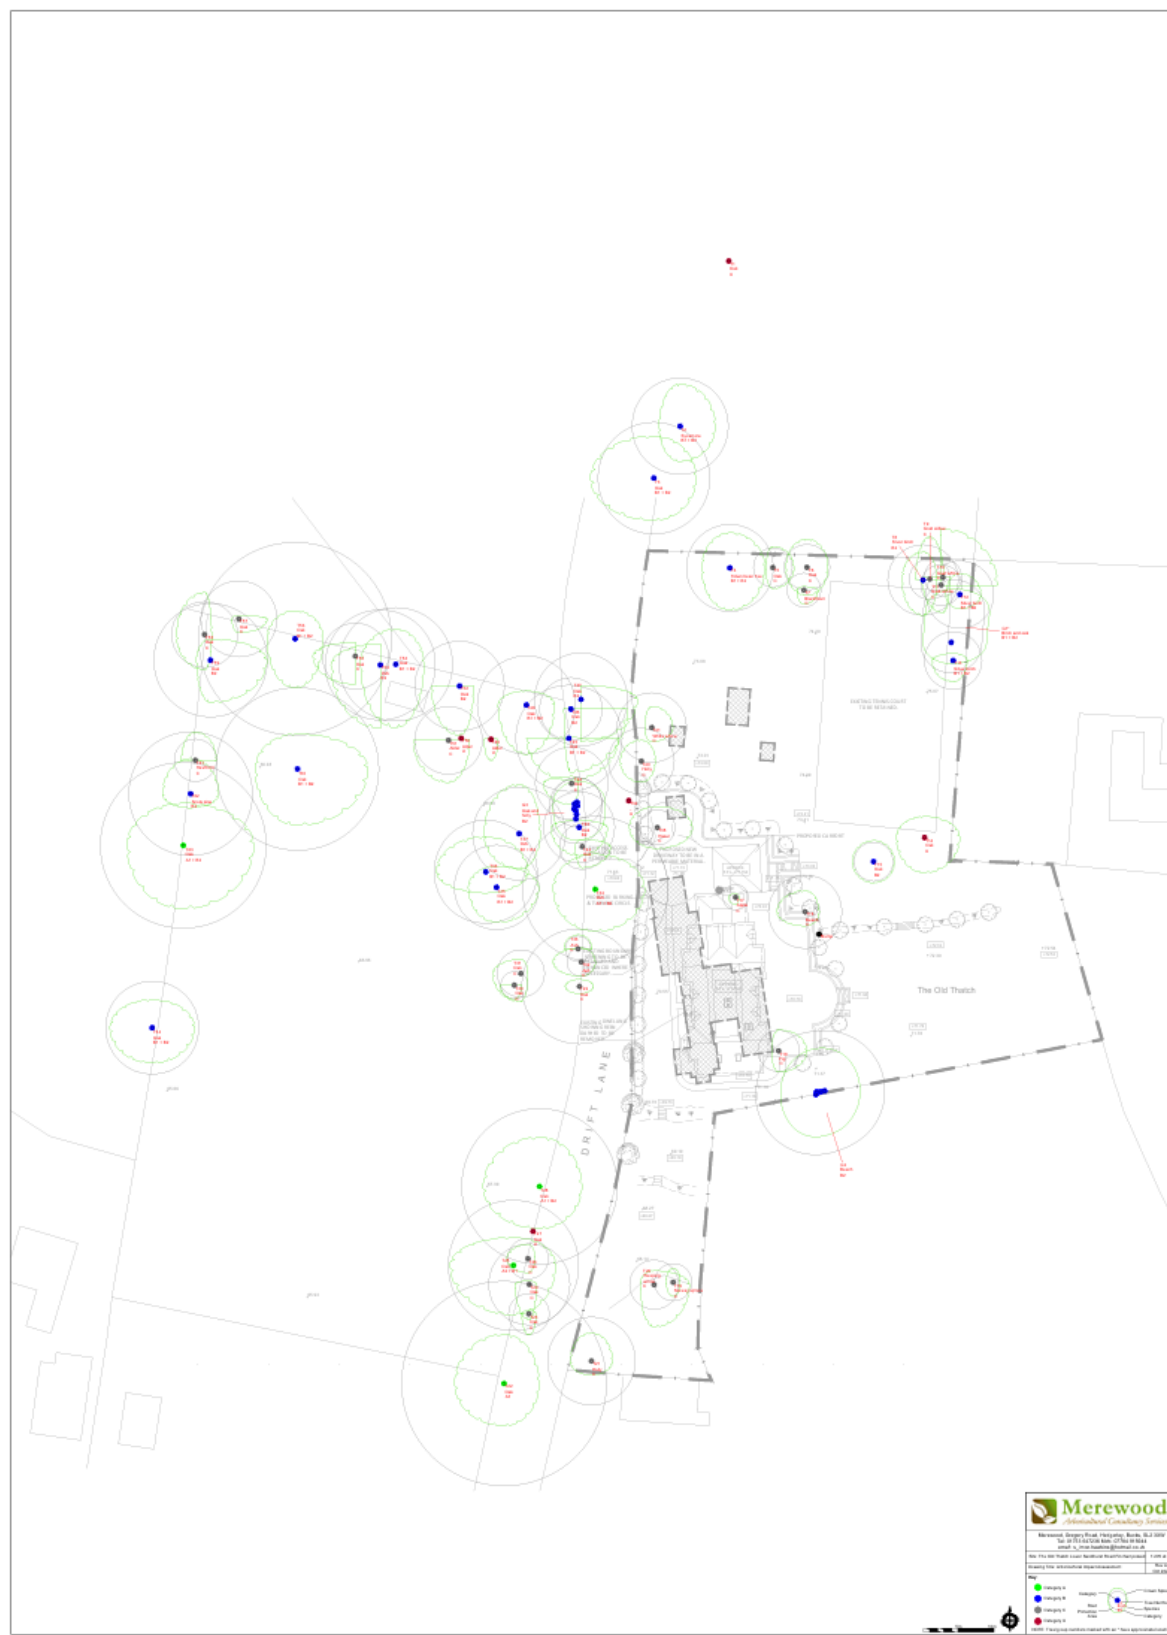
### **Impact Assessment Plan**

- 3.2.1 The proposals require the removal of a total of 5 category 'C' trees and one category 'B' group. These are T16, T17, T18, T38, T40 and G2.
- 3.2.2 In addition, dead and diseased trees with a limited life expectancy (category U) are to be removed in the interests of sound arboricultural management.

- 3.6.1 The proposed driveway takes a different shape and position to the existing driveway but would create only a very minimal impact on the RPA of the oak (T34). This conclusion is reached taking into account the existing driveway and the existing building, the footprint of which will be partly occupied by the new driveway following demolition.
