## ARBORICULTURAL DEVELOPMENT REPORT

### Development tree report for Mr I. Lowe

Site Address:  
42 Tanhouse Lane,  
Wokingham,  
Berkshire,  
RG41 2RL

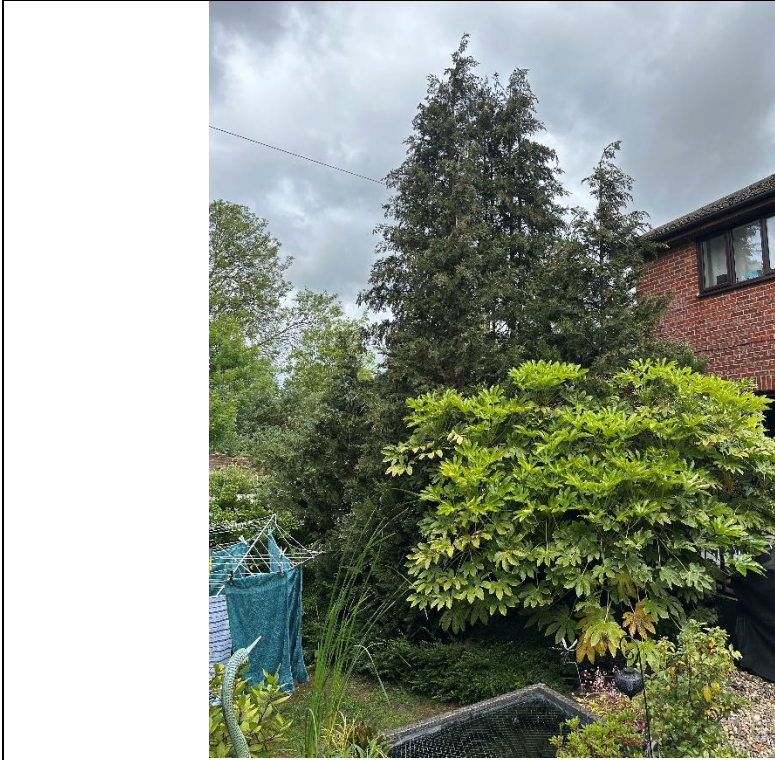
T1 – to be removed.

This tree has already been scheduled to be removed within two weeks of this report's writing. There are no other trees of influence within B.S.5837:2012 recordable size standards.

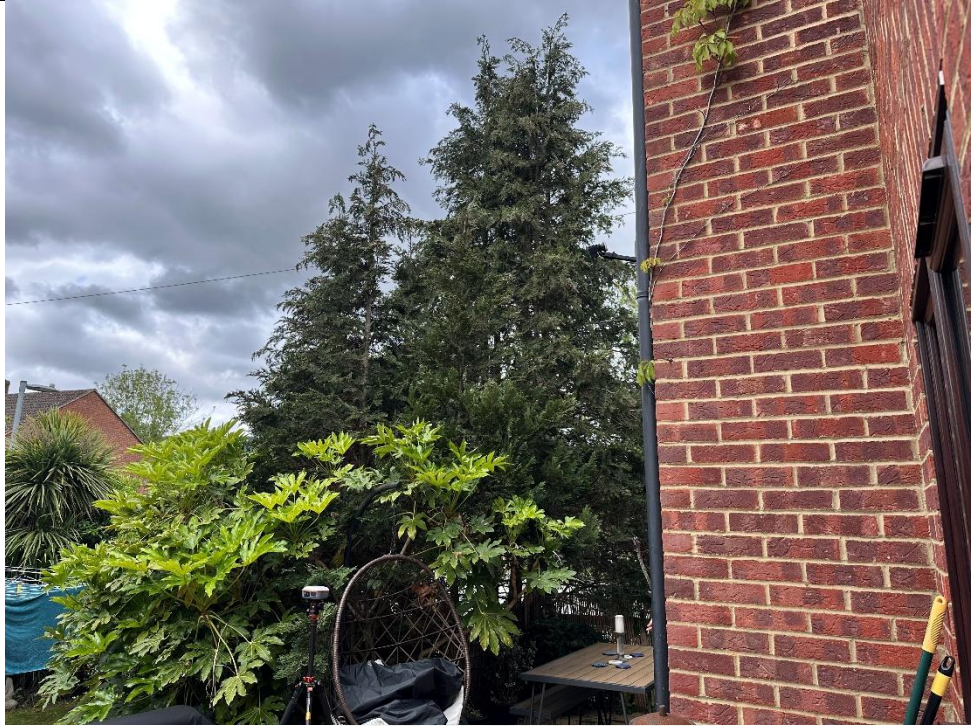
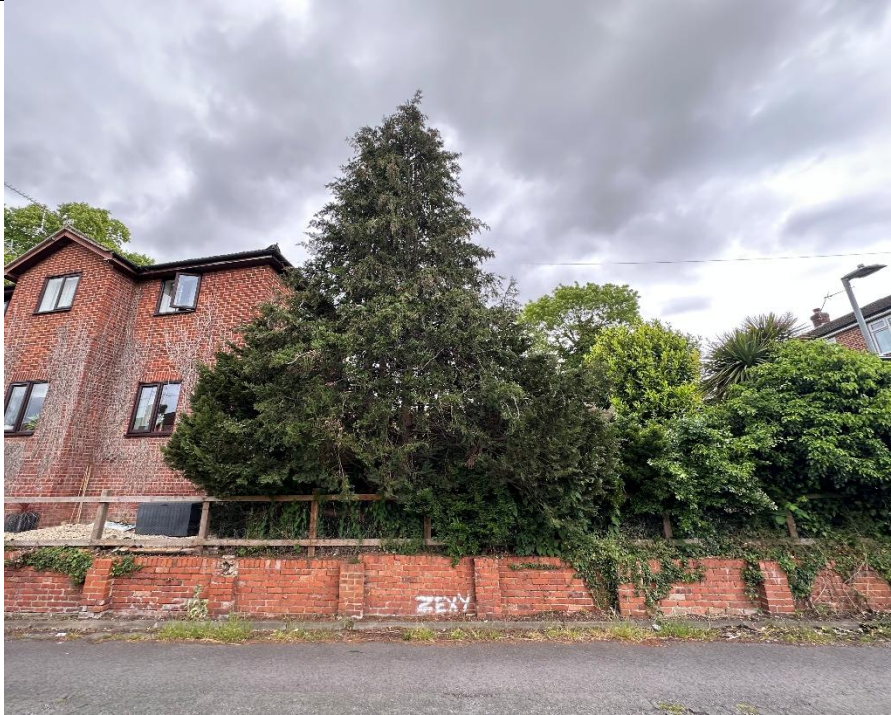
T1 viewed from Tanhouse Lane. Also depicts the area for materials to be delivered over the vegetation.

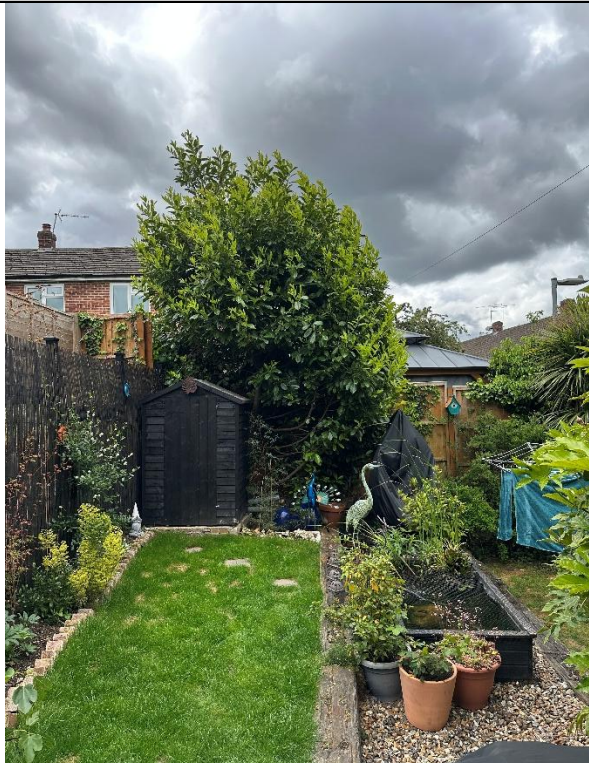
Laurel below recordable standards.

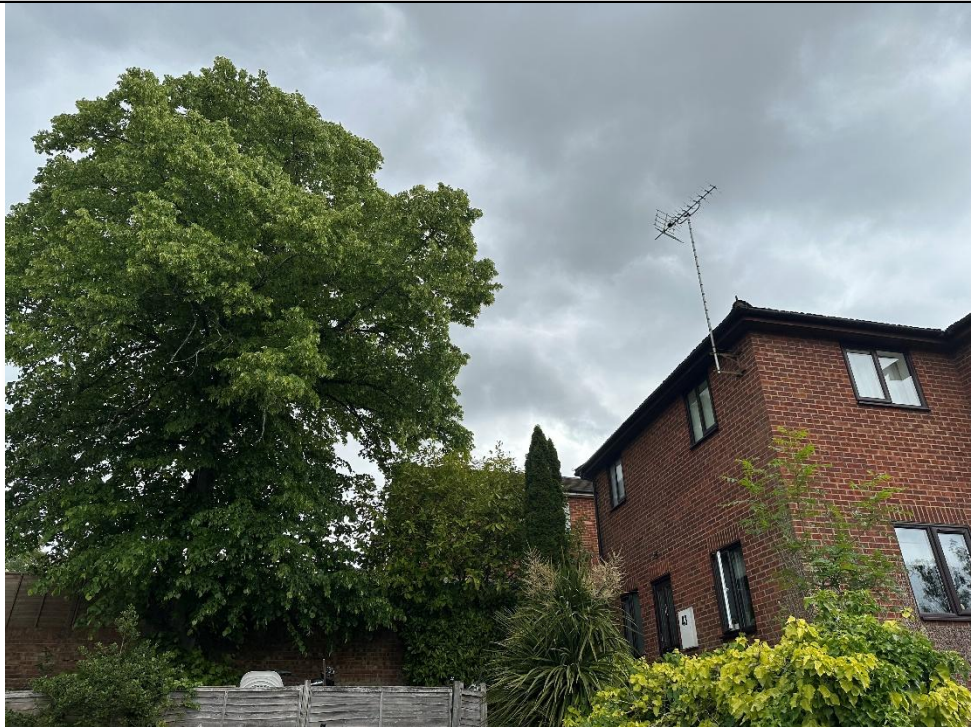
Common Lime (*Tilia x europaea*) located in the rear garden of 43 Tanhouse Lane.

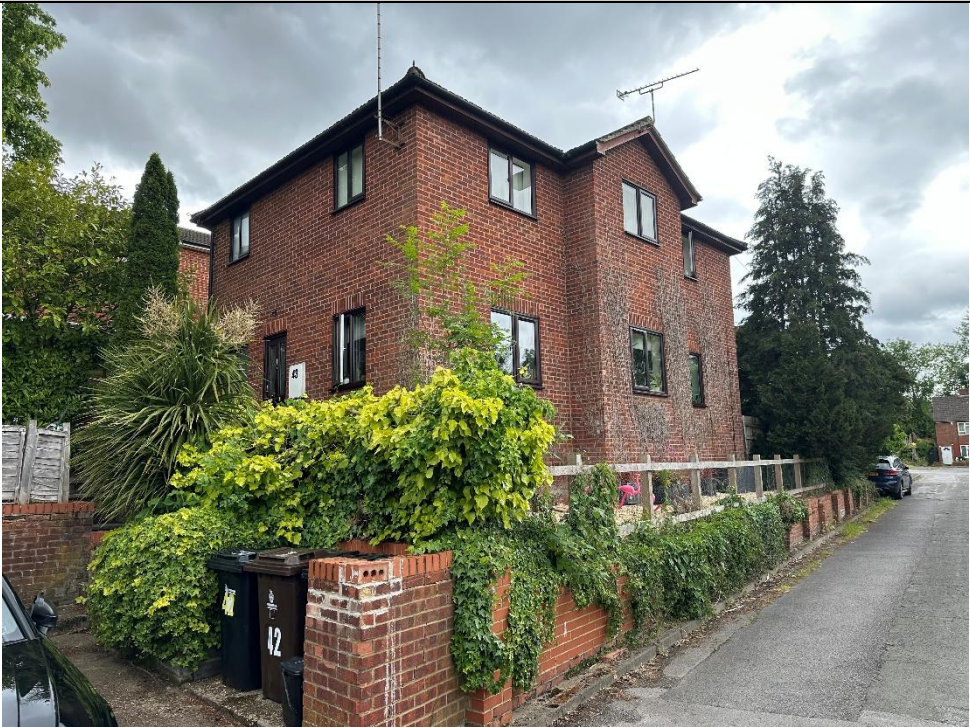
Overview of 42-43 Tanhouse Lane, with T1 in the background.
