## 2, The Rise

### Verification of application evidence

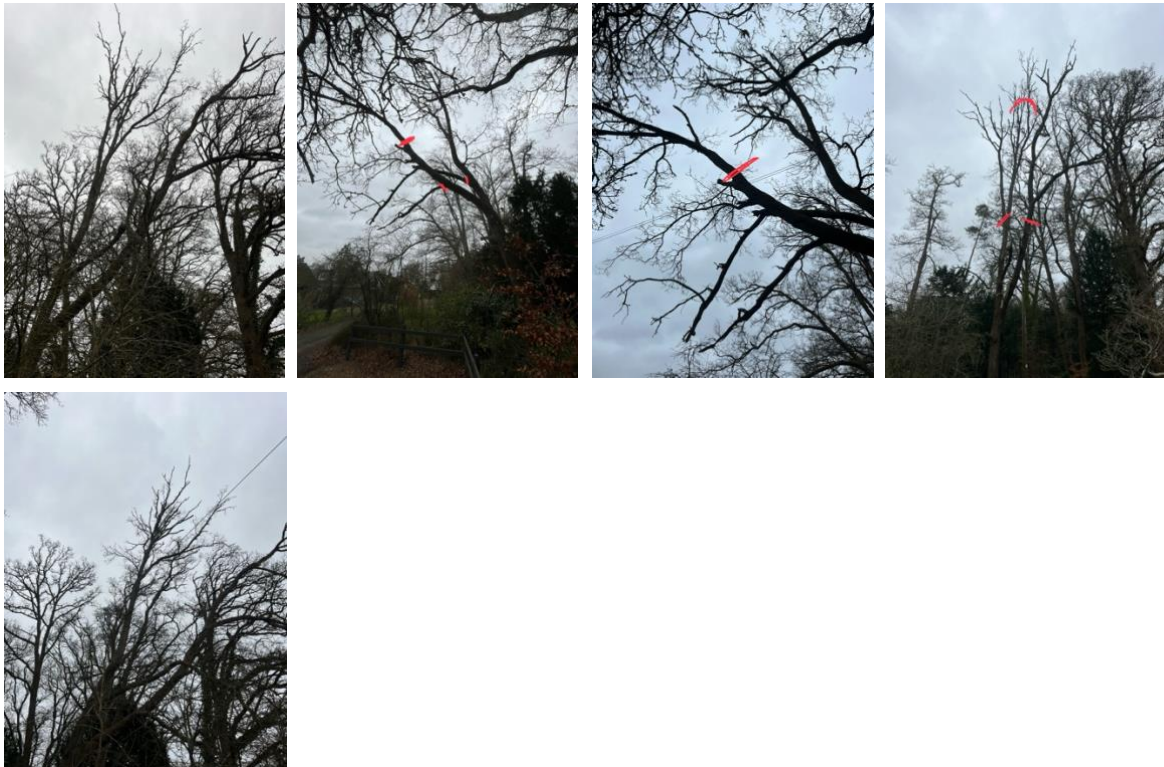
#### T1

These photos below demonstrate why the work has been requested for this tree. The tree is in decline, heavily weighted towards the property and with a large amount of deadwood present. I have proposed the large lower limb to be reduce and brought back to the small amount of live material approximately 2-3m from the main union. The danger being this would not split from the union but snap out over vehicle property in high winds. Tree also has a lot of dead material around the rest of the canopy. Particularly in the top where one of the two leaders has died off. I also believe reducing the height by 1-2 m will protect the tree from any further wind related damage.

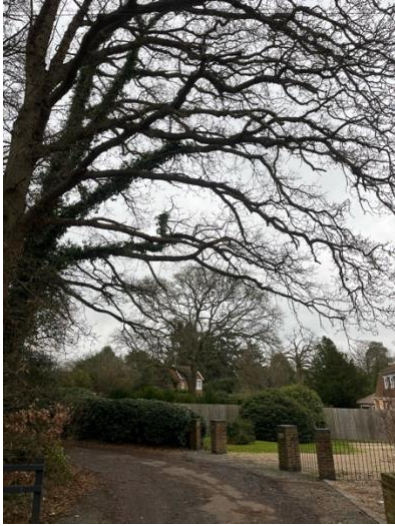
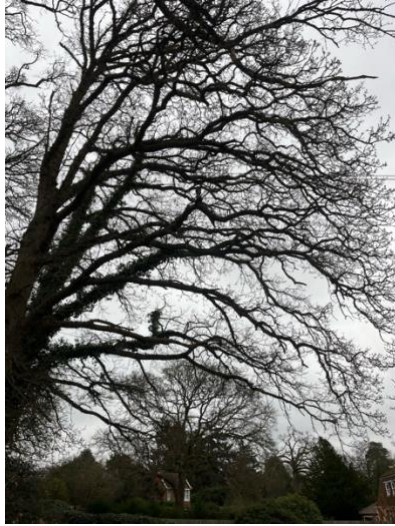
#### T2

Tree just needs a lift over the road as larger vehicles, mostly waste collection vehicles has struggled to fit underneath it without damaging them. Recommend lifting the tree up to 4.5m.
