### Arboricultural Impact Assessment

| Address: | Yaffles, Beech Hill Road, Spencers Wood, Reading RG7 1HT |
| Date: | 24/02/21 |

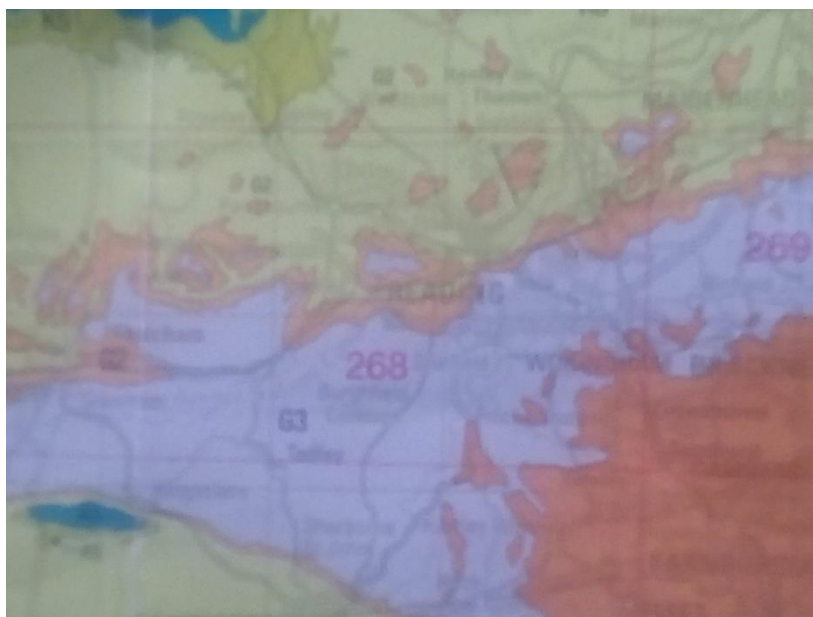
Figure 1

The British Standard advises at 4.3.1 that soil type should be considered when designing foundations. It appears (G3) from the British Geological survey map (figure 1 below) that the site is underlain by a silty clay and sandy clay (Thames Gp).

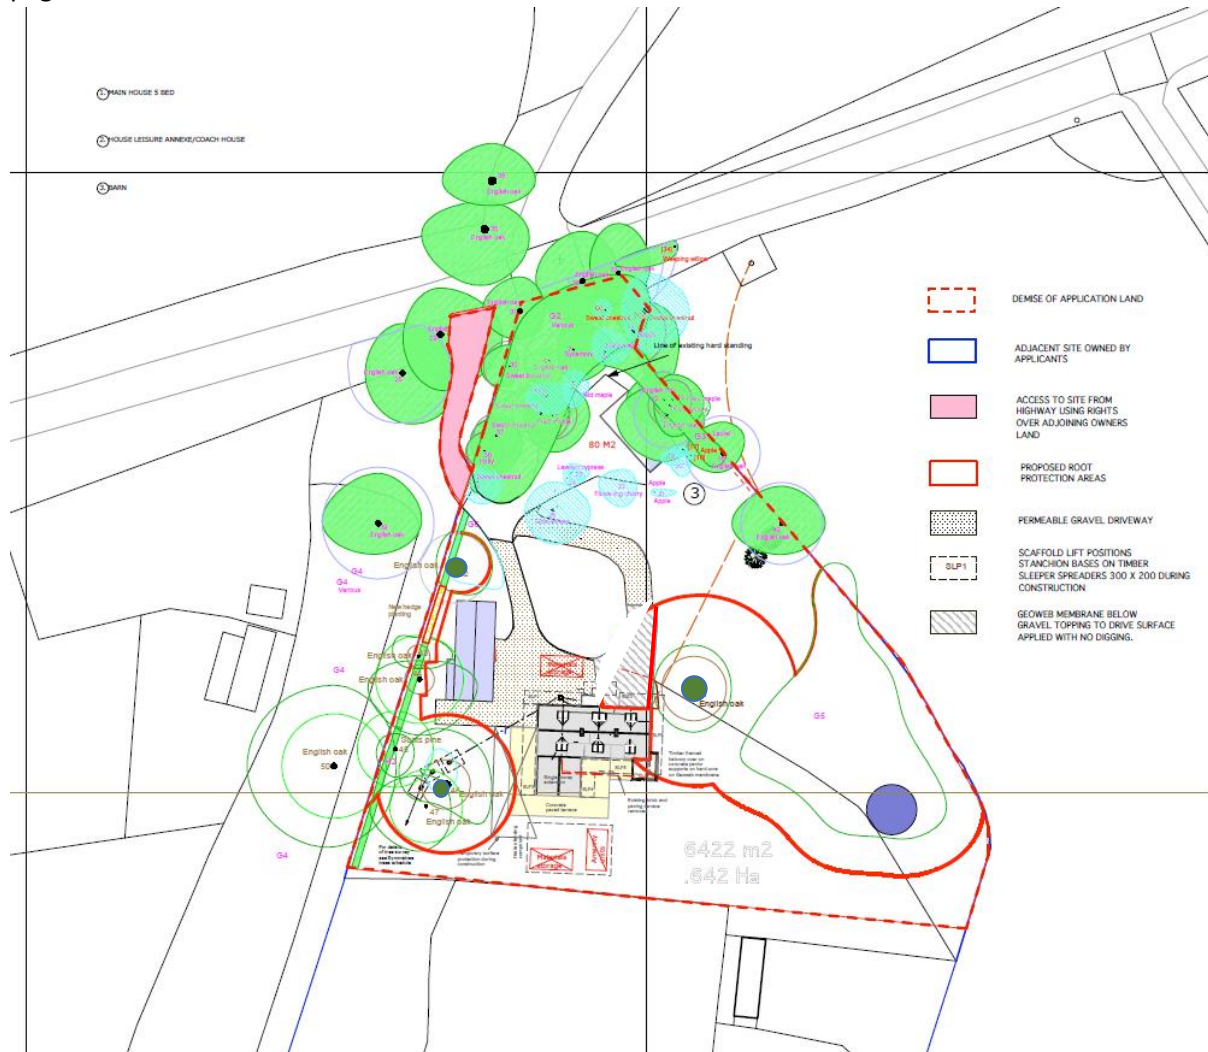
### 9.0 Tree Protection Plan

The following plan shows the positioning of the RPA fencing with distances from trees calculated in SYM01, and to be read in conjunction with page 07. The construction of fencing is shown in figure 2, page 11.

The positions of protective fencing must be erected before any groundworks take place or any materials are delivered on site. Fencing will remain in place throughout the construction and will only be taken down to allow final landscaping. For distances calculated see the table SYM 01, Page 7. To mitigate risk of damaging trees any access into the site and storage of materials must also be outside any exclusions zones.
