Clarke Webb Ecology Limited

GTO House

Proposed replacement of storage shed with new barn

Ecological Appraisal

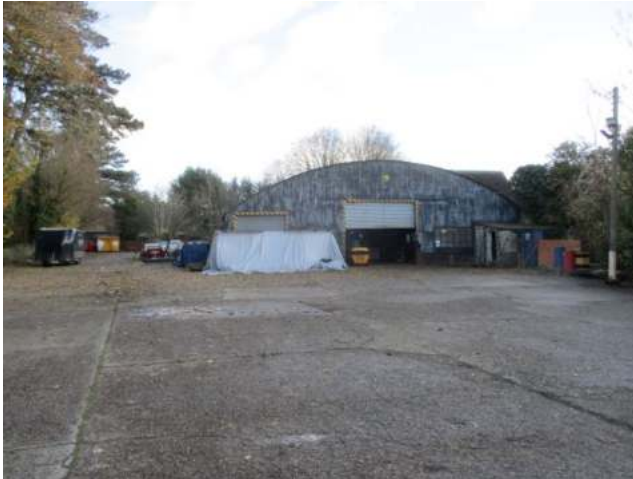
P1. Building B1 as viewed from across the yard to the northwest.

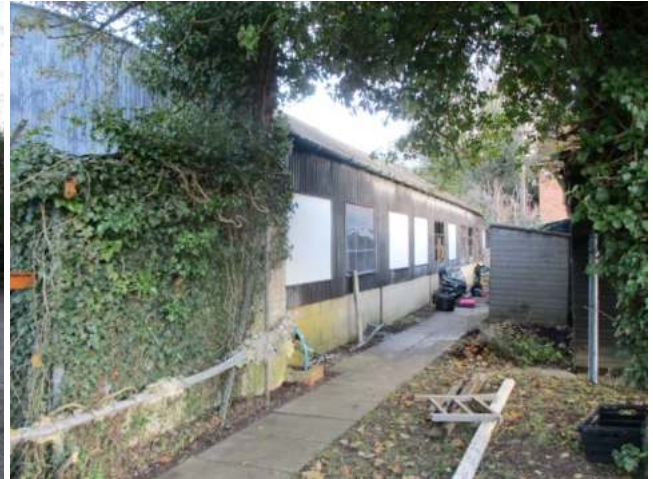
P2. The south elevation of Building B2 as viewed from its southwest corner.

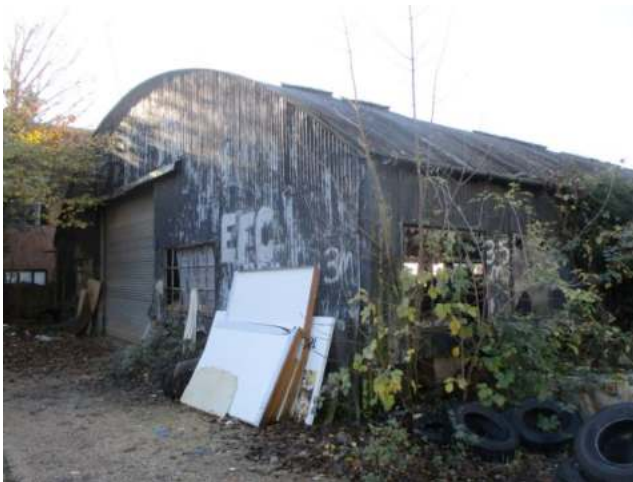
P3. Building B1 as viewed from the northeast.

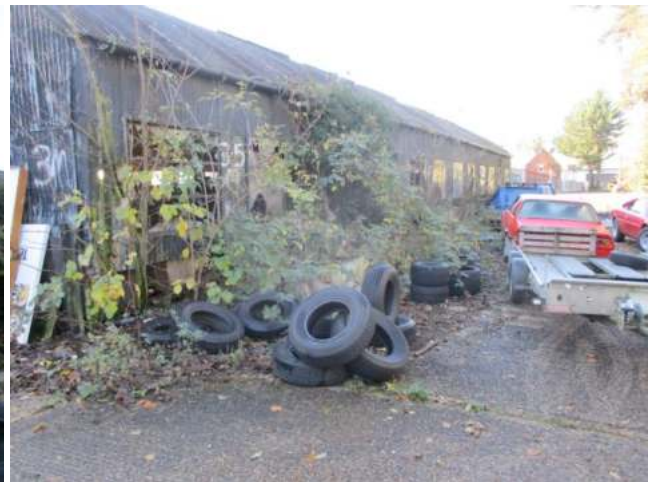
P4. The north elevation of Building B1 as viewed from its northeast corner.

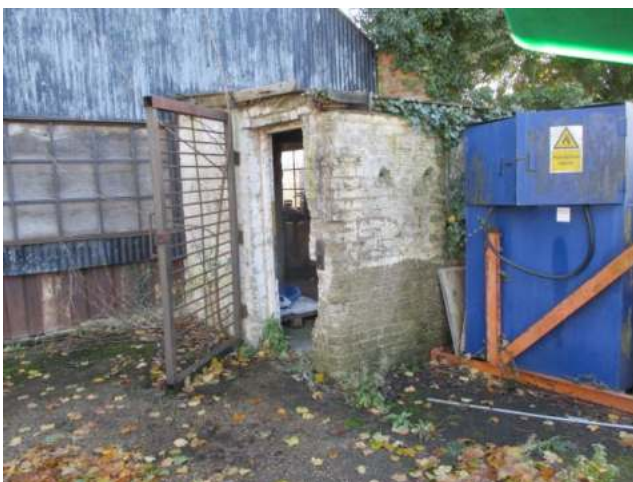
P5. The small, protruding entrance at the southwest corner of Building B1.

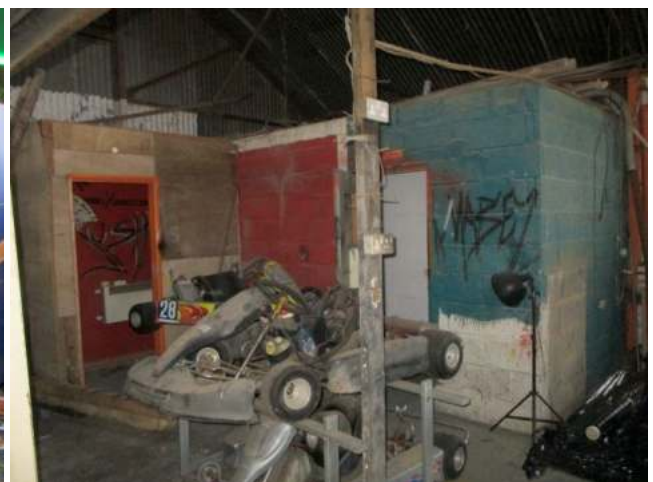
P6. The internal toilet block in Building B1.

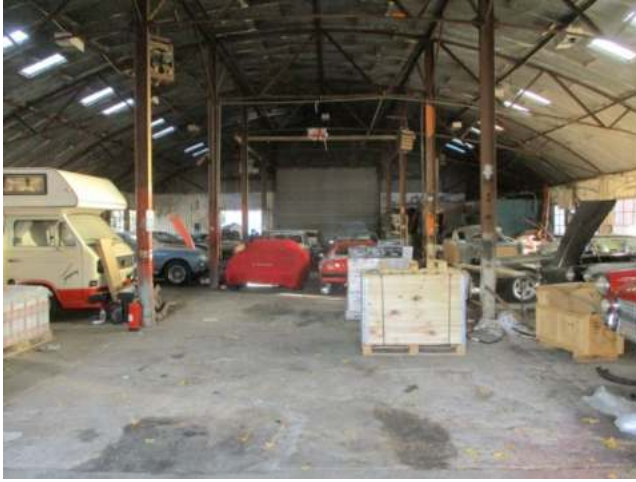
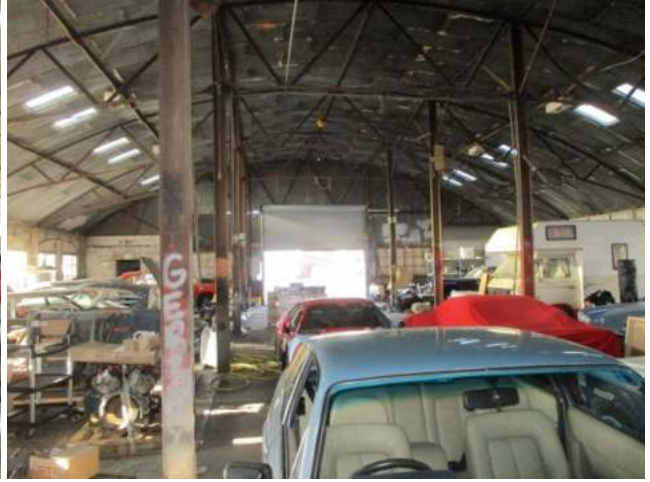
P7 and P8. The interior of Building B1.

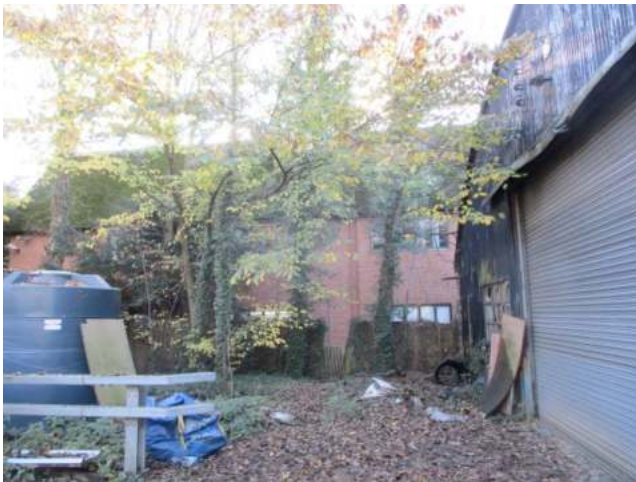
P9. The cluster of small Sycamore/Elm trees at the southwest corner of Building B1 (visible on the right) with GTO House visible beyond.

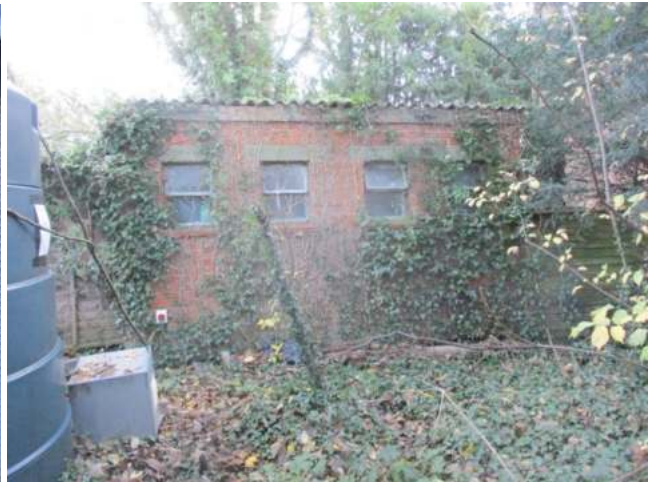
P10. The dilapidated outside toilet block to the east of Building B1.
