## Preliminary Roost Assessment

Hennerton House, Wargrave, Reading, Berkshire, RG10 8PD RG108PD

This report is prepared to inform a planning application with Wokingham Borough Council. This proposal can be described as the removal of existing single storey timber outbuildings that are structurally unsafe and replacement with a smaller single outbuilding for the same ancillary domestic use (storage and for the gardeners and their equipment). No residential floorspace is being created, removed, or altered. The gardeners' WC installed with the original sheds will be retained with minor refurbishment only.

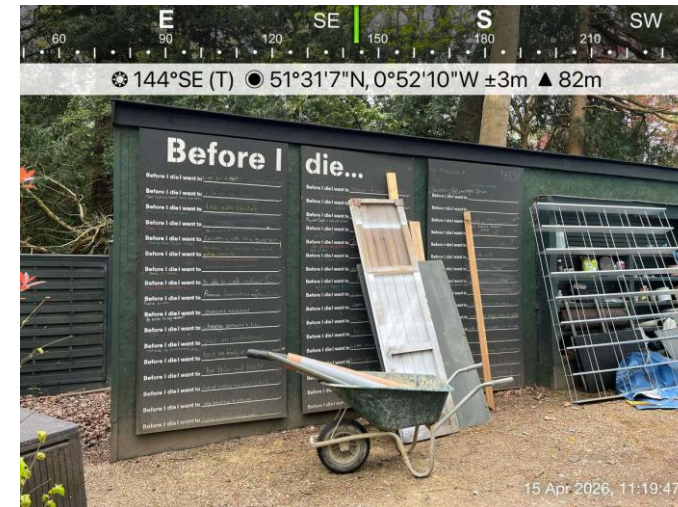
Northwest elevation of B1

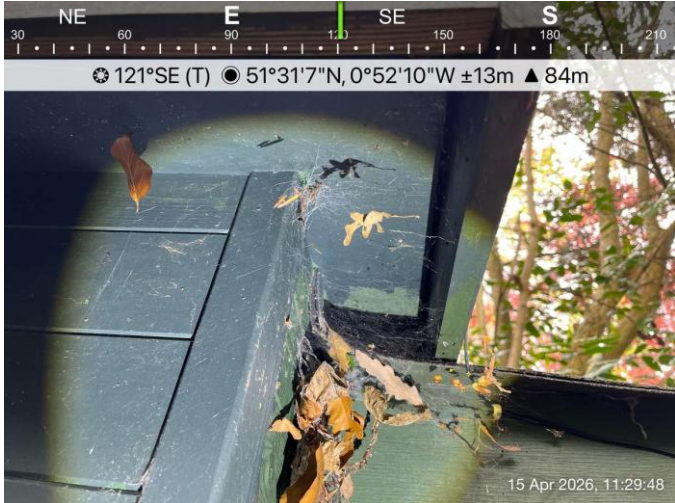
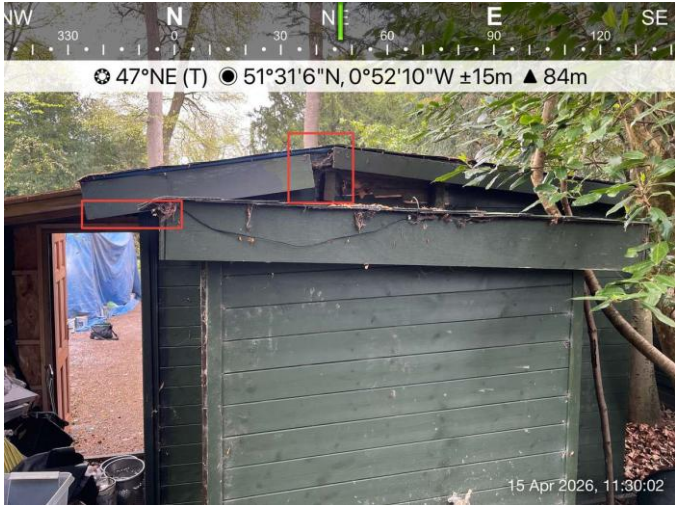
| | | | <p>Internal of the central section of the building.</p> |
|---|---|---|---|
| Eaves | Timber | The timber soffits were generally tightly sealed and well-fitted across the majority of the building. However, the soffit box on the southwest corner of the building is broken, with two open gaps leading inside the soffit box. It was possible to inspect the interior of the soffit box with a torch and see fully through both gaps. No suitable internal crevices were identified, and the soffit box is considered too open and exposed to the elements to support roosting bats. There was no evidence of bat presence, such | |

| | | | as droppings, urine stains, or feeding remains. | <p><i>View of gap in soffit box in the southwest corner with visible cobwebs</i></p> <p><i>View of the southwest elevation showing locations of gaps in soffit box</i></p> |

No evidence of nesting birds was identified on or within building B1. However, the broken soffit box may offer nesting opportunities for species such as house sparrows, starlings and tits.

Building removal should be undertaken outside the period 1st March to 31st August. If this timeframe cannot be avoided, a close inspection of the building should be undertaken immediately, by a qualified ecologist, prior to the commencement of work. All active nests will need to be retained until the young have fledged.
