## Preliminary bat roost assessment

| Site Location | 18 Silverdale Road, Wargrave, Reading, Berkshire,<br>RG10 8EA |
| Document<br>reference | CE4251 |
| Date of Site visit | 19 <sup>th</sup> April 2024 |

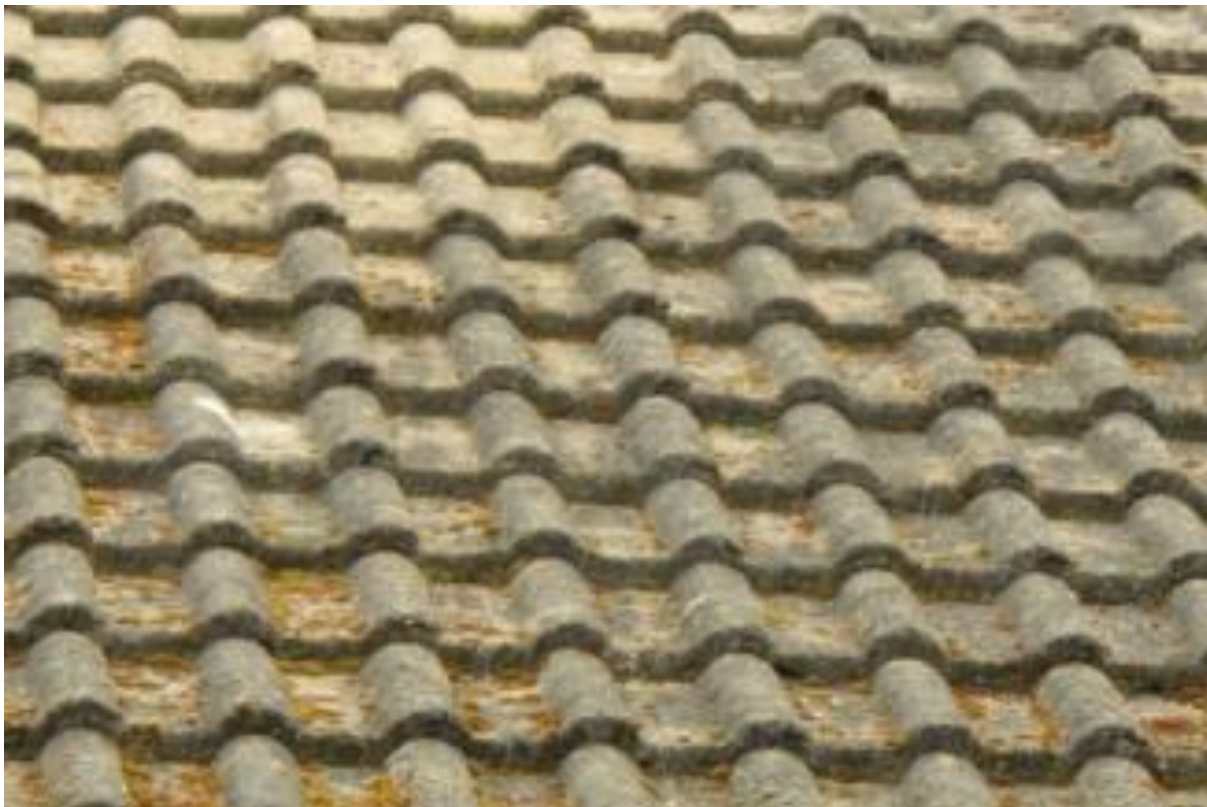
Image 2 – View of the front North facing roof coverings which have demonstrated a fair level of condition throughout

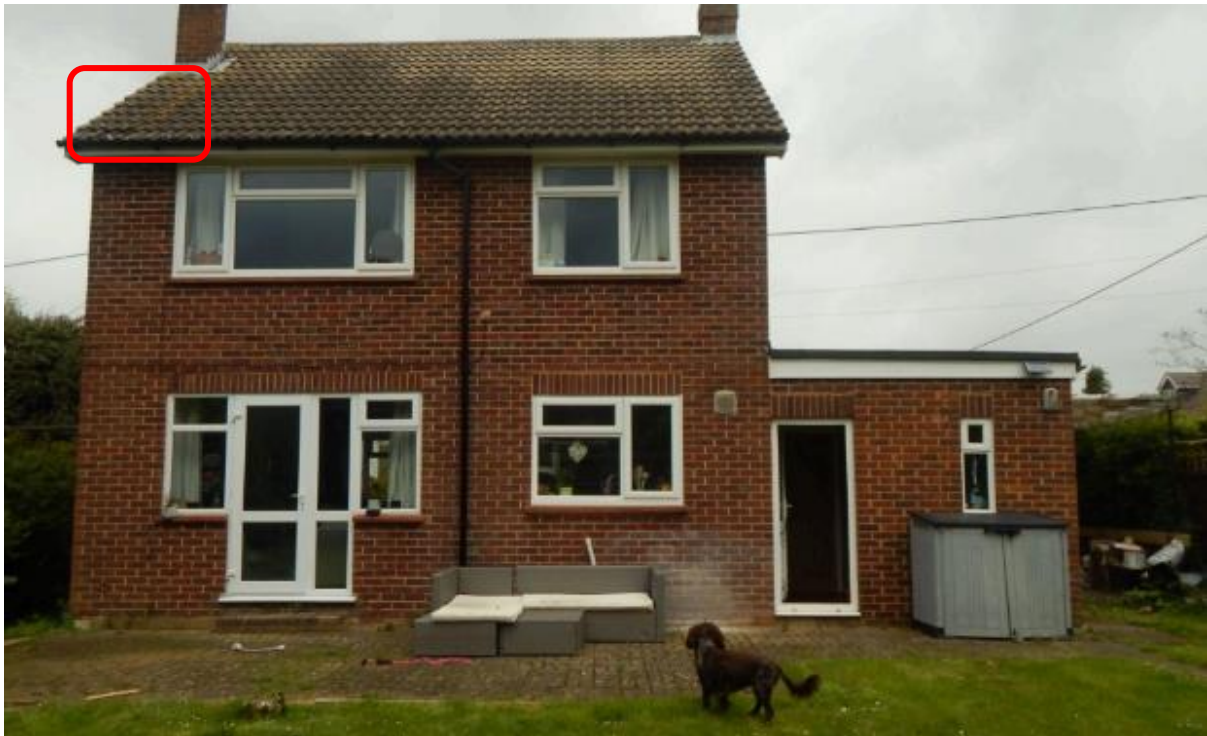
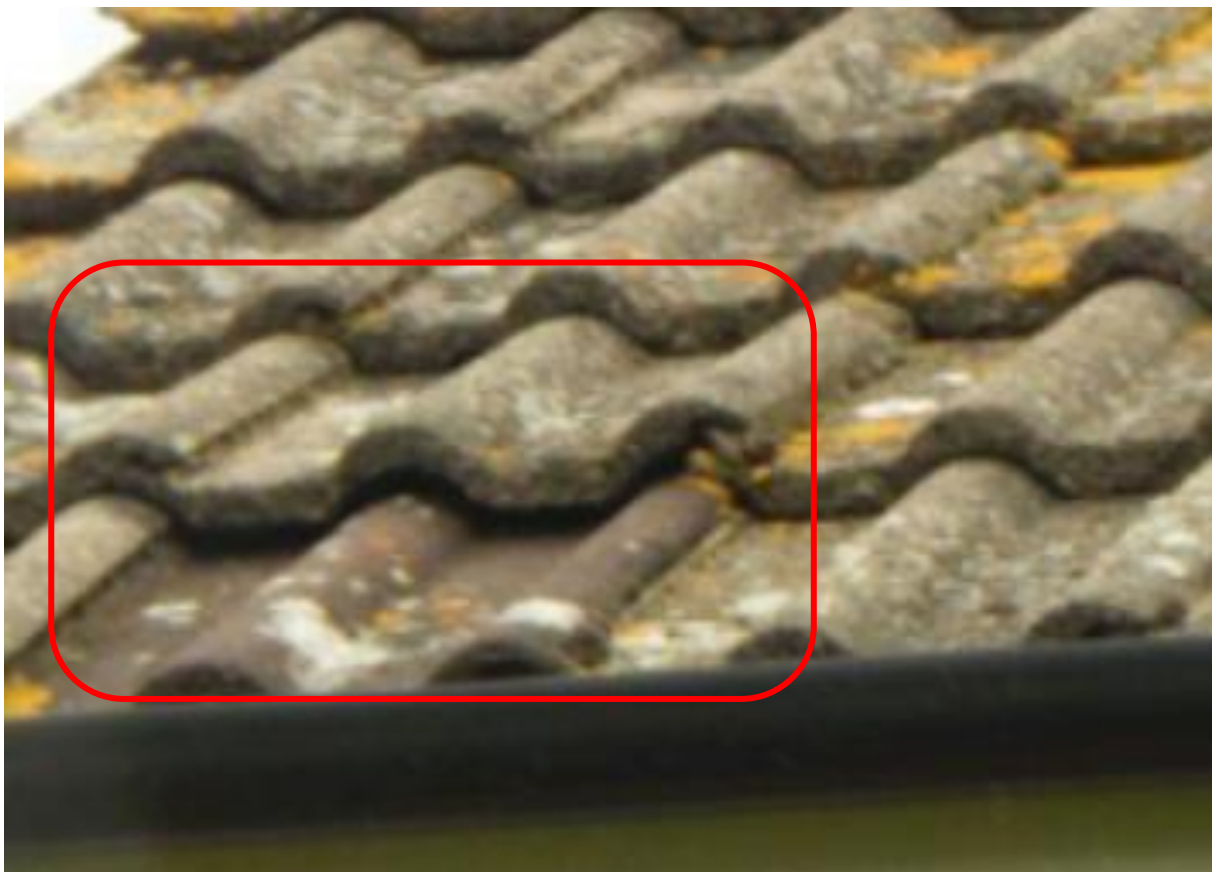
| External | Features of value to bats | Notes |
|---|---|---|
| Roof coverings | Yes | <p>The roof coverings in general have demonstrated a fair level of condition other than a small number of features to the rear South elevation.</p> <p>These features have included an area of raised tiles where the proposed development works take place which look to provide shelter/access opportunities for bats within.</p> |

Image 3 – Rear South facing elevation of the property offering an area of raised tiles of adequate proportions to offer likely shelter/access opportunities for bats

Image 4 – As per image three above

- 6.4** The main dwelling has evidenced roosting features of low value within the rear roof coverings which offer access and availability to both void & crevice dwelling bats and could not be fully ruled out during the Preliminary Roost Assessment without causing disturbance to materials which in effect may cause disturbance to possible bat roosts within.

- 6.6** In line with best practice survey guidelines, a structure that has demonstrated low value must have a further single emergence surveys to rule out or confirm activity from bats. This survey should be carried out within the recommended survey season from May to August.

**6.8** It is advised that no further works take place to the identified areas of value to bats at this stage as this may cause disturbance to bats and their roosts. see section 2.0 of this report

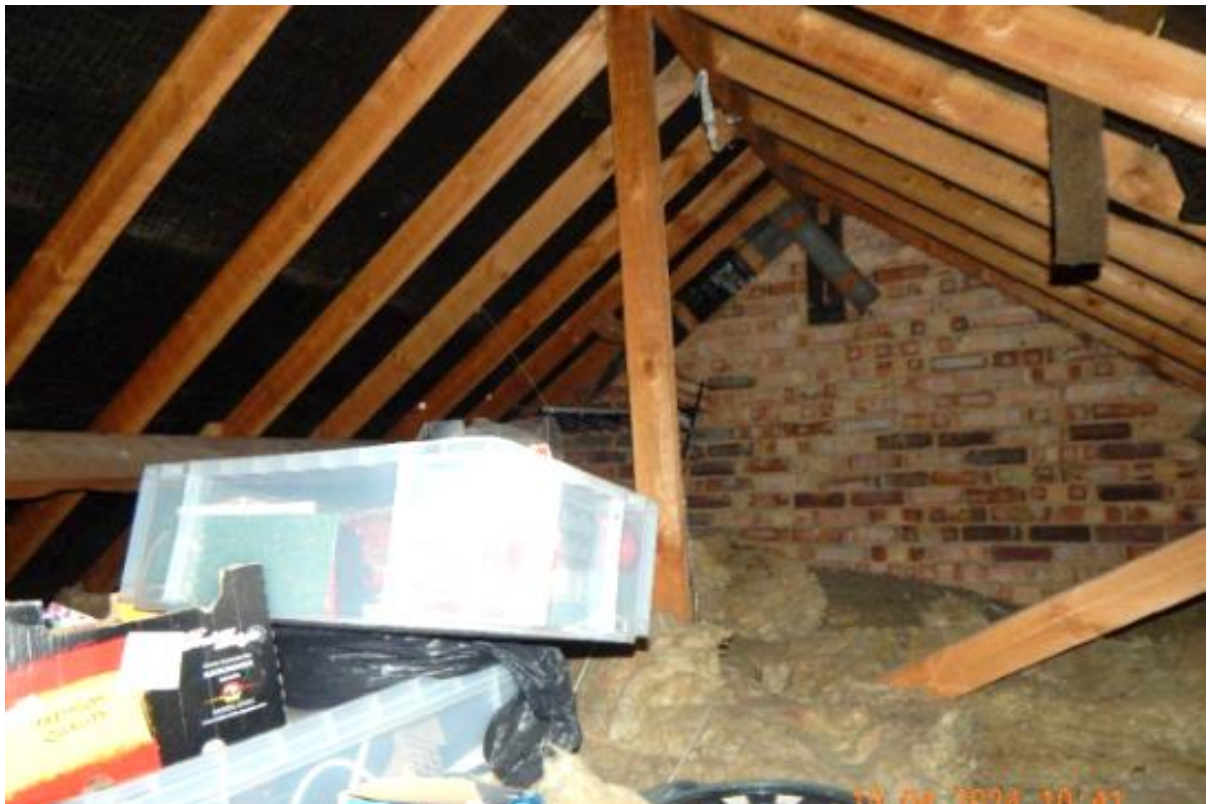
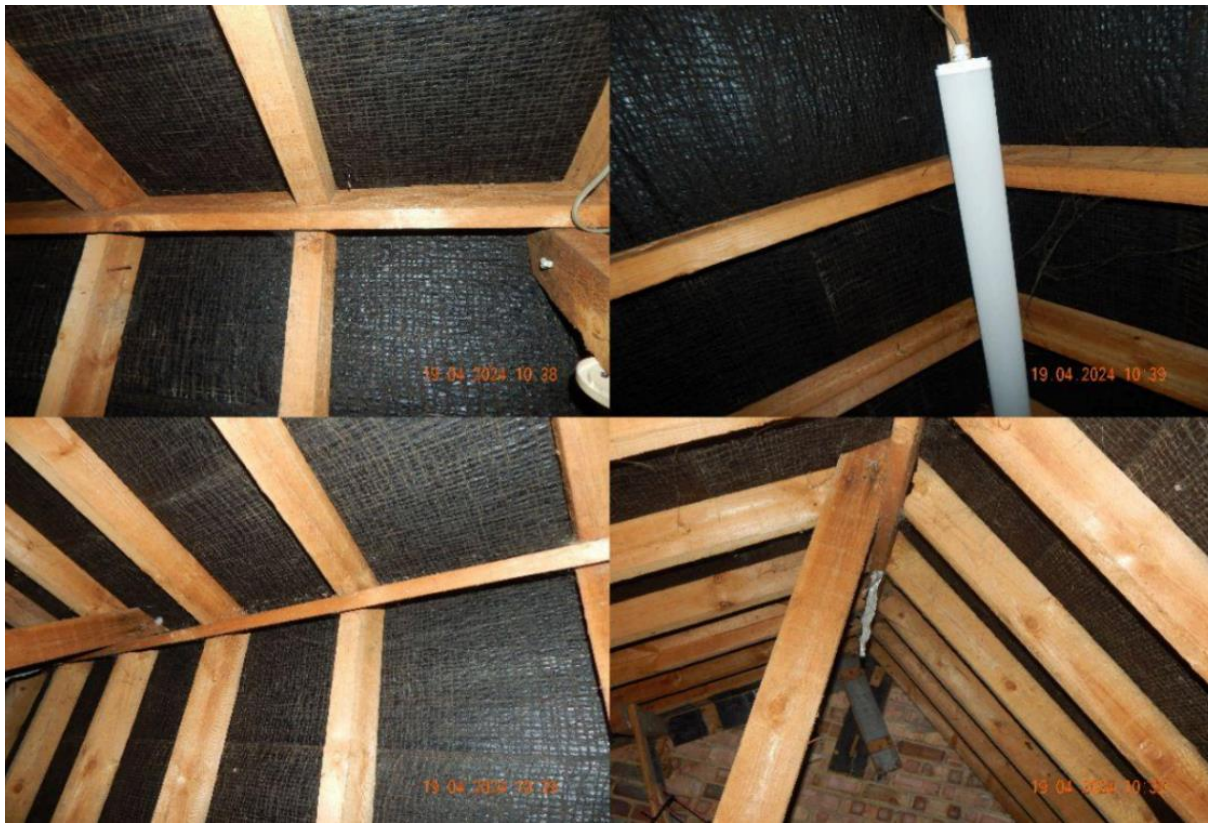
| Internal | Features of value to bats | Notes |
|---|---|---|
| Membrane coverings | Yes | <p>A felt membrane covering was observed throughout.</p> <p>Such coverings would offer further likely roosting habitats between the roof membrane and tiles where external gaps may provide access.</p> |

Image 8 – Internal view from within the main roof void spaces of the property

Image 9 – Internal view from within the main roof void spaces of the property

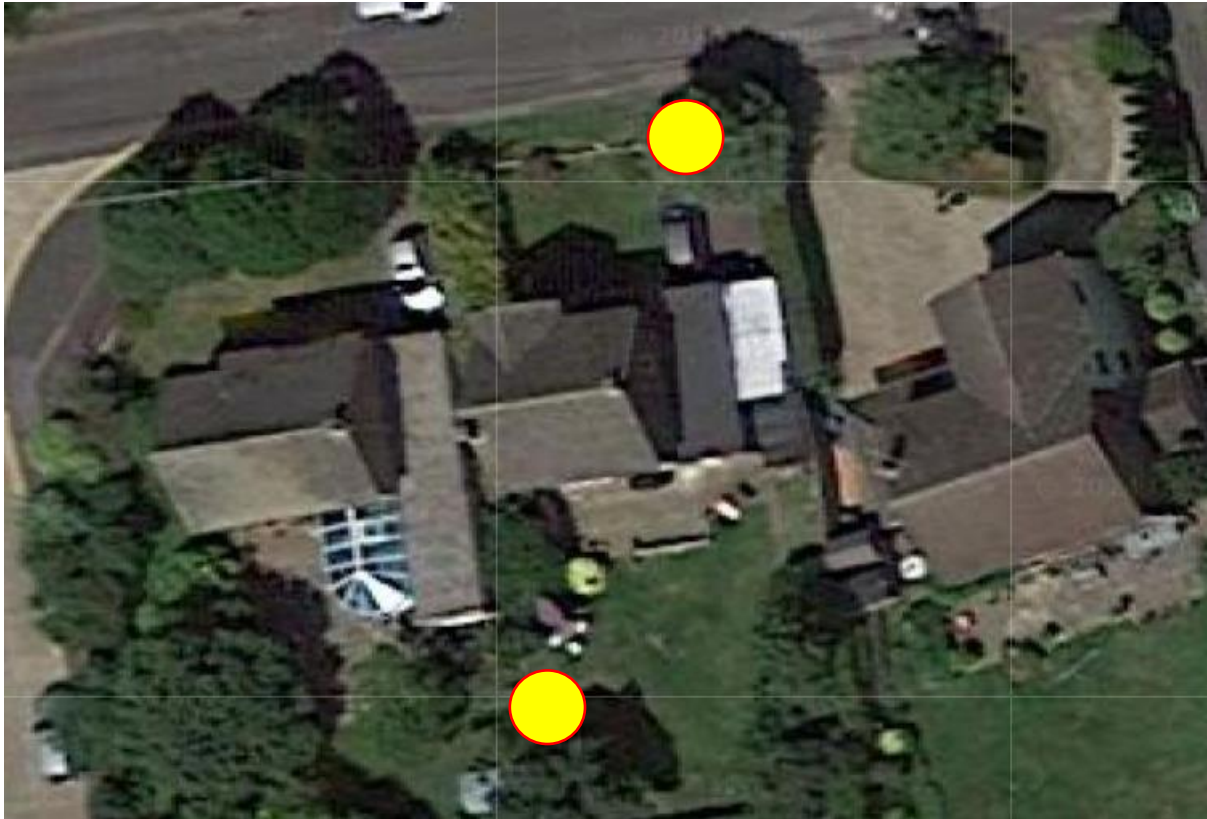
#### Appendix 4: Emergence Survey Location Points

Below site view to show suitable surveyor location points during each emergence survey to maintain visibility of the property.

In line with best practice survey guidelines, a total of two surveyors will be required to visually cover all elevations of the structure during each emergence survey.
