## **PRELIMINARY ECOLOGICAL APPRAISAL (DBW) AT 46 BEARWOOD ROAD WOKINGHAM**

**Prepared for:  
Mr J Patel  
46 Bearwood Road  
Wokingham  
RG41 4SY**

**14 April 2025**

**Ref: SPH/NP/PEA-25/08.04**

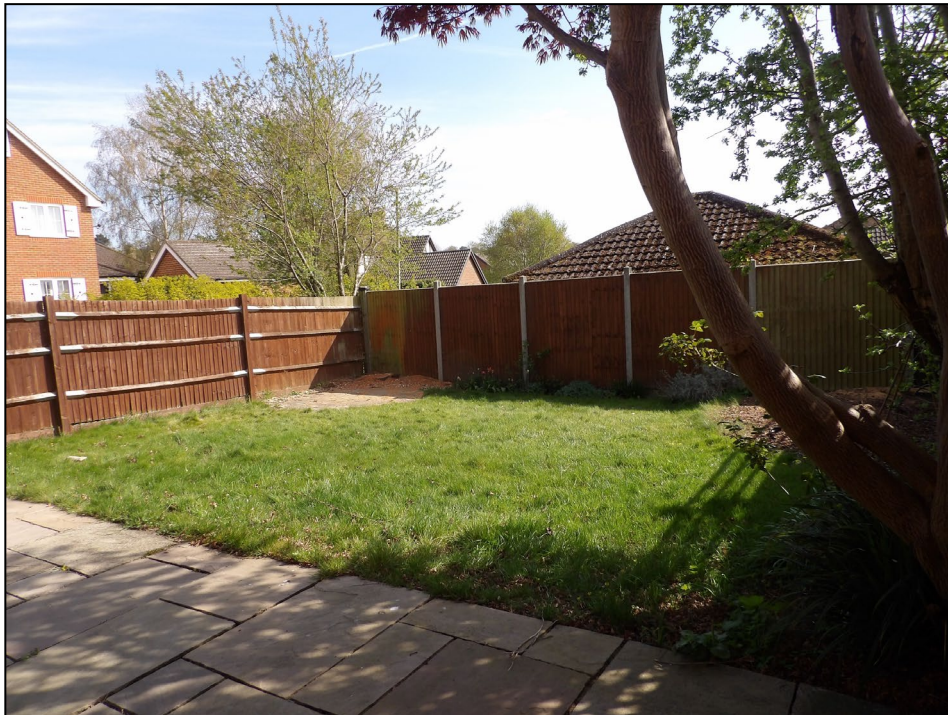
Figure 3. Rear garden. 46 Bearwood Road, Wokingham. 08.04.25

The application site comprises a detached, brick-built two storey property with integral garage and rear extension/conservatory. The remainder of the site comprises a paved front driveway/parking area. To the rear, the garden is mainly laid to lawn with patio area and a low number of shrubs/mature trees, see Figure 3 below. The site itself offers limited foraging and commuting habitat for bats and there is limited ecological connectivity to the wider landscape.

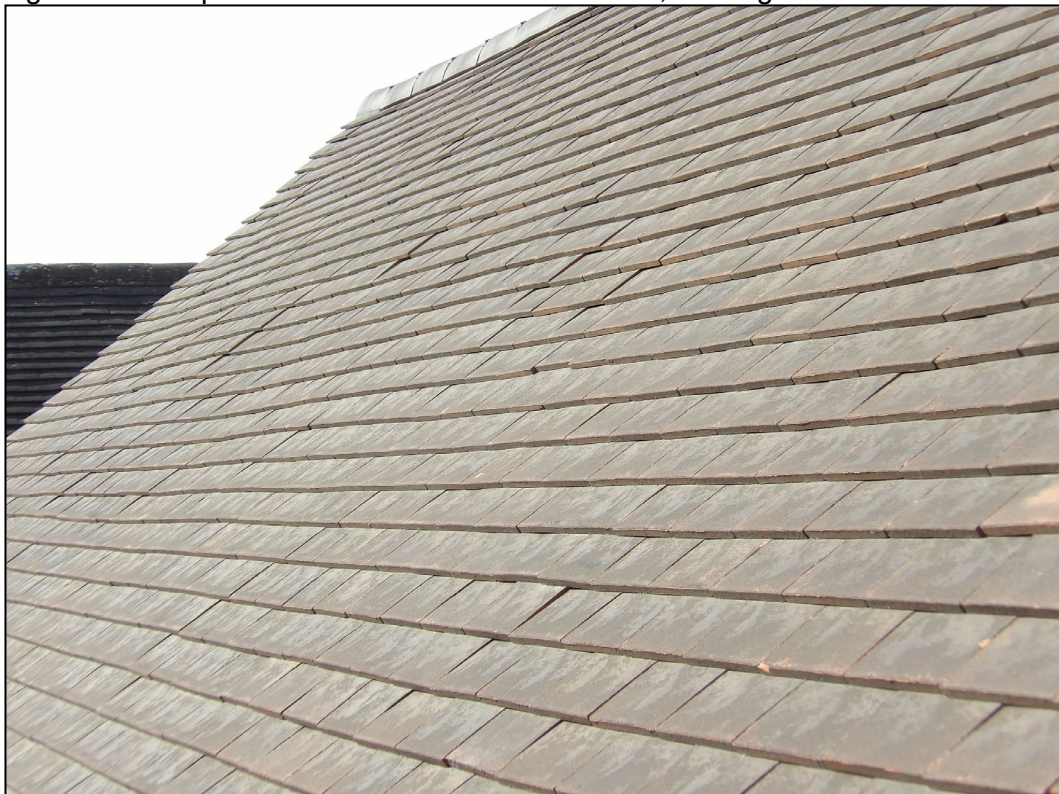
Figure 4. Example of roof tiles. 46 Bearwood Road, Wokingham. 08.04.25

The property is a detached, brick-built and part-rendered building which is in a good condition externally. The multi pitched roof with catslide section over the integral garage is covered in close fitting tiles, none of which are missing or broken, see Figure 4 below. The ridge and hip tiles, including those on the front dormer window, are all sealed with clips with no gaps in which roosting bats could exploit, see Figure 5 on page 9. The lead flashing around the chimney stack and flue pipes are flush with no gaps (see Figure 6 on page 9) and the soffits/fascias/windows and doors are all tightly fitted to the walls with no gaps in which roosting bats could exploit, see Figure 7 on page 10. To the rear is a brick build extension and uPVC and glass conservatory on dwarf wall, see Figure 8 on page 10. The roof of the extension is covered in close fitted tiles, it is firmly affixed to the main property and there is no missing mortar from the verges that could be exploited by crevice dwelling bat species, see Figure 9 on page 11. The roof of the conservatory is constructed of glass and firmly affixed to the main property (see Figure 10 on page 11) and, due to the construction material and light ingress the conservatory does not offer any roosting opportunities.

No bats or evidence of bats was recorded during the external inspection of the property and externally there were no visible roosting opportunities for bats or access into the building for roosting bats.

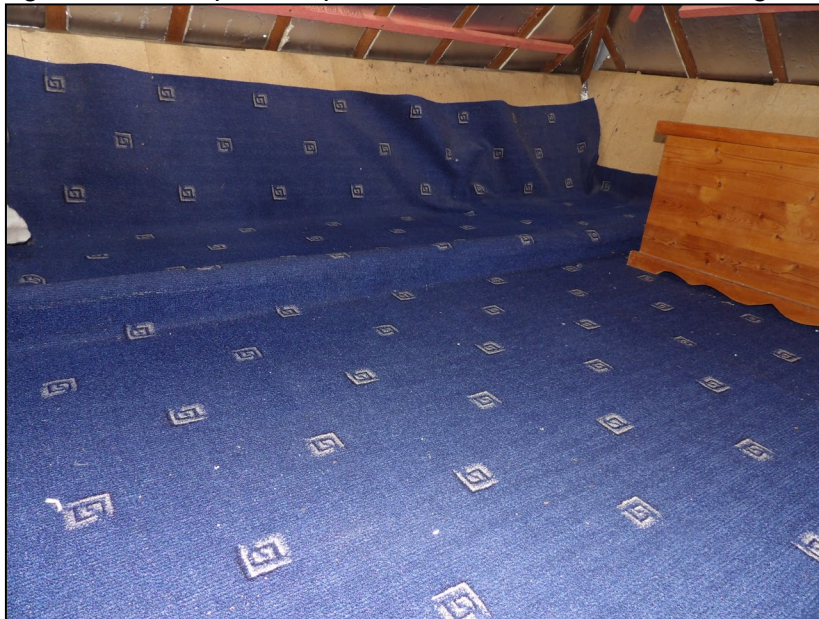
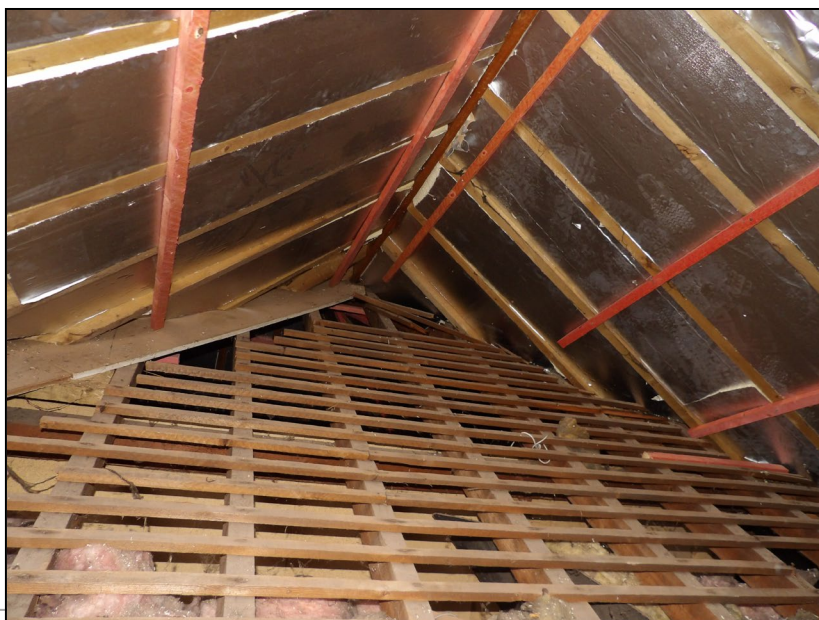
Figure 11. Example loft space. 46 Bearwood Road, Wokingham. 08.04.25

The loft was accessed through a hatch via a loft ladder and is in a good condition internally. The loft is lit, boarded and carpeted, see Figure 11 below. The roof tiles are insulated with membrane on the tiles behind the insulation, all of which is in a good condition, see Figure 12 on page 13. Internally, there is no loft space in the rear extension, as the ceiling is plastered and painted with no access hatch, see Figure 13 on page 13. Whilst we were unable to access the void over the rear extension, this was not considered to constrain the survey as the roof externally provided no roost potential.

No bats or evidence of bats was recorded during the internal inspection of the property and internally there appeared to be no roosting opportunities for bats within the building.
