**44 Hatch Ride  
Crowthorne  
Berkshire  
RG45 6LB**

# **Preliminary Roost Assessment**

Report ref.: R2832\_PRA\_a

**January 2025**

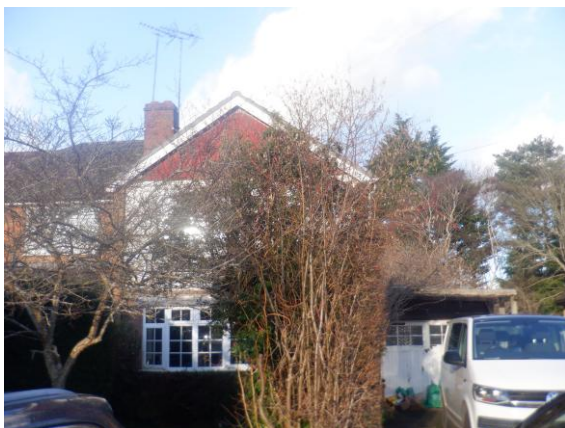
- 5.2.2** The semi-detached property of cavity wall construction had a hipped roof with a front pitched gable, that was clad with timber cladding, a single storey flat roof garage on the eastern elevation and a single-storey flat roof rear extension (**Photographs 1 & 2**).

*Photograph 1. Front of house viewed from south.*

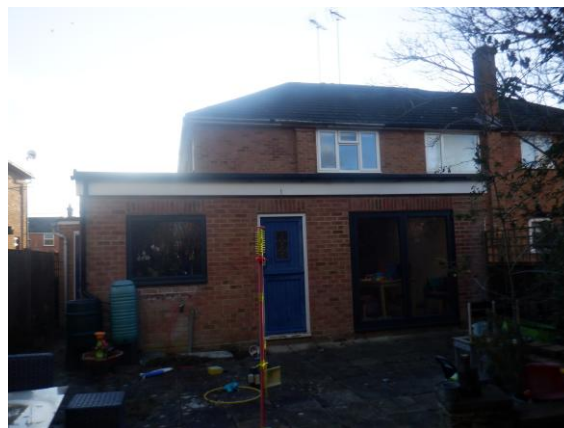
*Photograph 2. Rear of house viewed from north.*

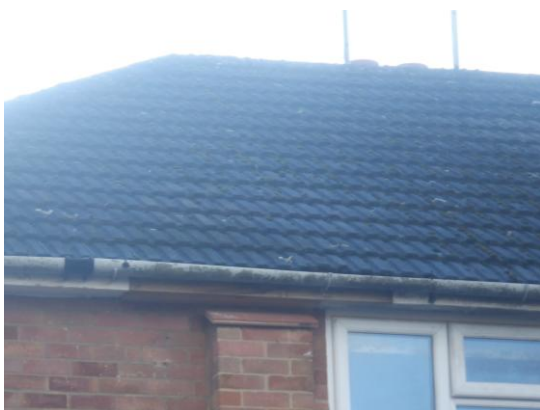
- 5.2.3** The roof was covered by concrete interlocking tiles that were tight across all elevations of the roof and slightly mossy in places (**Photograph 3**). The ridge and hip tiles were tight and the mortar was intact across the roof of the property (**Photograph 4**).

*Photograph 3. Tight interlocking roof tiles (northern elevation).*

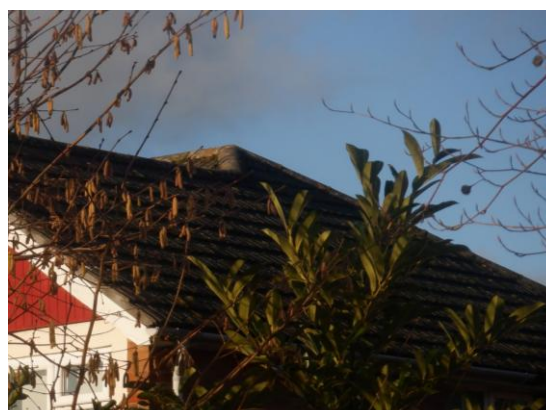
*Photograph 4. Ridge and hip mortar intact (eastern elevation).*

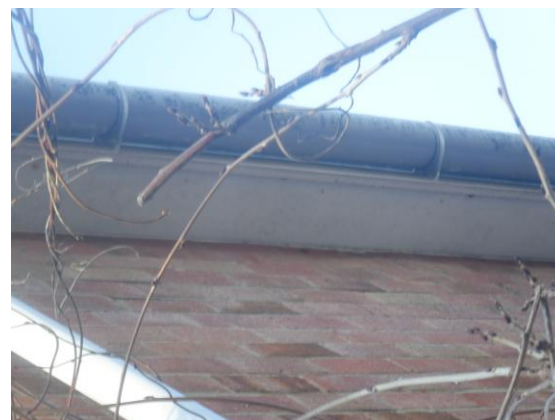
*Photograph 6. Intact sealant along the eaves of the main roof (eastern elevation).*

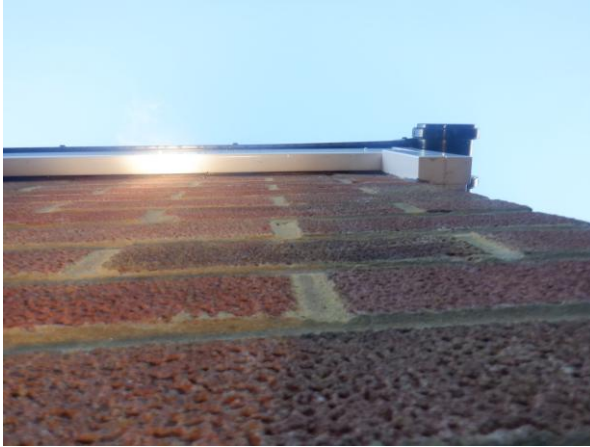
- 5.2.5** The soffit on the rear elevation of the single storey extension sat on top of the wall plate

and was tight to the brickwork. There was a slight gap under the barge board on the eastern elevation of the rear extension and the side of the garage – both were closely inspected and found to be of limited extent, offering no roosting or ingress opportunities for crevice-dwelling bats (**Photographs 7 & 8; Target notes 1 & 2**).

*Photograph 7. Gap of limited extent under barge board on single storey rear extension (eastern elevation).*

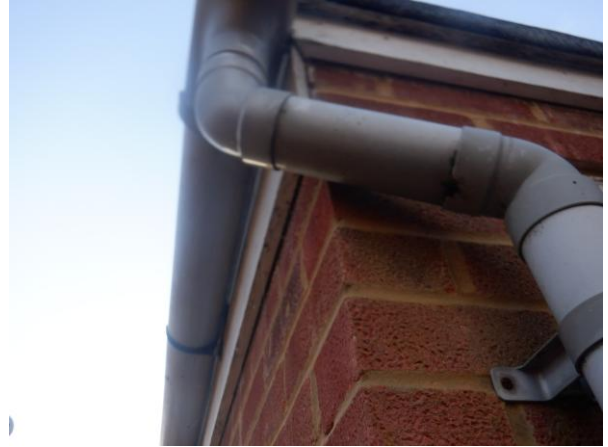
*Photograph 8. Gap of limited extent under barge board on (eastern elevation).*

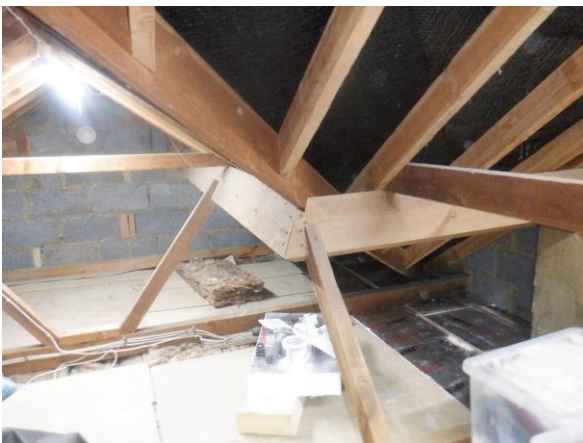
- 5.2.6** The property had one roof void that covered its two-storey footprint and was accessible via a loft hatch on the first floor. It was of cut and pitch construction and had an approximate floor-to-ridge height of 1.5 metres. The floor was boarded centrally, with fibreglass insulation present below and celotex insulation boards present in the south-western corner and northern side of the void (**Photograph 9**). The eaves were mostly filled with fibreglass insulation or shredded insulation (**Photograph 10**).

*Photograph 9. Boarding and fibreglass insulation in the centre of the void and celotex insulation (roof void).*

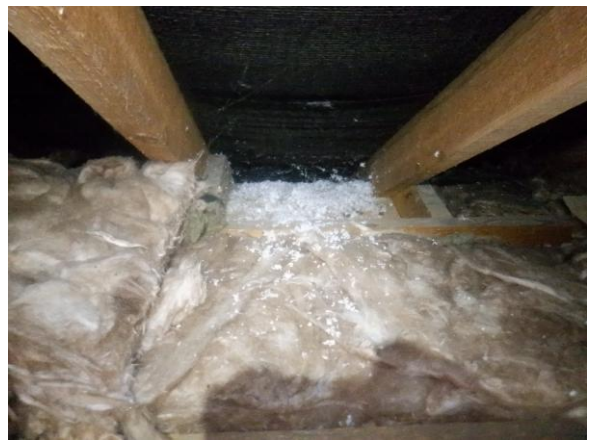
*Photograph 10. Shredded insulation in eaves (roof void).*

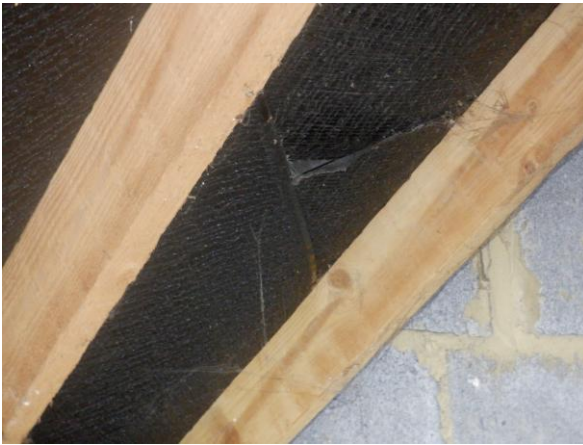
- 5.2.7** The roof was lined with a hessian reinforced bitumen felt that was mostly intact, with a small tear present on the south-eastern side of the roof (**Photograph 11; Target note 3**).

*Photograph 11. Small tear in bituminous roofing felt (roof void).*

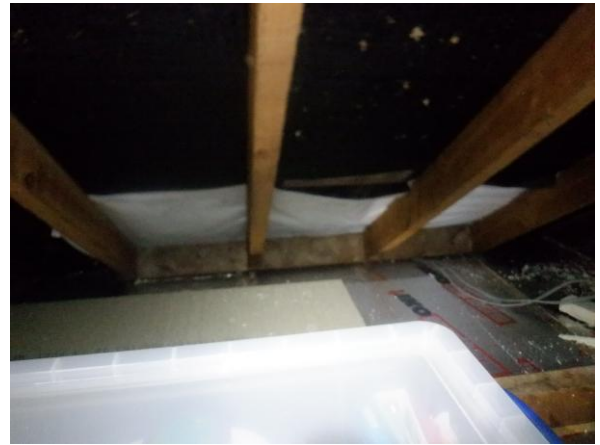
A chimney had been removed on the rear elevation with a section of loosely overlapping breathable roofing membrane present and the underside of the roof tiles were visible (**Photograph 12; Target note 4**).

*Photograph 12. Loosely overlapping breathable roofing felt where chimney was removed (roof void).*

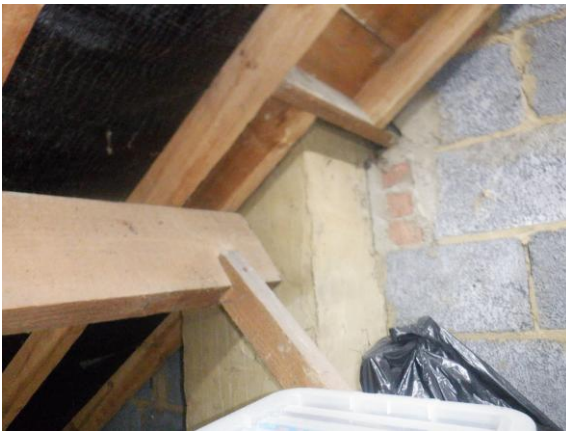
**5.2.8** There was a rendered chimney present on the party blockwork wall at the western side of the void, which was cobwebbed (**Photograph 13**). There was a slight gap between the timbers and the chimney, with the underside of the roof tiles visible along the edge, but the gap was cobwebbed and no daylight could be seen (**Photograph 14; Target note 5**). The southern gable had intact mortar tight to the roof line, with plastic sheeting visible in one section over the blockwork (**Photograph 15; Target note 6**).

*Photograph 13. Rendered chimney on the western party wall (roof void).*

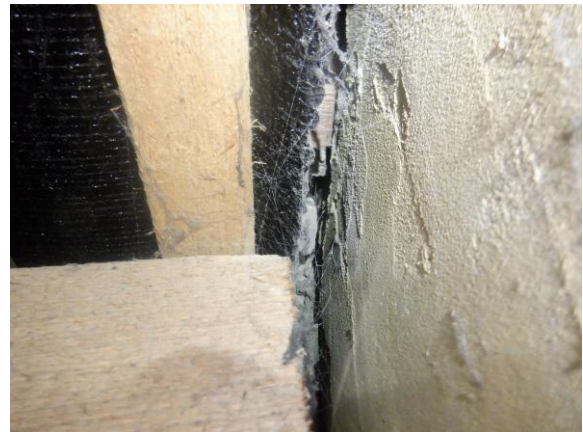
*Photograph 14. Slight cobwebbed gap beside chimney, with underside of roof tiles visible (roof void).*

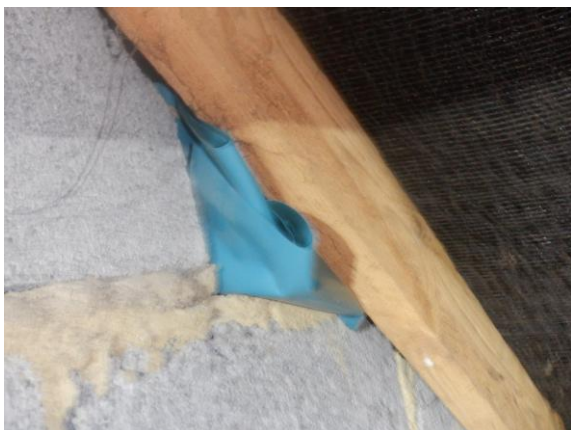
*Photograph 15. Plastic sheeting visible in gap over blockwork (roof void).*

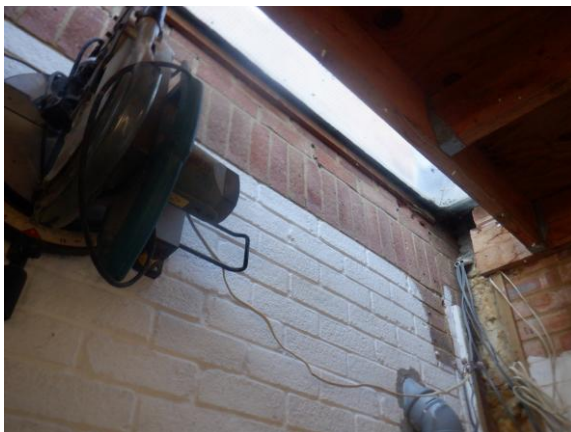
- 5.2.9** Internally, the attached garage had no roof void and was open to the underside of the flat roof boarding, with a skylight present adjacent to the wall of the house (**Photograph 16**). The brickwork walls were tight to the boarding and the eaves were blocked, with no daylight visible (**Photograph 17**).

*Photograph 16. Skylight in roof adjacent to the wall of the house (garage).*
