**Silver Birches,  
Heath Ride,  
Finchampstead,  
Berks,  
RG40 3QJ**

**PHASE 1 BAT SURVEY  
(Provisional roost assessment)**

**July 2025**

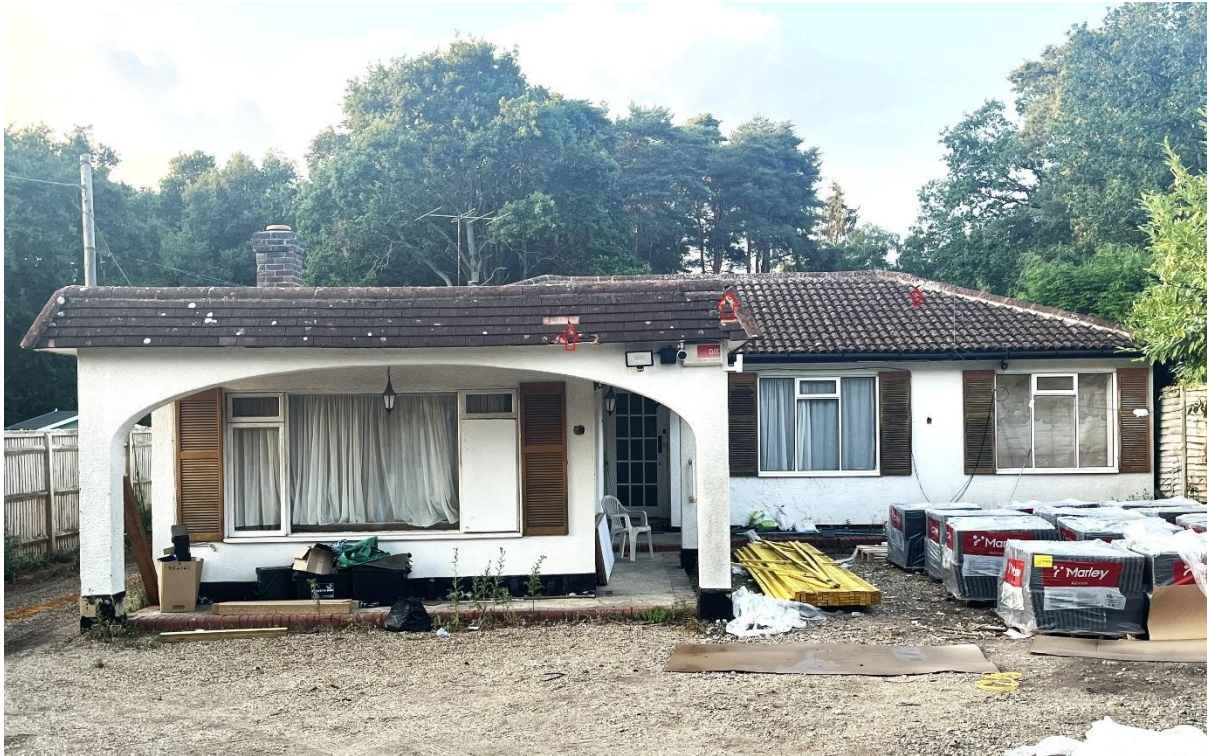
The bungalow is brick faced block walls with a low-pitched roof of clay tiles which are close fitting with no gaps. However, there are a few potential openings where the tile faced parapets have been damaged (see figures 3-4).

**Figure 3. Front elevation of bungalow looking northeast: Red arrows indicate potential openings for crevice roosting bats.**

The bungalow, rear extension and detached garage all have low potential for bats and a phase 2 survey is required.

A dusk emergence survey is required to confirm whether bats are utilising the properties. These surveys must be a minimum of three weeks apart between 1<sup>st</sup> May and end September, with two carried out before the end of August

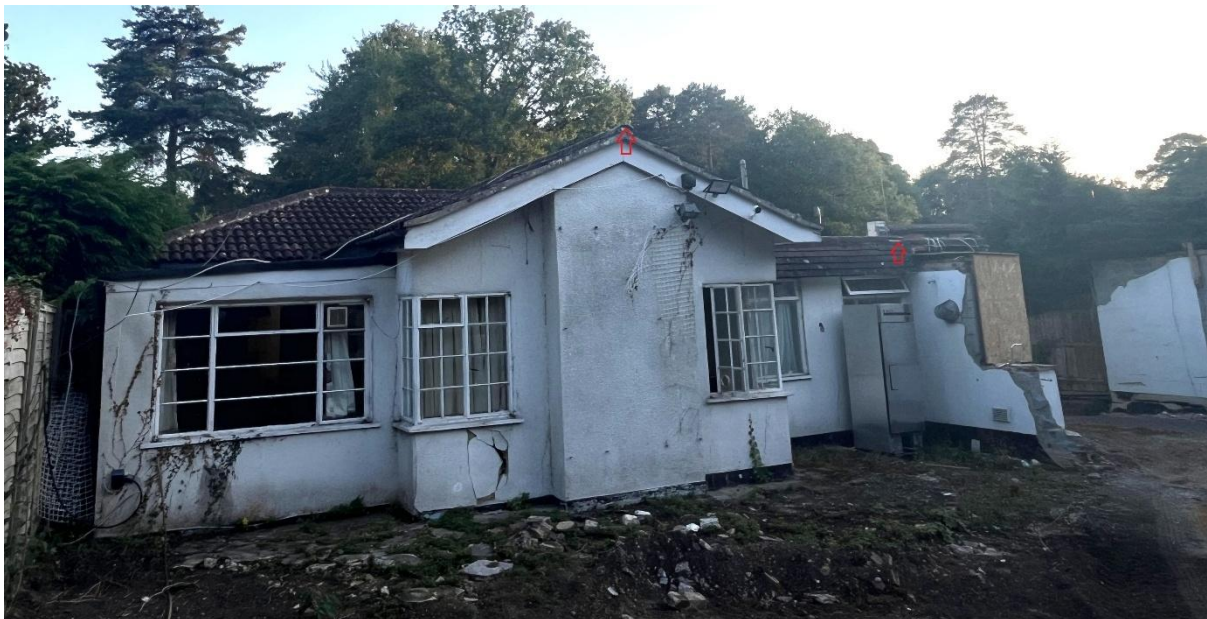
**Figure 4. Rear elevation of bungalow looking southwest: Red arrows indicate potential openings for crevice roosting bats.**

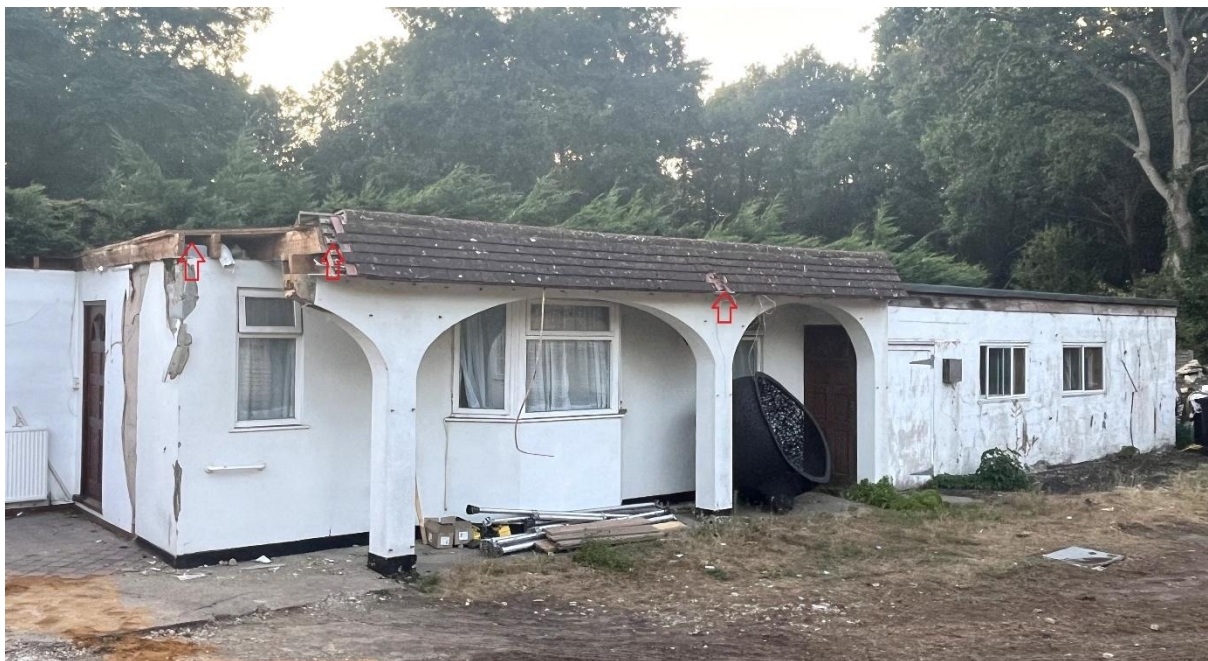
The elongate extension was formerly attached by a garage/utility area which has been removed. The north face of the former connecting roof section is partly exposed there are a few potential openings where the tile faced parapets have been damaged (see figure 5). The flat roofed eastern third of the extension has negligible potential for ats in absence of enclosed voids and closed off fascias (see figure 6).

**Figure 5. South face of rear extension looking north: Red arrows indicate potential openings for crevice roosting bats.**

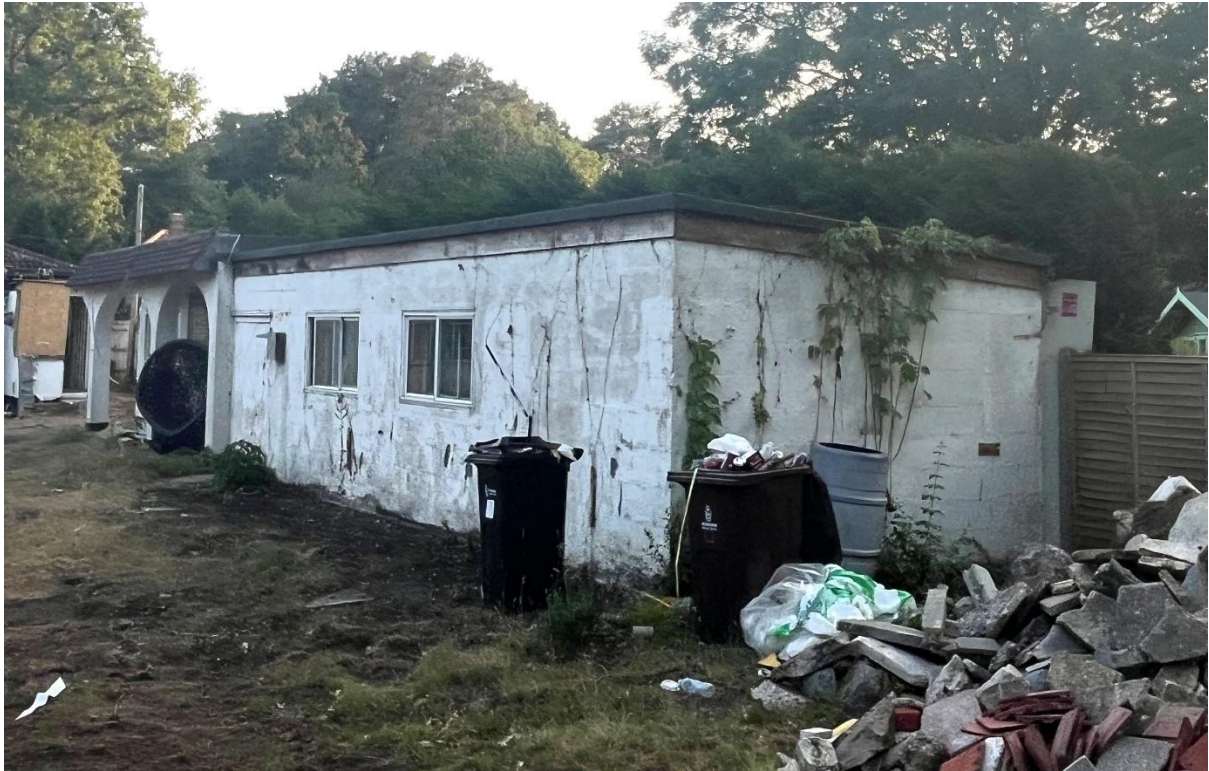
**Figure 6. Rear extension looking southwest.**

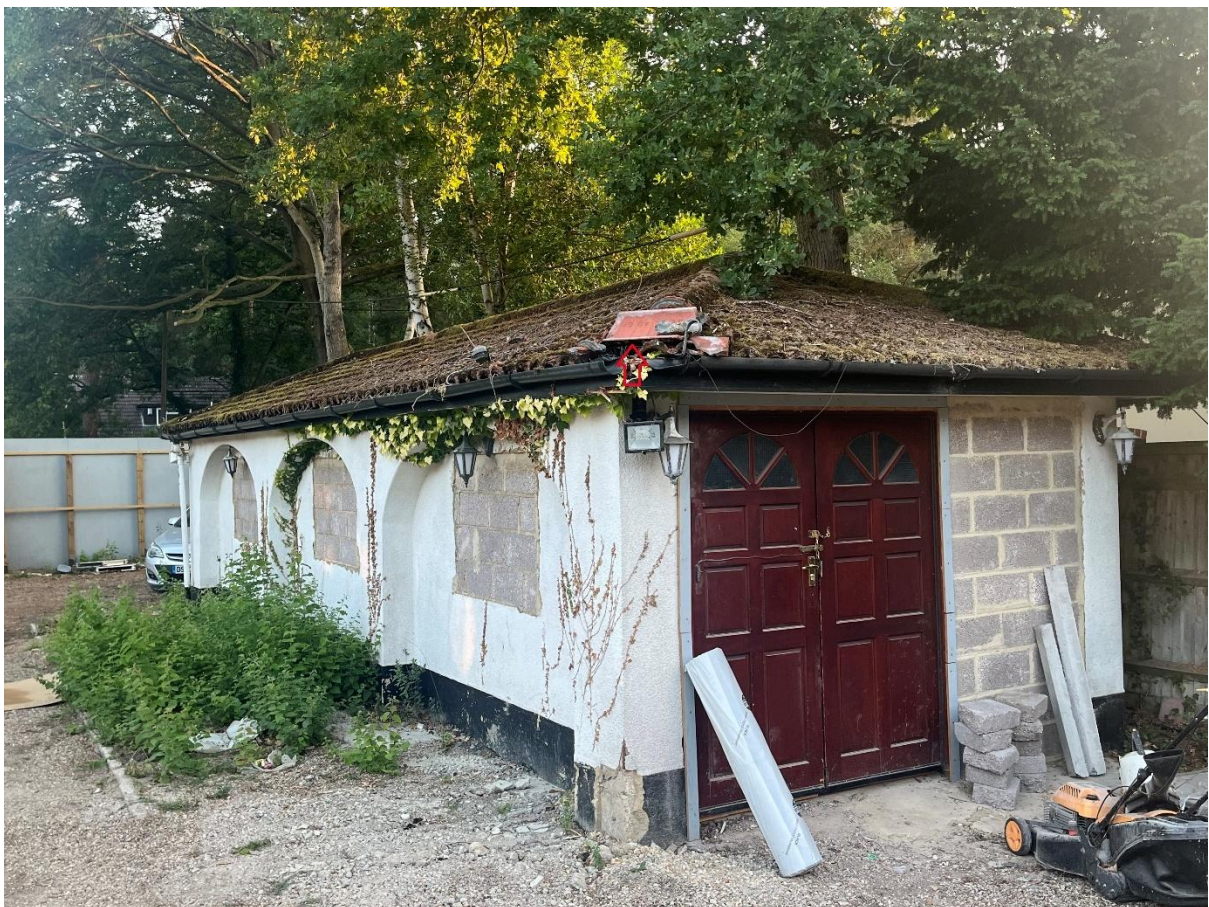
The detached garage is situated to southwest of bungalow and has a hipped single pitched roof of cement tiles. These are in good order but there is a broken ridge tile at northeast corner which bats could utilise to access the undertile spaces (see figure 7). The garage interior is permanently illuminated via side windows and has no enclosed roof void.

**Figure 7. Garage looking southwest: Red arrow indicates potential openings for crevice roosting bats.**
