30 Dukes Wood  
Crowthorne  
Berkshire  
RG45 6NF

## Preliminary Roost Assessment

Report ref.: R3023\_PRA\_a

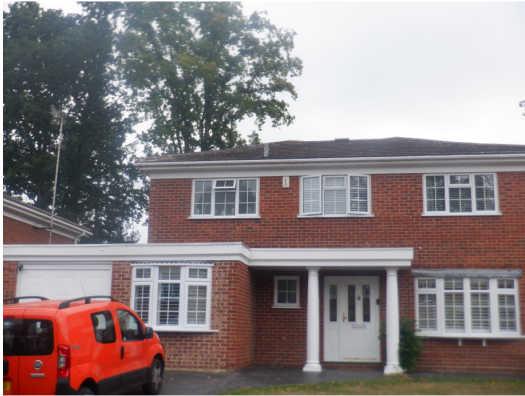
**5.2.2** The house is a detached brick built residential dwelling with a hipped roof covered with flat plain roof tiles, and an existing single-storey flat roofed front and side extension. (**Photographs 1 and 2**).

Photograph 1. Front of the house viewed from west.

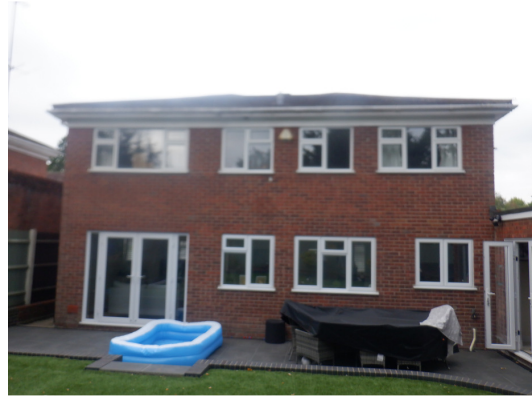
Photograph 2. Rear of house viewed from east.

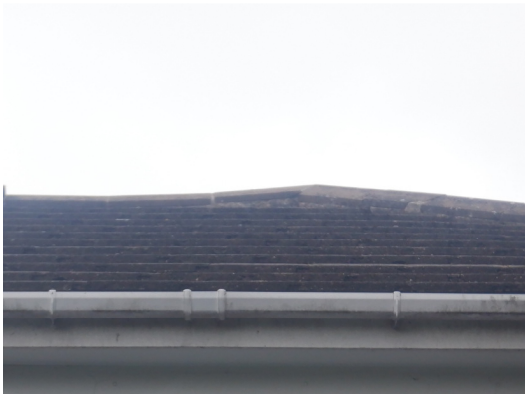
**5.2.3** The plain roof tiles were tightly fitted and intact across the roof (**Photograph 3**). The hip mortar was intact, with the hip and ridge tiles tightly mortared to the plain roof tiles across the roof (**Photograph 4**). There was an area of hip mortar that has been repaired on the front elevation of the property (**Photograph 5**).

Photograph 3. Intact/tight plain roof tiles (eastern elevation).

- 6.1.3** The intact plain roof tiles do not provide any potential roosting sites for bats. Furthermore, any visible gaps between barge boards and the brickwork of the property have been proven superficial and of limited extent, and therefore not suitable for use by crevice-dwelling bat species such as common pipistrelle (*Pipistrellus pipistrellus*) and soprano pipistrelle (*Pipistrellus pygmaeus*).

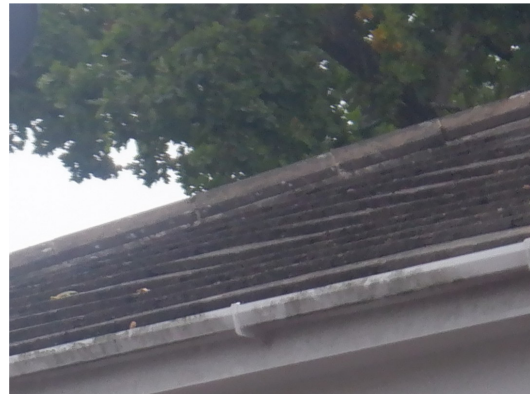
Photograph 4. Intact mortar between hip tiles and plain roof tiles (western elevation).

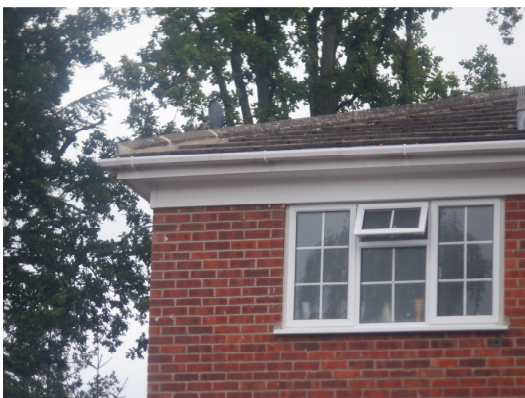
Photograph 5. Small area of repaired hip mortar (western elevation).

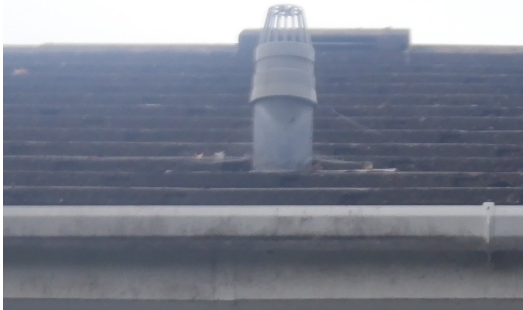
**5.2.4** The lead flashing around the flute pipe at the rear and front elevations was flush to the plain roof tiles (**Photograph 6**).

*Photograph 9. Tight lead flashing on around the flute pipe (eastern elevation).*

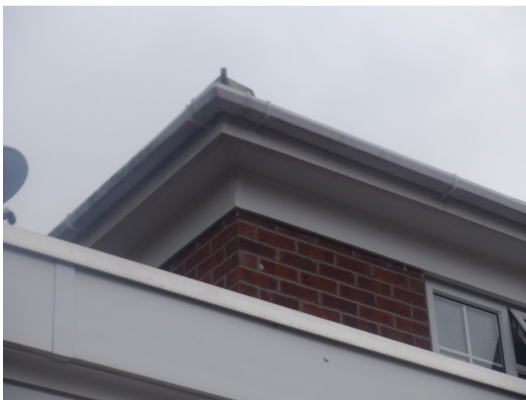
- 5.2.5** The uPVC soffits and barge boards around the detached house were intact and tight to the brick work of the property (**Photographs 7 & 8**).

*Photograph 7. Intact soffits tight to the brick of the property (north east elevation).*

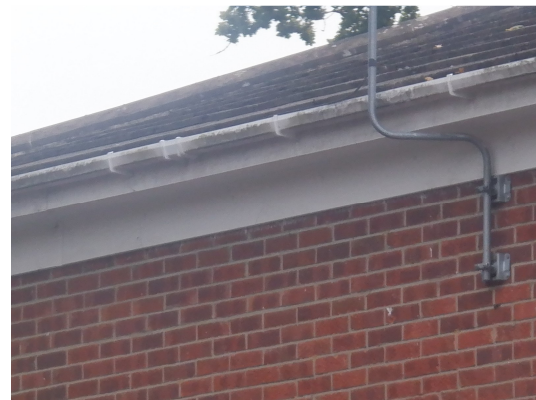
*Photograph 8. Tight and intact barge boards around property (northern elevation).*

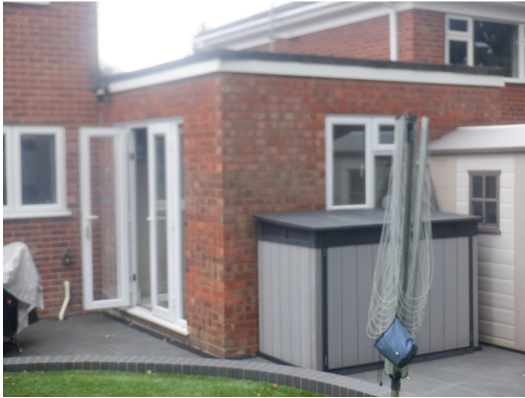
- 5.2.6** The flat roof of the existing front and side extension was of bitumen construction and was mostly tight to the uPVC barge boards and soffits (**Photograph 9**). There was an area of the bitumen roofing felt that had partially separated from the uPVC barge board to the rear eastern of the extension, however upon inspection the gap was very open and of limited extent (**Photograph 10; Target note 1**). A gap was visible along the northern elevation of the extension where the soffit box joined the wall however it was superficial as on close inspection timber and uPVC was visible behind (**Photographs 11 & 12; Target notes 2 & 3**).

*Photograph 9. Extension with bitumen roofing felt and uPVC bargeboards mostly tight.*

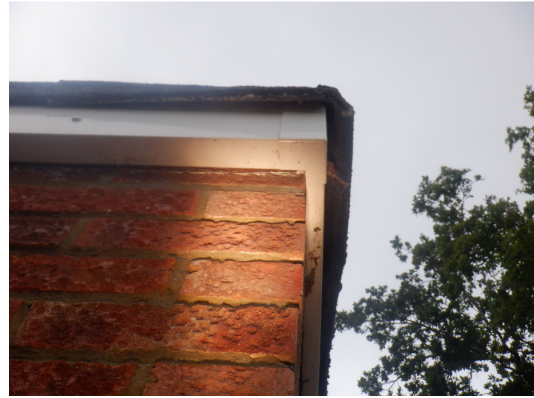
*Photograph 10. Small superficial gap between bitumen roofing and uPVC bargeboard (eastern elevation).*

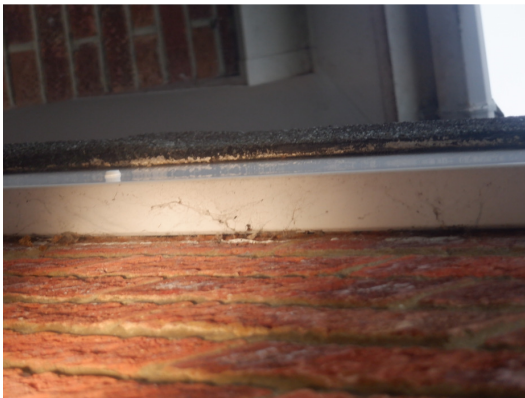
*Photograph 11. Slight gap blocked with timber where the soffit box joined the wall on the northern elevation of the side extension.*

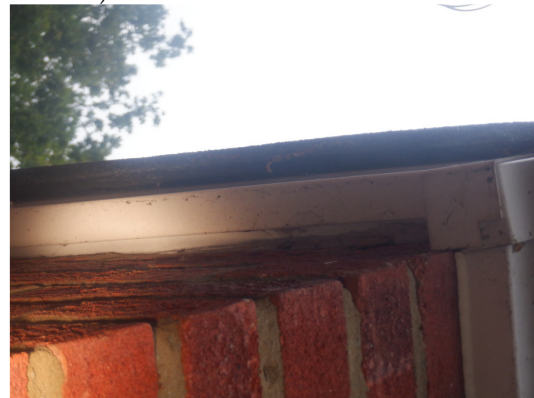
*Photograph 12. Gap underneath the barge board on northern elevation with uPVC visible above (northern elevation).*

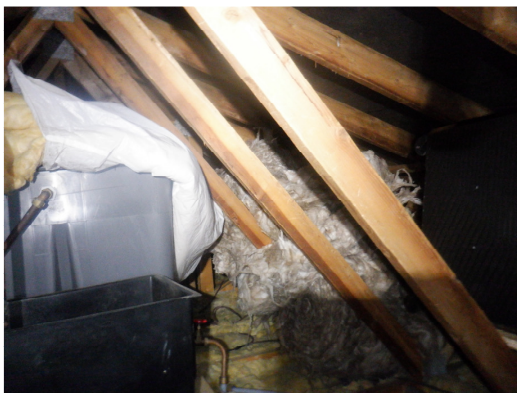
- 5.2.7** The detached house had one large roof void that was accessed via a first-floor loft hatch and had a ridge to floor height of approximately 0.5 metres (**Photograph 13**). The loft space was heavily cobwebbed and had no sign of bat activity.

*Photograph 13. Roof void.*

- 6.1.4** The roof void had no bat droppings found internally so the presence of void-dwelling bats is considered highly unlikely, such as brown long eared bat (*P. auritus*) recorded locally. Therefore, the detached house has been classified as negligible suitability (see **Appendix 1** for potential suitability categories).

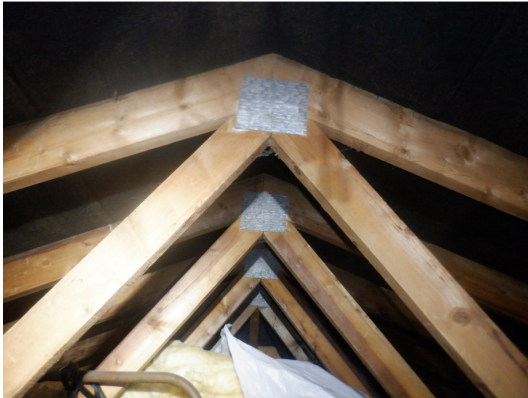
- 5.2.8** The hipped roof was of trussed rafter construction (**Photograph 14**). The roof was lined with bitumen felt that was intact and mostly tight to the timber, however there was a small area of loose felt that exposed timbers and the plain roof tiles but not daylight was visible (**Photograph 15**).

*Photograph 14. internal view of the roof void..*

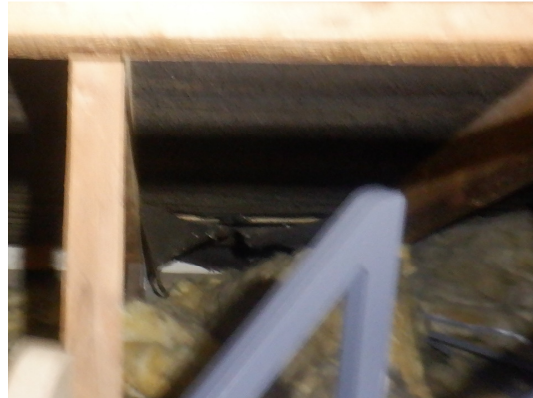
*Photograph 15. Small area of loose fitting bitumen felt (roof void).*

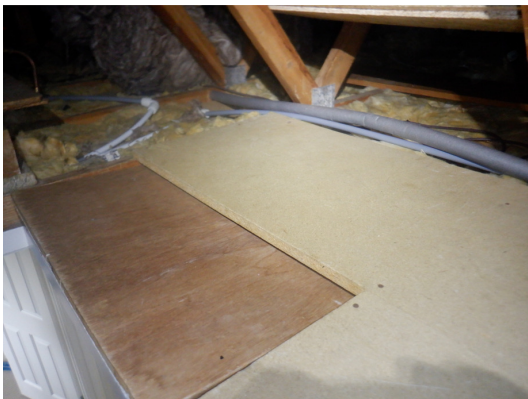
- 5.2.9** The floor was centrally boarded with thick fibreglass between the joists (**Photograph 16**). The eaves were mostly filled with fibreglass (**Photograph 17**). There was a large covered water tank to the south of the loft hatch (**Photograph 18**).

*Photograph 16. Centrally boarded roof void.*

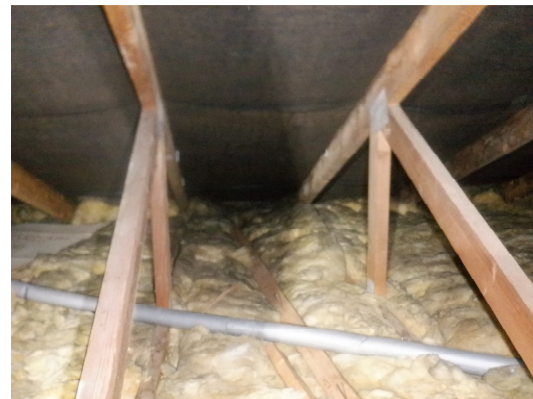
*Photograph 17. Fibreglass filling the eaves of the roof void.*

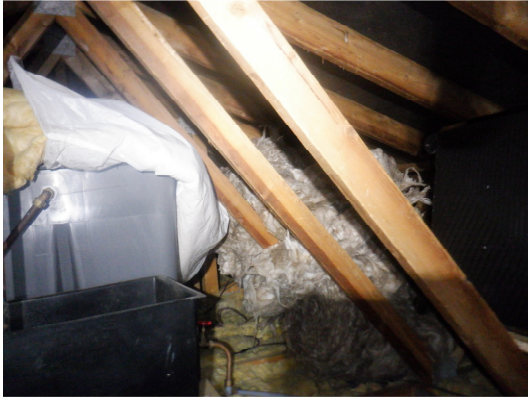
*Photograph 18. Covered water tank (roof void).*
