## **PRELIMINARY ECOLOGICAL APPRAISAL (DBW) AT ARLINGTON BASINGSTOKE ROAD, SPENCERS WOOD**

**Prepared for:  
Rammurti Design Limited  
268 Tilehurst Road  
Reading  
RG30 2NE**

**3 January 2025**

**Ref: SPH/NP/PEA-24/10.12**

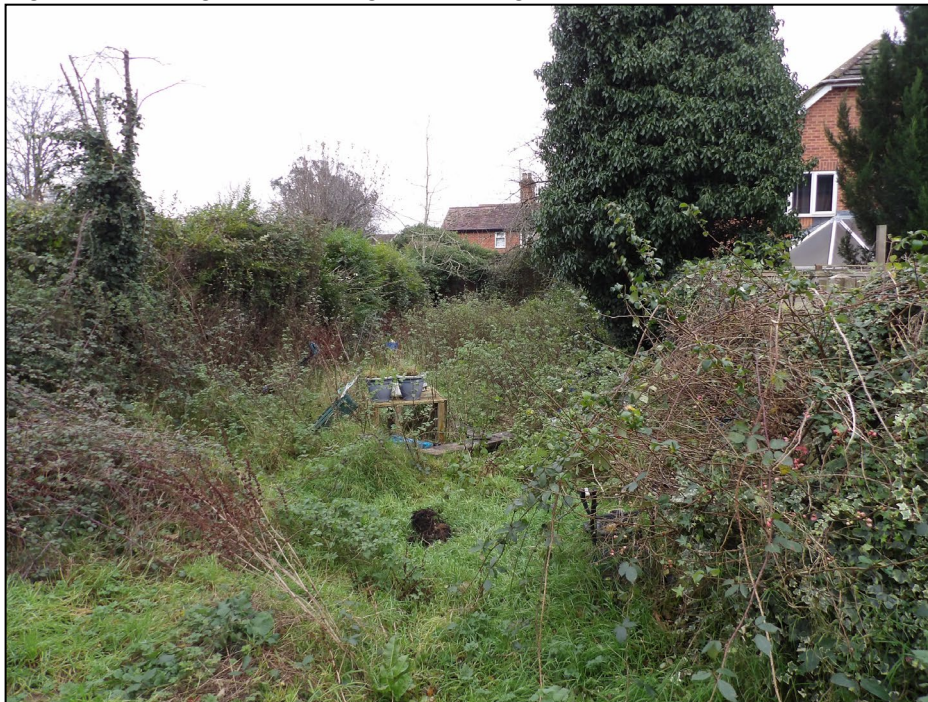
The application site comprises a vacant, semi-detached, brick-built property with attached garage/utility. The remainder of the site comprises a small front garden and parking/driveway, and an overgrown rear garden, see Figure 3 below. The site itself offers some foraging and commuting habitat for bats and there is good ecological connectivity to bat foraging and commuting habitat in the wider landscape.

Figure 3. Rear garden. Arlington, Basingstoke Road, Spencers Wood. 10.12.24

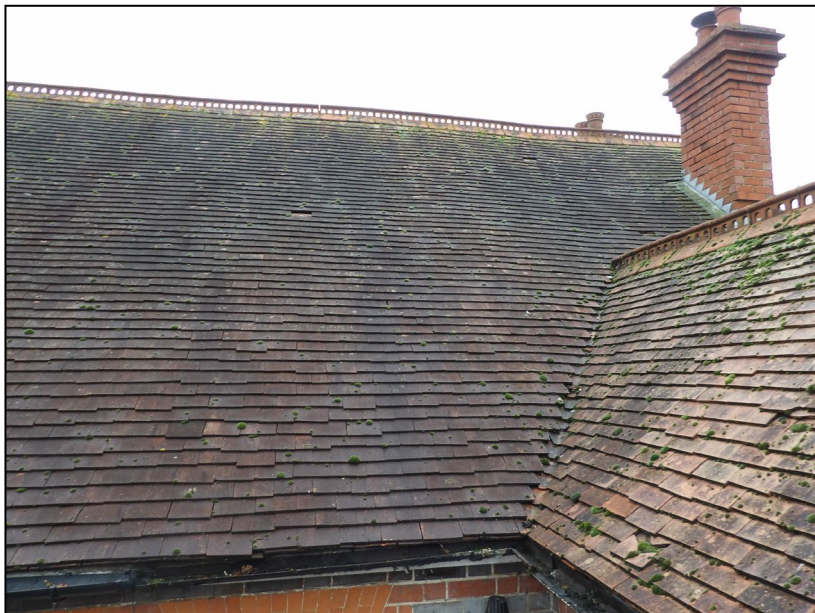
The property is a two-storey semi-detached brick-built building, which is in a fair condition externally. The cross pitched roof of the property is covered in tiles (see Figure 4 below), some of which are missing or broken, see Figure 5 on page 9. The ridge tiles on the main property are all tightly fitted and had no gaps in which roosting bats could exploit, and the verges are all well cemented with no gaps in which crevice dwelling bats could use for roosting, see Figure 6 on page 9. There are gaps in the tiles and lead flashing around both chimney stacks that could afford access into the building for bats, see Figure 7 on page 10. The soffits and fascias are tightly fitted to the walls and have no visible gaps in which bats could use for roosting, see Figure 8 on page 10. On the front elevation, at the top of the 2 storey bay window is an area of hanging tiles (see cover photo), and some of the tiles are lifted providing potential roosting opportunities for crevice dwelling bats, see Figure 9 on page 11. There is a single storey extension to the rear of the building (see Figure 10 on page 11), the part pitched/part 'lean-to' style roof of the extension are also covered in tiles, some of which are broken, see Figure 11 on page 12. The lead flashing affixing the extension to the main property is well sealed with no gaps, as are the ridge tiles, however there are gaps in the verges, see Figure 12 on page 12. However, this extension is not being affected by the proposed works. On the southern elevation is a brick built attached garage/utility, the roof of which is covered in well fitted tiles and the lead flashing affixing the garage/utility to the main property is sealed with no gaps, see Figure 13 on page 13. The wooden fascias are tight to the wall with no gaps that could be exploited by crevice dwelling bat species, see Figure 14 on page 13.

Figure 4. Example of roof tiles. Arlington, Basingstoke Road, Spencers Wood. 10.12.24

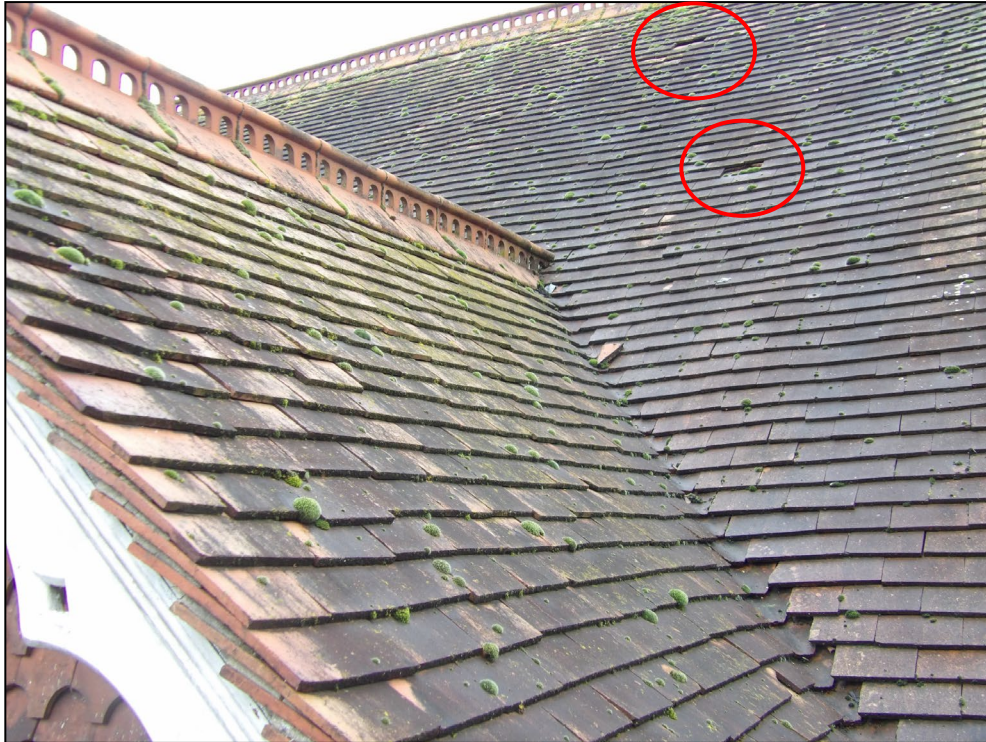
No bats or evidence of bats was recorded during the external inspection of the property or garage/utility although there were several gaps in the roof and hanging tiles and verges that could provide potential roosting opportunities or access into the building for roosting bats.

Figure 5. Missing roof/broken tiles. Arlington, Basingstoke Road, Spencers Wood.  
10.12.24

Based on the Bat Workers Manual and the Bat Surveys Good Practice Guidelines, two dusk emergence surveys must be undertaken on the property, between May and August, to establish the presence or absence of roosting bats and in order to inform appropriate mitigation for the proposed works if necessary. The features identified will require three survey positions equipped with bat detectors and night vision cameras in order to cover all the potential bat roosting features. If bats are recorded emerging from the building during the surveys, one further activity survey and an EPSL will be required in order for the development to proceed legally.

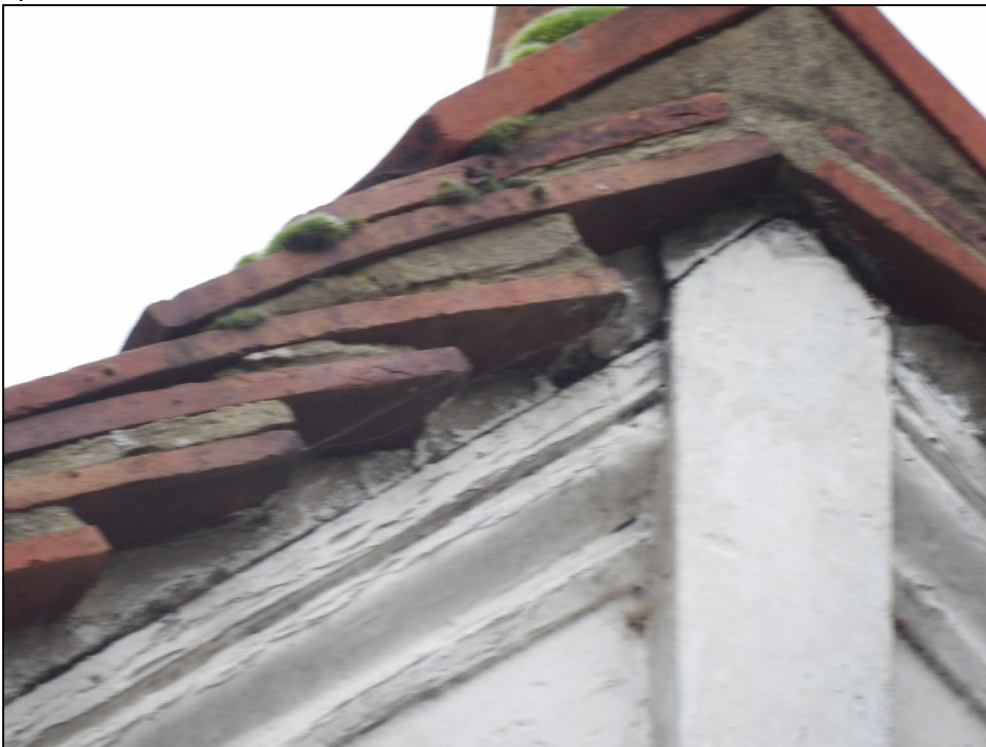
Figure 6. Well cemented verge on main property. Arlington, Basingstoke Road,  
Spencers Wood. 10.12.24

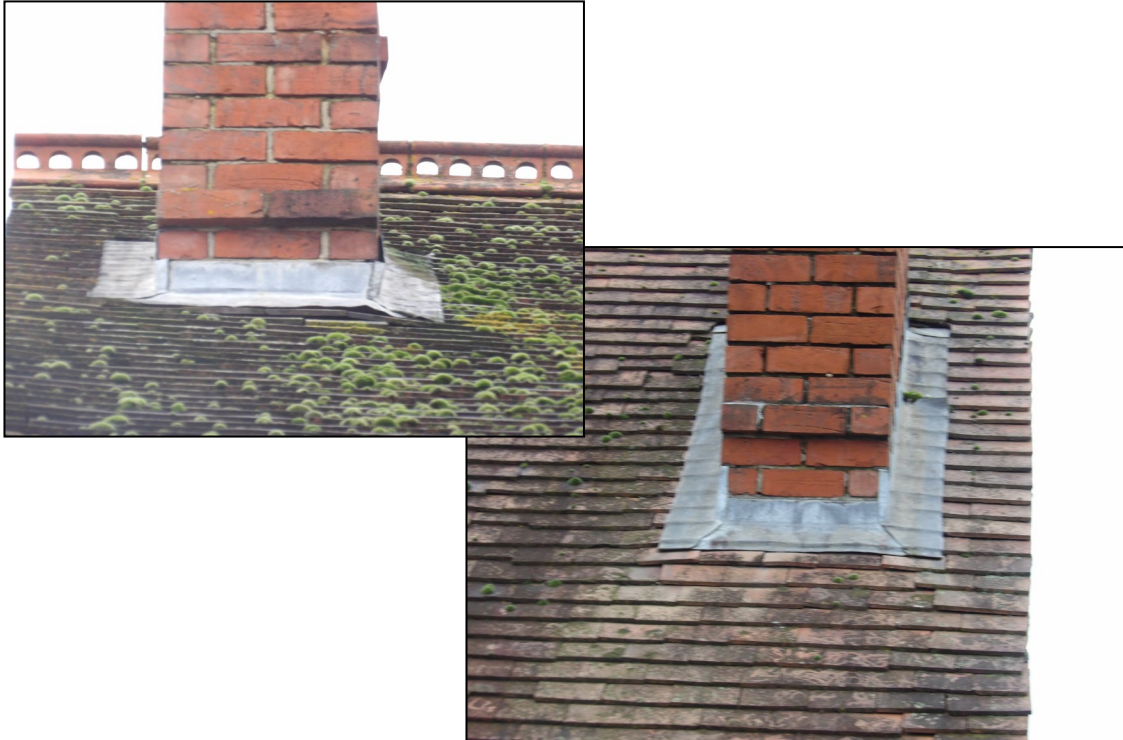
Figure 7. Example gaps in tiles/lead flashing around chimney stacks. Arlington, Basingstoke Road, Spencers Wood. 10.12.24

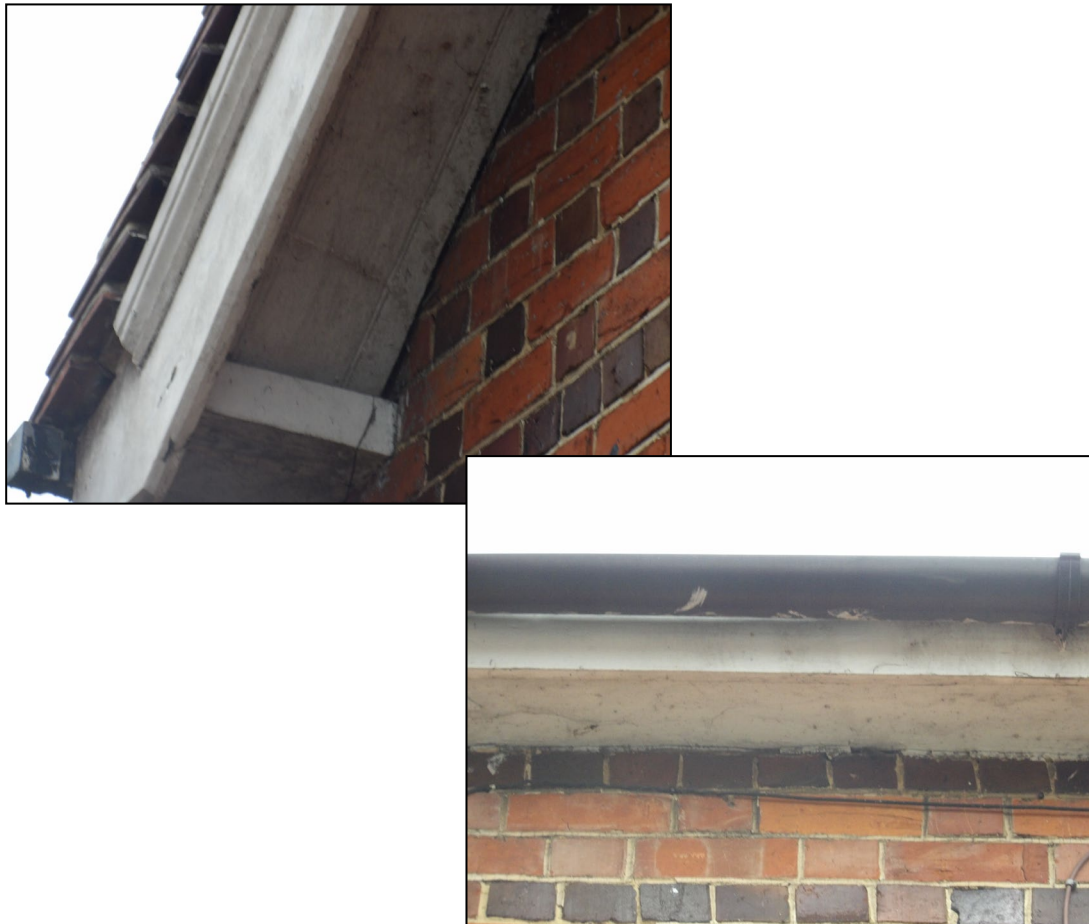
Figure 8. Example sealed soffits/fascias. Arlington, Basingstoke Road, Spencers Wood. 10.12.24

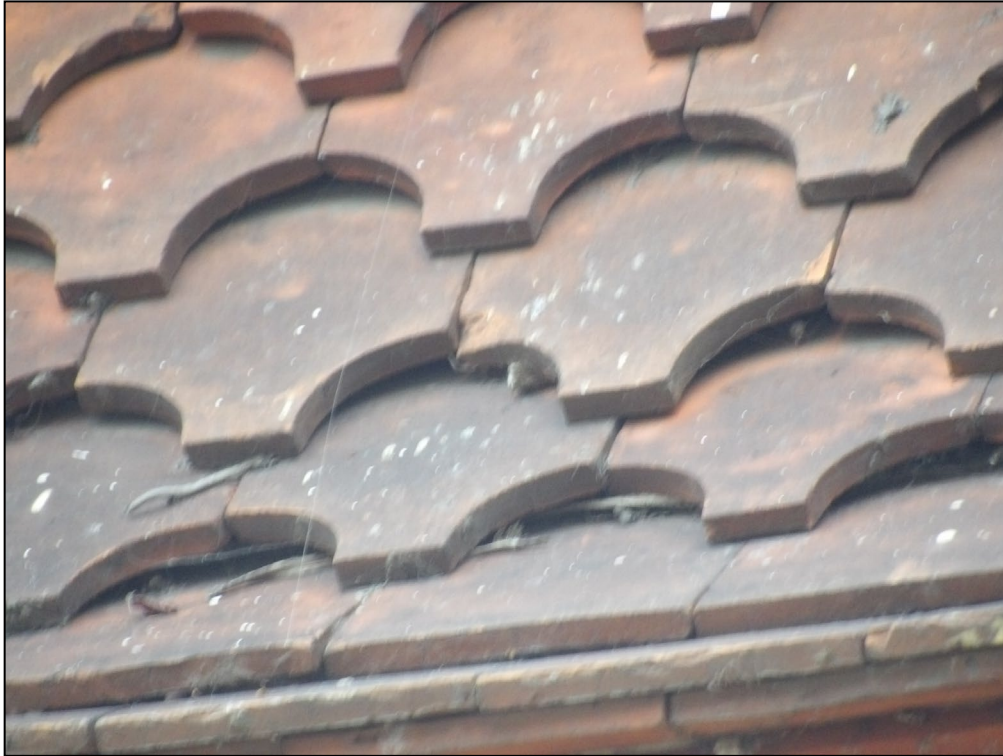
Figure 9. Example of gaps in hanging tiles. Arlington, Basingstoke Road, Spencers Wood. 10.12.24

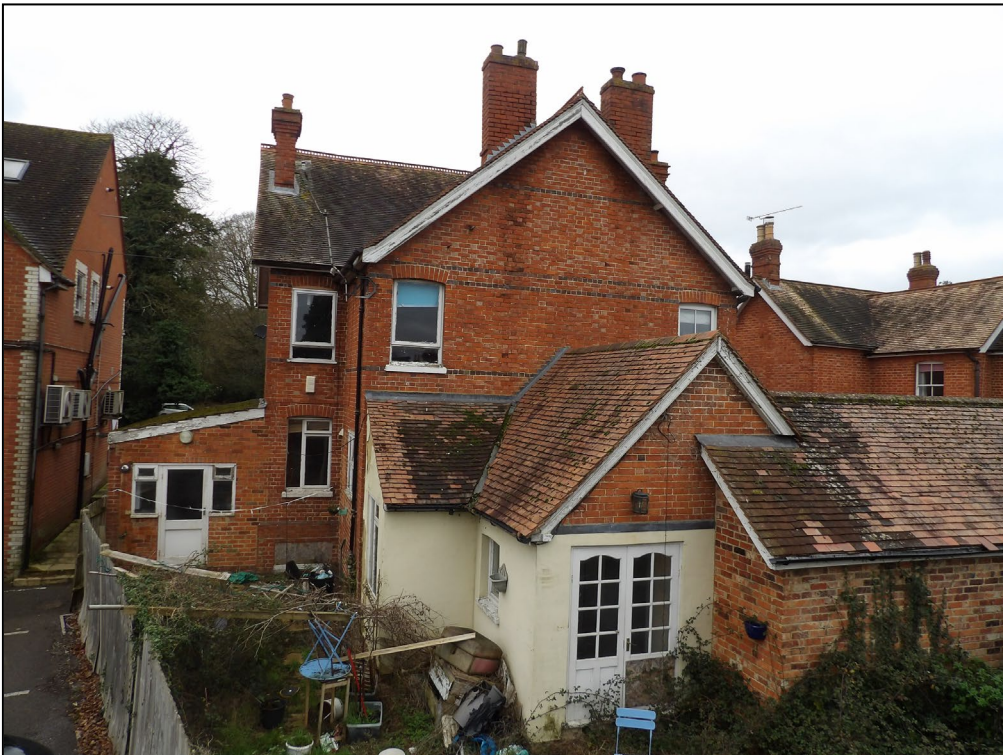
Figure 10. View of rear of building. Arlington, Basingstoke Road, Spencers Wood. 10.12.24

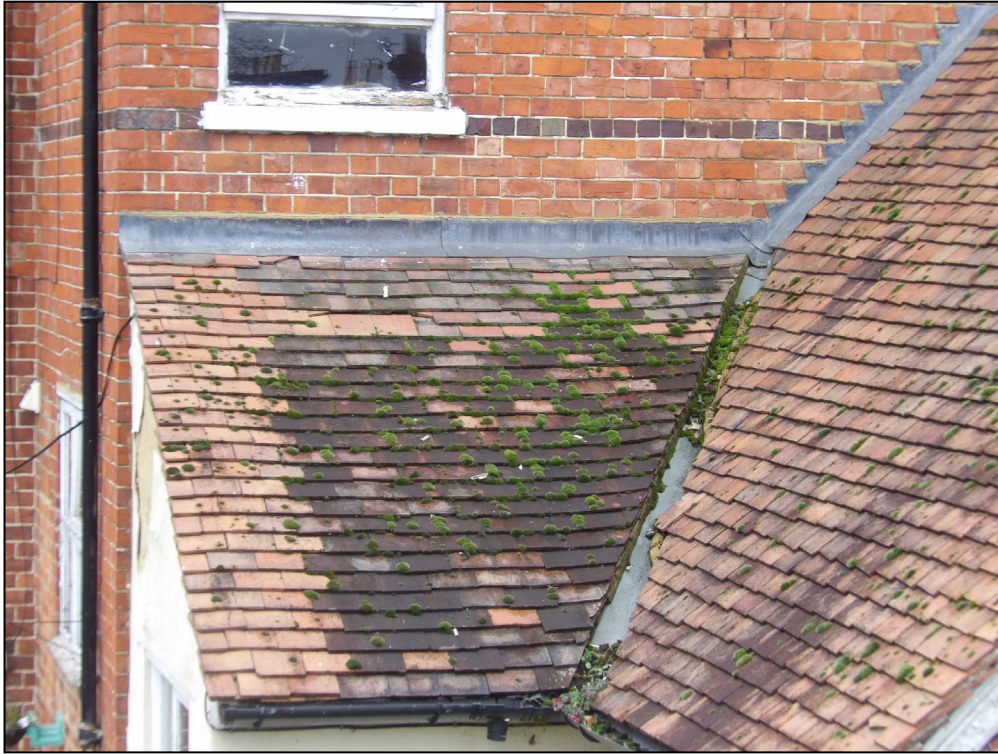
Figure 11. Broken roof tiles rear extension. Arlington, Basingstoke Road, Spencers Wood. 10.12.24

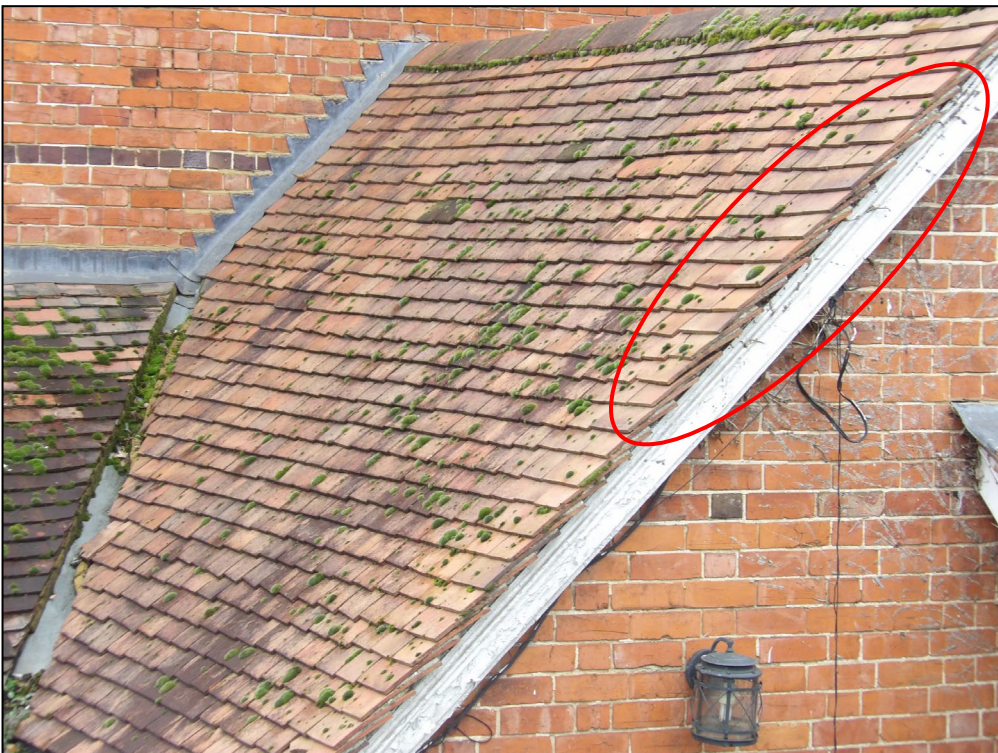
Figure 12. Gaps in verge of rear extension. Arlington, Basingstoke Road, Spencers Wood. 10.12.24

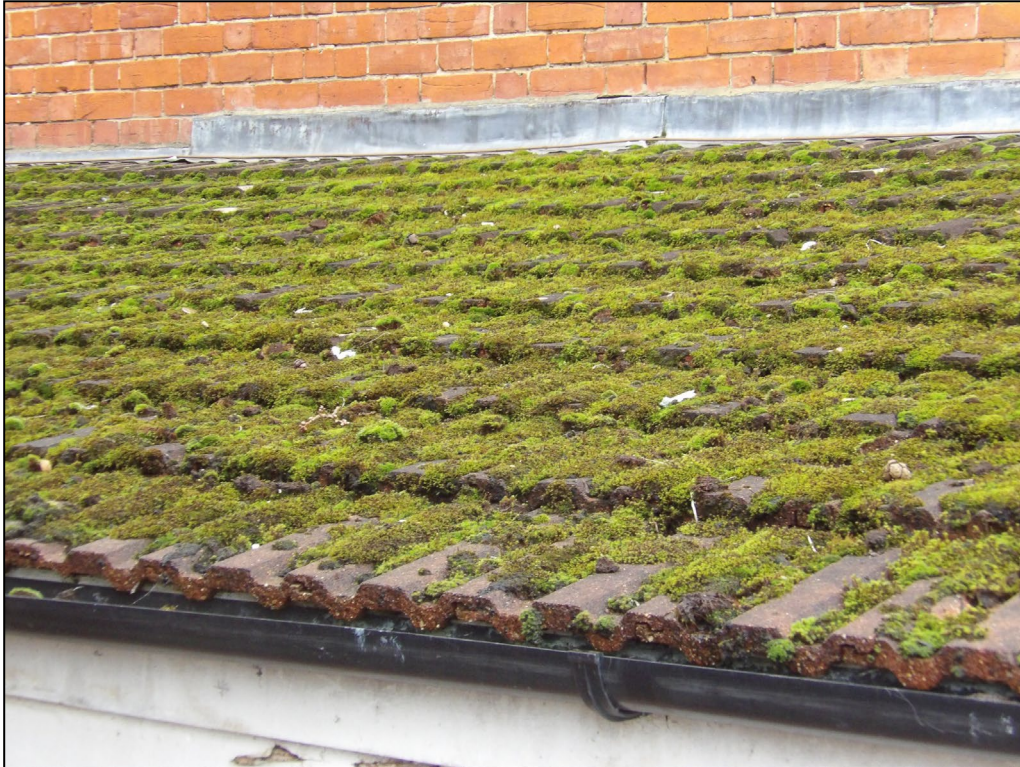
Figure 13. Example roof tiles on garage/utility and sealed flashing. Arlington, Basingstoke Road, Spencers Wood. 10.12.24

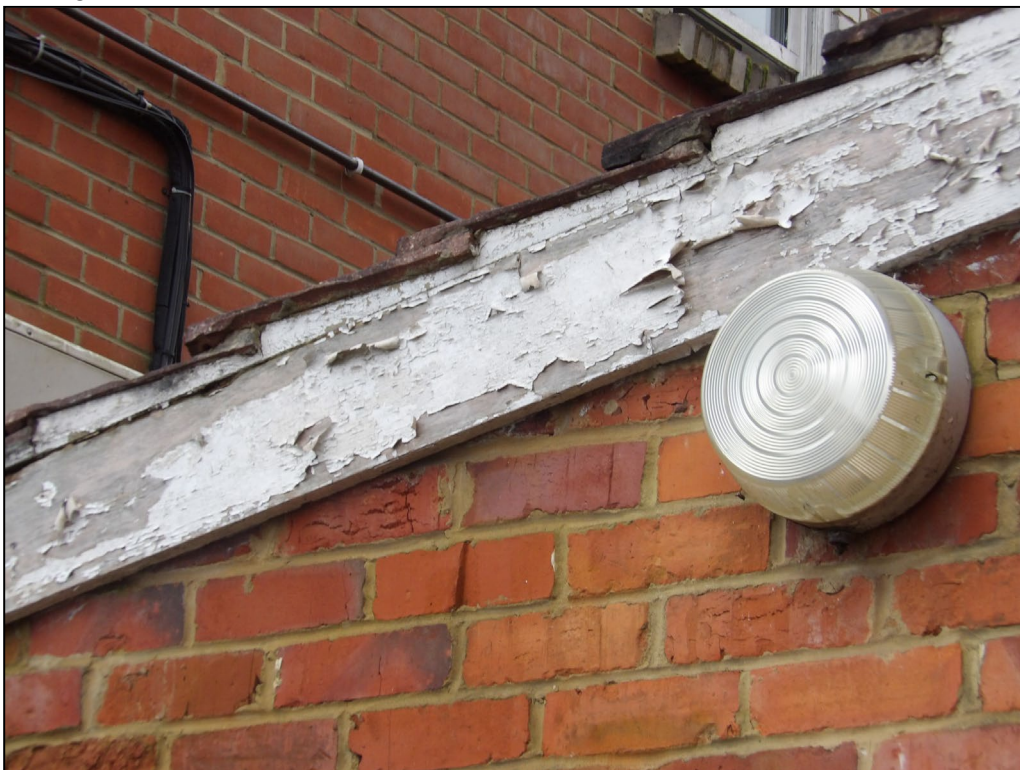
Figure 14. Example flush fascias and sealed verges on garage/utility. Arlington, Basingstoke Road, Spencers Wood. 10.12.24

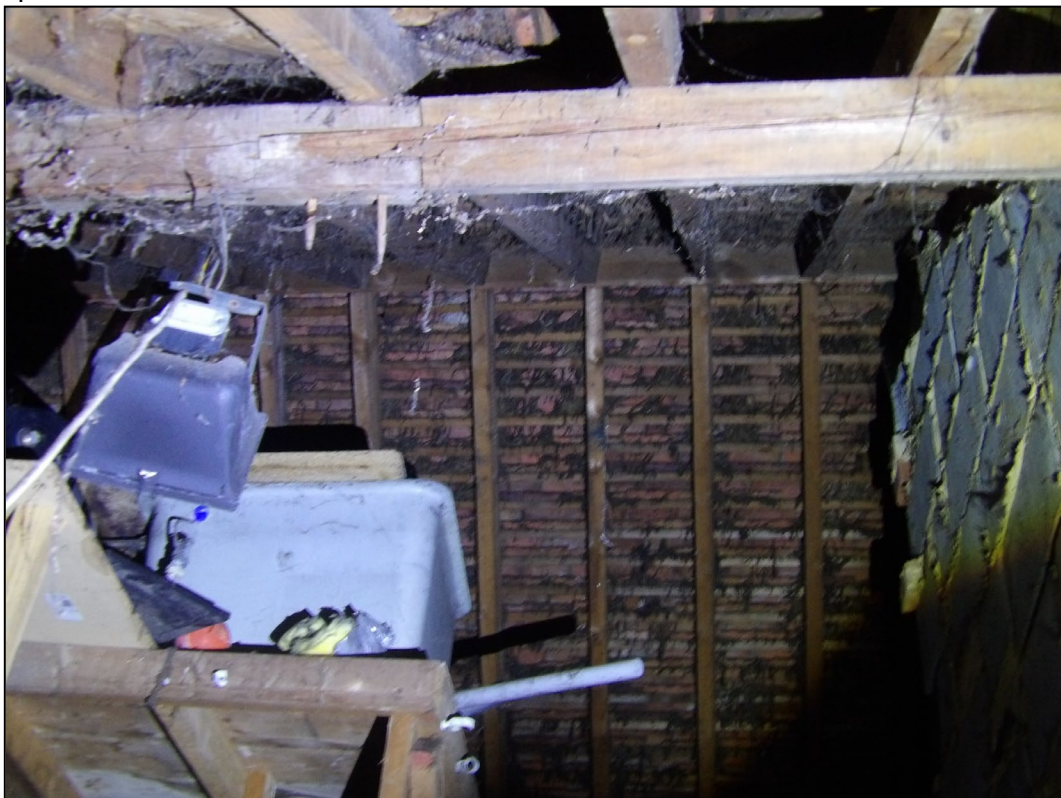
The loft space in the property was accessed through a hatch via steps and is in a poor condition internally. The loft is uncluttered, not lit, partially boarded and partially insulated and the roof tiles are unlined, see Figure 15 below. Due to the lack of boarding a thorough inspection of the loft space could not be undertaken.

No bats or evidence of bats was recorded during the internal inspection of the property or garage/utility however, due to the condition of the roof of the property and lack of lining beneath the roof tiles, bats could potentially access the building to roost.

Figure 15. Example of loft space and unlined roof tiles. Arlington, Basingstoke Road, Spencers Wood. 10.12.24

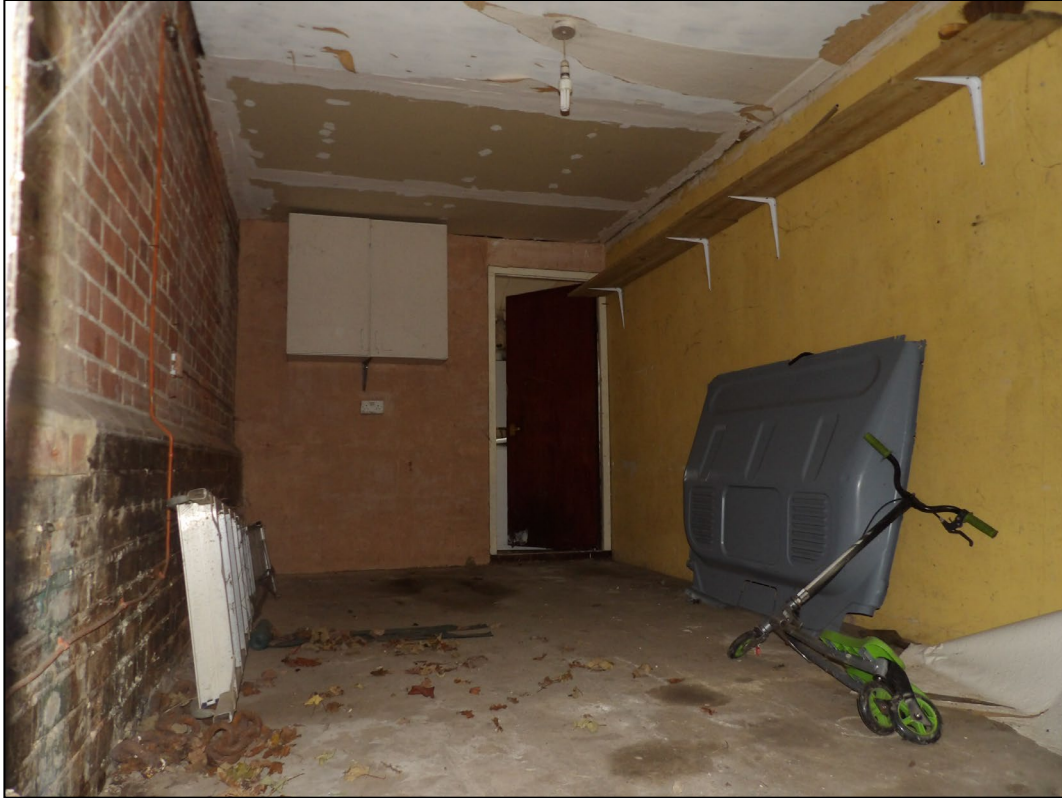
The garage/utility was also inspected internally. The roof in both these spaces is plaster boarded, see Figure 16 on page 15. There is no access to the void space above but given the good state of the garage/utility roof externally this was not thought to be a significant constraint to the survey.

Figure 16. Internal view of garage. Arlington, Basingstoke Road, Spencers Wood.  
10.12.24
