Land at Johnson Drive  
Finchampstead  
RG40 3NW

Palatine Homes Limited

23-176.01

| Report Quality Management | | | |
|---|---|---|---|
| <b>Project Title</b> | Preliminary Risk Assessment and Site Investigation | | |

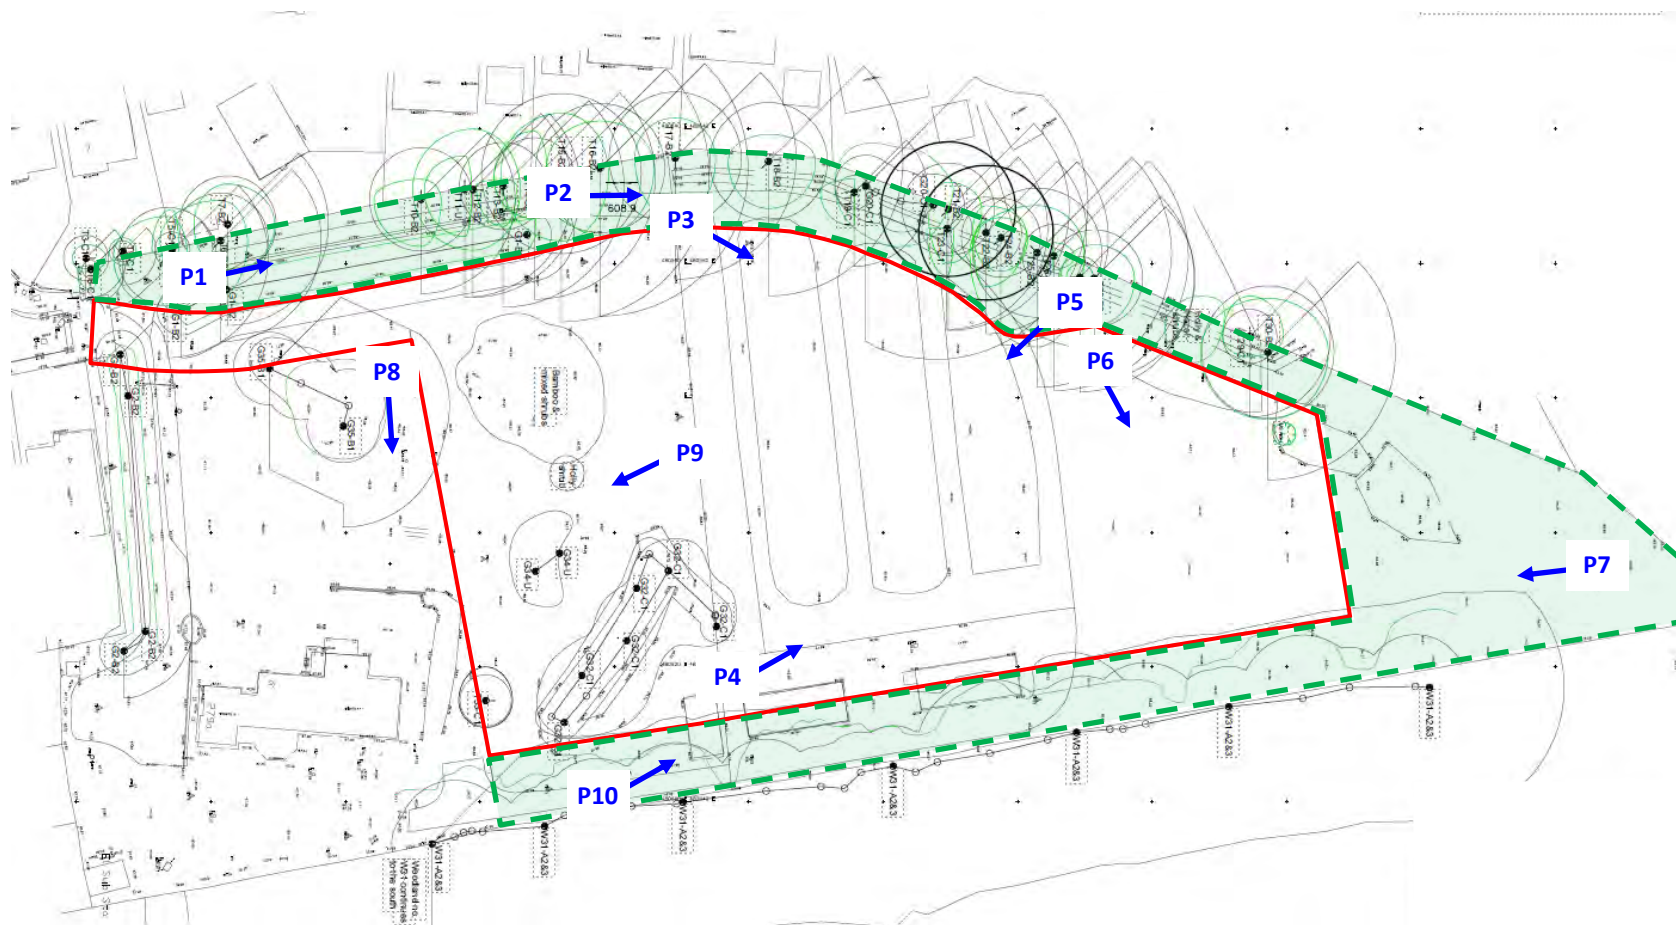
## Figure 2

| Table 1.2: Site Details | |
|---|---|
| <b>Current Land Use</b> | The site is split into two distinct areas, one in the north of the site accessed using a tree-lined gravel track leading off Johnson Drive in the south-west of the site, and the other in the south of the site via the garden of 6 Johnson Drive to the south.<br><br><b>Northern two-thirds</b> of the site: an area comprising disused land and woodland, used for the storage of a number of vehicles and stockpiles of building materials.<br><br>Two buildings/workshops are also located in the south-east of this area.<br><br><b>Southern third</b> of the site: a section of the rear garden of the adjacent number 6 Johnson Drive, including landscaped borders and trees.<br><br>An equestrian building is also located in the north-east of this area.<br><br><b>Figure 2</b> is presented as the Existing Site Layout Plan.<br><b>Figures 3 and 4</b> are presented as the Site Photographs. |

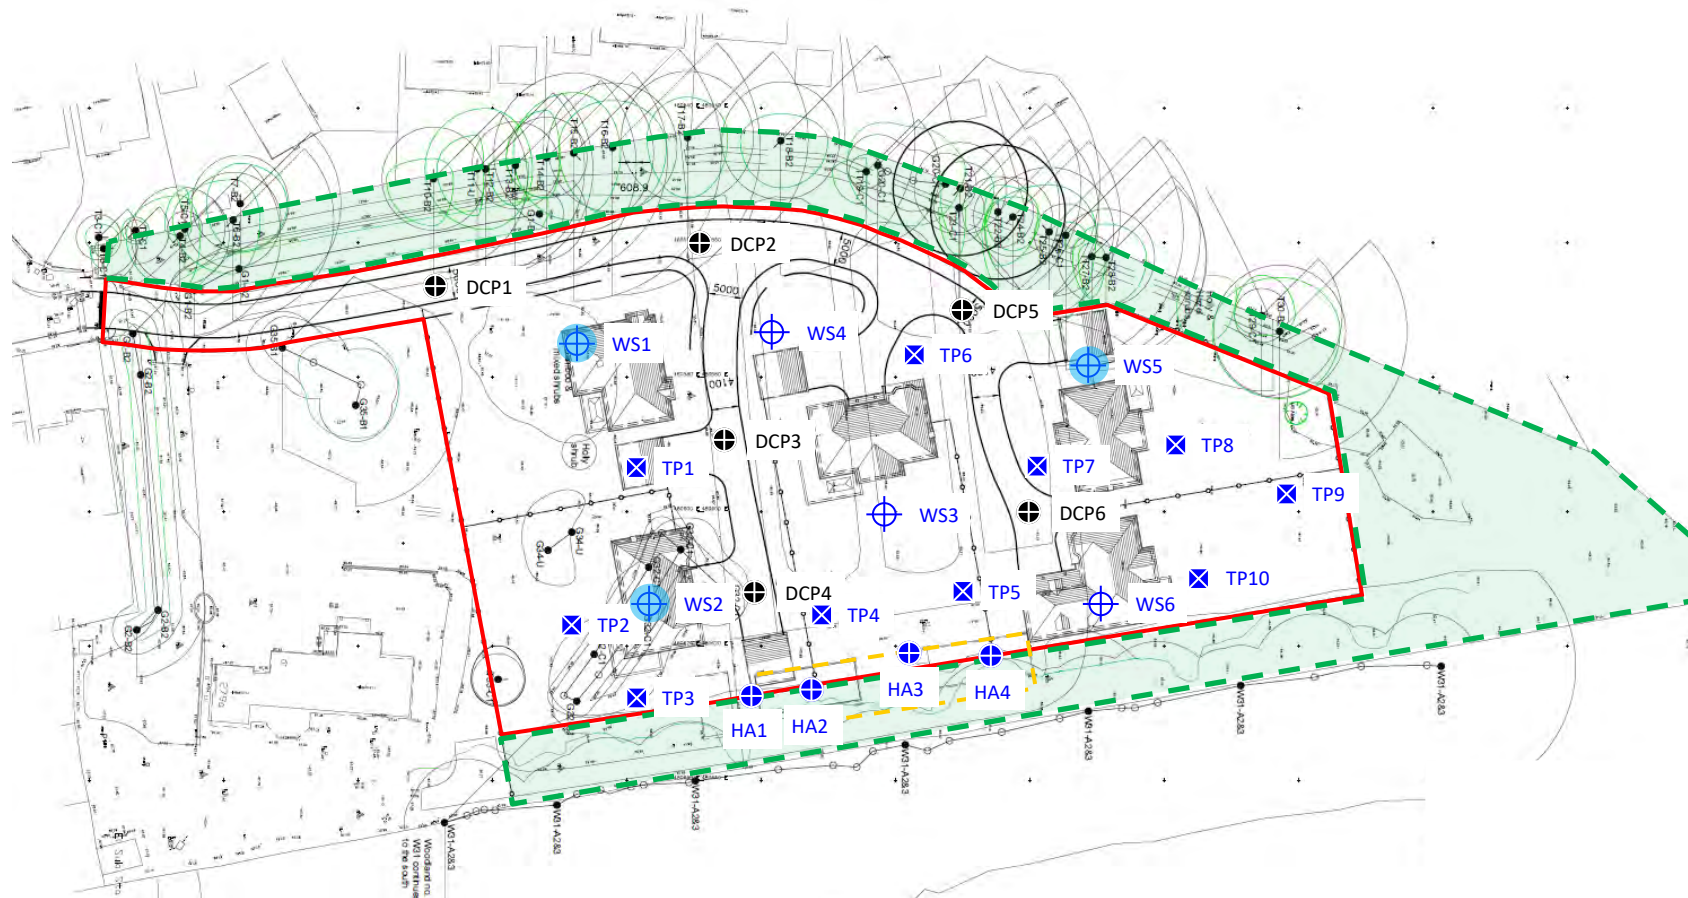
#### Figure 8

Exploratory Hole Location Plans are enclosed as **Figures 7 and 8**.

The tests were undertaken at the locations included in **Figures 7 and 8**.

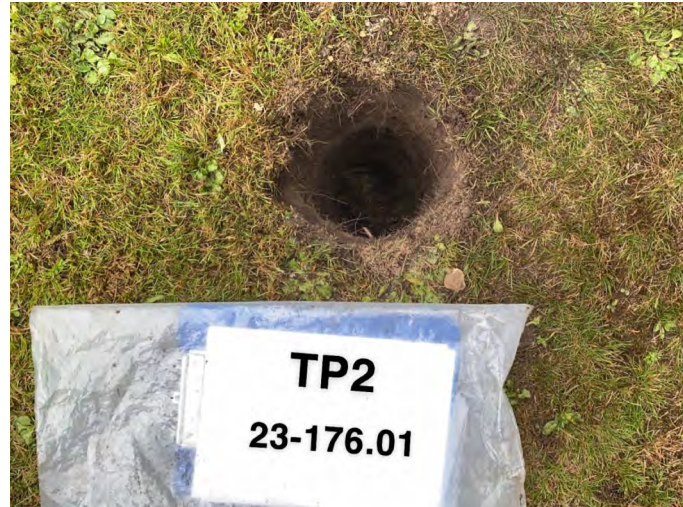
| TP2 | South-east of the site in the soft landscaped area, and rear garden of Plot 4, to determine shallow ground conditions and enable land contamination assessment/testing. | Not installed. |

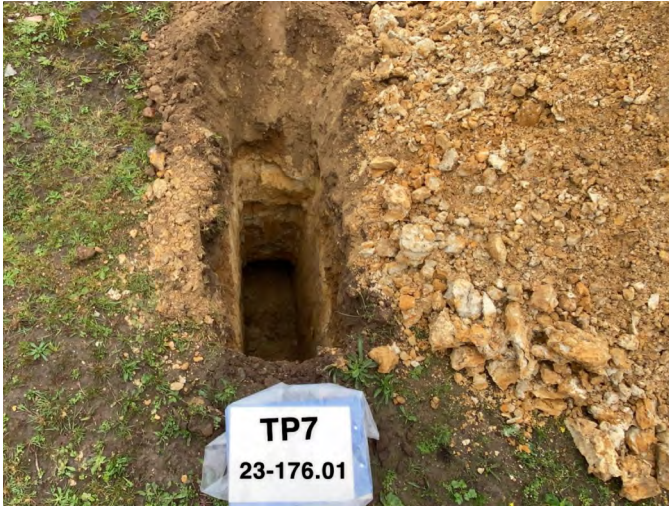
| TP7 | Centre-north of the site in the former car storage area, and front garden of Plot 1, to determine shallow ground conditions and enable land contamination assessment/testing. | Not installed. |

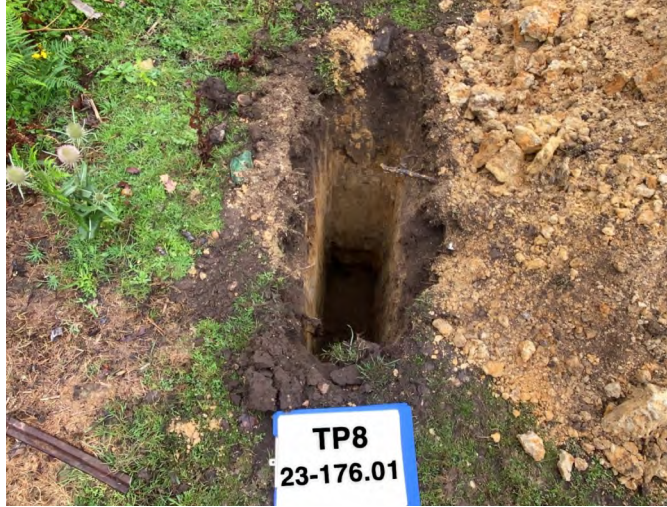
| TP8 | Centre-north of the site in the former builder's yard, and rear garden of Plot 1, to determine shallow ground conditions and enable land contamination assessment/testing. | Not installed. |
