# **Bat Roost Assessment**

## **Moor Green Barn, Finchampstead**

Project Code: 019

**Document by Echological Ltd**

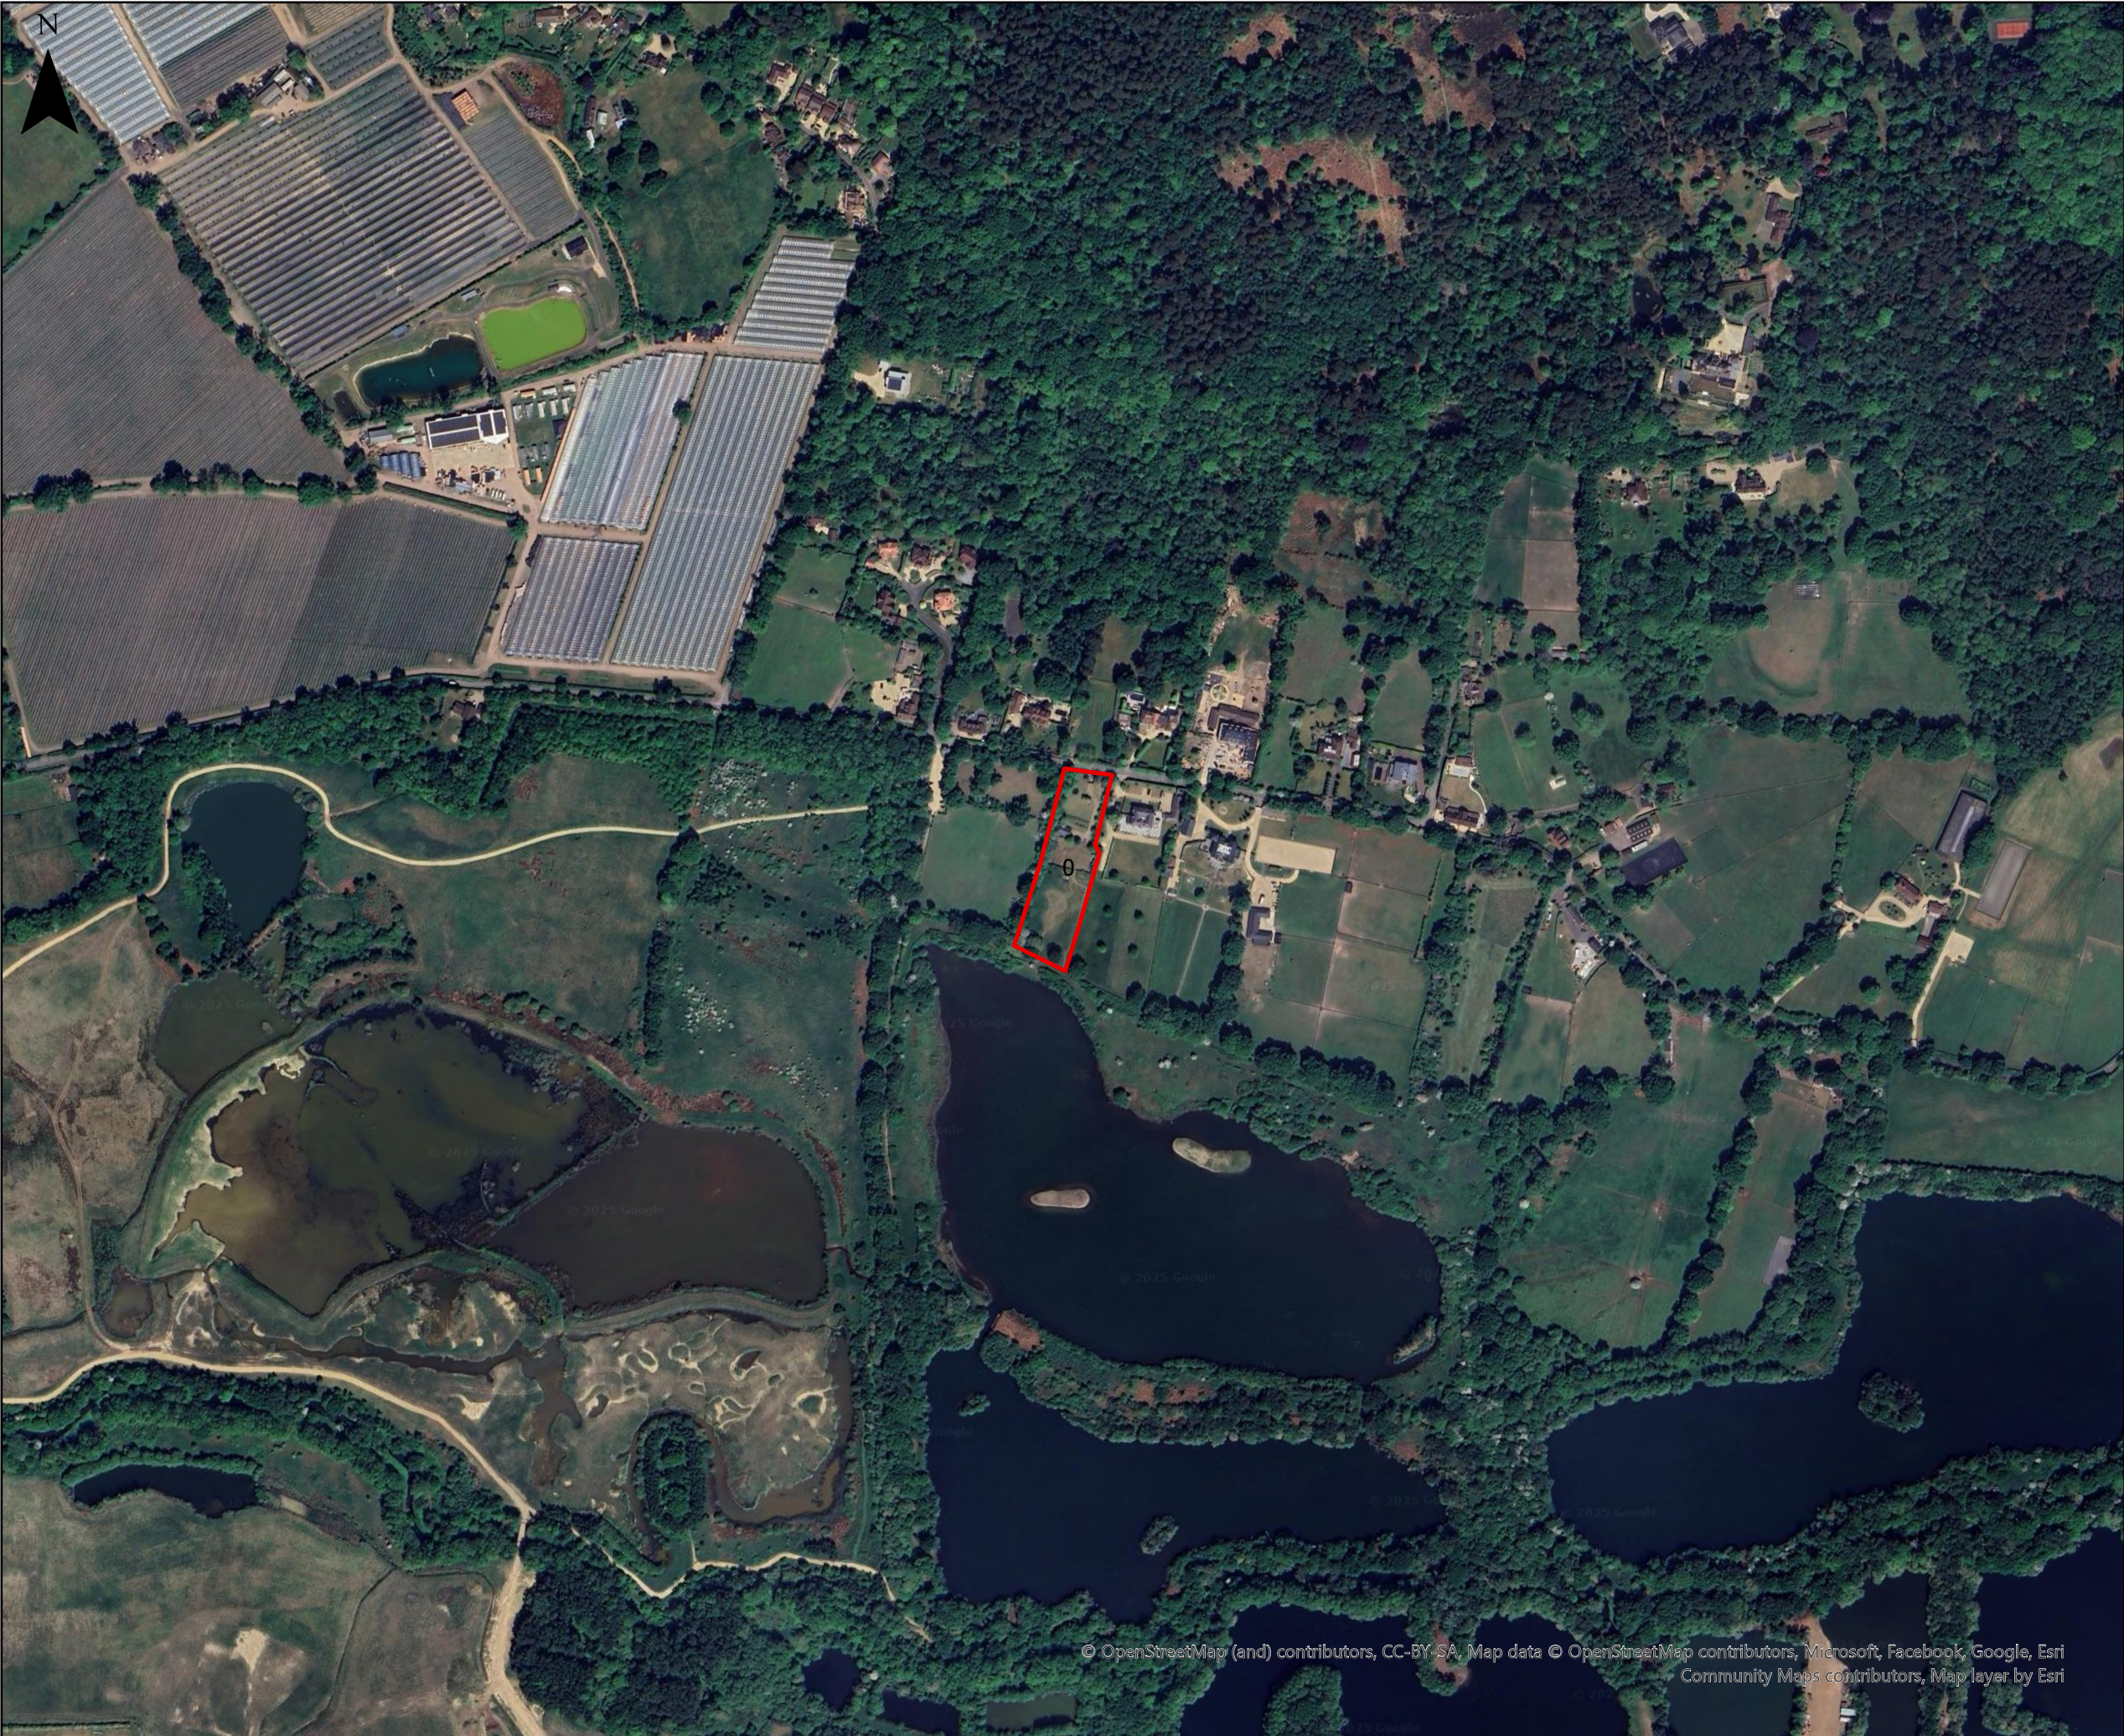
Figure 2 – Potential Roosting Features

A total of one structure (see Appendix C for overall building photos) was assessed for bat roosting potential. See Figure 2 for location of PRFs/features identified within the garage and Appendix D for photos and details of PRFs recorded:

- Bungalow - Is a small wooden cladded bungalow, with a basement. There is no roof void present as the insulation lines the pitched roof, so no roof void present. PRFa and b offer some suitability, but is limited due to the nature of the features, PRFa exposed to light from inside the bungalow and smooth plastic landing for feature b reduce potential, but maintain potential but low level at best. PRFc and e lead into the lean to shed, which offers suitability within, but no evidence was noted, which as there are sections covered in dust and cobwebs would have collected droppings from bats flying around, if they were present. The two main features of suitability are PRF-d and f, which both have good access into the features, though PRFd the access into is not simple and straight in, reducing the potential from moderate to low. The structure is not considered suitable for hibernation. No droppings or evidence of presence was found during the survey.

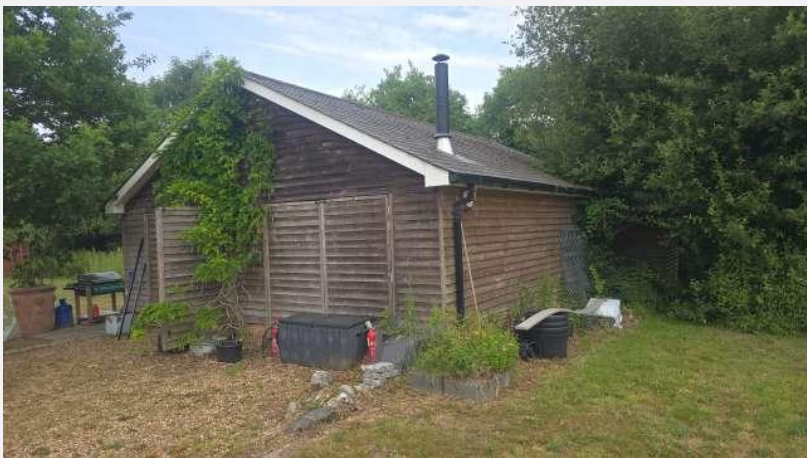
Photo Number	Description	Photo
1	Western aspect of the bungalow.

A photograph showing the western side of a small, weathered wooden bungalow. The building has a gabled roof with a dark chimney on the right side. The walls are made of horizontal wooden planks. The bungalow is surrounded by lush green trees and foliage. In the foreground, there is a grassy area with some scattered leaves and a few small plants.
2	Southern aspect of the bungalow, showing front door.

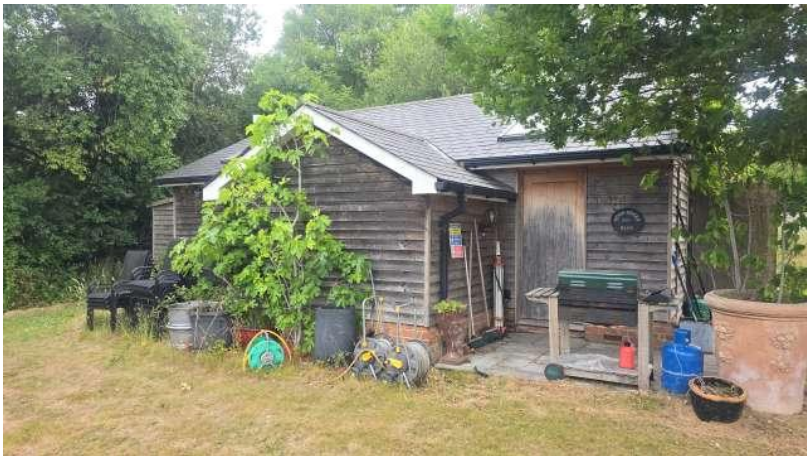
A photograph showing the southern side of the bungalow, which includes the front entrance. The front door is a simple wooden door. To the left of the door, there is a small porch area with some outdoor furniture. To the right, there is a small wooden structure, possibly a shed or a storage area. The bungalow is surrounded by trees and foliage. In the foreground, there is a grassy area with some scattered leaves and a few small plants.

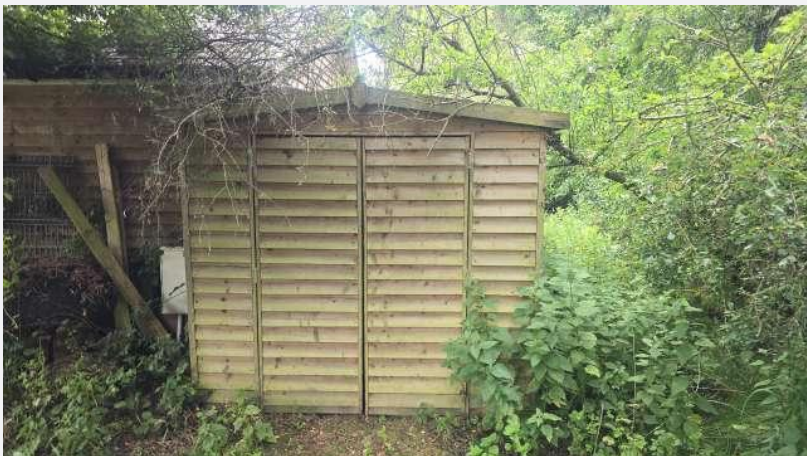
3	Lean to shed, to the rear of the property, north facing.

A photograph showing a small, lean-to shed located at the rear of the property. The shed is made of horizontal wooden planks and has a gabled roof. It is surrounded by dense green foliage and trees. The shed appears to be in good condition and is well-maintained.

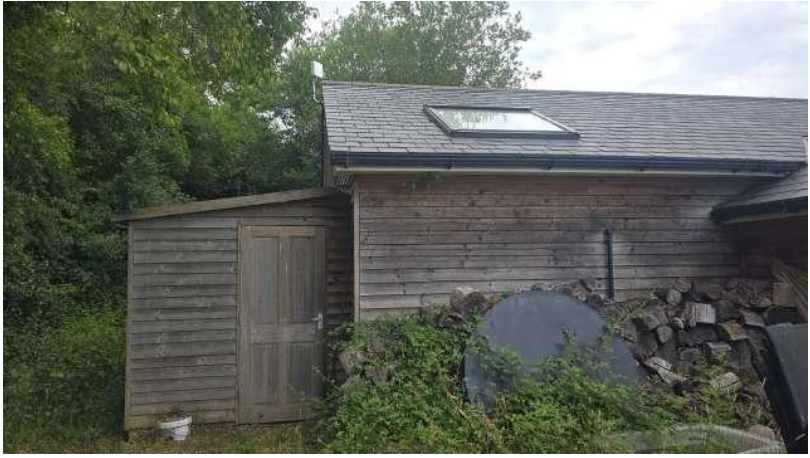
4	<p>Lean to shed, to the rear of the property, south facing.</p>

A photograph showing the exterior of a lean-to shed. The shed has a wooden door and a skylight on the roof. It is surrounded by greenery and a stone wall.
5	<p>Internal view of lean too shed, where no droppings could be found on any available surface.</p>

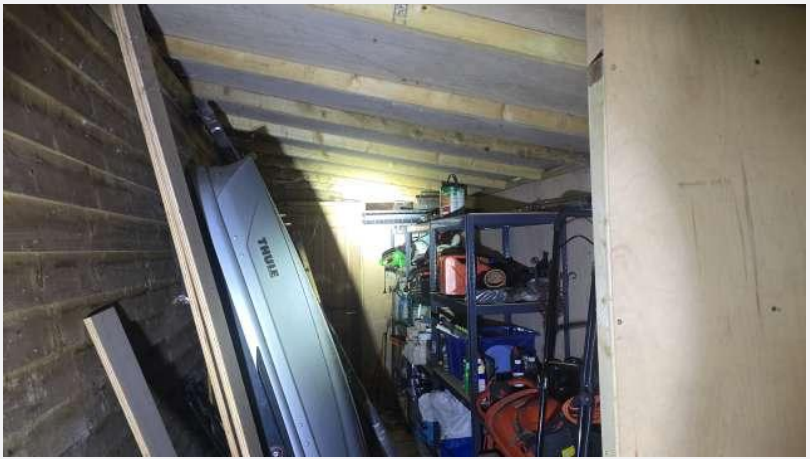
A photograph showing the interior of the lean-to shed. The space is cluttered with various items, including a metal structure, shelving, and tools. The walls are made of wood.

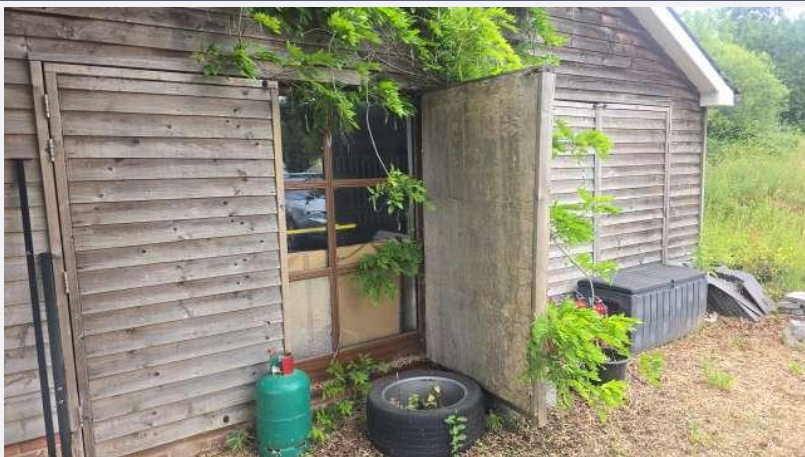
PRF Number	Description	Photo
a	Space behind both large wooden window covers on eastern aspect, with a gap between the window and the covers, which can be accessed around the gaps.

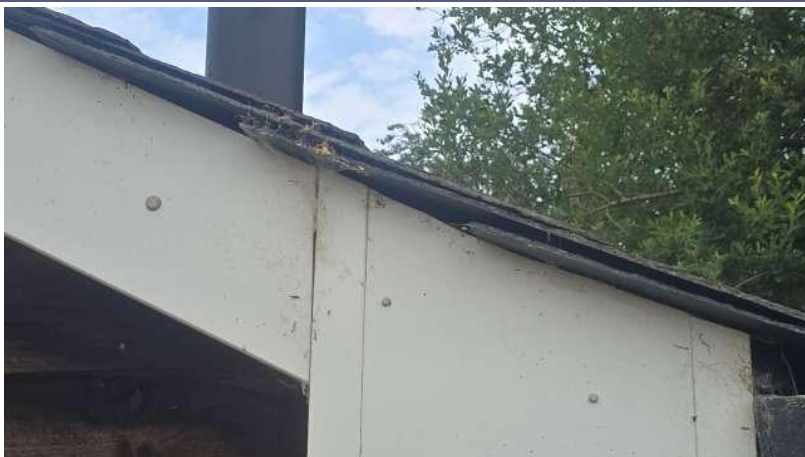
b	Height, 2.2m, east facing, gap between the roof tiles and the fascia, leading to likely roosting opportunity, though the landing area is smooth plastic making the feature hard for bats to access.

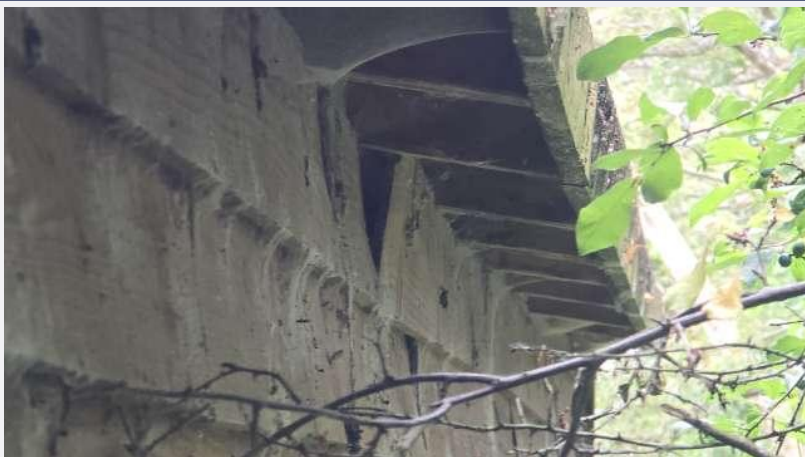
c	Height 1.8m, west facing, gap between wooden panels at the eaves of the shed, allowing access into the lean to shed. The area surrounding is slightly cluttered, reducing suitability slightly.

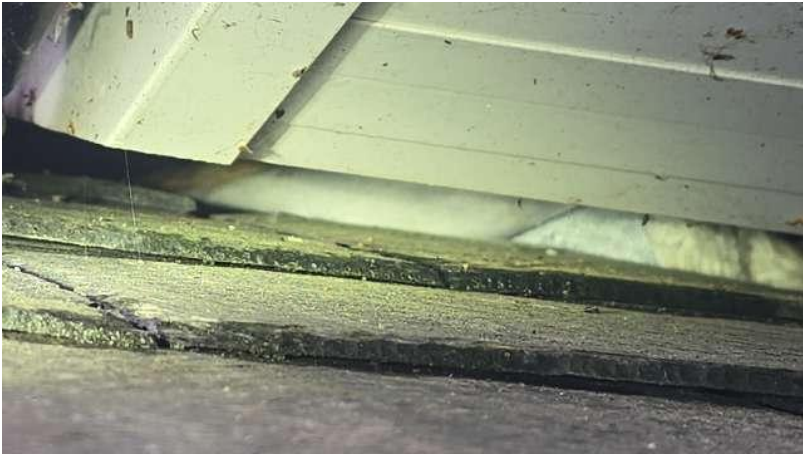
d	Height 2m, south facing, gap between where the two pitches over lap, where you have clear access into a suitable feature, which also has suitable landing for bats to crawl up. The only thing limiting this feature is that is tuck up and the gap doesn't have a free drop, reducing the likelihood of use by bats. No droppings around both aspects of the pitch.

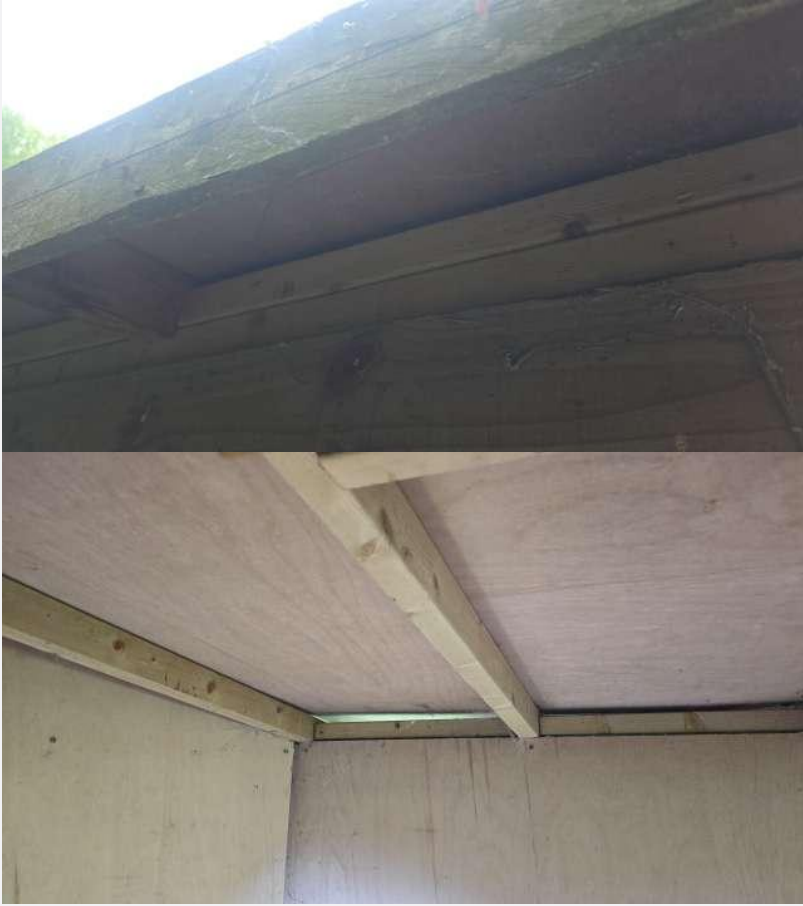
e	Height, 2m, west facing, gap in the eaves of the lean to shed, allowing suitable access into the internal aspect of the shed.

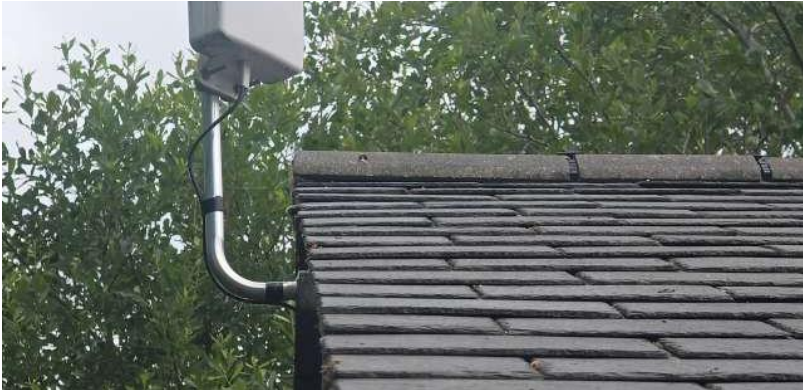
f	Gap under ridge tile at western gable end.
