# Orchards Paddock, Basingstoke Road, Swallowfield, Reading, Berkshire, RG7 1PT

## Bat Survey Report

October 2025

**Bat Survey Report**  
**Orchards Paddock, Basingstoke Road, Swallowfield, Reading, Berkshire, RG7 1PT**  
**for**  
**Chris & Julie Dearing**

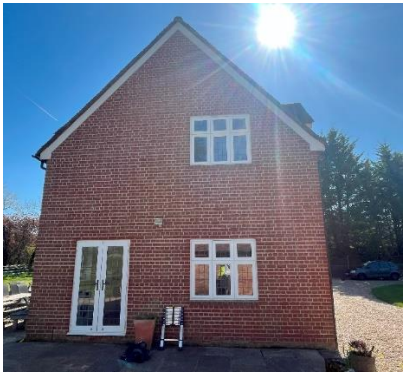
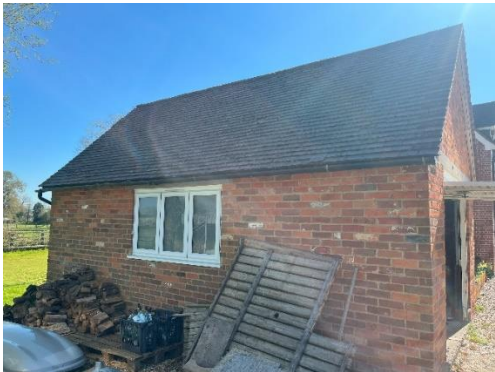
| Type/Name | House | Semi-detached garage | Outbuilding |
|---|---|---|---|
| <b>Photos</b> | North-west elevation<br> | North-west elevation<br>N/A semi-detached | North-west elevation<br> |

| Type/Name | House | Semi-detached garage | Outbuilding |
|---|---|---|---|
| <b>Exterior</b> | Dormers, chimney, lead-flashing, hanging tiles, damaged tiles | Lead-flashing, hanging tiles, damaged tiles, wooden cladding | Damaged tiles, cracks in the brickwork, wooden eaves |

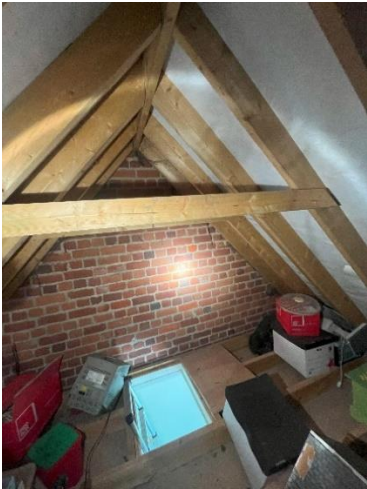
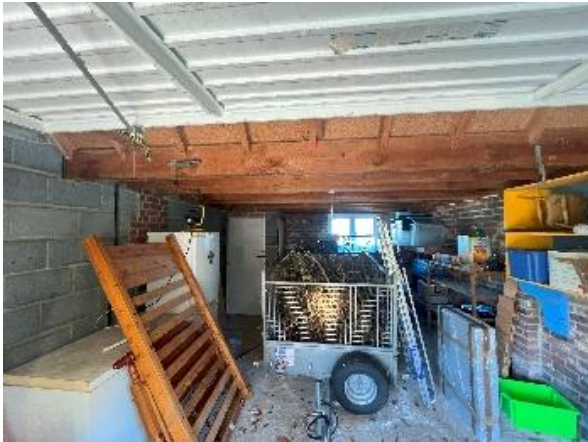
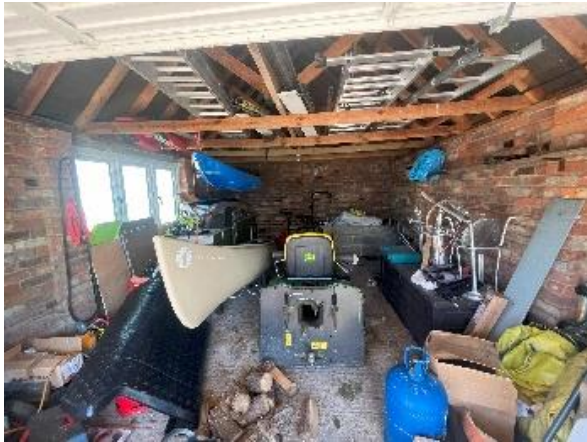
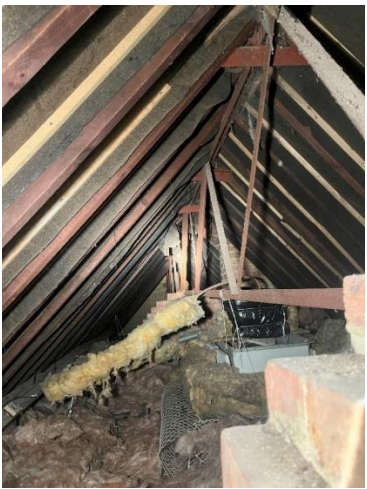
| <b>Roof void description</b> | Roof void 1: Uncluttered construction. The floor is lined with wooden boards. | N/A – open from the floor to the rafters | N/A – open from the floor to the rafters |

| <b>Roof void dimensions</b> | Roof void 1: c.4m wide x c.5m long<br> | N/A – open from the floor to the rafters<br> | N/A – open from the floor to the rafters<br> |
| | Roof void 2: c.4m wide x c.15m long<br> | | |

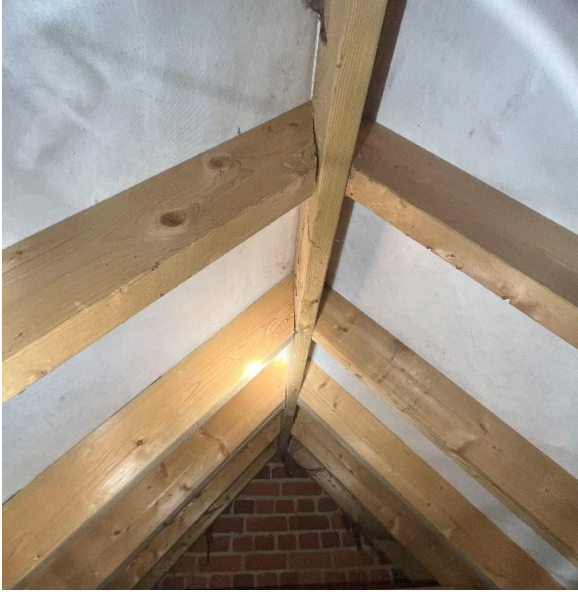
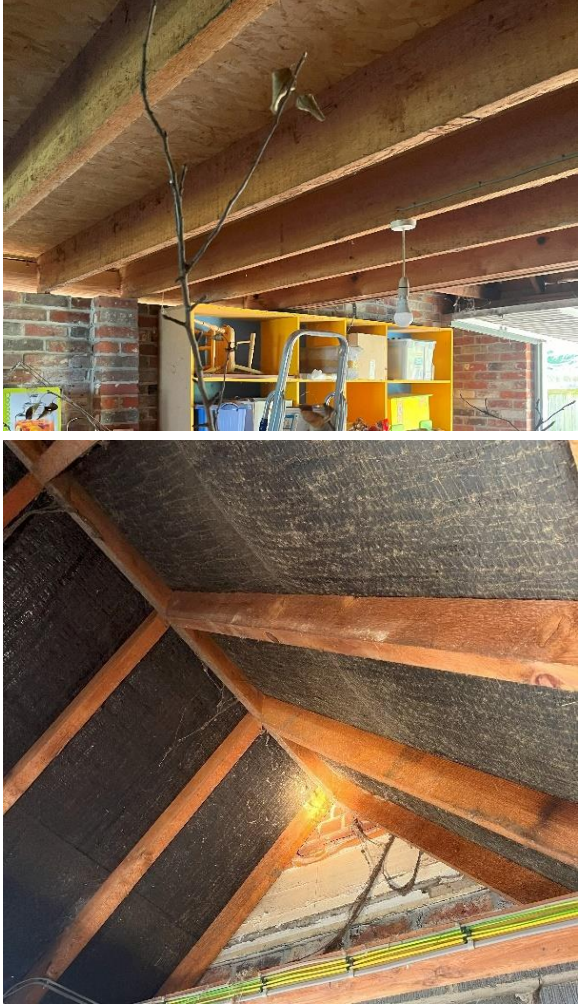
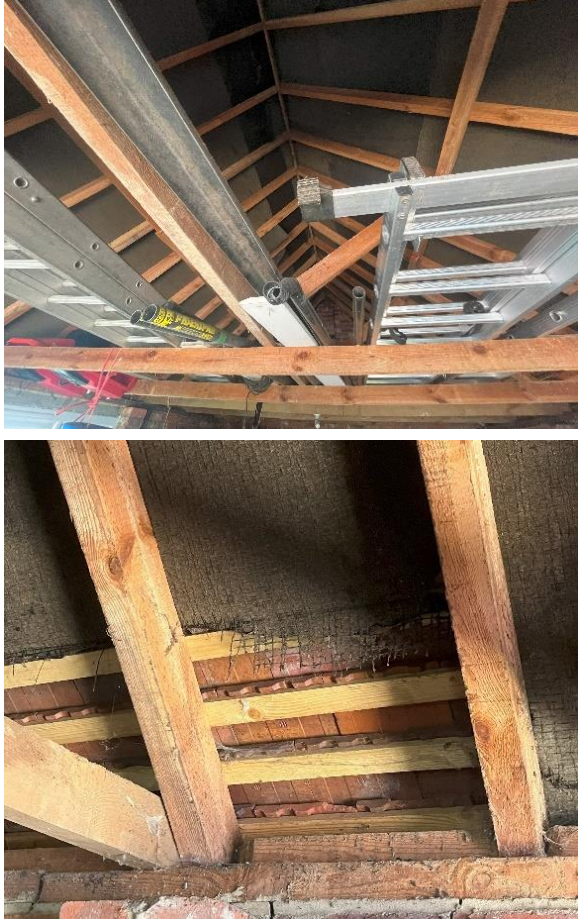
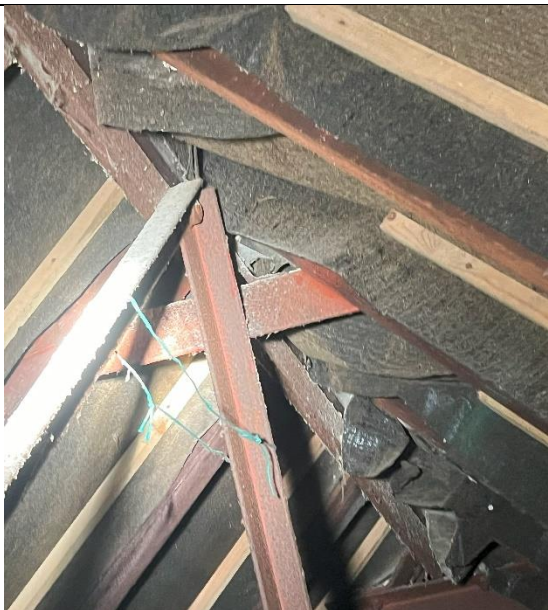
| <p><b>Potential roosting locations</b></p> | <ul style="list-style-type: none"> <li>• Against the ridge beam.</li> <li>• Between the roof tiles and the internal lining.</li> <li>• Within the brickwork where there is missing mortar.</li> <li>• The roof lining has ripped in places and could allow bats to access the roof void from under the tiles.</li> </ul> | <p>Against the wooden beams and ridge.</p> | <p>Against the wooden beams and ridge.</p> <p>The roofing felt has ripped in places and could allow bats to access the building from under the roof tiles.</p> |

| <b>Bat evidence</b> | Yes (bat droppings)<br> | None | None |
| <b>Bat suitability</b> | Moderate (confirmed bat roost) | Low | Low |

Bat droppings were found in both roof voids of the house (see *Table 4.2.1* in *Section 4.2*). The droppings were consistent in size, shape and texture with those of pipistrelle bats. The locations of the bat droppings are illustrated in *Figure 4* in *Section 6*.

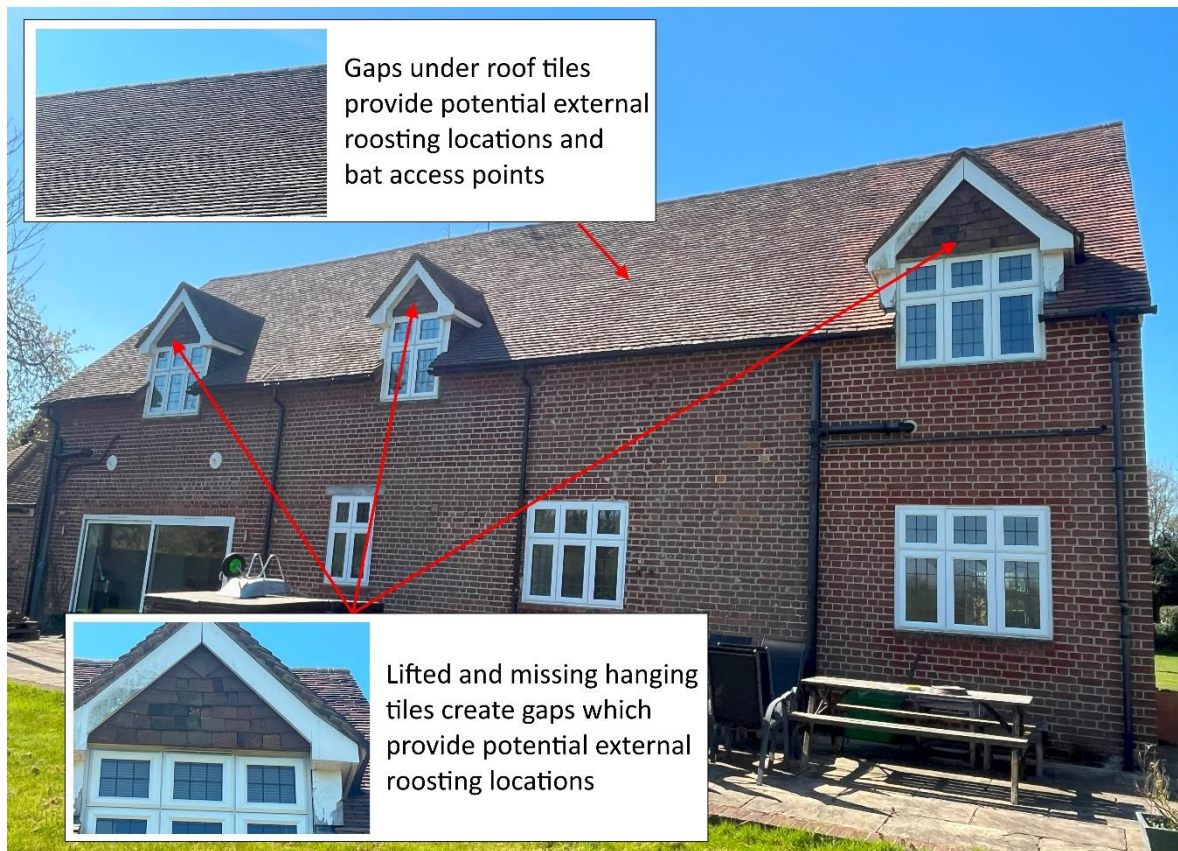
The majority of the roof appears in fairly good condition, although due to the shape and age of the tiles there are potential access points and potential external roosting locations under the roof and hanging-tiles. Therefore, the building is classed as having moderate suitability to be used by roosting bats, following the criteria in *Table 3.2.4.1*. The locations and details of the potential bat access points and potential exterior roosting features are illustrated in *Images 4.3.1 & 4.3.1.2*.

*Image 4.3.1.1. Location of potential bat access points and potential external roost locations on the north-east elevation of the house.*

The house is being re-roofed and as such the mitigation and compensation for these works are limited to providing replacement bat access points into the area under the roof tiles and the two roof voids.

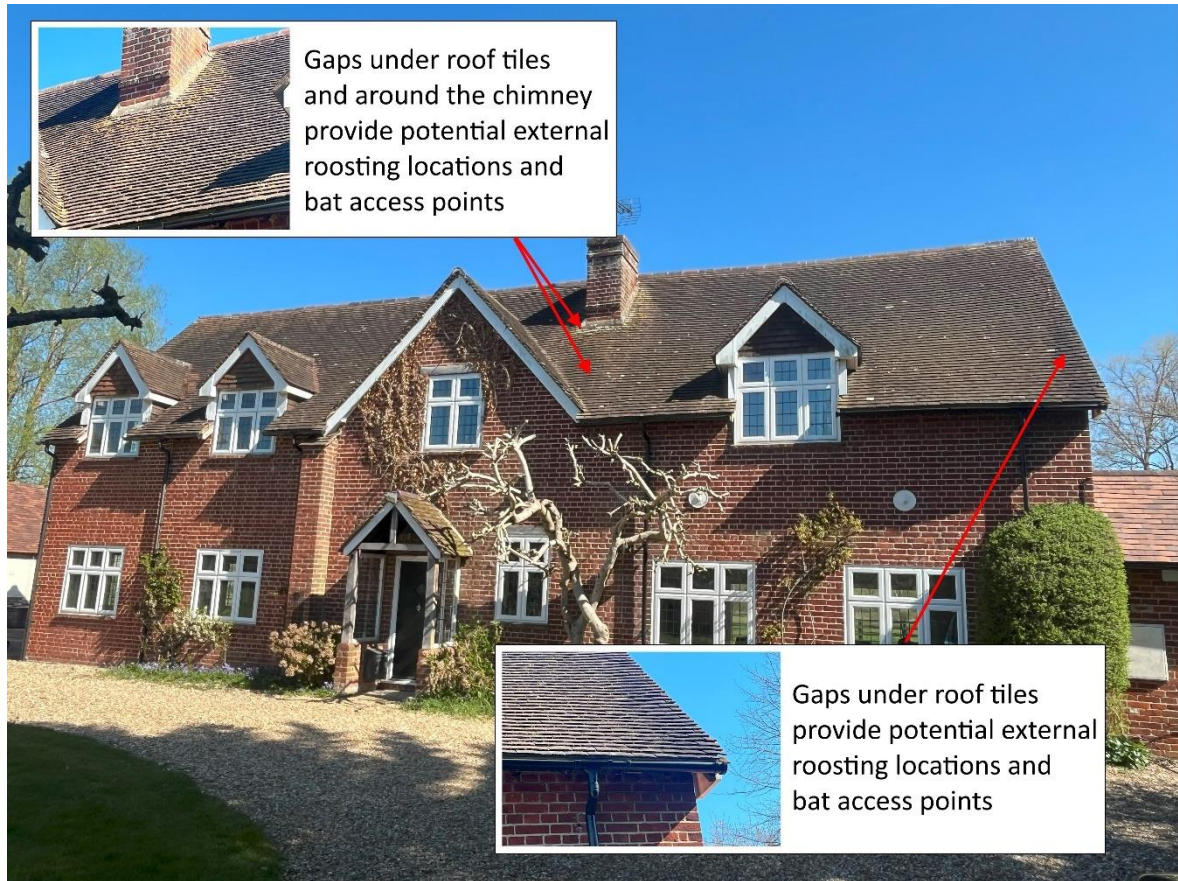
*Image 4.3.1.2. Location of potential bat access points and potential external roost locations on the south-west elevation of the house.*

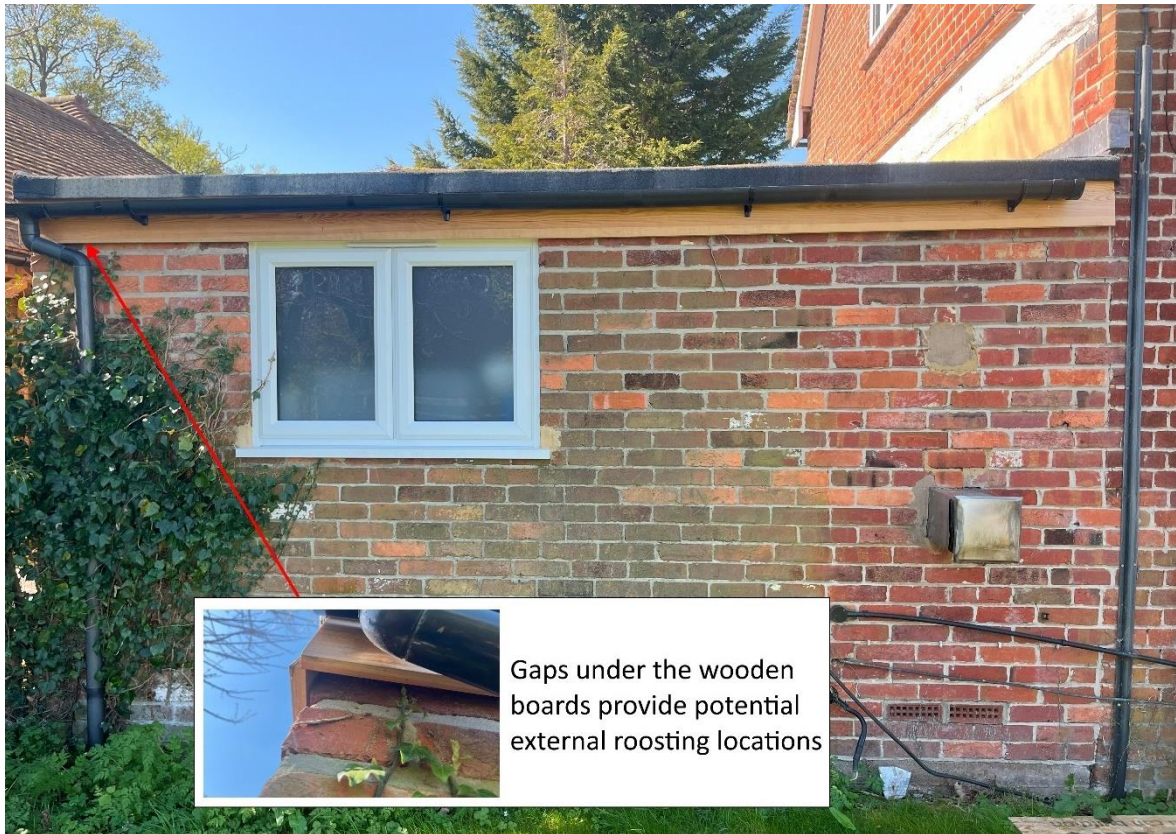
The majority of the garage appears well-sealed and in good condition. However, there are a few potential external roosting features and potential bat access points into the building. Therefore, the building is classed as having low suitability to be used by roosting bats, following the criteria in *Table 3.2.4.1*. The locations and details of the potential bat access points and potential exterior roosting locations are illustrated in *Images 4.3.2.1 & 4.3.2.2*.

*Image 4.3.2.1. Location of potential external roost locations on the north-east elevation of the semi-detached garage.*

8. No bats were observed emerging from the garage during the bat activity (dusk emergence) survey. Therefore, no mitigation or compensation measures are needed for this building and works to the garage can take place without further survey or constraints regarding bats (subject to any planning constraints).

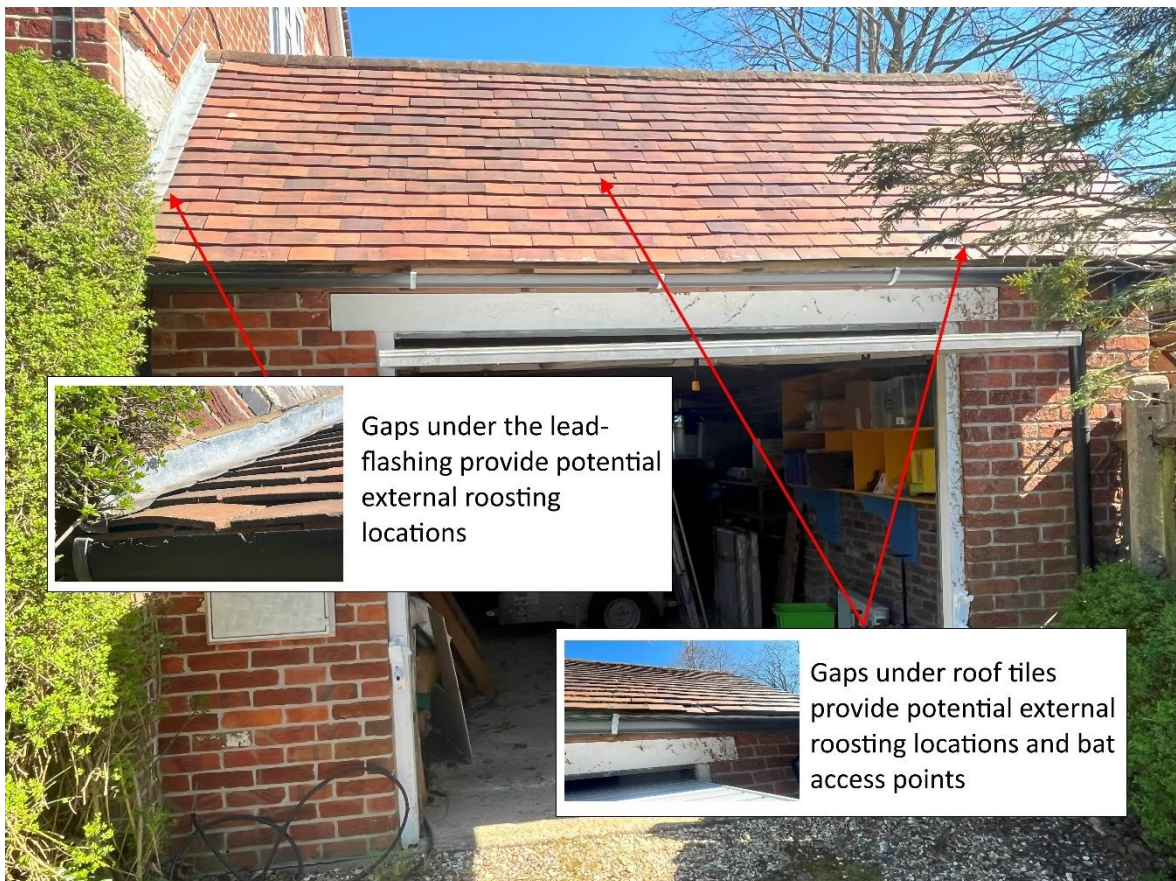
*Image 4.3.2.2. Location of potential bat access points and potential external roost locations on the south-west elevation of the semi-detached garage.*

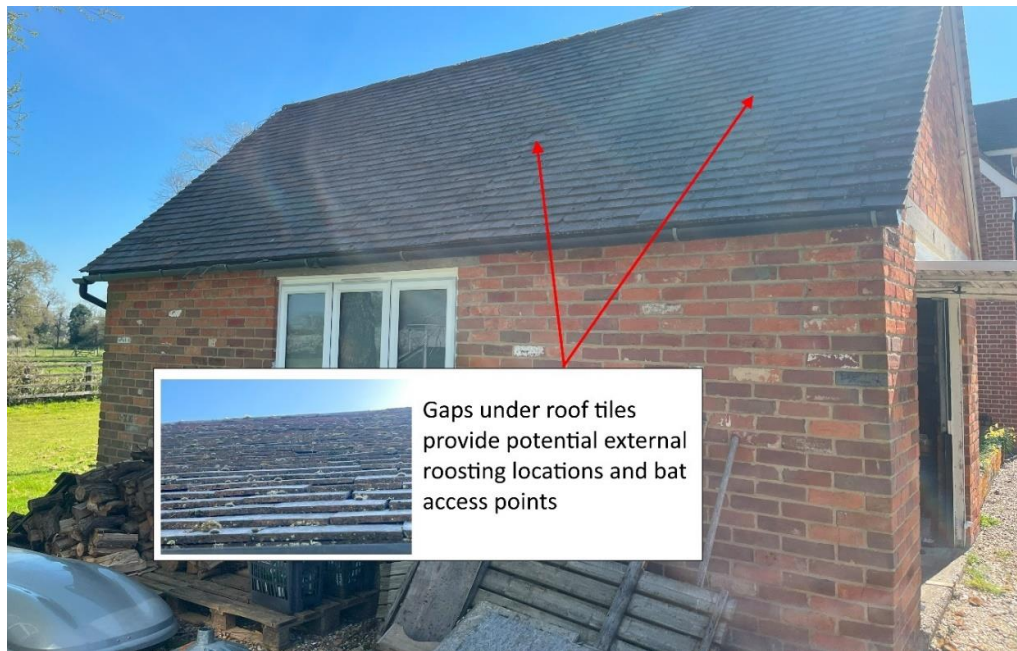
The majority of the building appears well-sealed and in good condition. However, there are a few potential external roosting features and potential bat access points into the building. Therefore, the building is classed as having low suitability to be used by roosting bats, following the criteria in *Table 3.2.4.1*. The locations and details of the potential bat access points and exterior roosting features are illustrated in *Images 4.3.3.1 & 4.3.3.2*.

*Image 4.3.3.1. Location of potential bat access points and potential external roost locations on the north-west elevation of the outbuilding.*

To provide compensation for the loss of the bat roosts in the outbuilding, a replacement will be provided in the new garage. This will consist of access to the area under the roof tiles as well as into a roof void within the new garage.

Bat access tiles (see *Figure 15* in *Section 6*) will be used to provide access into the replacement roof void in as close to the orientation of the access points in the roof of the outbuilding as possible. In addition, they will be used to provide access into the area under the roof tiles of the new extension.

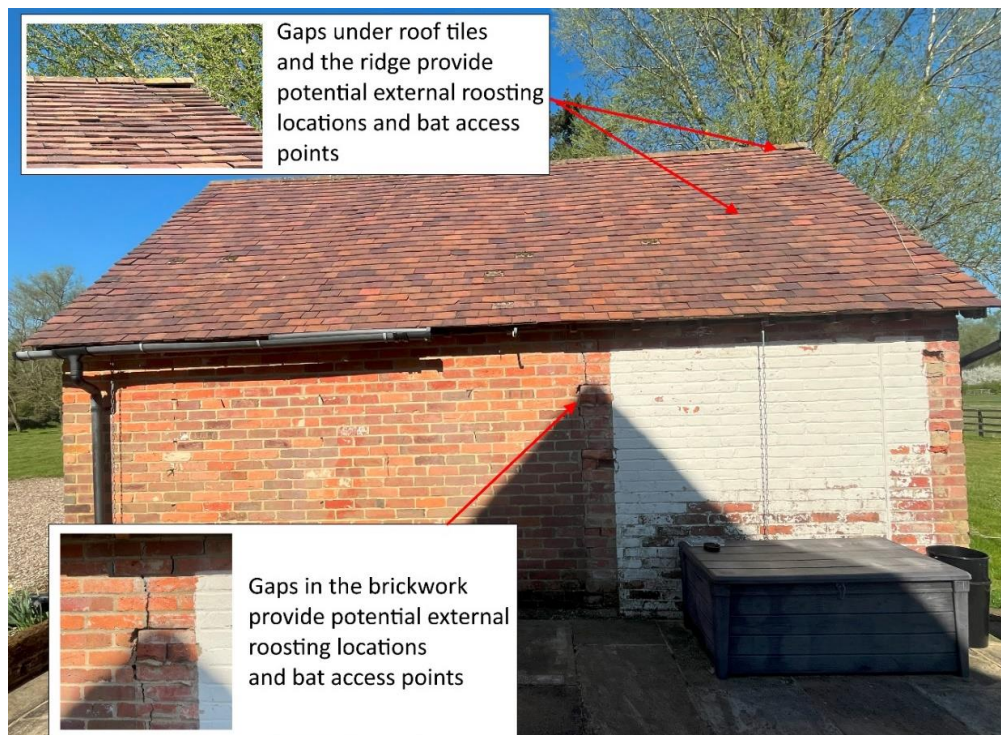
*Image 4.3.3.2. Location of potential bat access points and potential external roost locations on the south-east elevation of the outbuilding.*

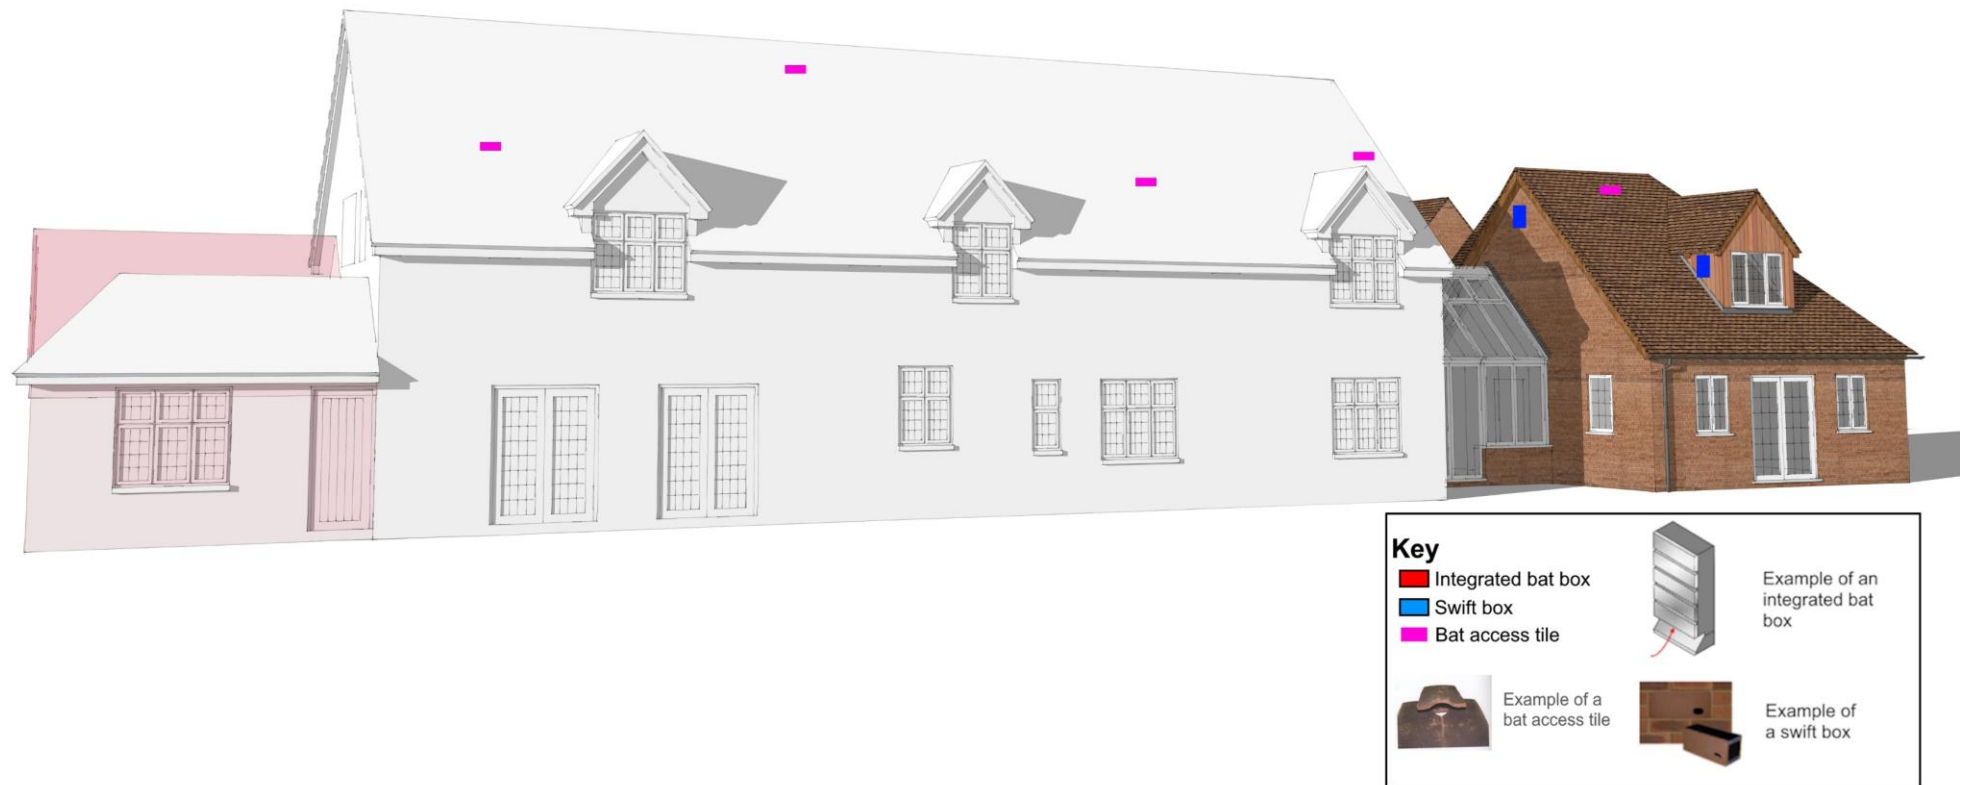
Figure 13. Plan showing the indicative locations of the proposed mitigation, compensation and enhancement (not to scale).

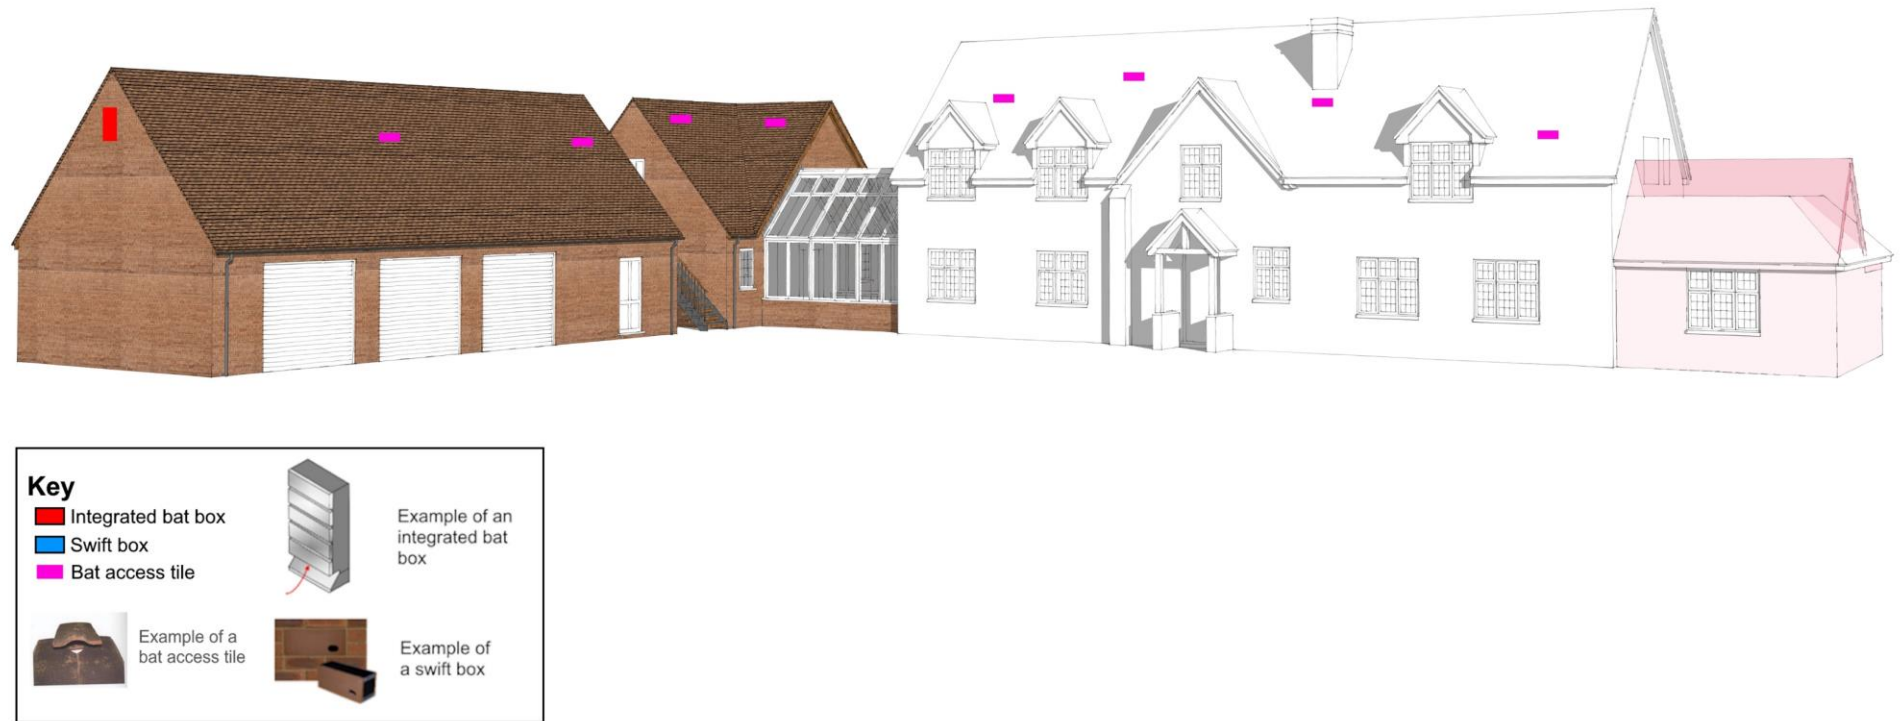
Figure 14. Plan showing the indicative locations of the proposed mitigation, compensation and enhancement (not to scale).

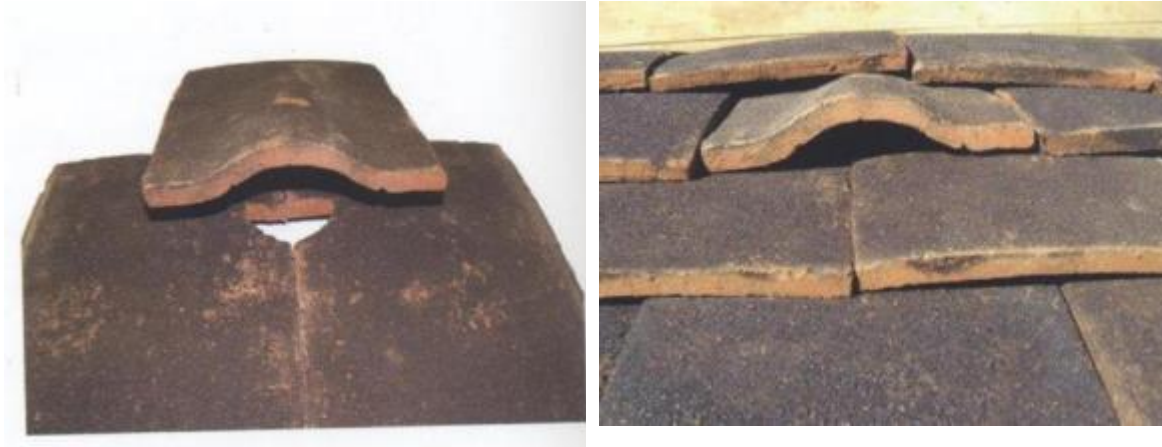
*Figure 15. An example of a Bat Access Tile Set from the Tudor Roof Tile Co. Limited is given below (taken from Biodiversity for Low and Zero Carbon Buildings: A Technical Guide for New Build (Williams, 2010)).*
