# **Bat Mitigation Strategy 2025**

**Moyle House, Fleet Hill, Finchampstead,  
Wokingham, Berkshire, RG40 4LJ**

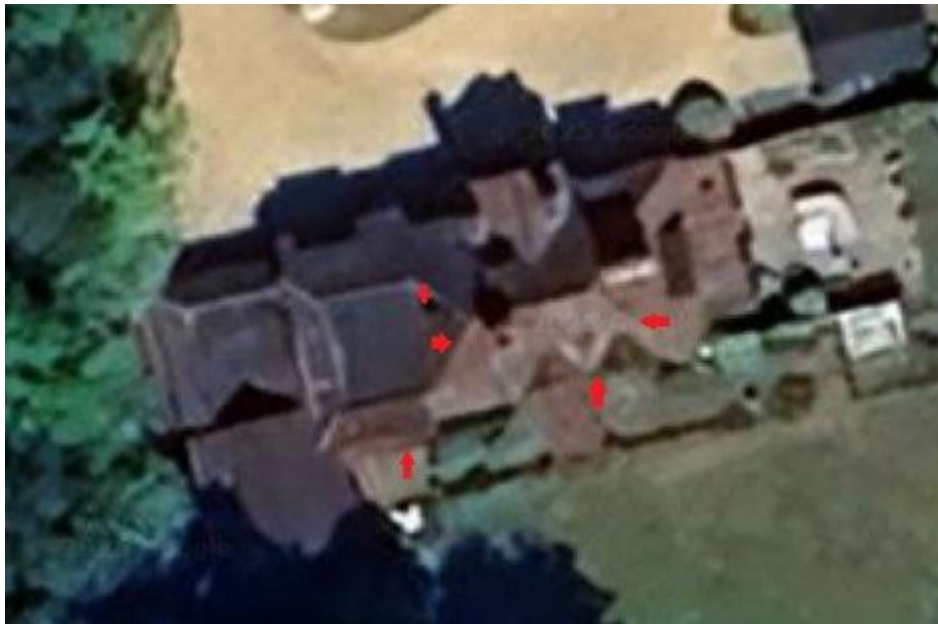
*Fig.2. Emergence points on property 2025*

- 3.4 The first dusk survey was carried out on 8<sup>th</sup> August recorded five common pipistrelles emerging from the house from four roost spaces.
- 3.5 The second dusk survey, was undertaken on 29<sup>th</sup> August recorded four common pipistrelles emerging from the west hip of the house roof.

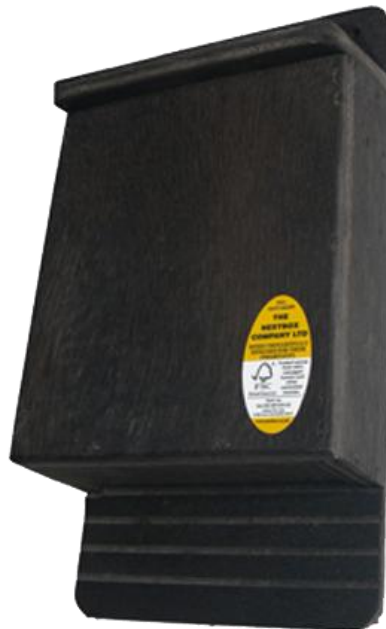
*Figure 3: The improved cavity box to be established on site*

- 4.13 The siting of bat boxes is important, bat boxes are best located, and have the best rate of occupancy, when they are situated within or adjacent to bat-friendly features, such as

hedgerows or woodland, providing connectivity to the wider landscape. The bat boxes should be situated where they are sheltered from strong winds, and should be exposed to the sun for most of the day, therefore southern aspects are favourable. Bat boxes should be hung as high as possible, preferably around 5m high, although lower boxes may also be used by brown long-eared bats.

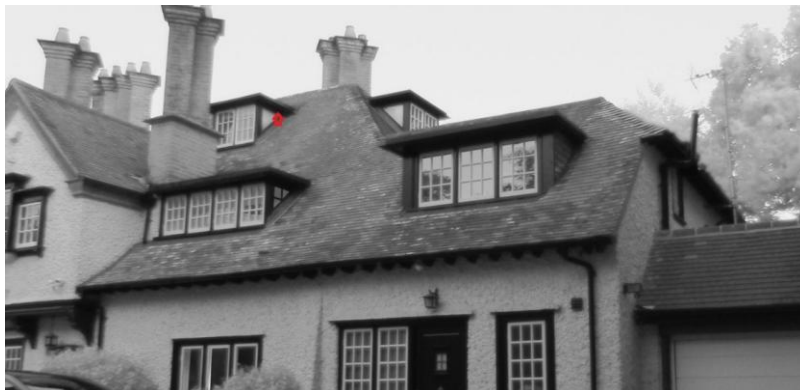
Figure 4. Emergence point of common pip on 8.8.25

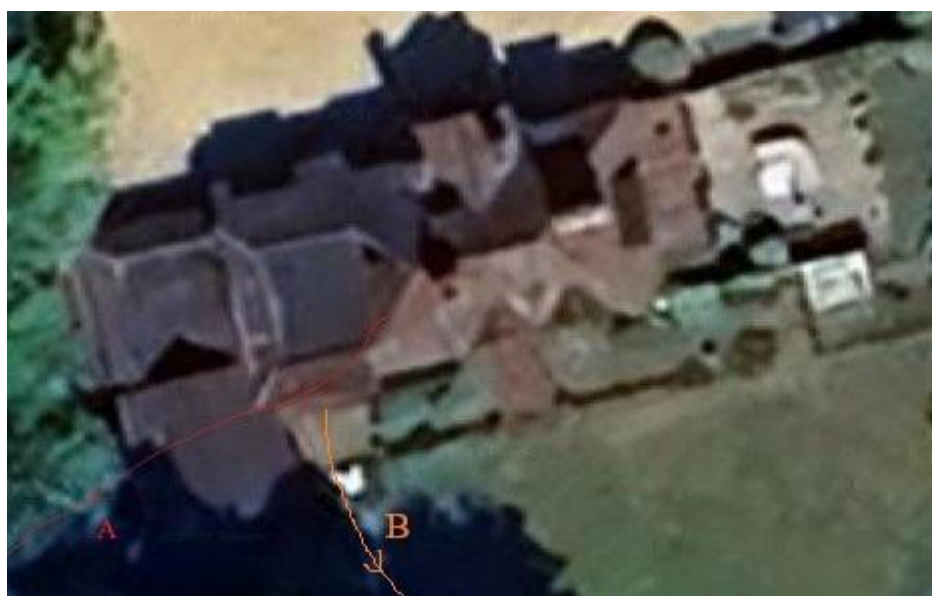
| SE,SW | 20.01 | Common pipistrelle | 1 | 1 | Emerged from edge of west hip flew off W (Flightpath A on fig. 9) | | |
| SE, SW | 20.03 | Common pipistrelle | 1 | 1 | Emerged from edge of west hip flew off W (Flightpath A on fig. 9) | | |
| SE, SW | 20.05 | Common pipistrelle | 1 | 1 | Emerged from edge of west hip flew off W (Flightpath A on fig. 9) | | |
| SE, SW | 20.09 | Common pipistrelle | 1 | 1 | Emerged from edge of west hip flew off W (Flightpath A on fig. 9) | | |
| SE, SW | 20.12 | Common pipistrelle | 1 | 1 | Emerged from balcony overhang flew off SW (Flightpath B on fig. 9) | | |

Figure 9. Emergees on 29.8.2025
