## PRELIMINARY BAT ROOST APPRAISAL

201 READING ROAD  
WOKINGHAM RG41 1LH

Date: 5<sup>th</sup> June 2026

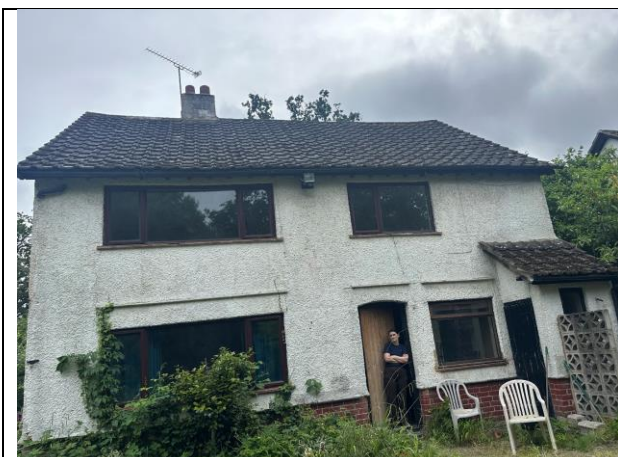
3.1.1 The house was a two storey rendered brick structure that appeared to have been built during the early twentieth century and included three gables. The roof was covered with concrete interlocking tiles, which were in good condition and showed no PRFs; the tiles were in place the eaves and all mortar at the ridge and lead at the chimney were tightly sealed. The weather boards at the south gable offered opportunities for temporary / opportunistic use by bats, however these PRFs were very shallow and were not considered to offer long-term roosting opportunities. No evidence of bats was encountered at the exterior of the house, including at the weather boards. Typically, when crevice-dwelling bats occupy spaces / cavities behind weather boards, droppings are normally present on the vertical surfaces, particularly in June when the survey was undertaken when bats are highly active.

Photo 1 North elevation

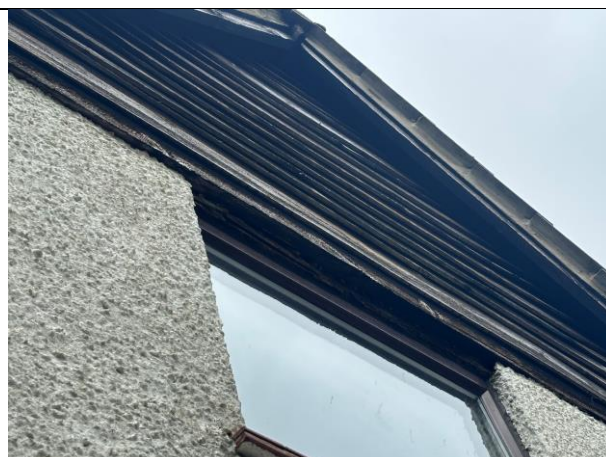
3.1.3 The south gable weather boards were found to be covered with plaster and therefore no cavity was present. No evidence of bats was encountered.

Photo 2 South elevation weather boards

4.1.4 To avoid the potential for an offence under the Conservation of Habitats and Species Regulations 2017 (as amended), precautionary measures will be implemented during works to the weatherboarding on the southern elevation, where potential roost features (PRFs) were identified. These works will be undertaken under the supervision of a suitably licensed bat ecologist.

4.1.5 Immediately prior to any intrusive works, all PRFs will be subject to a hand-held torch inspection by the licensed bat ecologist. Removal of materials will then proceed slowly and carefully by hand, under continuous ecological supervision, with works stopped if any features that might suggest higher bat suitability or evidence of bats are identified.

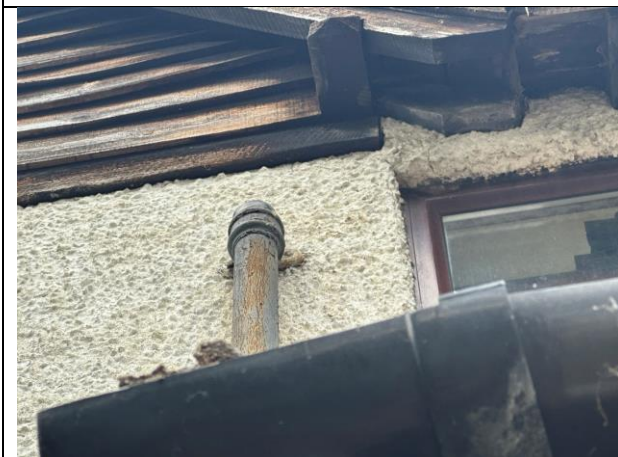
Photo 3 Minor gaps beneath weather boards

- During removal of the weather boarding, a licensed bat worker will carry out a check for bats beneath the weather boarding gaps. Should any bats be found prior to destructive works, work will immediately stop until the Local Planning Authority and Natural England (0300 060 3900) have been contacted for advice on how to proceed. In such a scenario it is likely that an EPSL application would need to be made to Natural England before works could recommence.

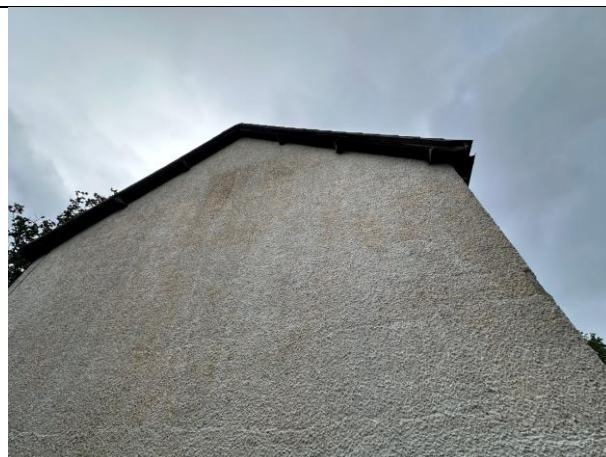
Photo 4 Sealed verge

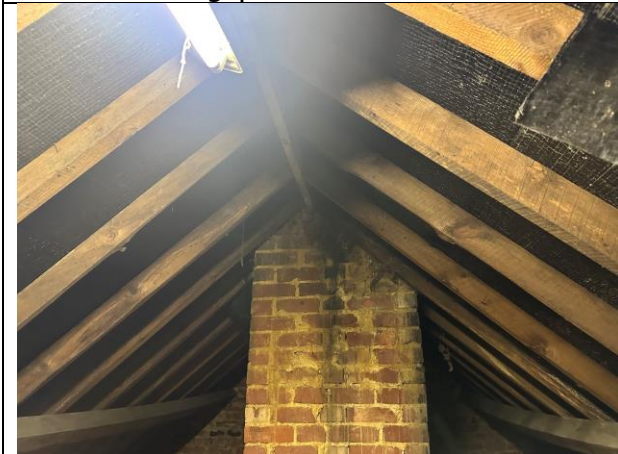
3.1.2 Inside the loft void it was apparent that the roof was supported by light weight timbers and was lined with traditional bitumen felt. Low levels cobwebbing was present at the ridge, which evidenced that no bats had used this feature in recent times. High levels of cobwebbing were found elsewhere between the rafters and gables, and around the chimney stack / roof intersection. The loft floor was covered with fibreglass insulation, and this supported old dust and debris, although no evidence of bats was encountered. Evidence of mice was present in the form of droppings and bits of chewed material. No evidence of bats was encountered.

Photo 5 Roof void

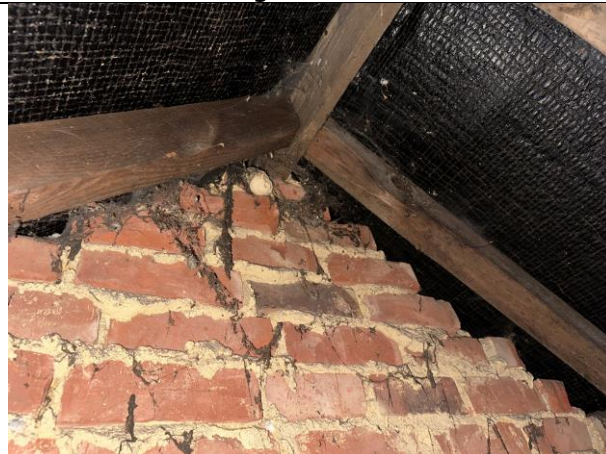
Photo 6 Cobwebbed gable

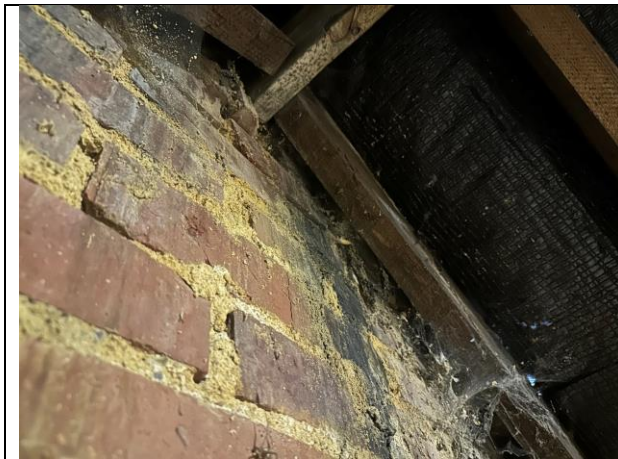
Photo 7 Cobwebbed gable

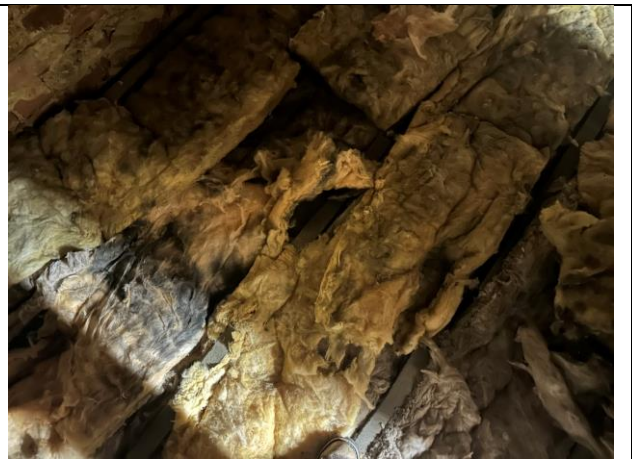
Photo 8 Dust at loft floor – no evidence of bats

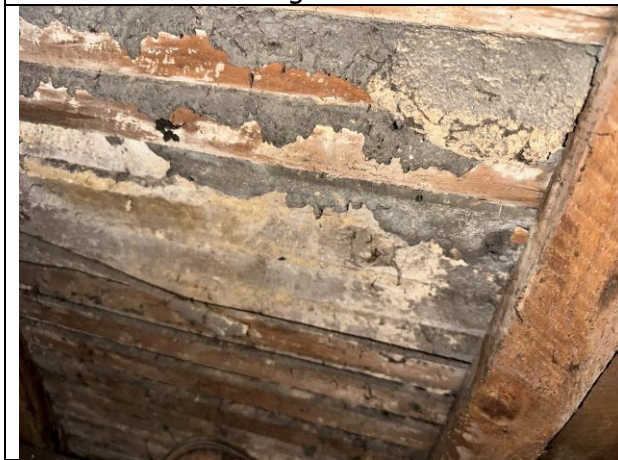
Photo 9 Plastered underside of weather boards south gable

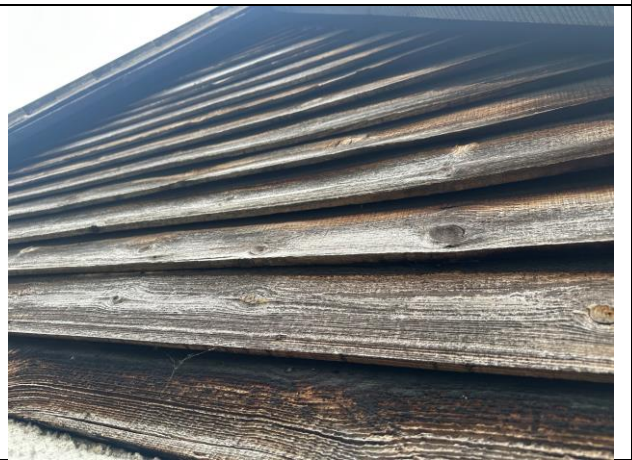
3.1.5 The single storey garage to the rear was a timber structure. The roof was covered with natural slate tiles, which were in good condition and showed no PRFs. Access for bats and birds was possible via the open door.

Photo 10 Garage weather boards

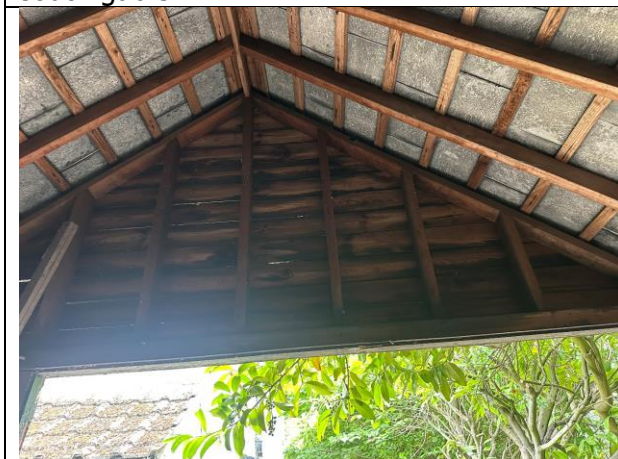
Photo 11 Garage open front

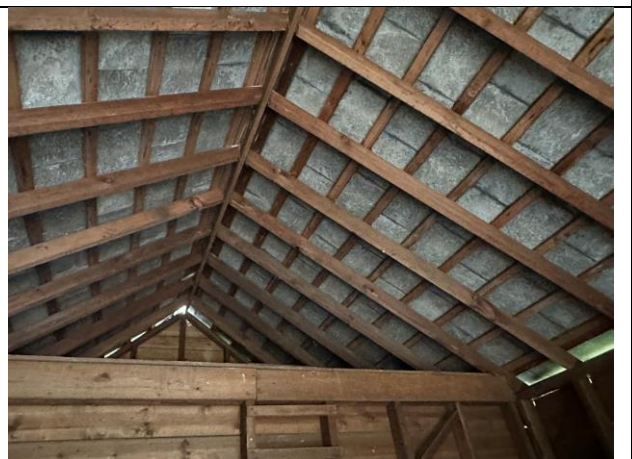
3.1.6 Inside the garage structure, the roof was unlined and vaulted, with an open and exposed interior. No PRFs were identified other than roof timbers, which may provide limited perching or temporary resting opportunities. No evidence of bats or breeding birds was recorded. The garage was assessed as having negligible bat roosting suitability. While void-seeking species could potentially utilise the structure opportunistically (e.g. for perching while feeding), no evidence of such activity was recorded, and further survey effort is considered unlikely to yield additional roost evidence.

Photo 21 Garage unlined / vaulted roof
