# Preliminary Ecological Appraisal

**Reddam House**

**December 2024**

**Project:                          ETH24-285**

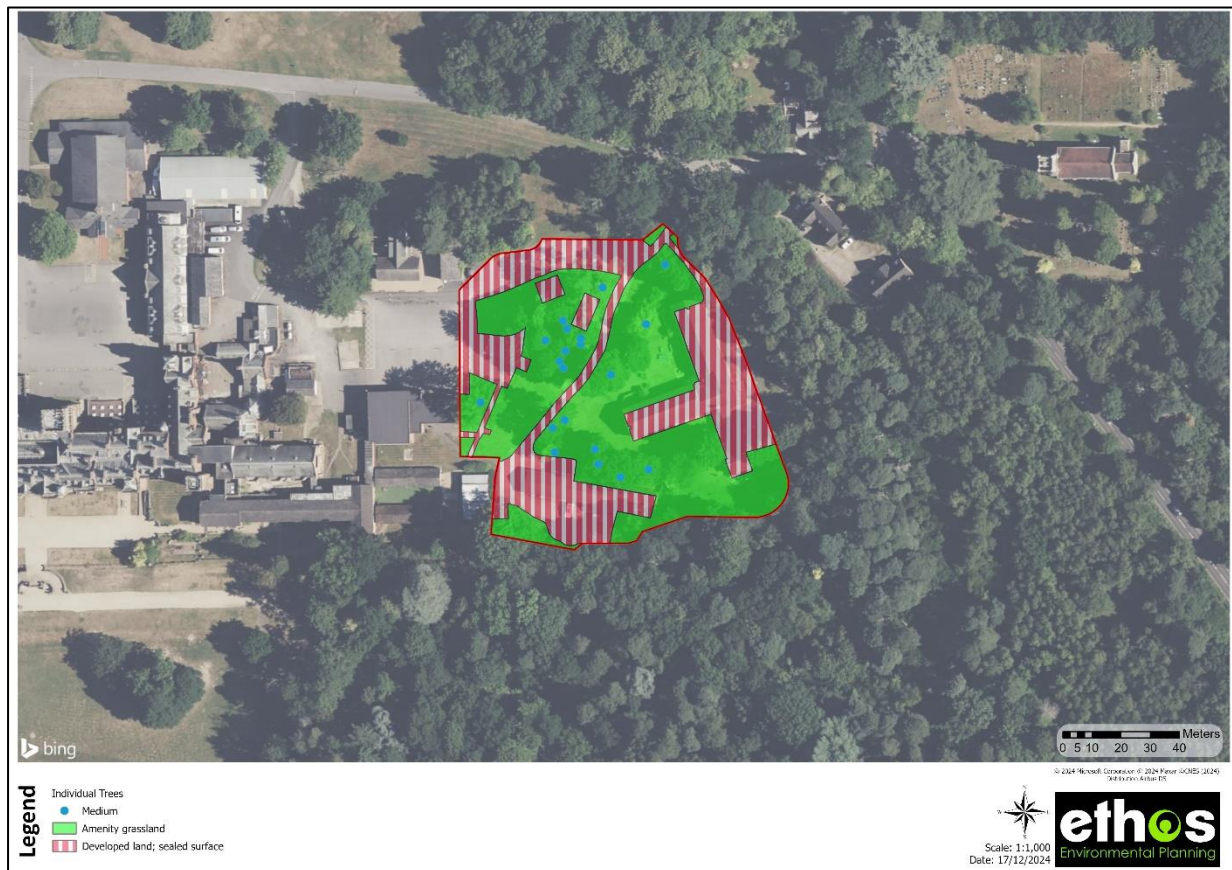
Figure 3 UK Hab survey results

- 4.2.2 Figure 3 displays the key habitats using the UK Habitat classifications. Descriptions of the habitats are provided in the following section and comprise:

- Grassland – Modified grassland (g4);
- Urban – Developed land; sealed surface (u1b);
- Individual Trees

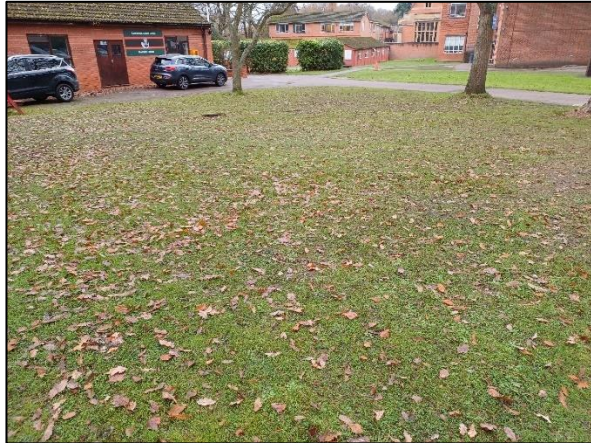
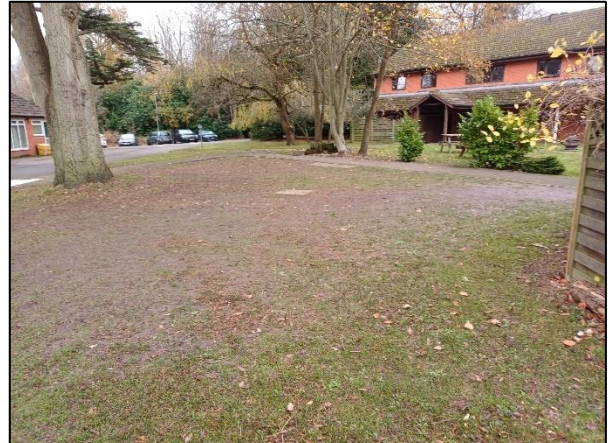
- 4.2.3 A large proportion of the site contains modified grassland, managed for amenity use. The grassland was assessed to be in poor condition due to recreational impact, with high levels of bare ground throughout the sward. At the time of survey, the grassland

was managed to a short sward throughout and had a low species diversity. Four quadrats were taken from across the grassland, with the results displayed in Appendix 2. The grassland contained an average of 4.5 species per quadrat.

- 4.2.4 The grassland is assessed to contain low value for biodiversity and is not considered further in this appraisal.

*Photo 1 Grassland on site*

*Photo 2 Grassland on site*

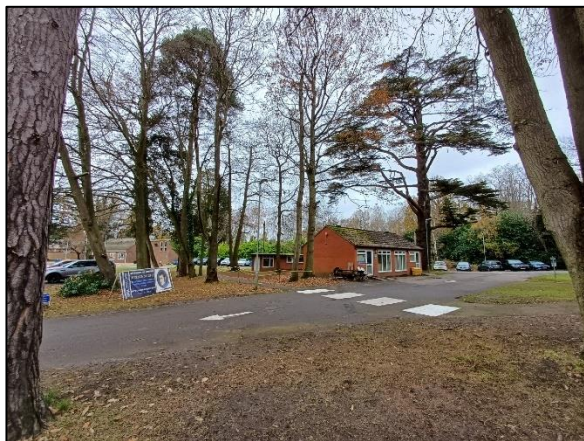
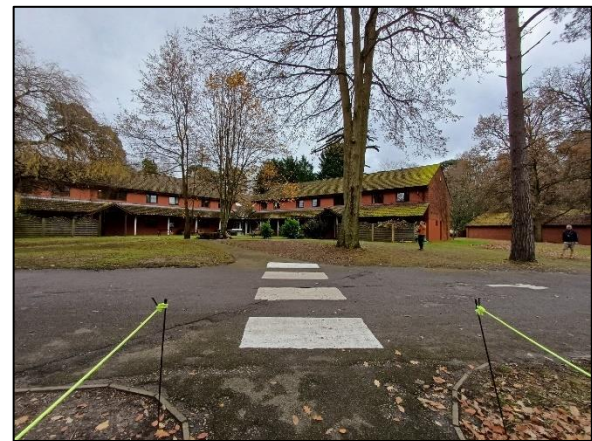
- 4.2.5 Areas of sealed surface are present across the site including roads, car parks and buildings. Roads and car parks are largely tarmac as the main surface covering, which offer negligible value for wildlife. The buildings are further discussed within Section 4.7 in relation to bats, with the remainder of the sealed surface habitat not considered further in this appraisal.

*Photo 3 Sealed surface road*

*Photo 4 Sealed surface road*

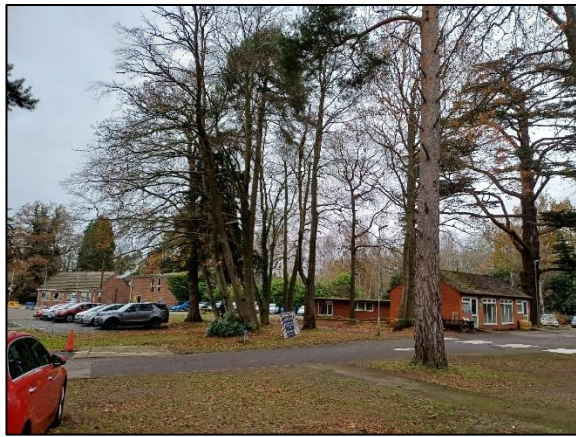
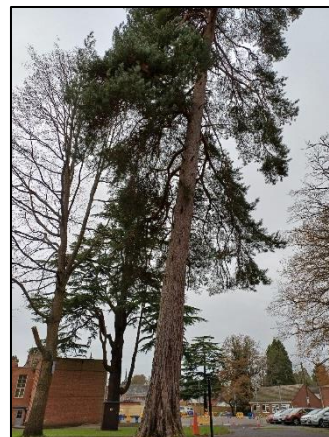
- 4.2.6 There are several mature individual trees present across the site, including pedunculate oak, common beech and scots pine. These trees are discussed further in relation to bats in Section 4.7.

Photo 5 Scattered trees on site

Photo 6 Scattered trees on site

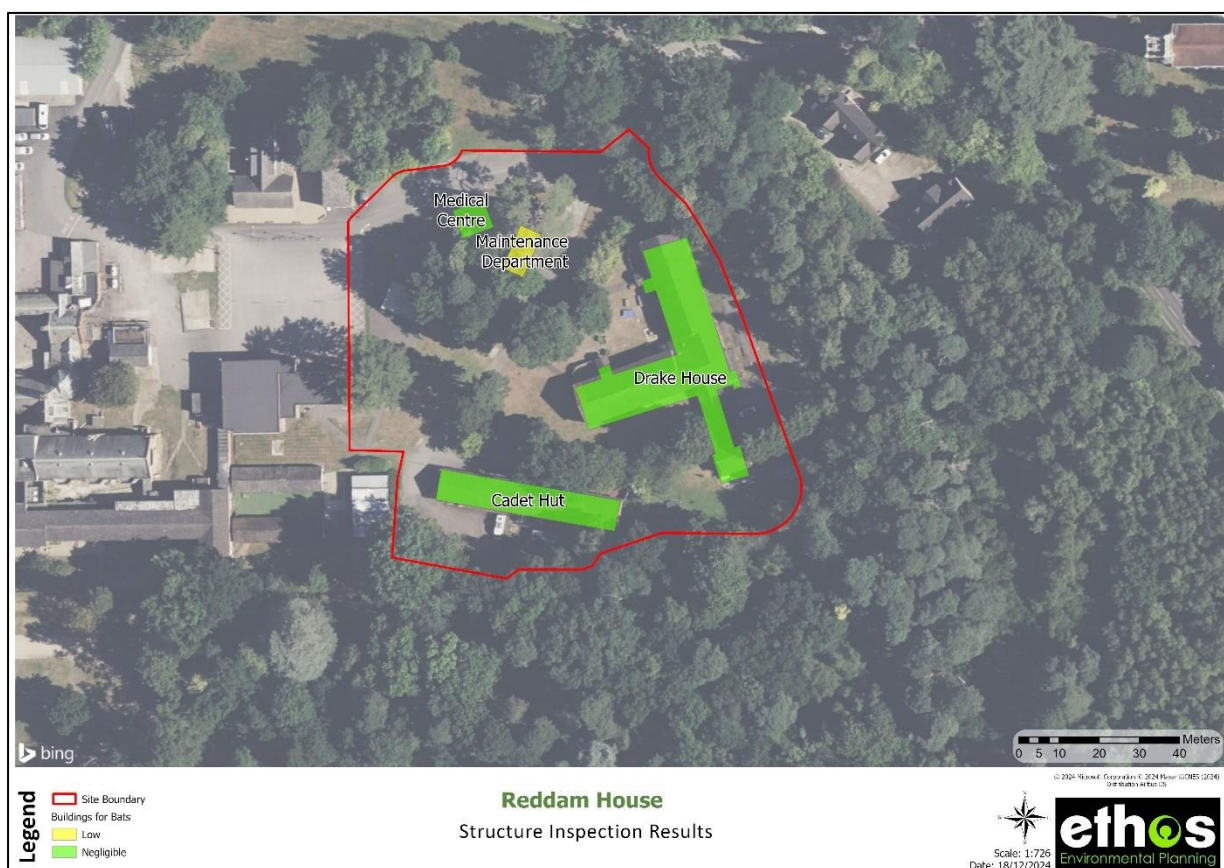
Figure 4 Structure inspection results

- 4.3.5 The maintenance building contains two damaged tiles and a missing soffit vent, which could provide a roost feature for bats. Overall, the maintenance building was assessed to contain low potential for roosting bats, in line with Table 4.1 of the Bat Conservation Trust Survey Guidelines (Collins, 2023), which states:

- 4.3.6 The remaining three buildings were assessed to contain **negligible potential for roosting bats**. There was a single potential roost feature on the medical centre building which was fully inspected with an endoscope and determined to be unsuitable to support roosting bats, as it did not extend backwards to form a cavity and was open and exposed to the elements.

- 4.3.7 **No evidence of roosting bats** was identified during the structure inspection.

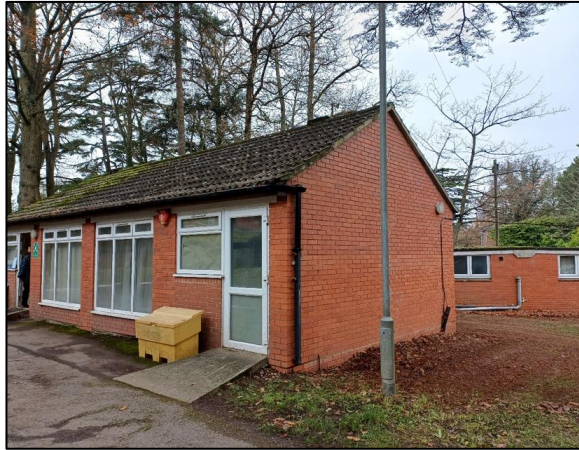
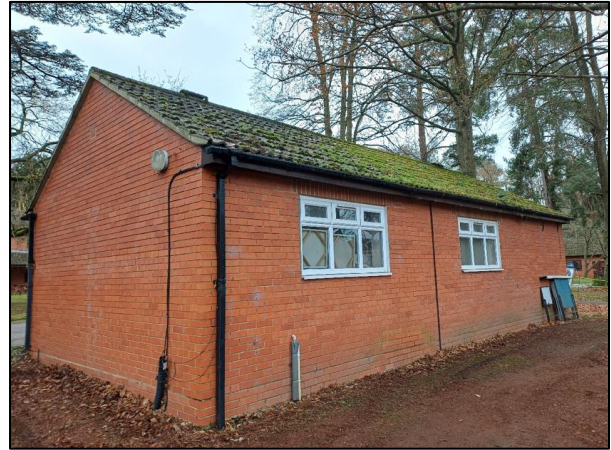
| Building reference | Description | Suitability for bats | Impacts |
|---|---|---|---|
| Maintenance building | <p>Single story detached building. Brick built with UPVC windows. Single pitched roof with clay roof tiles.</p> <p>Internally, a loft occupies the entire roof space with rock wool insulation to ceiling level. The loft had extensive spider webbing at the time of survey and rat droppings were noted throughout.</p> | <b>Low</b> - due to damaged tiles and missing soffit vent, offering potential access for bats to suitable voids. | Demolition |

*Photo 7 Maintenance building*

*Photo 8 Maintenance building*

- If bats are found to be roosting in the maintenance building, mitigation measures will be required in order to demolish the structure legally. This would include obtaining a bat licence from Natural England and precautionary working methods. Compensation for loss of the roost may also be required, depending on the significance of the roost.

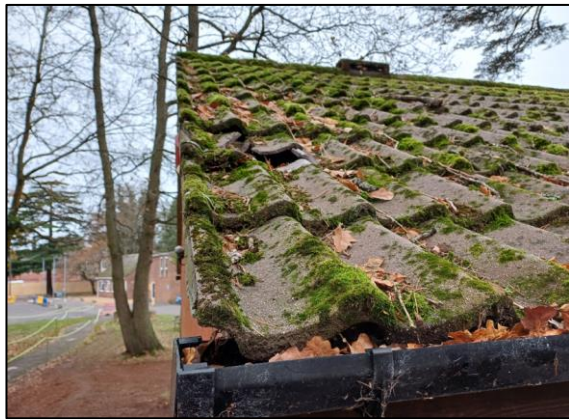
*Photo 9 Crack in tile on maintenance building*

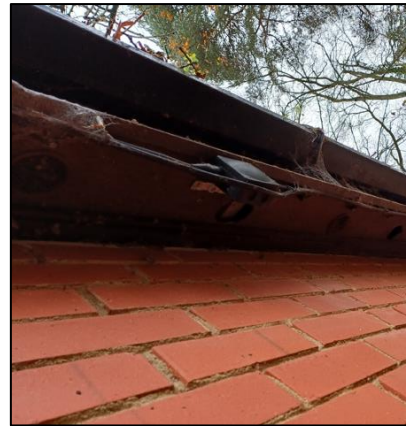
*Photo 10 Gap in soffit on maintenance building*

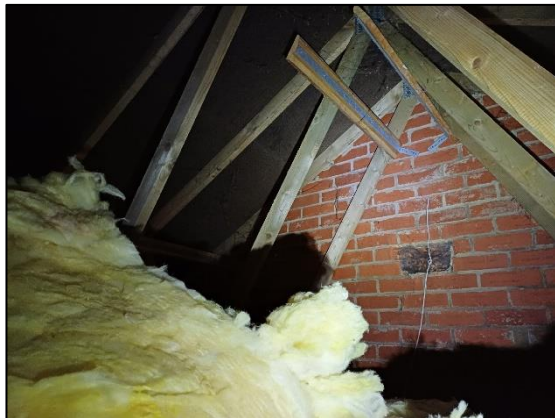
*Photo 11: Internal gable end of maintenance building*

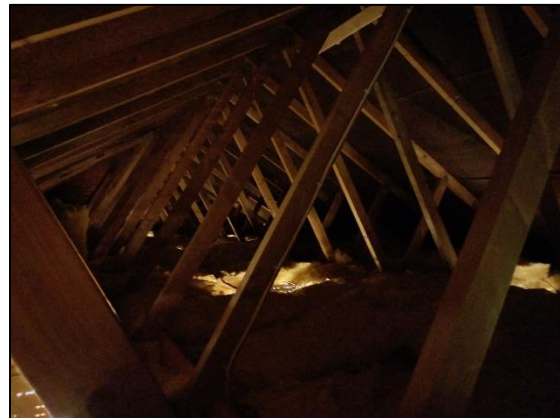
*Photo 12: Loft space of maintenance building*

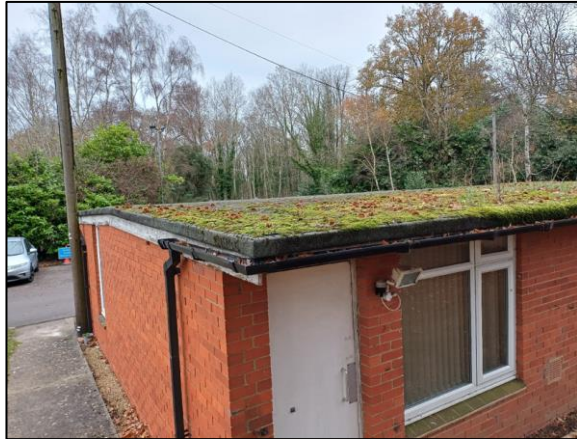
*Photo 13 Medical centre roof*

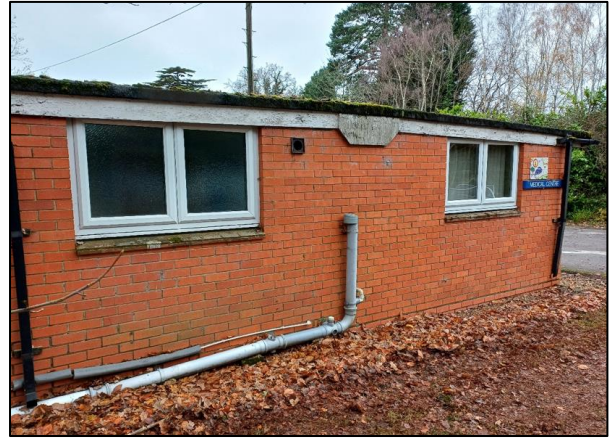
*Photo 14 Medical centre*

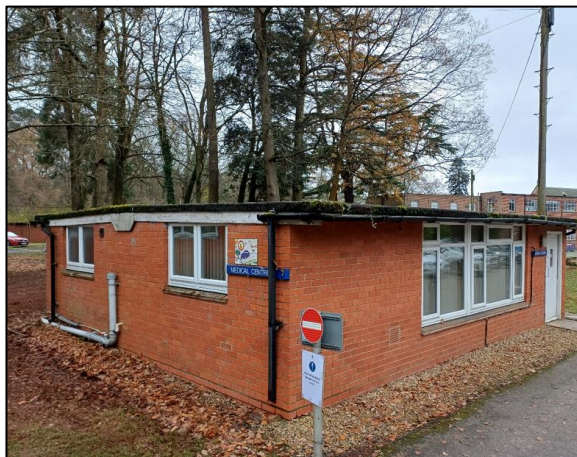
*Photo 15 Medical centre northern elevation*

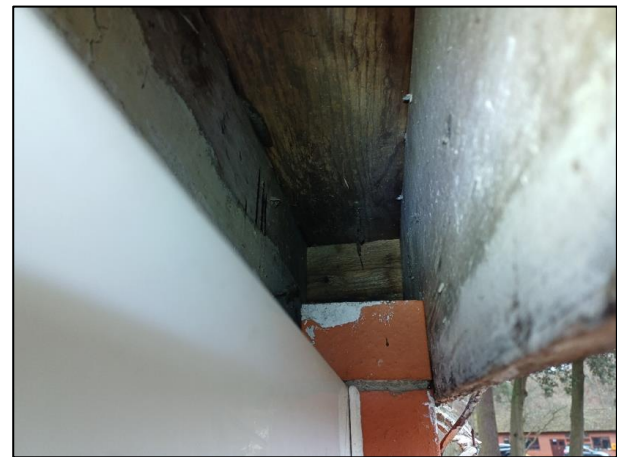
*Photo 16 Medical centre gap above window - no PRF and fully explored*

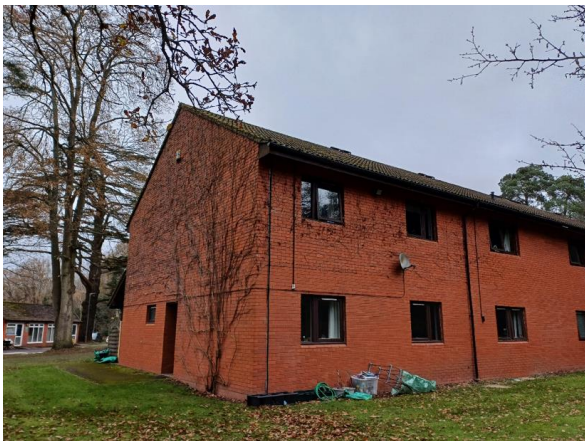
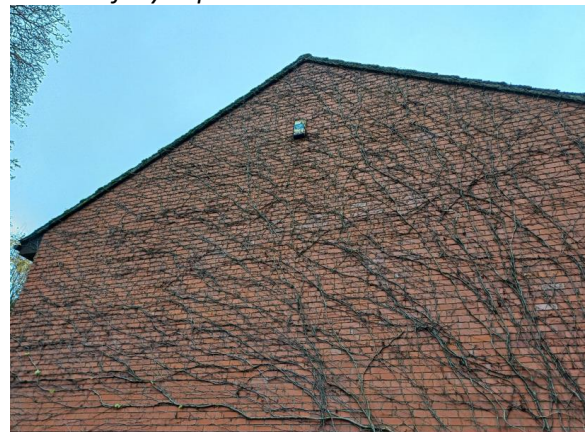
| Building reference | Description | Suitability for bats | Impacts |
|---|---|---|---|
| Drake House | Two story brick-built structure in good condition, including the roof and soffits. The roof has extensive moss coverage. | Negligible | Retained, impacts limited to lighting |

*Photo 17 Drake House*

*Photo 18 Drake House*

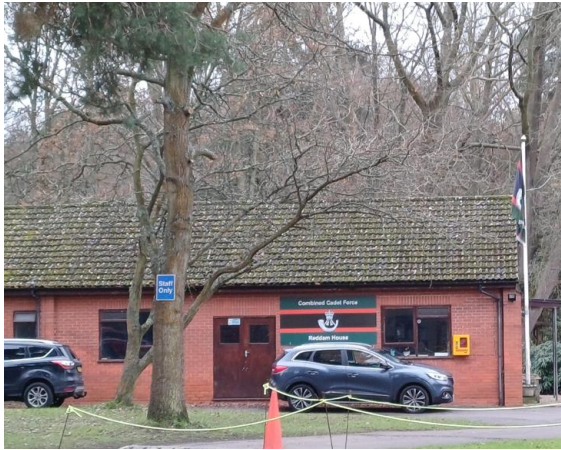
| Building reference | Description | Suitability for bats | Impacts |
|---|---|---|---|
| Cadet Hut | Single story modern brick-built structure. The roof and soffits are in good condition throughout. | Negligible | Retained, impacts limited to lighting |

*Photo 19 Cadet Hut*

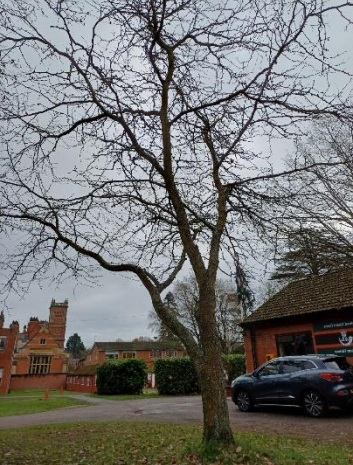
| Tree Number and suitability | Description | Photograph |
|---|---|---|
| T1 – no PRFs | Tree in good condition with no prf. minor pruning cuts | |

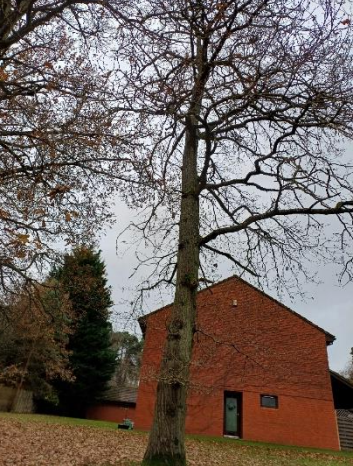
| Tree Number and suitability | Description | Photograph |
|---|---|---|
| T2 – no PRFs | good condition oak with no prf. minor pruning cuts | |

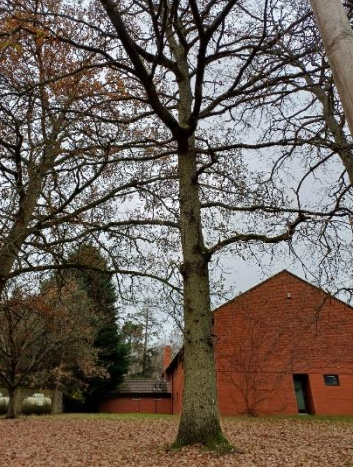
| Tree Number and suitability | Description | Photograph |
|---|---|---|
| T3 – no PRFs | good condition oak with well healed pruning cuts | |

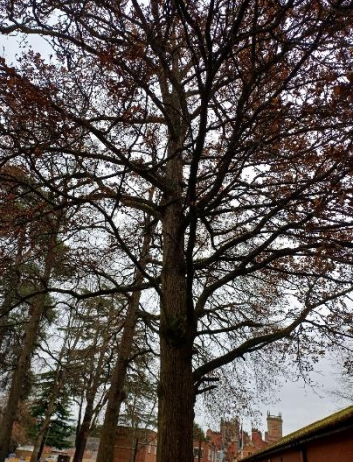
| Tree Number and suitability | Description | Photograph |
|---|---|---|
| T4 – no PRFs | good condition oak with well healed pruning cuts | |

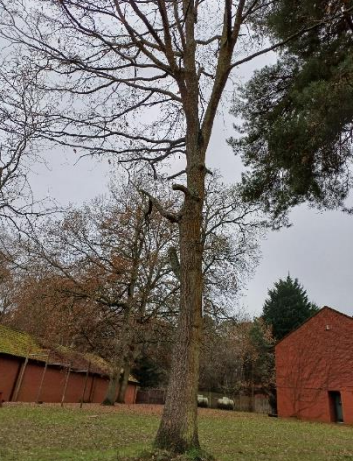
| Tree Number and suitability | Description | Photograph |
|---|---|---|
| T9 – no PRFs | no PRFs some pruning cuts to lower limbs | |

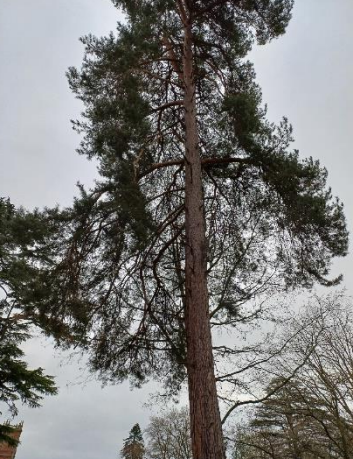
| Tree Number and suitability | Description | Photograph |
|---|---|---|
| T10 – no PRFs | impressive pine in good condition minus slight lean to north-west. no features | |

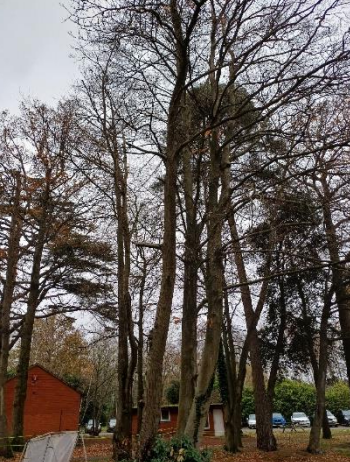
| Tree Number and suitability | Description | Photograph |
|---|---|---|
| T11 – no PRFs | No PRFs identified | |

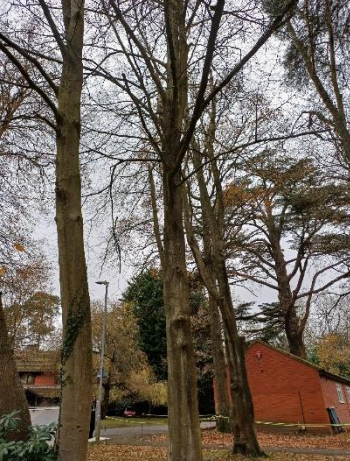
| Tree Number and suitability | Description | Photograph |
|---|---|---|
| T12 – no PRFs | No PRFs identified | |

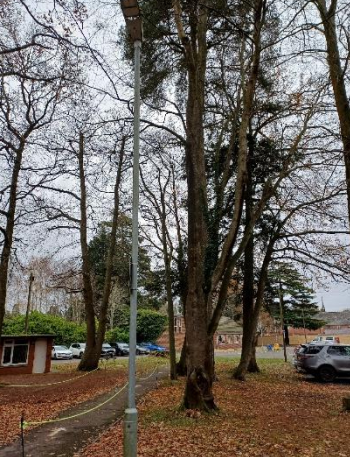
| Tree Number and suitability | Description | Photograph |
|---|---|---|
| T13 – PRF-I and PRF-m | <p>two tear out features on eastern elevation. one at 10m other at 15m main trunk.</p> <p>three nut hatch sized holes at 7m on southern limb.</p> | |

- 5.1.1 There are several trees with features suitable for roosting bats, including features suitable for multiple bats (PRF-M). Mature trees with features for bats should be retained where possible within the development design. For trees with features which require removal, the loss of the features should be replaced like-for-like in line with best practice guidance (UK Bat Mitigation Guidelines, 2023).
- 5.1.2 The maintenance building was identified as having low potential for roosting bats, therefore further surveys have been recommended to identify the status of roosting bats within this structure, including the requirement for mitigation or EPS licensing.

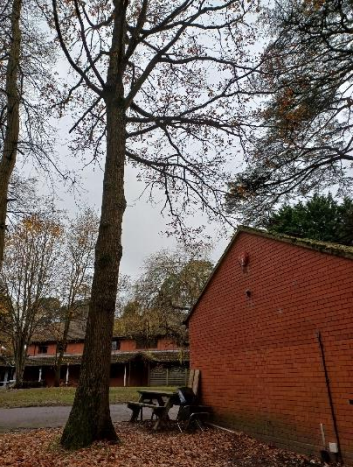
| Tree Number and suitability | Description | Photograph |
|---|---|---|
| T14 – no PRFs | No PRFs identified | |

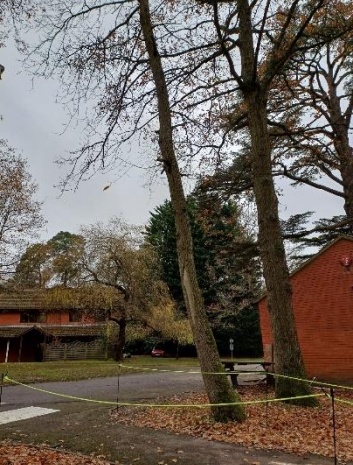
| Tree Number and suitability | Description | Photograph |
|---|---|---|
| T15 – no PRFs | damage to bark on southern elevation but does not create a feature. no other features | |

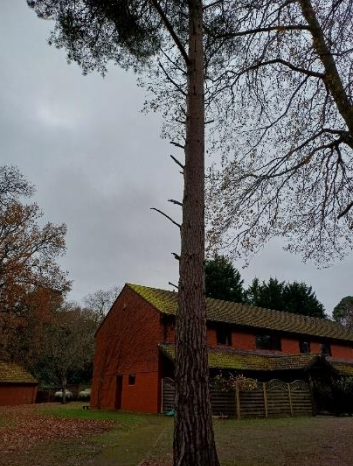
| Tree Number and suitability | Description | Photograph |
|---|---|---|
| T16 – no PRFs | No identified PRFs. | |

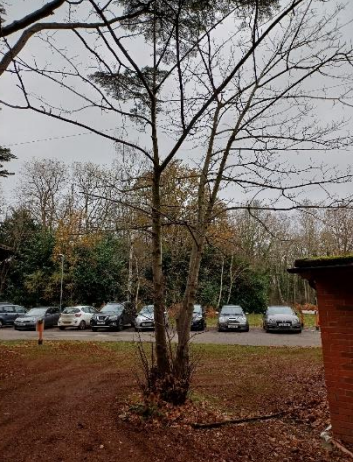
| Tree Number and suitability | Description | Photograph |
|---|---|---|
| T17 – no PRFs | young triple stem sycamore with no prf | |

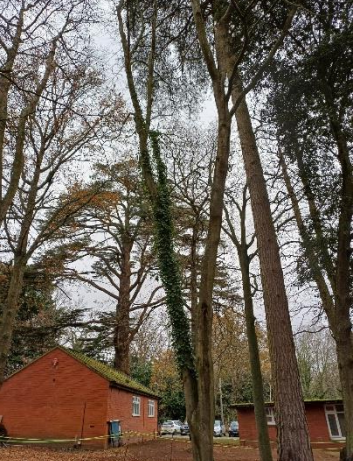
| Tree Number and suitability | Description | Photograph |
|---|---|---|
| T18 – PRF-i | Twin stemmed beech. a dead limb at top of tree on E stem. decay is open at the top and exposed to the elements. suitable for crevice dwelling bats but unlikely to support significant roosts. No PRF M identified. One PRF-I identified. | |

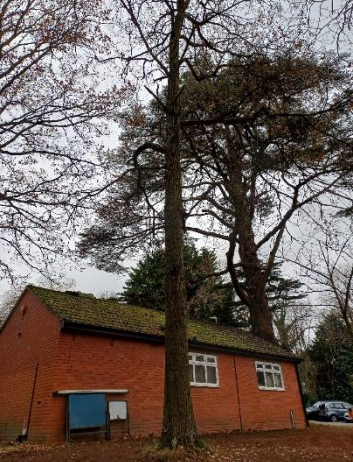
| Tree Number and suitability | Description | Photograph |
|---|---|---|
| T19 – no PRFs | No identified PRFs. | |

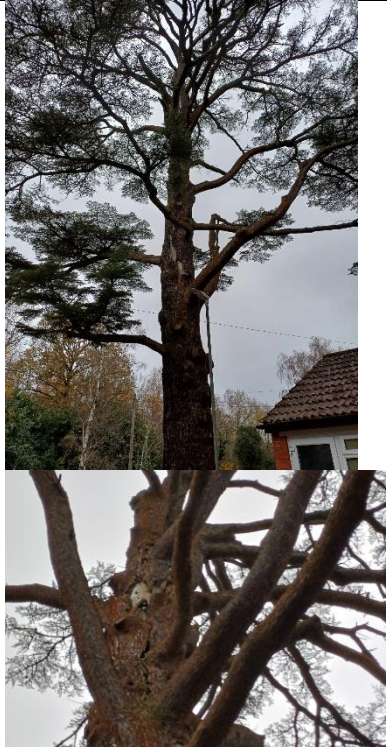
| Tree Number and suitability | Description | Photograph |
|---|---|---|
| T21 – PRF-I and PRF-m | <p>PRF 1 - lifted and missing bark in several places on main stem. starting at 8m high with some lifted bark up to 18/20m.</p> <p>PRF 2 - Decay /woodpecker hole located about 16m high on NW elevation in area of missing bark. Cannot assess if recess or whether opens into cavity.</p> <p>PRF 3 - fissure running vertical down stem on NW elevation starting at 12m up to 20m. could be bark lifting or could be cavity.</p> <p>all three PRFs have potential for PRF M and I. High roosting potential.</p> | |

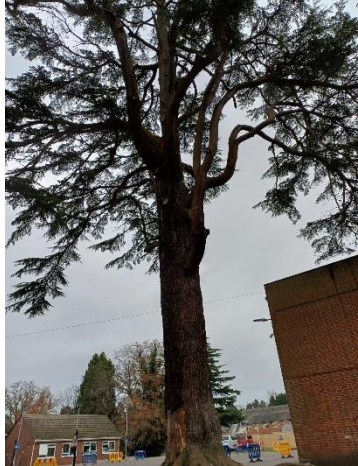
| Tree Number and suitability | Description | Photograph |
|---|---|---|
| T56 – no PRFs | <p>large TPO cedar. many pruning cuts from previous tree works. all clean cuts and no apparent damage to tree. no features noted. tree to be retained.</p> | |

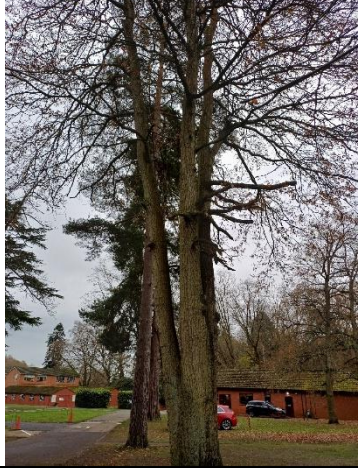
| Tree Number and suitability | Description | Photograph |
|---|---|---|
| G4 – no PRFs | <p>Three stemmed oak. relatively young with no PRFs identified</p> | |

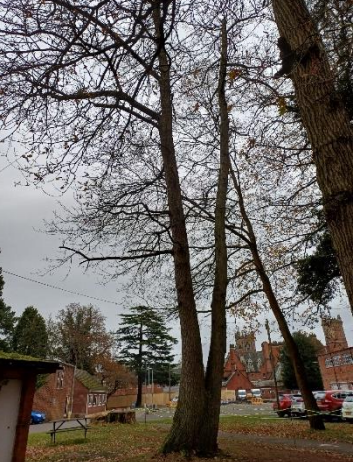
| Tree Number and suitability | Description | Photograph |
|---|---|---|
| G5 – PRF-m | double stem beech with missing tops on both trunks. Northern trunk appear to offer rot hole features as PRF-m | |

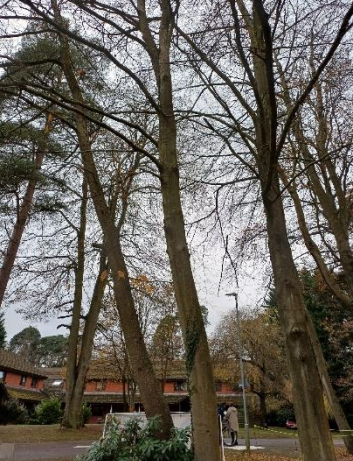
| Tree Number and suitability | Description | Photograph |
|---|---|---|
| G5 – no PRFs | Beech with no PRF identified | |

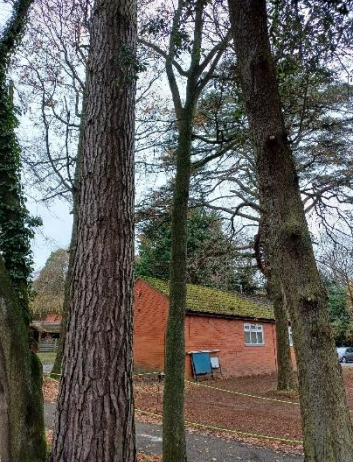
| Tree Number and suitability | Description | Photograph |
|---|---|---|
| G5 – no PRFs | young beech. No PRFs identified | |

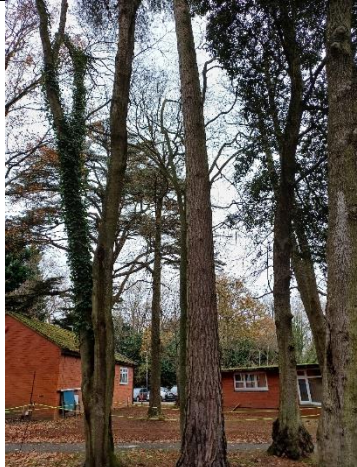
| Tree Number and suitability | Description | Photograph |
|---|---|---|
| G5 – no PRFs | Cedar with no PRFs identified | |

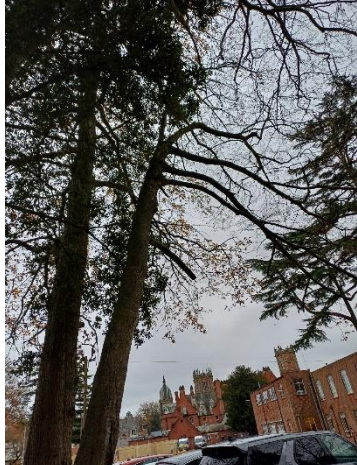
| Tree Number and suitability | Description | Photograph |
|---|---|---|
| G5- no PRFs | leaning young beech with all branches on W elevation. No PRFs identified | |

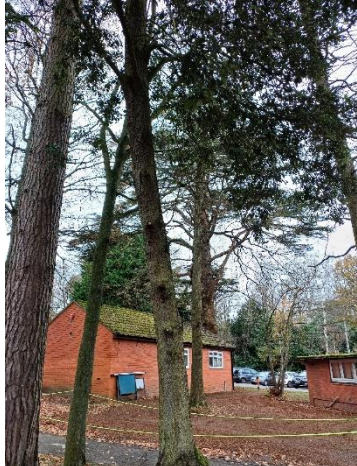
| Tree Number and suitability | Description | Photograph |
|---|---|---|
| G5 – no PRFs | Young tree with no identified PRFs | |

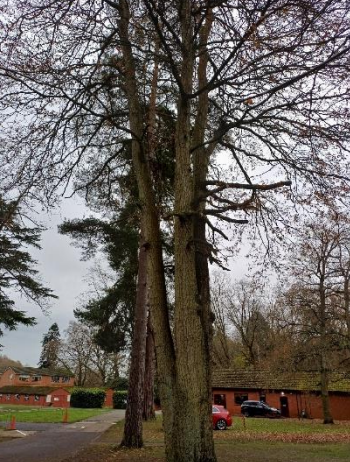
| Tree Number and suitability | Description | Photograph |
|---|---|---|
| G5 – no PRFs | managed oak with evidence of pruning. no evidence of damage or decay with no PRFs identified | |

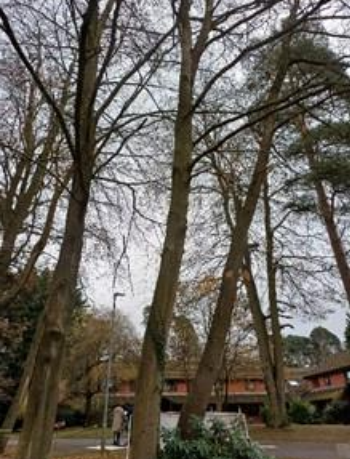
| Tree Number and suitability | Description | Photograph |
|---|---|---|
| G5 – no PRFs | Young oak with no PRFs identified | |
