12 St Marys Road  
Sindlesham  
Wokingham  
Berkshire  
RG41 5DA

## Preliminary Roost Assessment

Report ref.: R3232\_PRA\_a

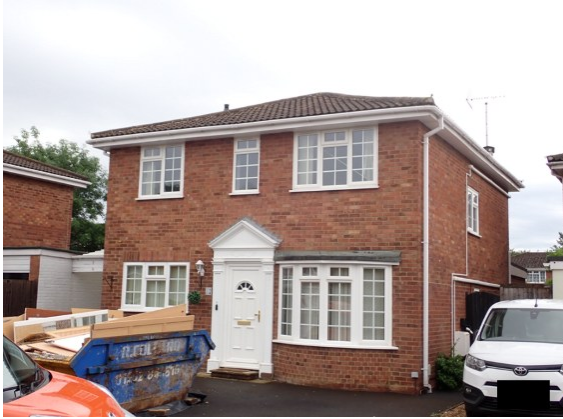
**5.2.2** The link-detached house is of modern cavity wall construction with a hipped roof, a rear single-storey extension and an attached flat roofed garage (**Photographs 1 & 2**).

*Photograph 1. Front of property viewed from the northwest.*

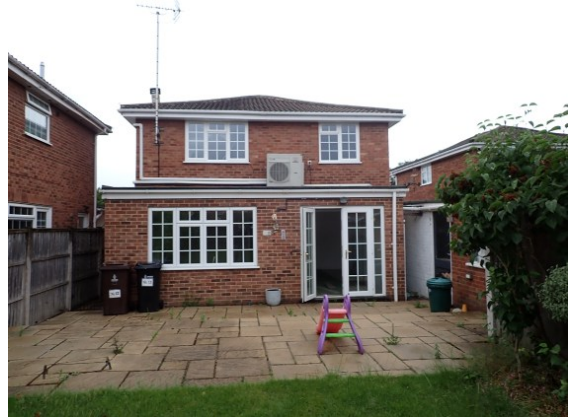
*Photograph 2. Rear of property viewed from the southeast.*

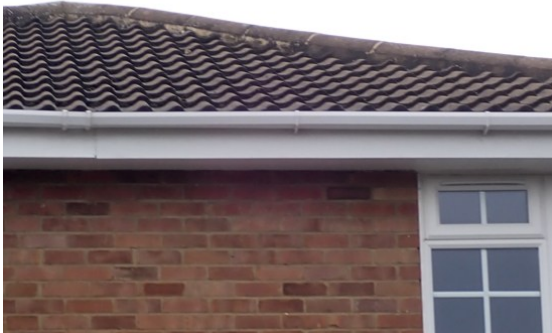
- 5.2.3** The hipped roof was covered by overlapping concrete tiles that were flat across all elevations (**Photograph 3**). In addition, the hip and ridge mortar was fully intact (**Photograph 4**).

*Photograph 3. Flat overlapping tiles and intact hip mortar (rear elevation).*

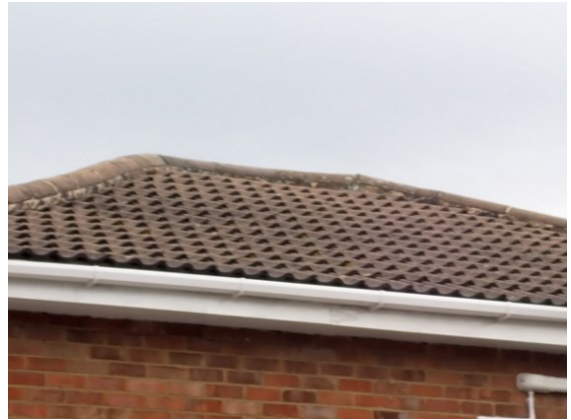
*Photograph 4. Flat overlapping tiles and intact ridge and hip mortar (southwestern elevation).*

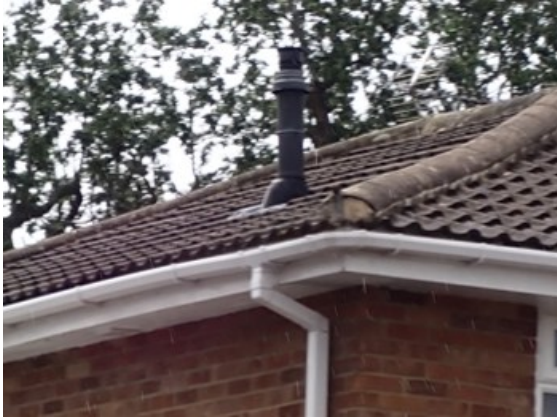
- 5.2.4** Whilst the lead flashing at the base of the northeast flue pipe was tight to the roof tiles, the lead flashing at the base of the southwest flue pipe was slightly lifted, however, the resulting gap was wide open with no crevice roosting feature available (**Photographs 5 & 6; Target note 1**).

*Photograph 5. Lead flashing tight to roof tiles (northeastern elevation).*

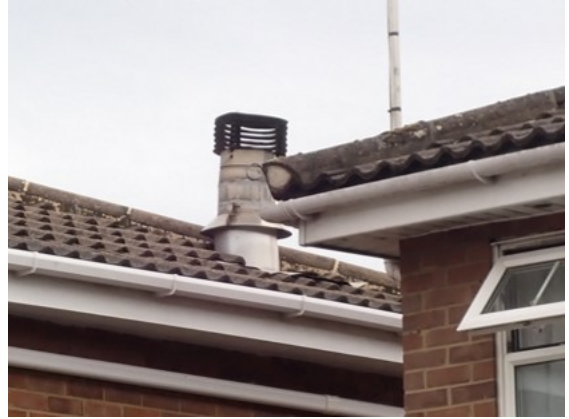
*Photograph 6. Lifted lead flashing with open gap beneath (southwestern elevation).*

**6.1.2** The property and attached garage lacked any potential bat access points or crevice roosting opportunities. Whilst the lead flashing was lifted around the flue on the southwestern elevation of the roof, the resulting feature was open and considered unsuitable for use by crevice-dwelling bats. The area surrounding the flue was able to be closely inspected during the internal survey, and was found to be open, cobwebbed and no evidence of roosting bats was observed. Furthermore, whilst a gap was situated between the timber fascia and brickwork along the single-storey rear extension, this feature was found to be heavily cobwebbed and wide open, therefore lacking crevice roosting opportunities.

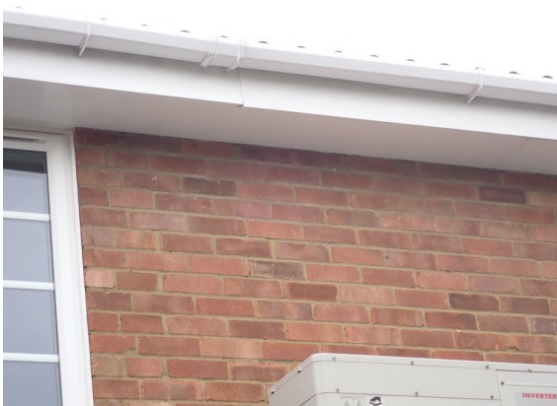
- 5.2.5** The uPVC soffit along the second-storey elevation was fully sealed to the brickwork of the house (**Photograph 7**). There was a gap situated between the timber fascia and the brickwork along the single-storey rear extension, however, close inspection with a high-powered torch confirmed the feature to be heavily cobwebbed, with insulation visible in places and was deemed to be open with a lack of crevice roosting opportunities (**Photograph 8; Target note 2**). The bitumen felt was tight to the fascia across the flat roofs on the rear extension, garage and front bay window (**Photographs 9 & 10**).

*Photograph 7. uPVC soffit sealed to the brickwork (rear elevation).*

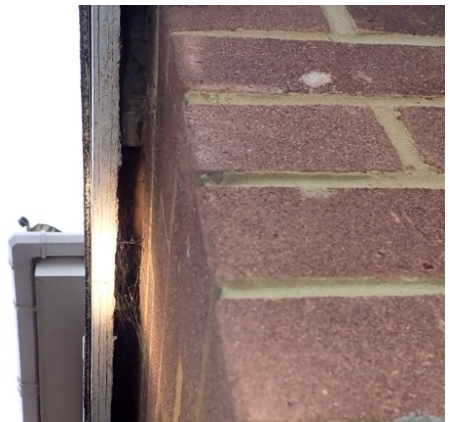
*Photograph 8. Cobwebbed gap between fascia and brickwork; open space with no crevice opportunities (rear elevation).*

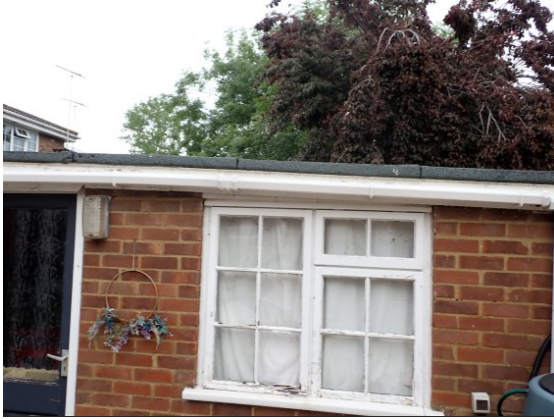
*Photograph 9. Bitumen felt tight to the fascia across the flat roofed garage (southwest elevation of garage).*

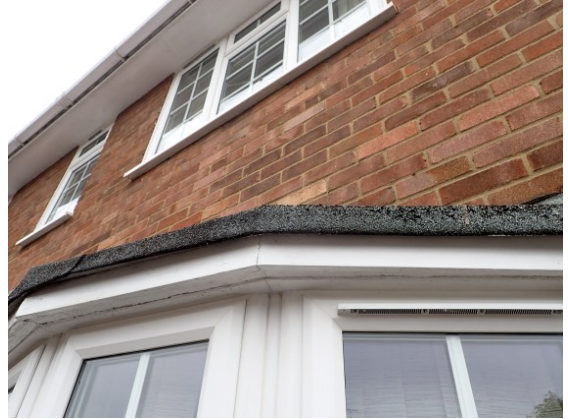
*Photograph 10. Bitumen felt tight across the bay window (front elevation).*

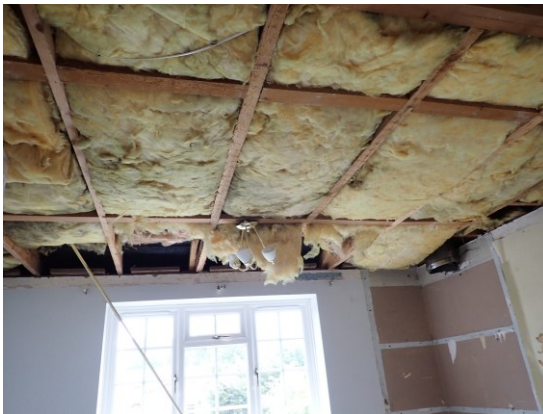
- 5.2.1** The floors and ceiling of the property had mostly been stripped due to water damage caused by a broken water pipe which occurred within the month leading up to the survey visit, resulting in a modified roof void. However, the fibreglass insulation within the void was mostly still in place (**Photograph 11**). The void covered the second-storey footprint of the property with access via a first-floor loft hatch. The void was of pre-trussed construction with an approximate floor-to-ridge height of 1.5 metres and the ridge was cobwebbed throughout (**Photograph 12**).

*Photograph 11. Stripped ceiling with fibreglass insulation mostly remaining.*

**6.1.3** The roof void had been recently modified prior to the survey, however, the majority of the fibreglass insulation remained in situ and therefore any evidence of bat presence would still have been visible. Prior to modification, the void would have been of a suitable size and condition for void dwelling bats, such as the locally recorded brown long-eared (*Plecotus auritus*), however, no evidence of this species or bat activity, were observed, and the only potential access points through gaps in bitumen felt were blocked with fibreglass insulation, the presence of void-dwelling bats is considered to be highly unlikely.

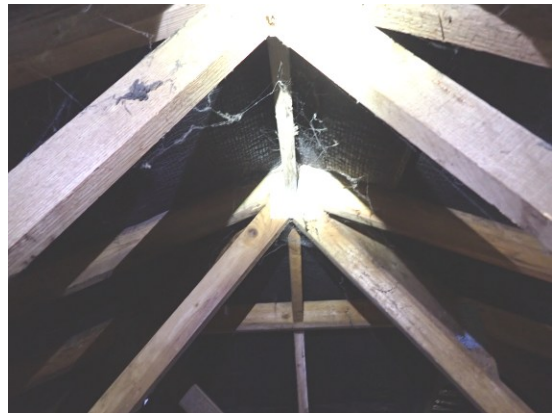
*Photograph 12. Roof of trussed rafter construction.*

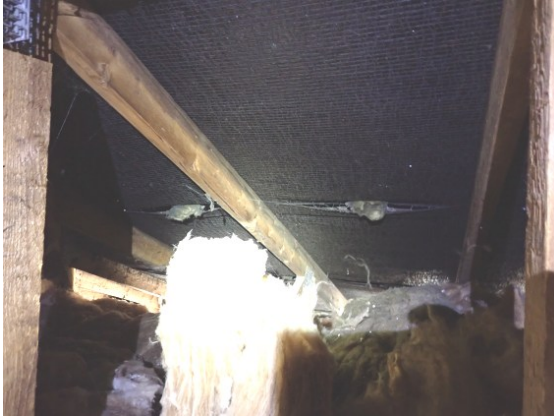
- 5.2.2** The roof was covered by bitumen felt that was mostly intact other than occasional small tears and overlapping sections, which had fibreglass insulation in places (**Photograph 13; Target note 3**). The eaves were mostly unblocked, allowing access to the uPVC soffit (**Photograph 14**).

*Photograph 13. Overlapping sections of bitumen felt blocked by fibreglass insulation.*

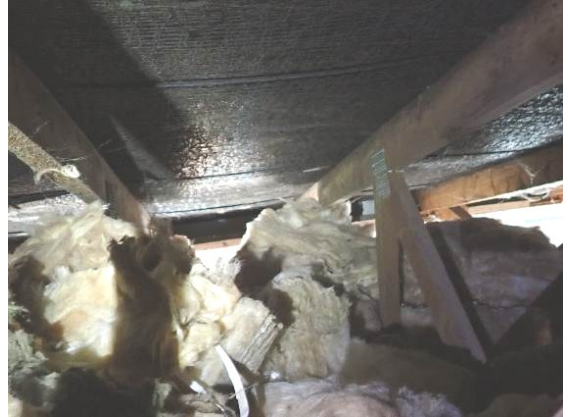
*Photograph 14. Open eaves with access to the uPVC soffit.*

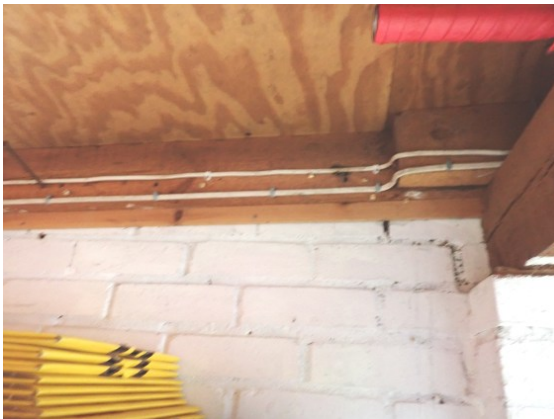
**5.2.3** There was no void within the attached garage, with the roof covered by timber boarding and plaster boarding in places, that were tight to the brickwork (**Photographs 15 & 16**).

*Photograph 15. Timber panels sealed to the painted brickwork (garage).*

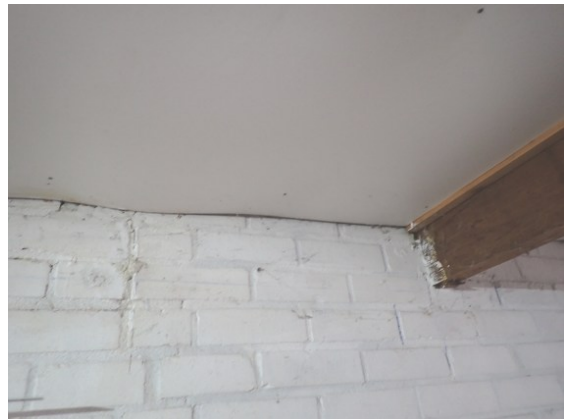
*Photograph 16. Plasterboards sealed to the painted brickwork (garage).*
