## **PRELIMINARY ECOLOGICAL APPRAISAL (DBW) AT 7 PINE DRIVE FINCHAMPSTEAD**

**Prepared for:  
Mr R Curry  
7 Pine Drive  
Finchampstead  
RG40 3LD**

**6 May 2025**

**Ref: SPH/NP/PEA-25/22.04**

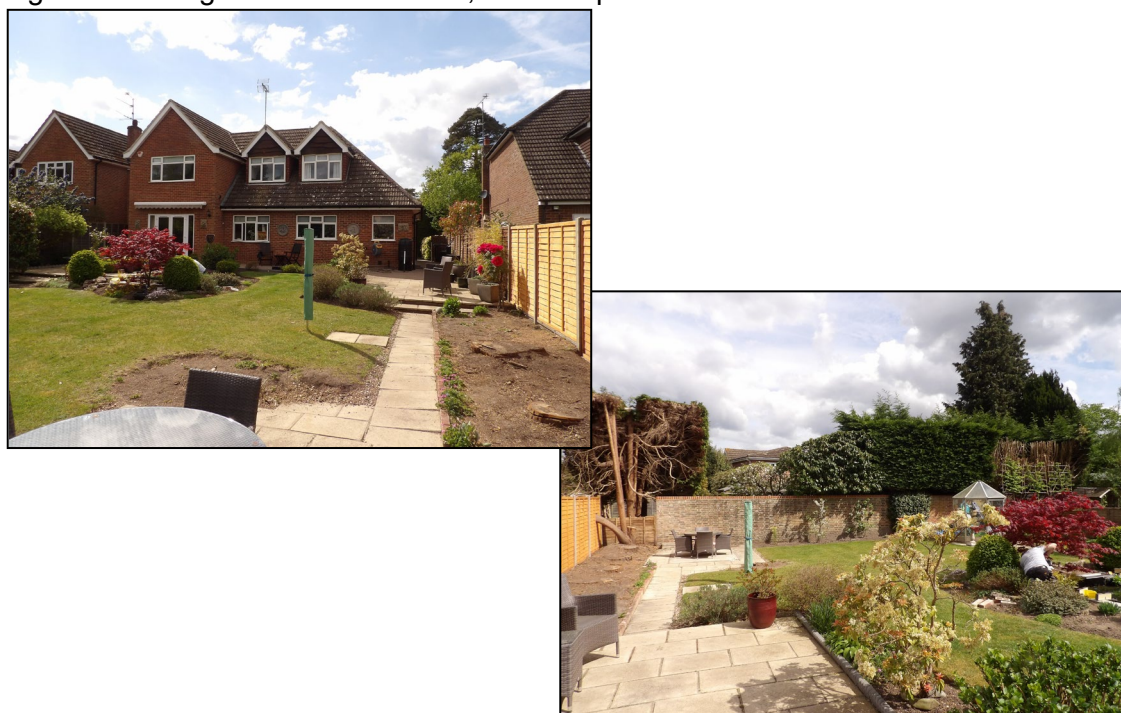
Figure 3. Rear garden. 7 Pine Drive, Finchampstead. 22.04.25

The application site comprises a detached, brick-built 2 storey property with integral garage. The remainder of the site comprises a large front garden with tarmacked driveway/parking area, lawn and mature hedgerows and a rear garden which is mainly laid to lawn, with patio area and flowerbed/shrubs throughout, see Figure 3 below. The site itself offers good foraging and commuting habitat for bats and, via the garden network, there is some ecological connectivity to bat foraging and commuting habitat in the wider landscape.

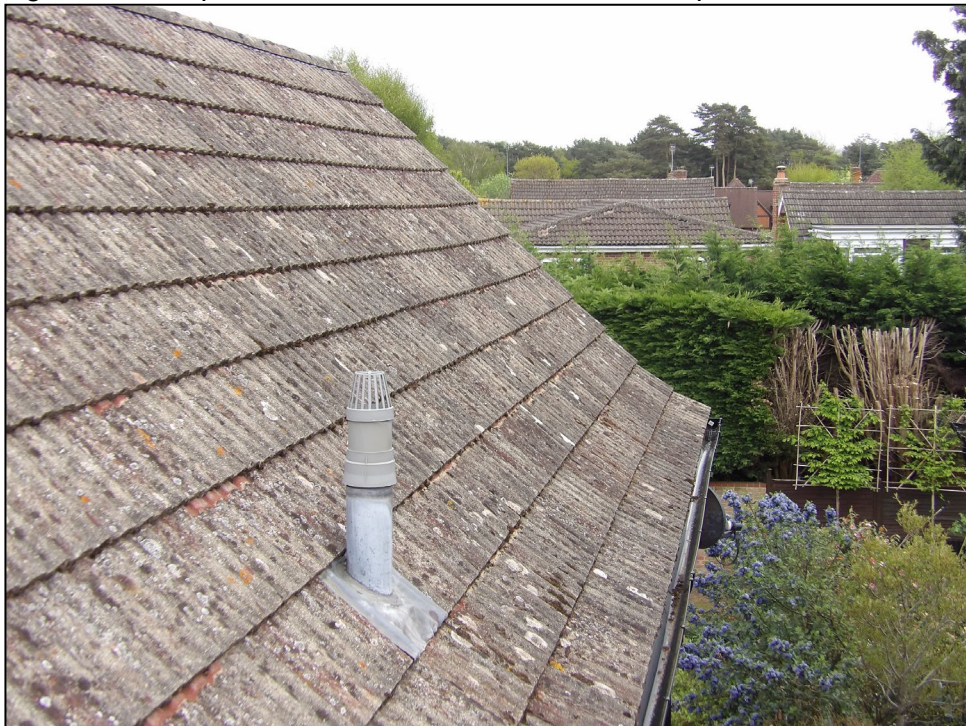
Figure 4. Example of roof tiles. 7 Pine Drive, Finchampstead. 22.04.25

The property is a detached, brick-built building that is in a good condition externally. The part pitched, part hipped roof is covered in interlocking tiles, none of which are missing or broken, see Figure 4 below. The ridge and hip tiles are all tightly sealed with tile clips and had no gaps in which crevice dwelling bats could utilise for roosting, see Figure 5 on page 9. The verges are all well cemented with no gaps which roosting bats could exploit (see Figure 6 on page 9) and all lead flashing on the building is flush. The soffits and fascias are all tightly fitted to the walls and had no cracks or splits which bats could use to roost (see Figure 7 on page 10), as is the tightly fitted up-and-over garage door, see Figure 8 on page 10. There are dormer windows on the front and rear elevations of the property, see Figure 9 on page 11. The roofs of the dormers are covered in tiles, all of which are tightly fitted with no gaps in which roosting bats could exploit and the verges are sealed, see Figure 10 on page 11. The sides of the dormer windows are covered in hanging tiles and the fronts in wooden cladding, some of the wooden cladding on all the dormers is warped and lifted resulting in gaps which could be used by roosting bats, see Figure 11 on page 12. The front pitched elevation is covered in hanging tiles, the majority of which are tightly fitted with no gaps however, on the corner some tiles have moved leaving gaps that could be exploited by bats, see Figure 12 on page 12.

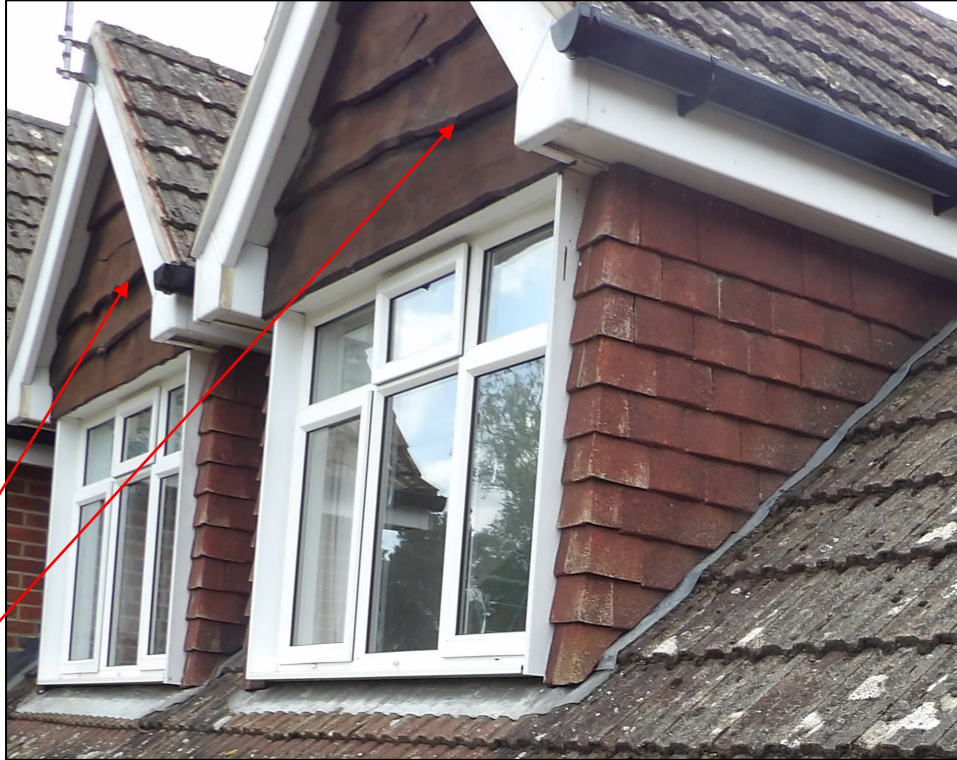
Figure 11. Hanging tiles and gaps in timber cladding on dormer windows. 7 Pine Drive, Finchampstead. 22.04.25

Should the development plans change, and the dormer windows on the front or rear elevation of the property and/or the hanging tiles on the front elevation of the property be affected, then further survey effort will be required.

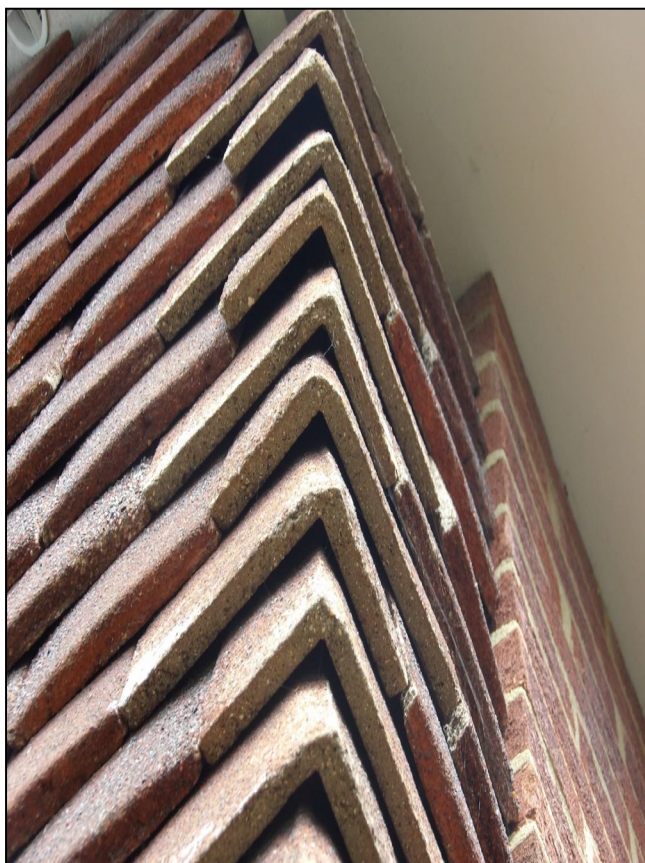
Figure 12. Moved hanging tiles on corner of front elevation. 7 Pine Drive, Finchampstead. 22.04.25

Should the development plans change, and the dormer windows on the front or rear elevation of the property and/or the hanging tiles on the front elevation of the property be affected, then further survey effort will be required.

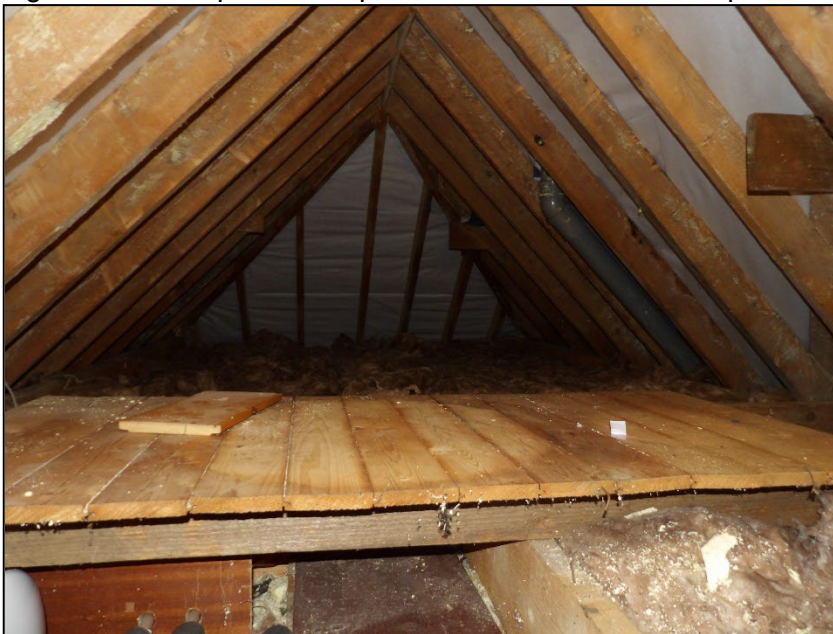
Figure 13. Example of loft space. 7 Pine Drive, Finchampstead. 22.04.25

The loft space was accessed via a loft ladder through a hatch and is in a good condition. The loft space is uncluttered, partially lit, not boarded and insulated, see Figure 13 below. The roof tiles were lined with membrane, none of which we observed was ripped or torn, see Figure 14 below.
