# Preliminary Ecological Appraisal and Roost Assessment

Stanford End Farmhouse, Barge Lane, Reading, RG7 1SY

This report is prepared to inform a planning application with the Wokingham Borough Council. The proposal is described as:  
The full renovation of the farmhouse and adjoining barns to create one dwelling.

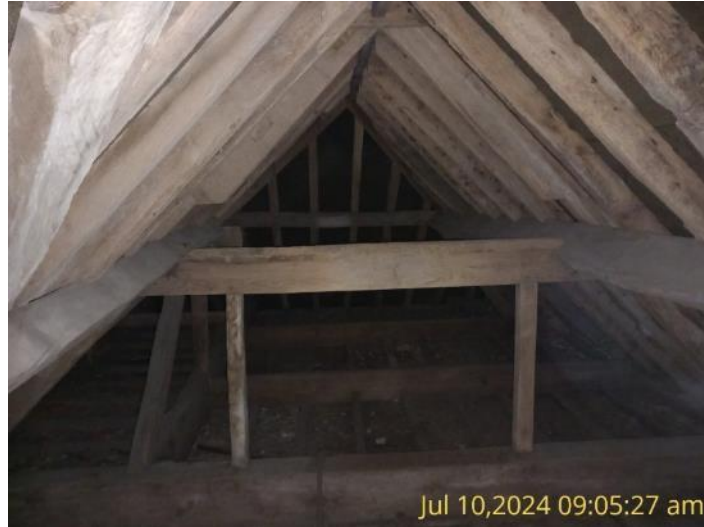
Figure 2: L1 – Loft space within the interior of B1.

*Loft Space 1 - L1 (Figure 2)*

It is constructed from original timber beams, including the ridge beam, rafters and purlins. The beams may provide roosting sites for void-dwelling bats. The roof is lined with bitumen felt which is in moderate condition with no tears, however gaps are present at the ridgeline. The floor of the loft is lined with mineral wool insulation and timber boards are in place. Daylight can be seen from within the loft through gaps in the bitumen felt, around the chimneys and at the top of the brick walls. The internal abiotic recordings at the time of the survey were 18.6°C and 86% relative humidity. The approximate loft dimensions were 12m long x 9m wide x 2m high. Approximately 100 droppings were located within the loft space, noticed along the joists and caught in cobwebs (see Appendix 5). B1 is a confirmed roost for a brown long eared maternity roost and common pipistrelle maternity roost (Arbtech Consulting Ltd, 2022).

Given the number of features identified on the property and the presence of excellent bat habitat around the site, as well as the bat droppings located within the loft, it is assessed that B1 provides **high** habitat value for roosting bats.

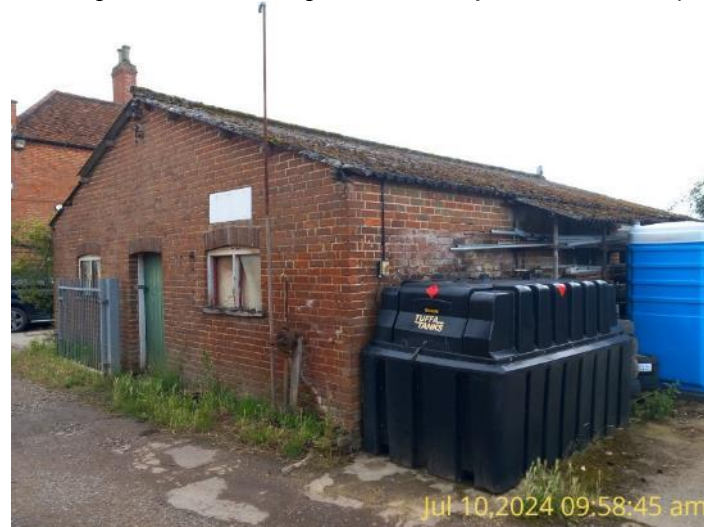
Figure 2: B2 – North elevation.

B2 is a one-storey brick-built semi-detached outbuilding with a pitched and gabled roof clad in corrugated asbestos roofing. The roof sheeting appears in good condition with no raised sections visible for roosting bats to utilise. The window and door frames are of timber construction and are tight-fitting to the brickwork. There are no suitable gaps for roosting bats to utilise. The interior of B2 is open with a vaulted ceiling and there is no separate loft space. The roof structure is comprised of metal beams. The roof is single-skinned and unlined. The building is not insulated and has large doors, reducing the suitability for bats as temperature and humidity would fluctuate rapidly.

Given the absence of features identified on the property, it is assessed that B2 provides **negligible** habitat value for roosting bats.

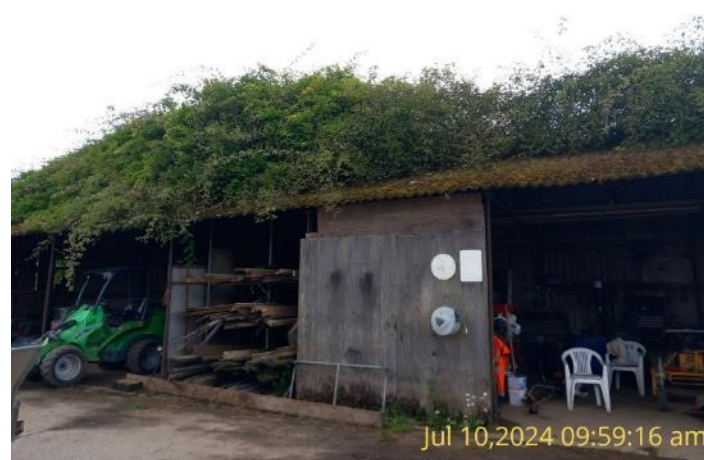
Figure 3: B3 – North elevation.

B3 is a one-storey metal framed outbuilding with a pitched and gabled roof comprised of corrugated asbestos sheeting. The sheeting is in moderate condition. The eastern elevation is entirely open, with no doors or windows, allowing birds and bats to enter freely. However, this also reduces the stability of the interior conditions and reduces the likelihood of bats roosting, as temperature and humidity will fluctuate rapidly. There is also abundant daylight within B3. The roof is not lined, and the back of the sheeting is exposed. The building has a vaulted ceiling and no separate loft space. There is significant vegetative growth on the roof of the building which could be used by nesting birds.

Given the absence of features identified on the property, it is assessed that B3 provides **negligible** habitat value for roosting bats.

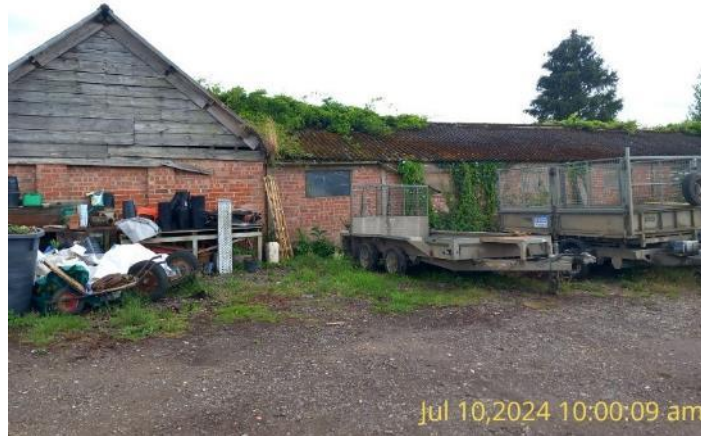
Figure 4: B4 – Northwest elevation.

B4 is a one-storey brick-built semi-detached outbuilding with a pitched and gabled roof clad in plastic composite roof tiles and asbestos corrugated roof sheeting. The roofing appears in good condition, with no raised sections under which bats could roost. The windows and doors are timber framed and are in good condition with no gaps around them in which bats could roost. The gable ends are clad in timber panelling which is in good condition, there are no warped boards or gaps suitable for bats. The interior of the building is open, and the ceiling is vaulted, with no separate loft space. The building is single skinned and is extremely light and prone to temperature fluctuations, reducing the suitability for bats.

Given the absence of features identified on the property, it is assessed that B4 provides **negligible** habitat value for roosting bats.

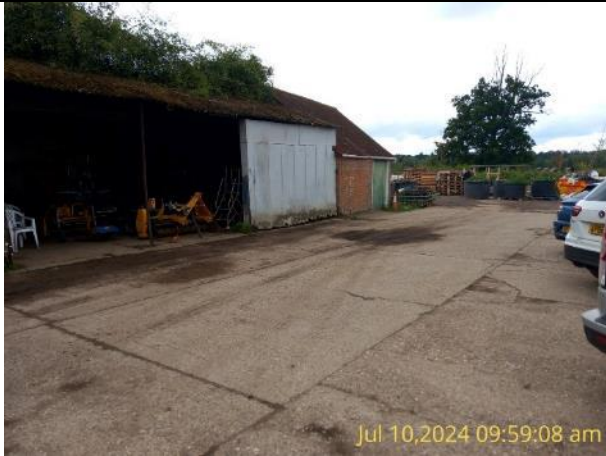
**B3 – East elevation and hardstanding.**
