STANFORD END FARMHOUSE,  
SWALLOWFIELD, BERKSHIRE. RG7 1SY

HERITAGE STATEMENT

for Wellington Estates

by James Edgar  
Historic Buildings Consultants Ltd.

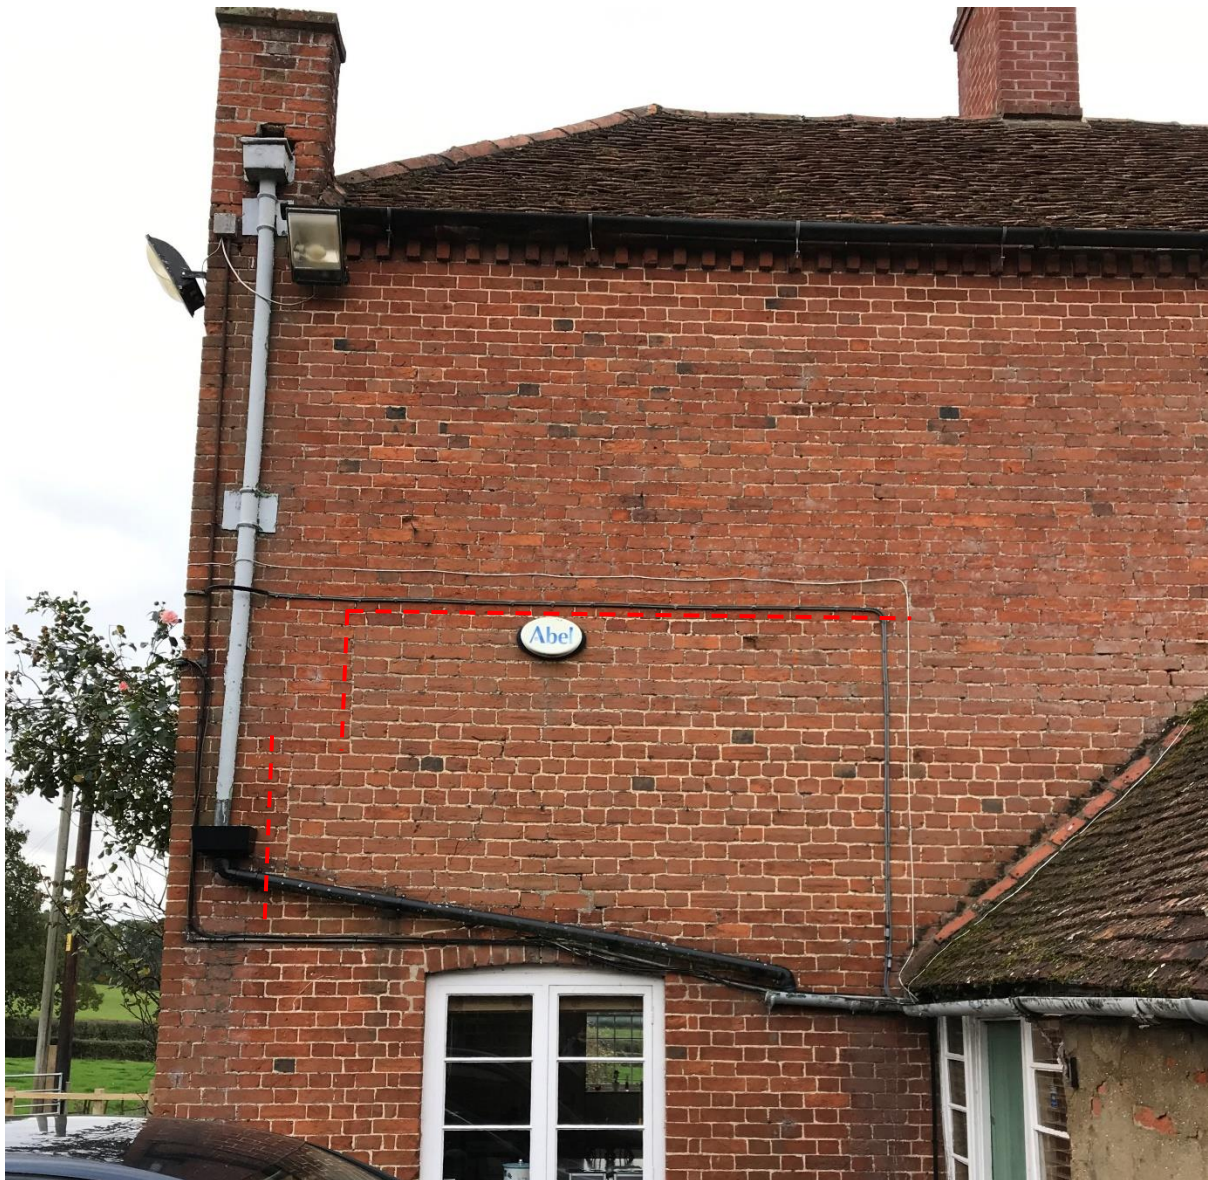
2.3 The east, west and south elevations have no straight joints or anomalies, suggesting that they were all erected in the same phase. The north elevation, however, exhibits straight joints and two different types of brick and bonding, indicating that either an older structure has been incorporated or that there has been rebuilding after the removal of a larger north wing.

Fig. 3. Straight joints/differences in brickwork on the north elevation.

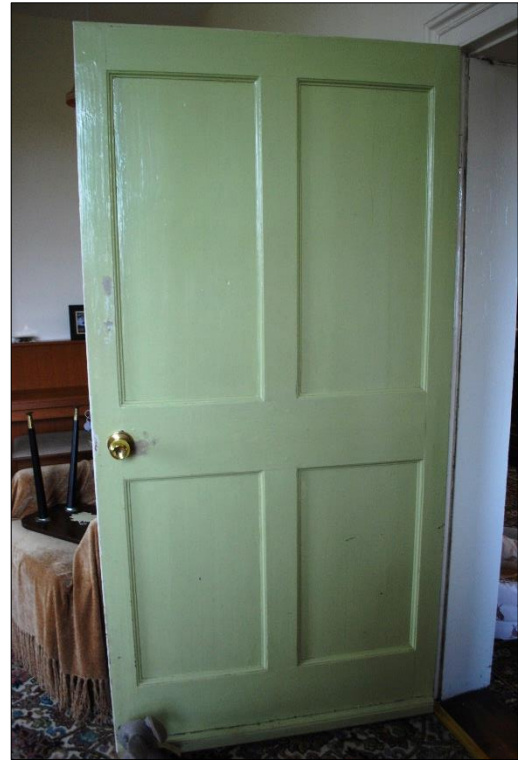
Fig. 8.

2.9 Internally, a few original or historic features survive. These include four-panel doors in wide flat architraves in the entrance hall and elsewhere. There are no cornices and no historic fireplaces. The staircase is the finest features in the house and is original. The stair turns around a well that is lit by a large sash window; the open string has plain tread ends and there is a slender mahogany handrail on plain, square balusters, and a curtail step.

a. Staircase

b. Four panel door.

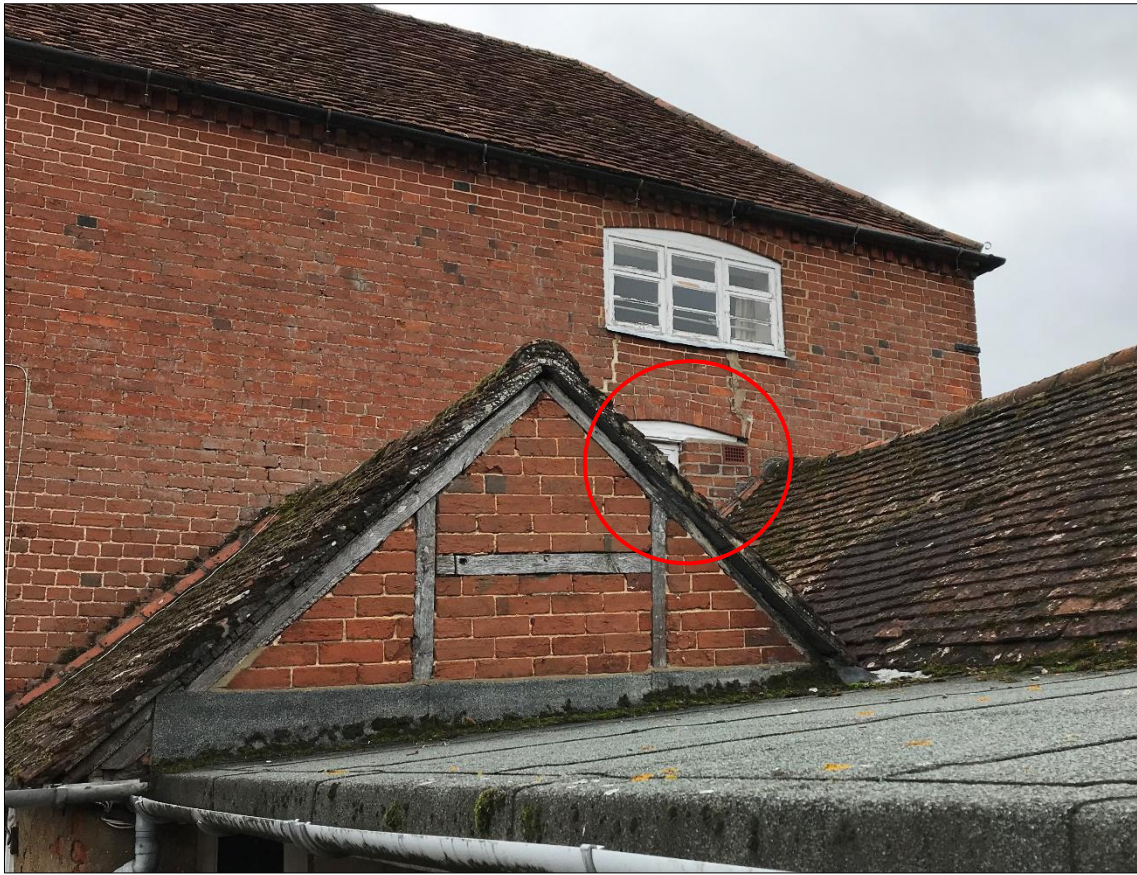
2.13 This conclusion is corroborated by the physical evidence: the roofs of the extensions partially block a window on the north side of the farmhouse (Fig. 13).

Fig. 13. Farmhouse window partially blocked by the roof of the extension.

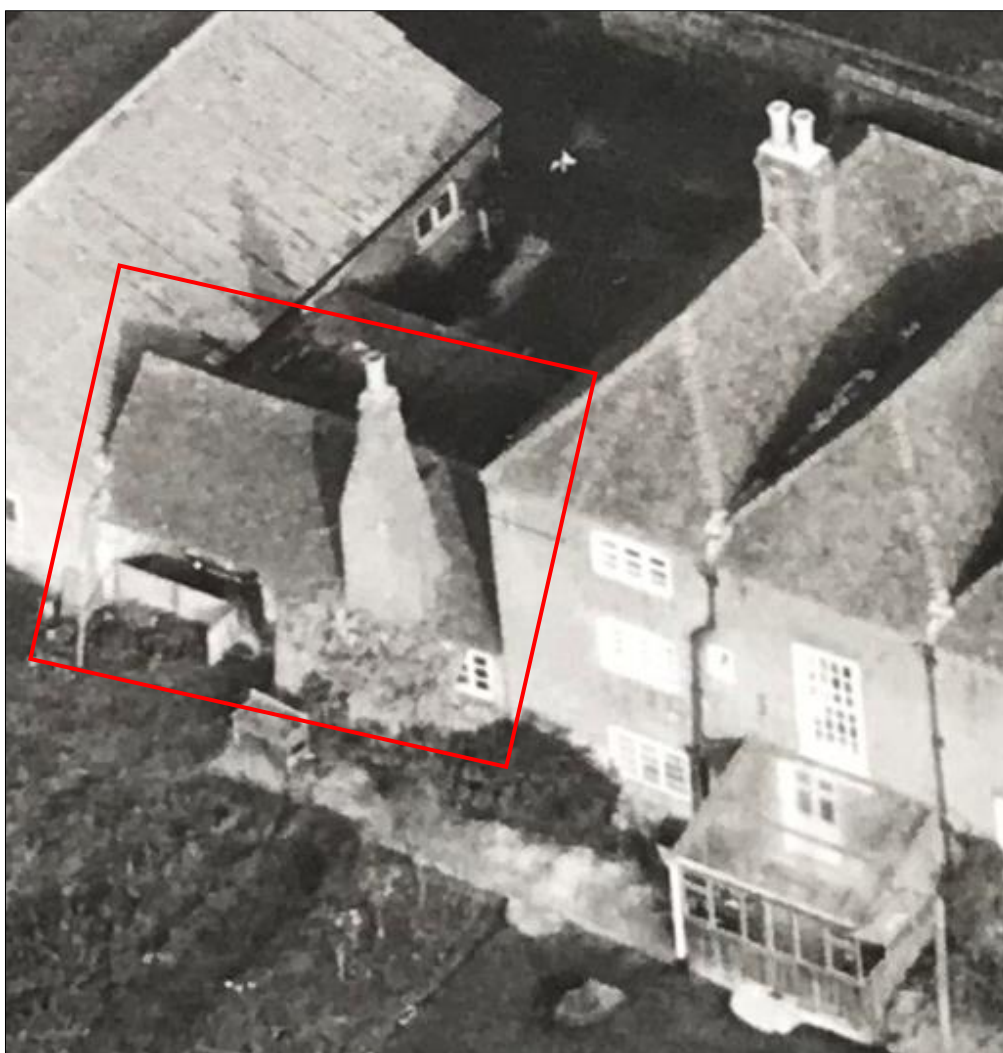
2.15 The long range adjoining the garden was an open shed; there was no wall to the garden elevation (Fig. 14). The majority of this long range and the projecting wing were demolished when the present large shed further to the northwest was erected in the mid-twentieth century.

Fig. 14. Late C20. Aerial view showing stack and open shed.

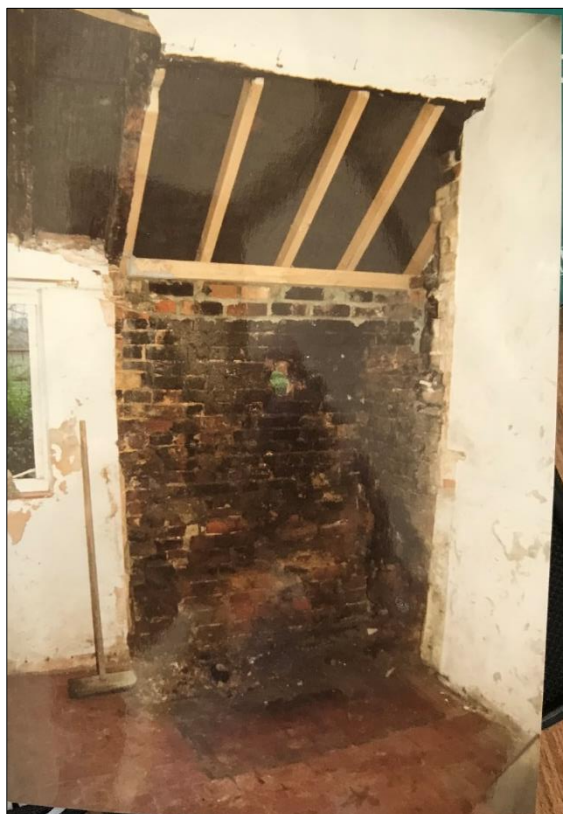
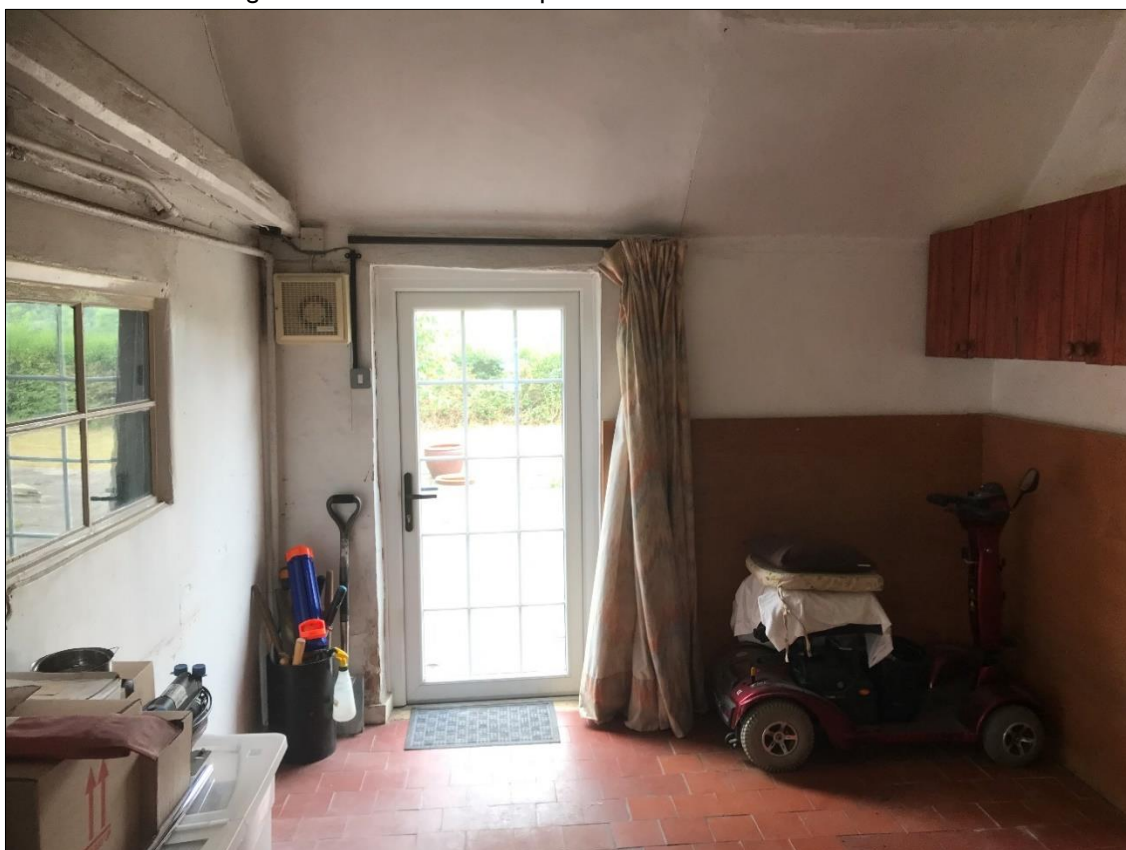
Fig. 15a. Rear room with fireplace removed and late C20 door.

Fig. 15b. Rear room with fireplace removed and late C20 door.

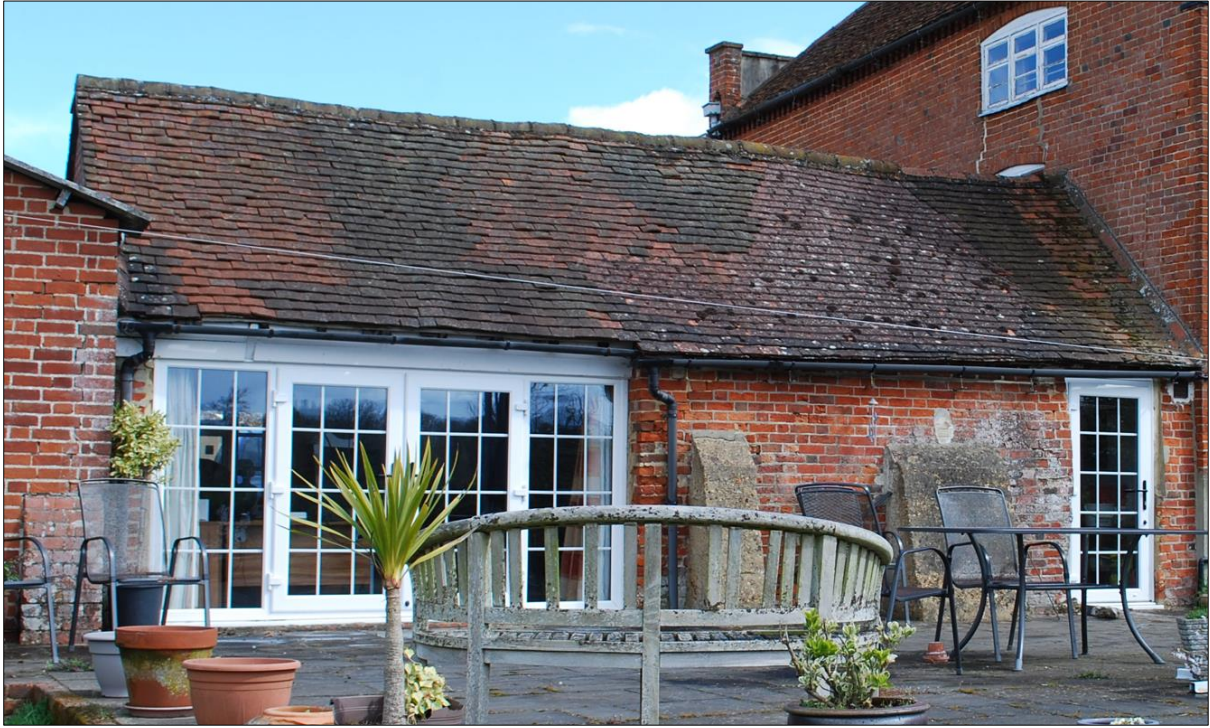
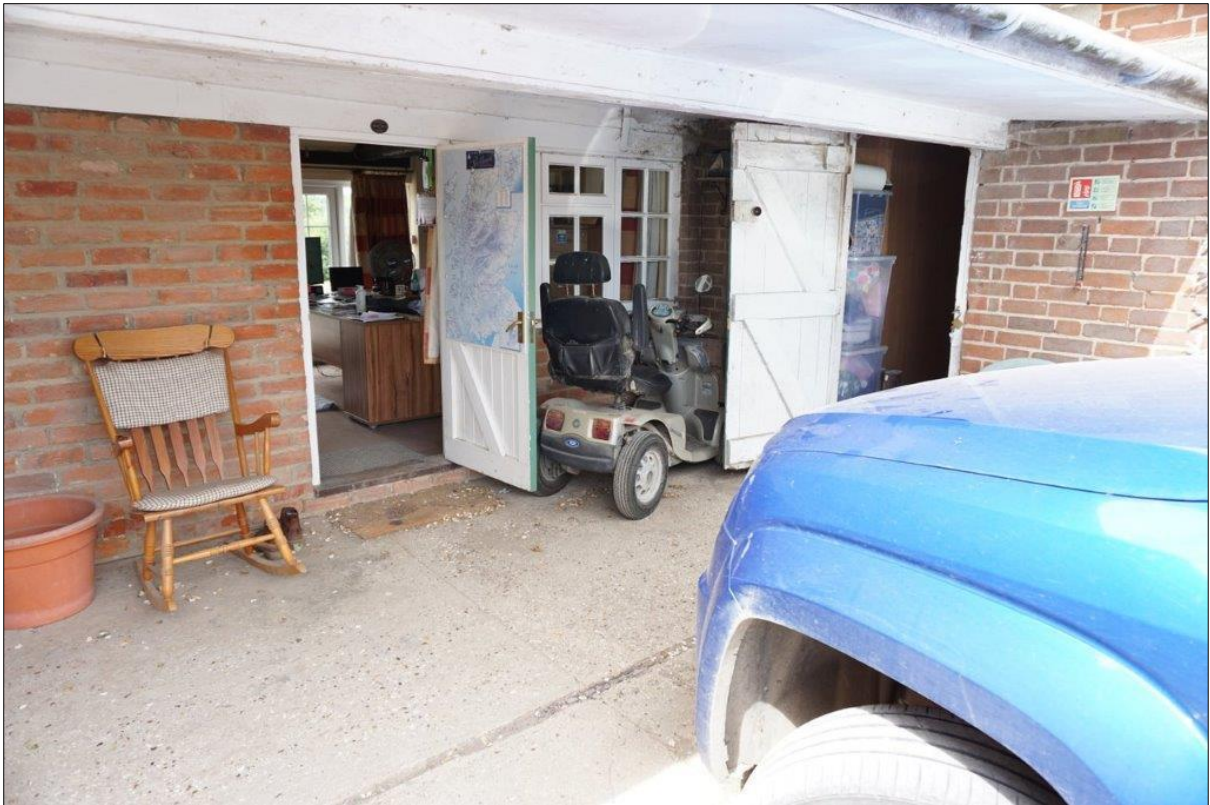
2.16 In the later twentieth century the garden elevation of the former open shed has been glazed in with a four-light, French window and side lights; the northeast elevation has been rebuilt in stretcher-bond brickwork, a modern casement window has been inserted and the whole of the area in front was covered over with a flat-roofed canopy (figs. 16 & 17).

Fig. 16. Garden elevation. Late C20 windows, doors and canopy.

Fig. 17. Late C20 canopy, windows, doors and wall to east elevation.

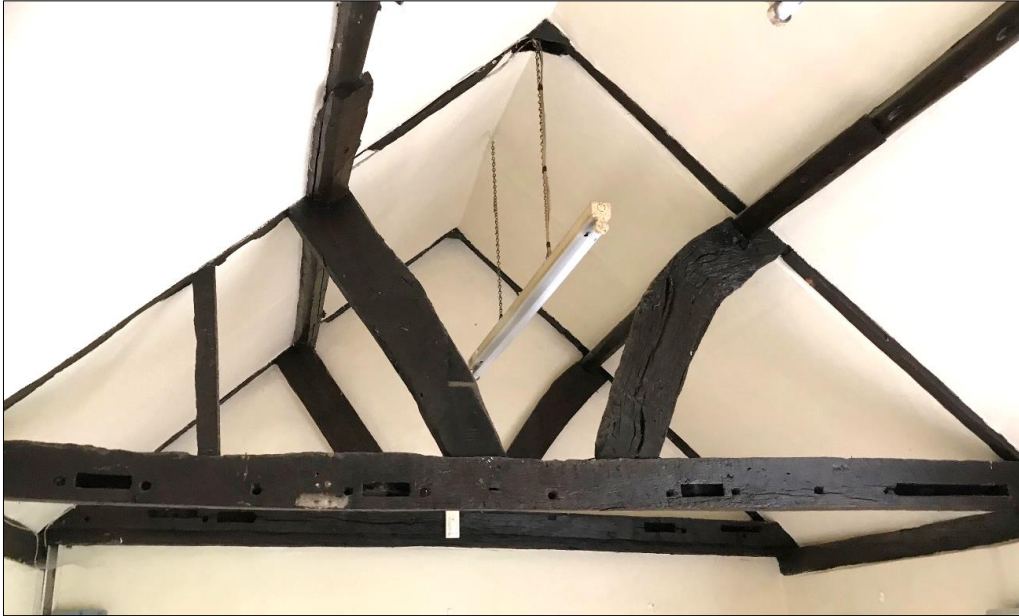
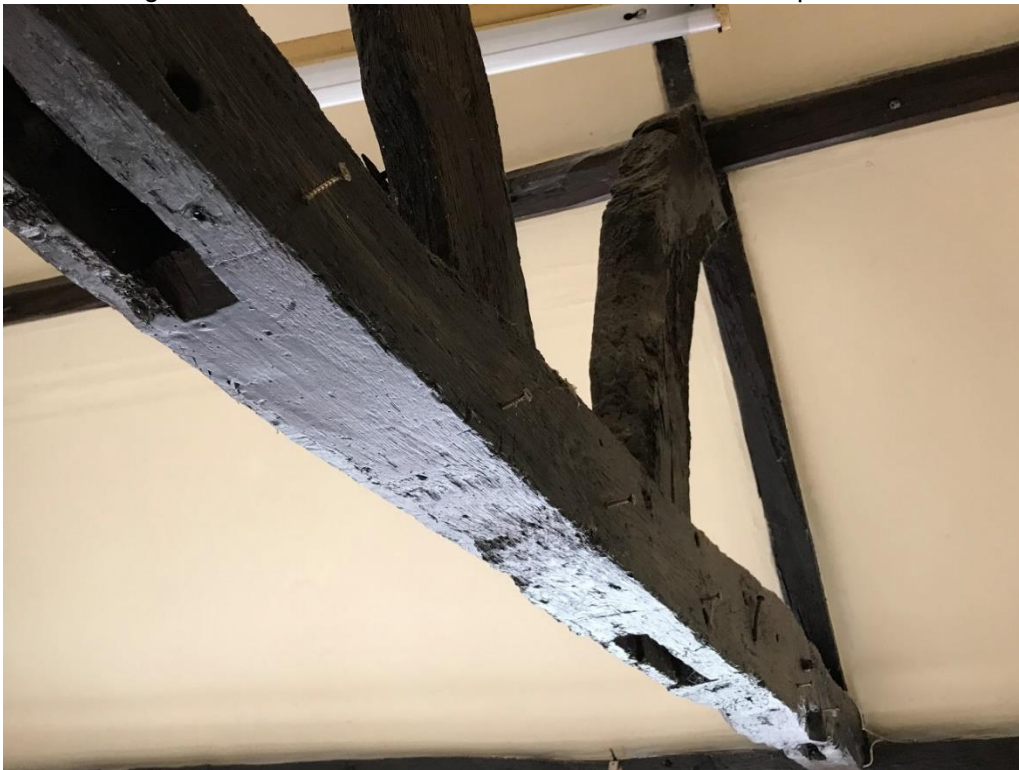
2.17 Internally there is little of interest. In the former office/open shed are trusses that have been assembled with re-used timbers – see the mortices and peg holes to the soffit and face of the beams and the iron reinforcing straps (Fig. 18). It is possible that this roof structure is contemporary with the construction of the open shed, i.e. after 1797 but before 1840. Otherwise, there is nothing of interest inside the structures as the buildings were extensively remodelled in the late twentieth century.

Fig. 18a. Trusses formed of re-used timbers in former office/open shed.

Fig. 18b. Trusses formed of re-used timbers in former office/open shed.
