## PRELIMINARY ECOLOGICAL APPRAISAL (DBW) AT 52 OATLANDS ROAD SHINFIELD

**19 February 2024**

**Ref: SPH/NP/PEA-24/08.02**

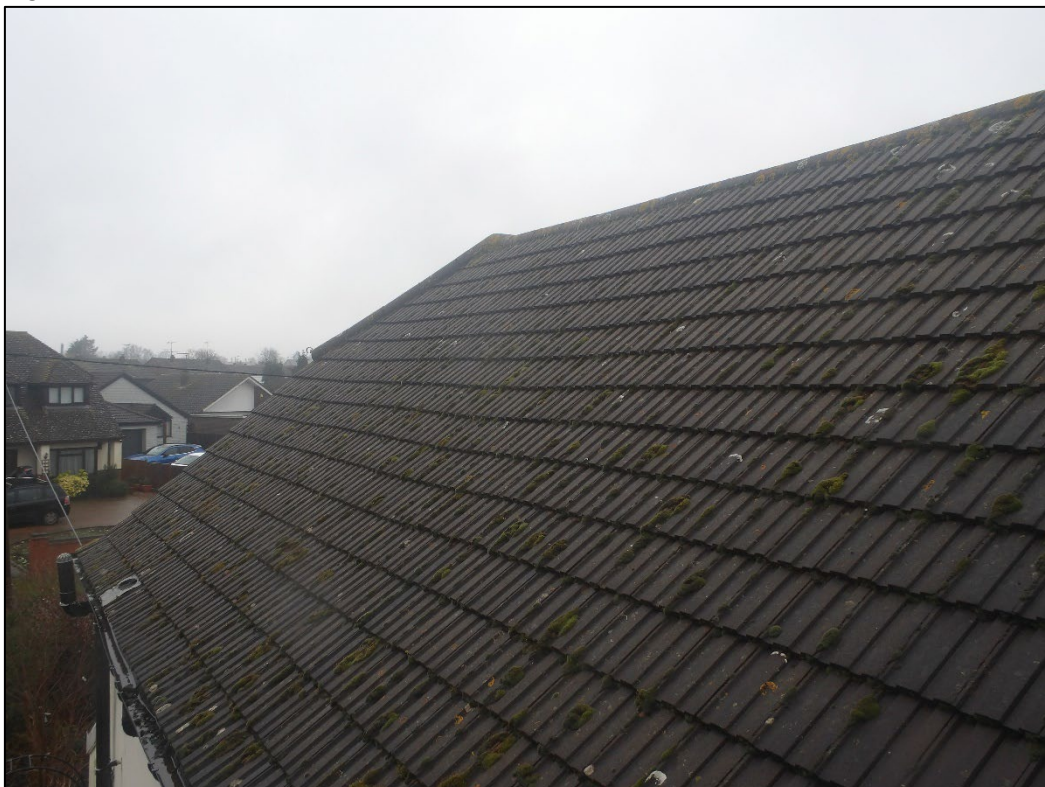
Figure 4. Example roof tiles. 52 Oatlands Road, Shinfield. 08.02.24

The property is a detached, brick-built and rendered/painted building with part attached/part integral garage. The cross hipped roof is covered in interlocking composite tiles, none of which are missing or broken, see Figure 4 below. The ridge and hip tiles and valleys are all in a good condition with no gaps which roosting bats could exploit and the verges are well sealed with no missing mortar, see Figure 5 on page 9. There are hanging tiles on the front bay window gable end, all of which are tightly fitted with no gaps that could be exploited by crevice dwelling bat species (see Figure 6 on page 9), as are the uPVC fascias and soffits, see Figure 7 on page 10. The pitched roof of the rear, single storey extension is also covered in well fitted interlocking composite tiles with sealed fascias and verges, and the lead flashing affixing it to the building is tight to the wall with no gaps or splits, see Figure 8 on page 10.

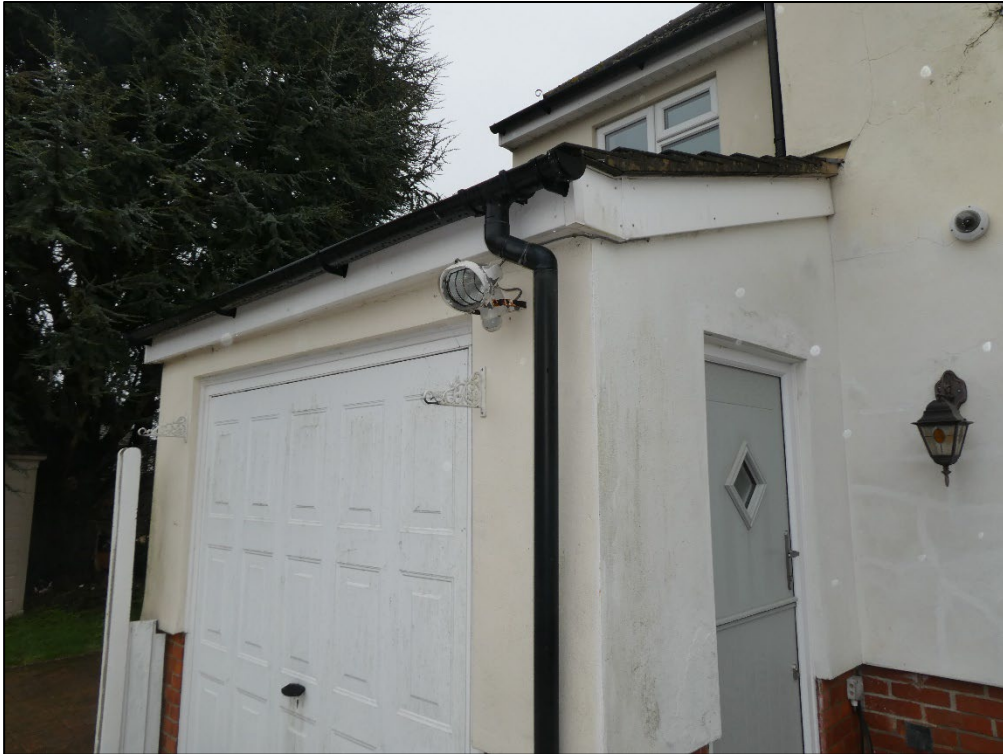
Figure 9. Garage. 52 Oatlands Road, Shinfield. 08.02.24

The garage is also brick built, rendered and painted and in a good condition, see Figure 9 on page 11. The pitched roof is also covered in well fitted interlocking composite tiles with sealed fascias and verges, and the lead flashing affixing it to the building is tight to the wall with no gaps or splits, see Figure 10 on page 11.

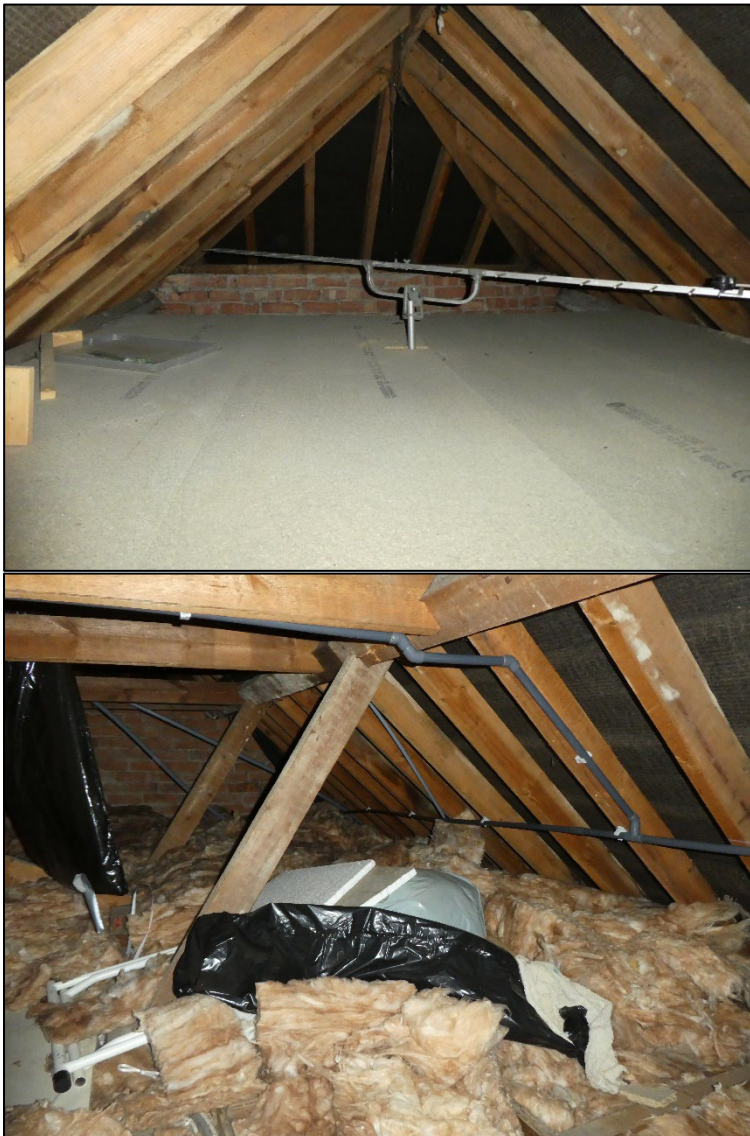
Figure 11. Example loft space. 52 Oatlands Road, Shinfield. 08.02.24

The loft of the property was accessed via a loft ladder and was in a good condition internally. The loft was not lit, partially boarded and deeply insulated (see Figure 11 below) but this did not hinder the inspection. The roof tiles are lined with bitumen felt, all of which appears to be in a good condition with no rips or tears which could be utilised by roosting bats, see Figure 12 on page 13.

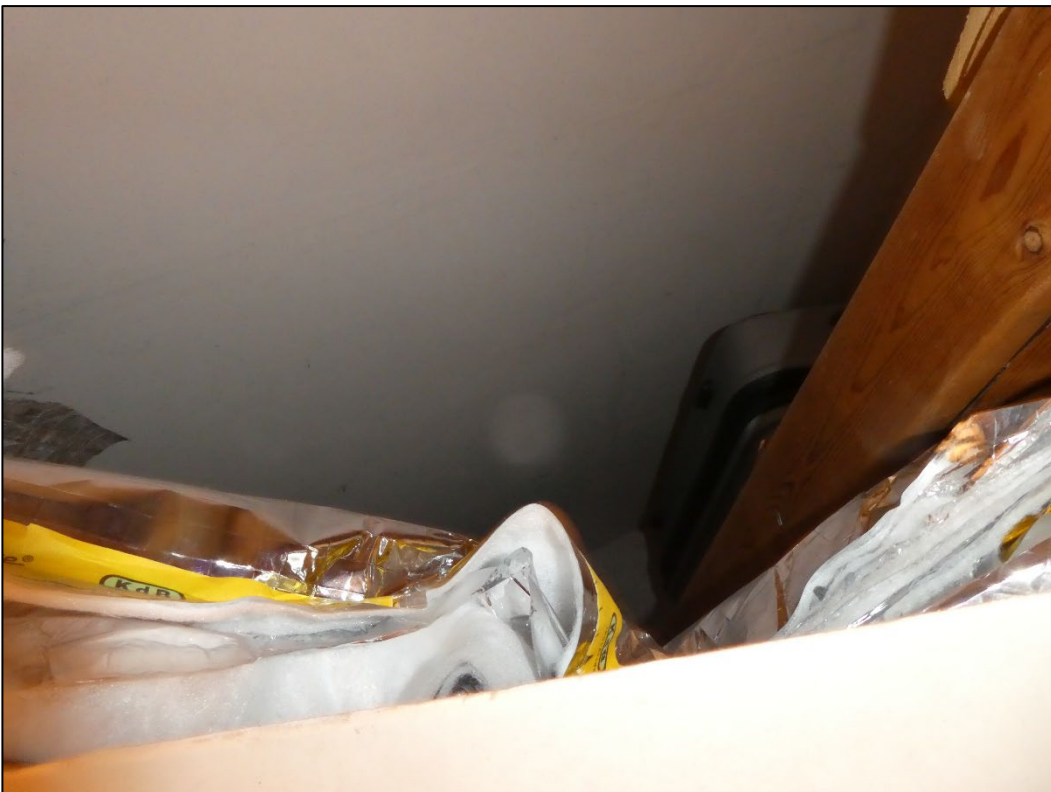
Figure 11. Example remaining garage roof space. 52 Oatlands Road, Shinfield. 08.02.24

The garage was also inspected internally. The garage has been converted into habitable accommodation. The remaining loft space was accessed via a small loft hatch from steps, and the low roof height restricted a full inspection, see Figure 13 on page 12.
