Monitoring Details:

Property Address: 14 Fakenham Close, Lower Earley, Reading, Berkshire, RG6 4AB

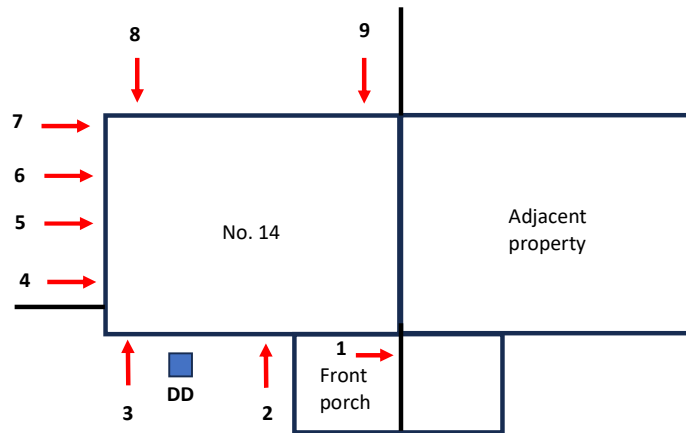
## Site Plan

**FRONT**
