### Crack and Level Monitoring

**Provider Name:** SML Subsidence

**Address:** 14 Fakenham Close, lower Early, RG6 4AB

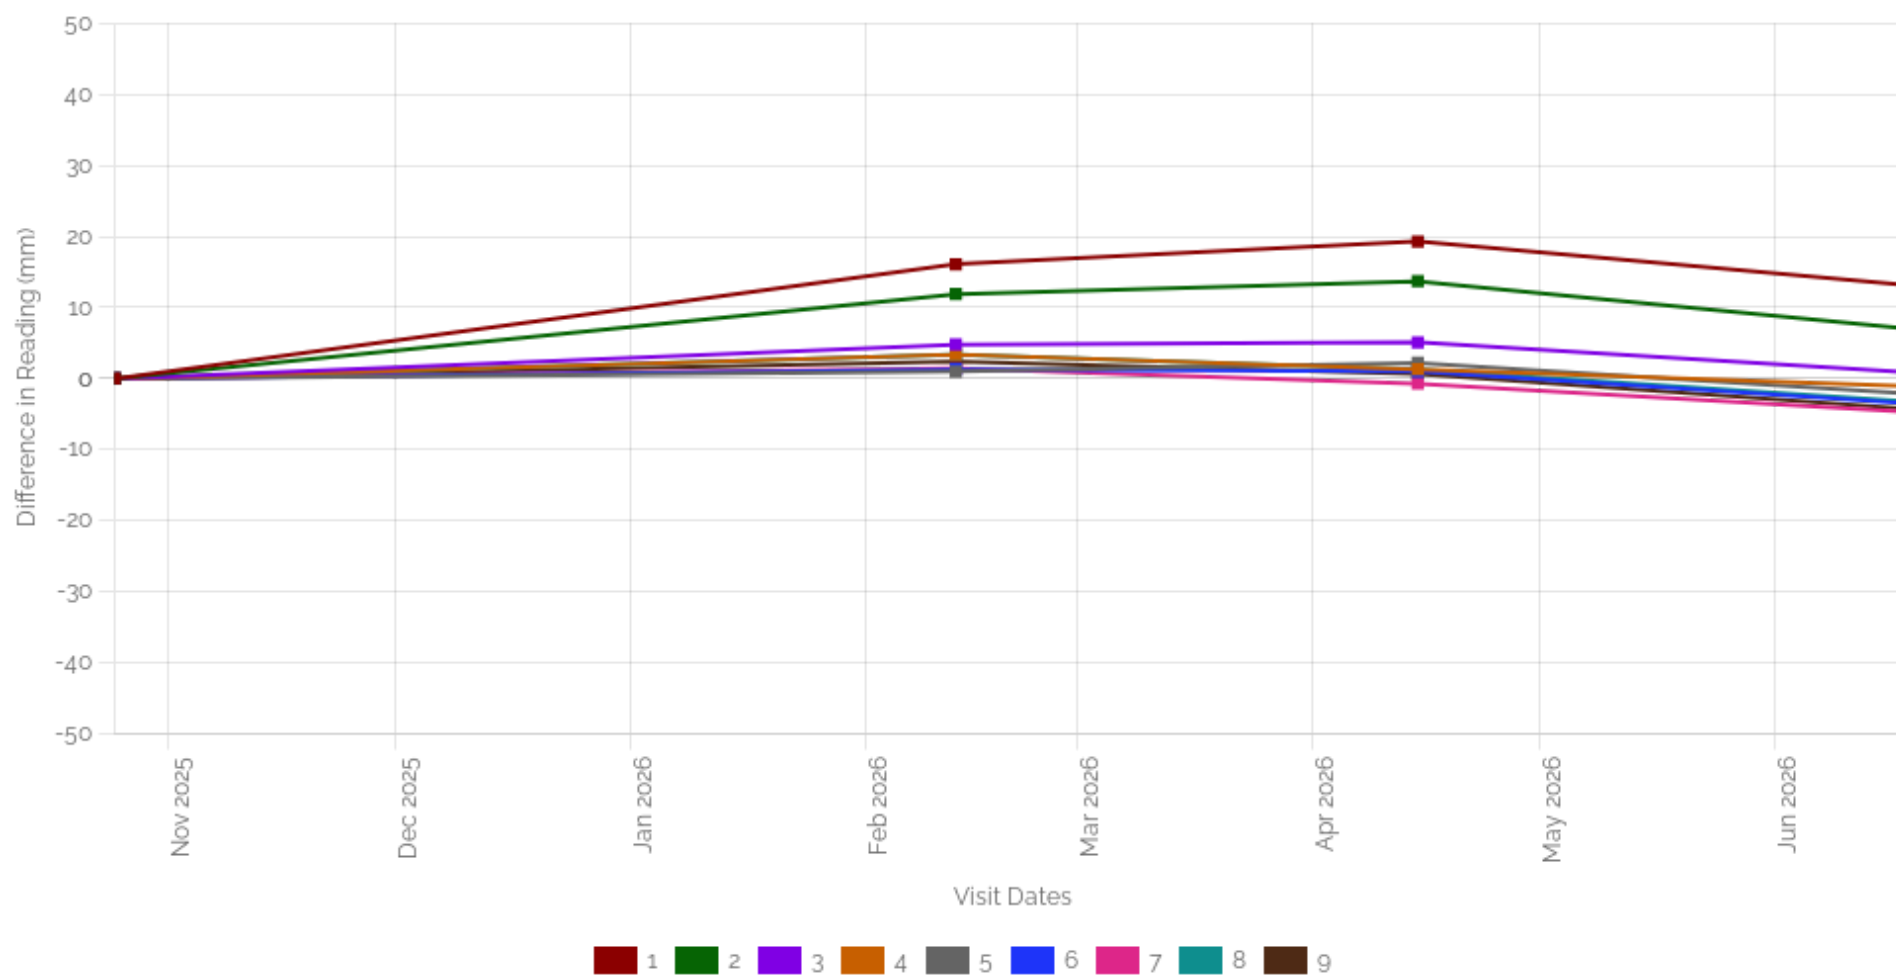
## Level Readings Chart (Points 1 - 9)

| | Visit 1 | Visit 2 | Visit 3 | Visit 4 | Visit 5 | Visit 6 | Visit 7 | Visit 8 |
|---|---|---|---|---|---|---|---|---|
| 1 | 0 | +16.1 | +19.3 | +13.1 | | | | |
| 2 | 0 | +11.9 | +13.7 | +7 | | | | |
| 3 | 0 | +4.8 | +5.1 | +0.9 | | | | |
| 4 | 0 | +3.4 | +1.3 | -1.1 | | | | |
| 5 | 0 | +1 | +2.2 | -2.1 | | | | |
| 6 | 0 | +1.3 | +1 | -3.5 | | | | |
| 7 | 0 | +1.4 | -0.7 | -4.7 | | | | |
| 8 | 0 | +3.4 | +1.3 | -3.2 | | | | |

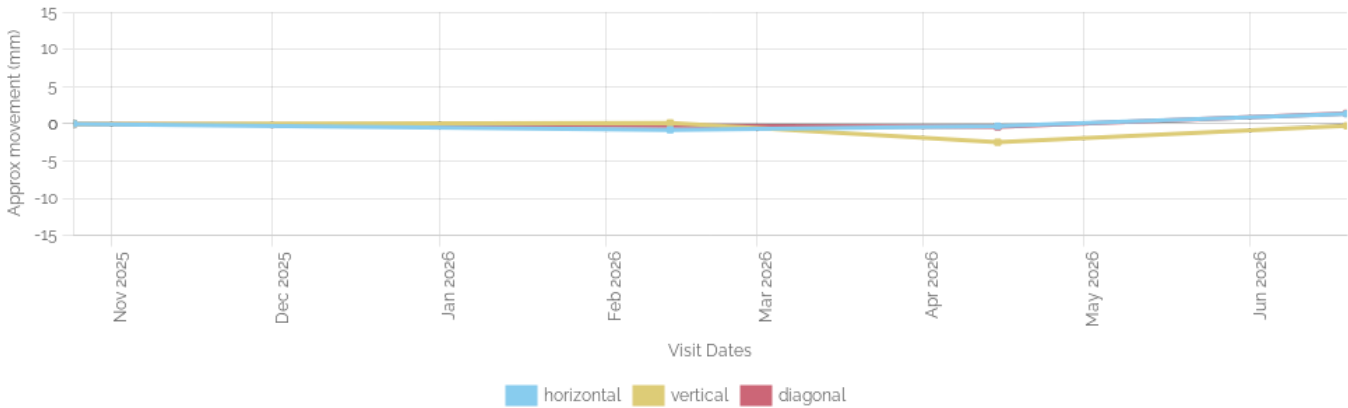
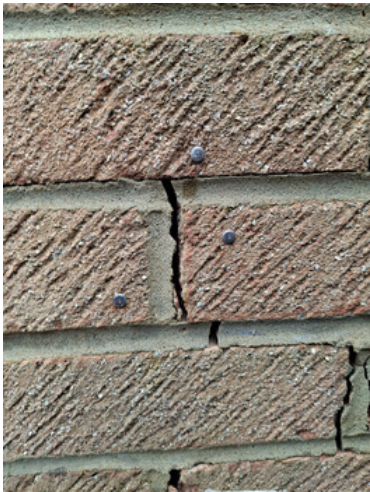
(External) left elevation above gas box - Photo

(External) left elevation above gas box

(External) left elevation above gas box - Crack Readings Differences (Displayed in Millimetres)

| | Visit 1 | Visit 2 | Visit 3 | Visit 4 | Visit 5 | Visit 6 | Visit 7 | Visit 8 |
|---|---|---|---|---|---|---|---|---|
| H | 0 | -0.8 | -0.31 | 136 | | | | |
| V | 0 | 0.13 | -2.47 | -0.26 | | | | |
| D | 0 | -0.26 | -0.4 | 14 | | | | |

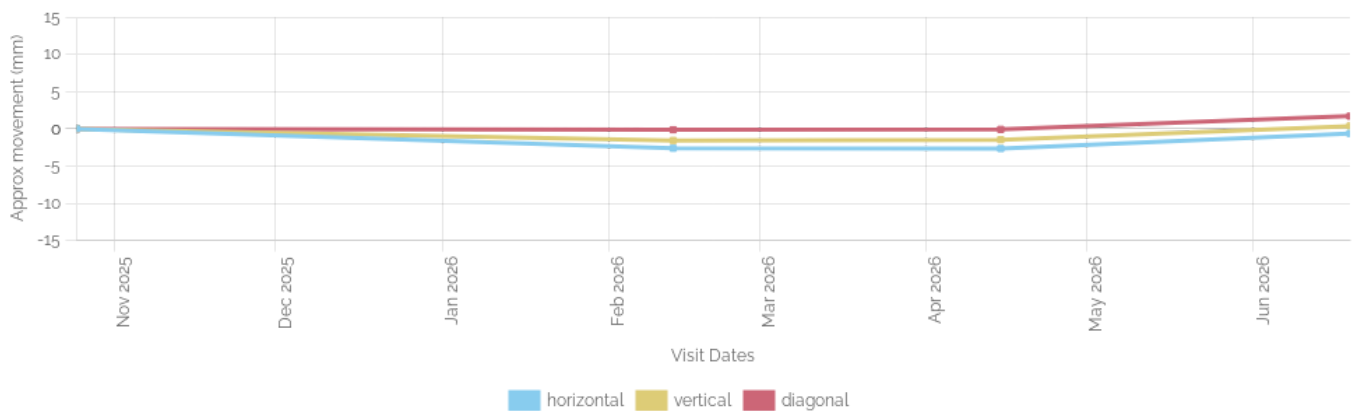
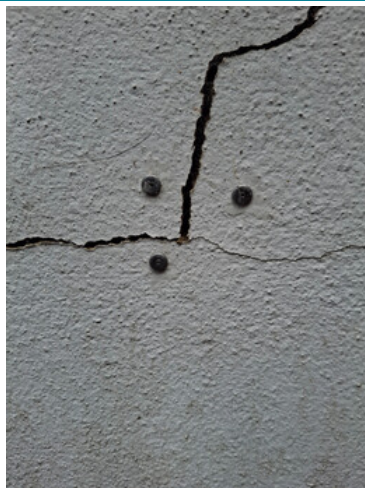
(External) front elevation under window - Photo

(External) front elevation under window

(External) front elevation under window - Crack Readings Differences (Displayed in Millimetres)

| | Visit 1 | Visit 2 | Visit 3 | Visit 4 | Visit 5 | Visit 6 | Visit 7 | Visit 8 |
|---|---|---|---|---|---|---|---|---|
| H | 0 | -2.61 | -2.65 | -0.62 | | | | |
| V | 0 | -1.56 | -1.46 | 0.38 | | | | |
| D | 0 | -0.12 | -0.07 | 1.7 | | | | |
