Title - Preliminary Roost Assessment (PRA) on dwelling and garage at Oakland Farm, New Mill Rd, Eversley, Hook RG27 0RB

Report title	PRA - Dwelling and garage at Oakland Farm, New Mill Rd, Eversley, Hook RG27 0RB
Version	Version 1
Report ref	PRA.V1.D.G.OF.NMR.E.H
Date produced	03/08/2025
Report checked by	Jan Forkasiewicz BA (Hons)
Report validation	This report is only valid until the Bat Roost Characterisation Survey recommended within this report has been carried out

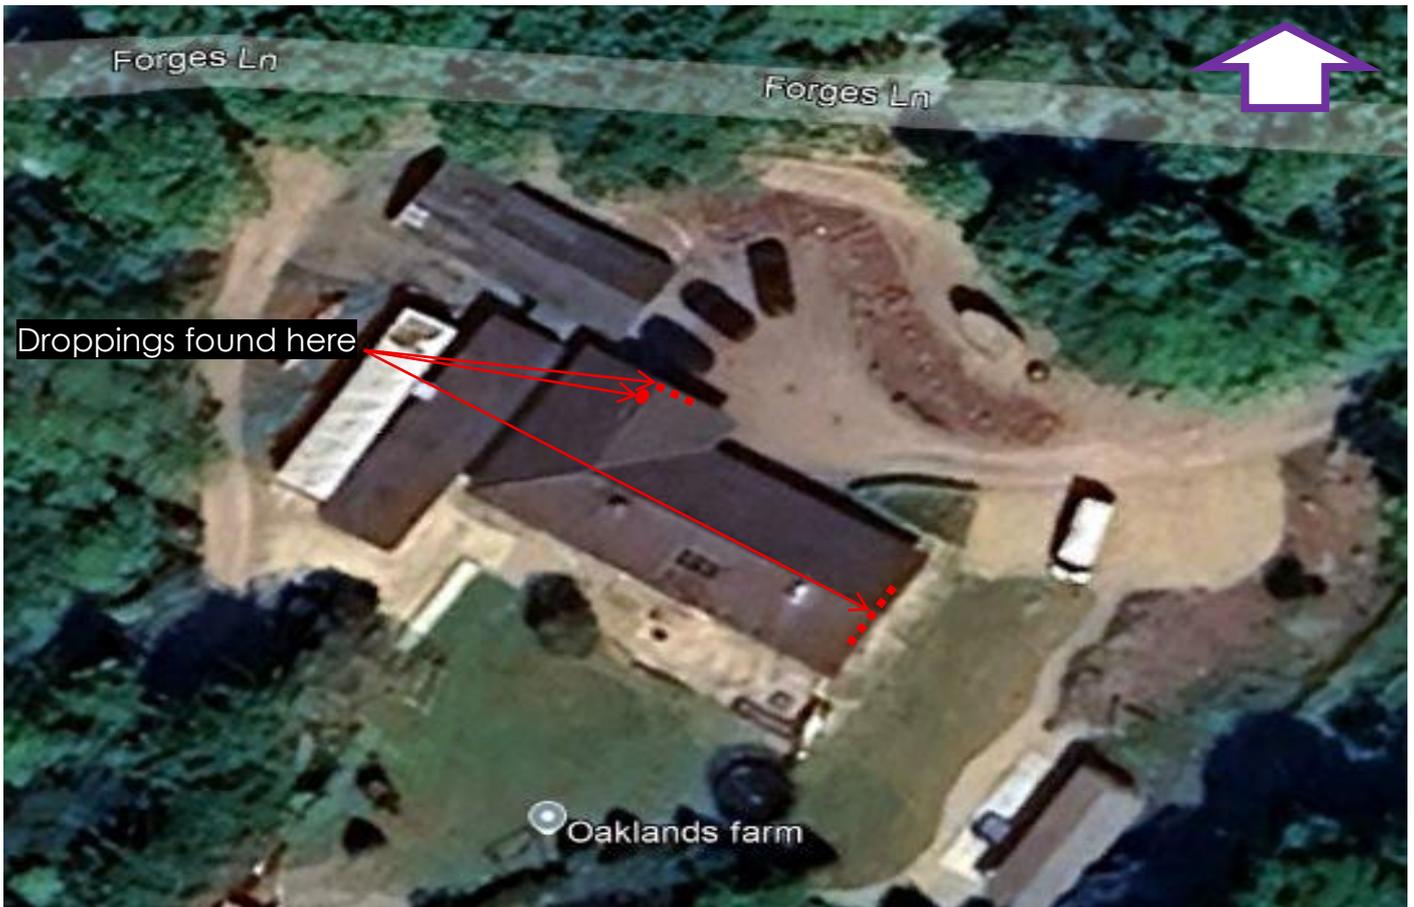
The dwelling; detached with southeast/northeast gable ends, a pitched roof with concrete ridge tiles/concrete interlocking roof tiles/two chimneys with lead flash seating/solar panels at the rear/timber facias and flush timber cladding on the gable ends. The roof space has a bituminous membrane.

2. In accordance with the guidelines, and Government Circular 06/2005, a Bat Roost Characterisation Survey consisting of three emergence surveys should be carried out on the dwelling. Two of the emergence surveys need to be carried out during the optimal survey period (May to August) and all the surveys must be spaced  $\geq 3$ -weeks apart, during optimal conditions and recorded using NVAs.

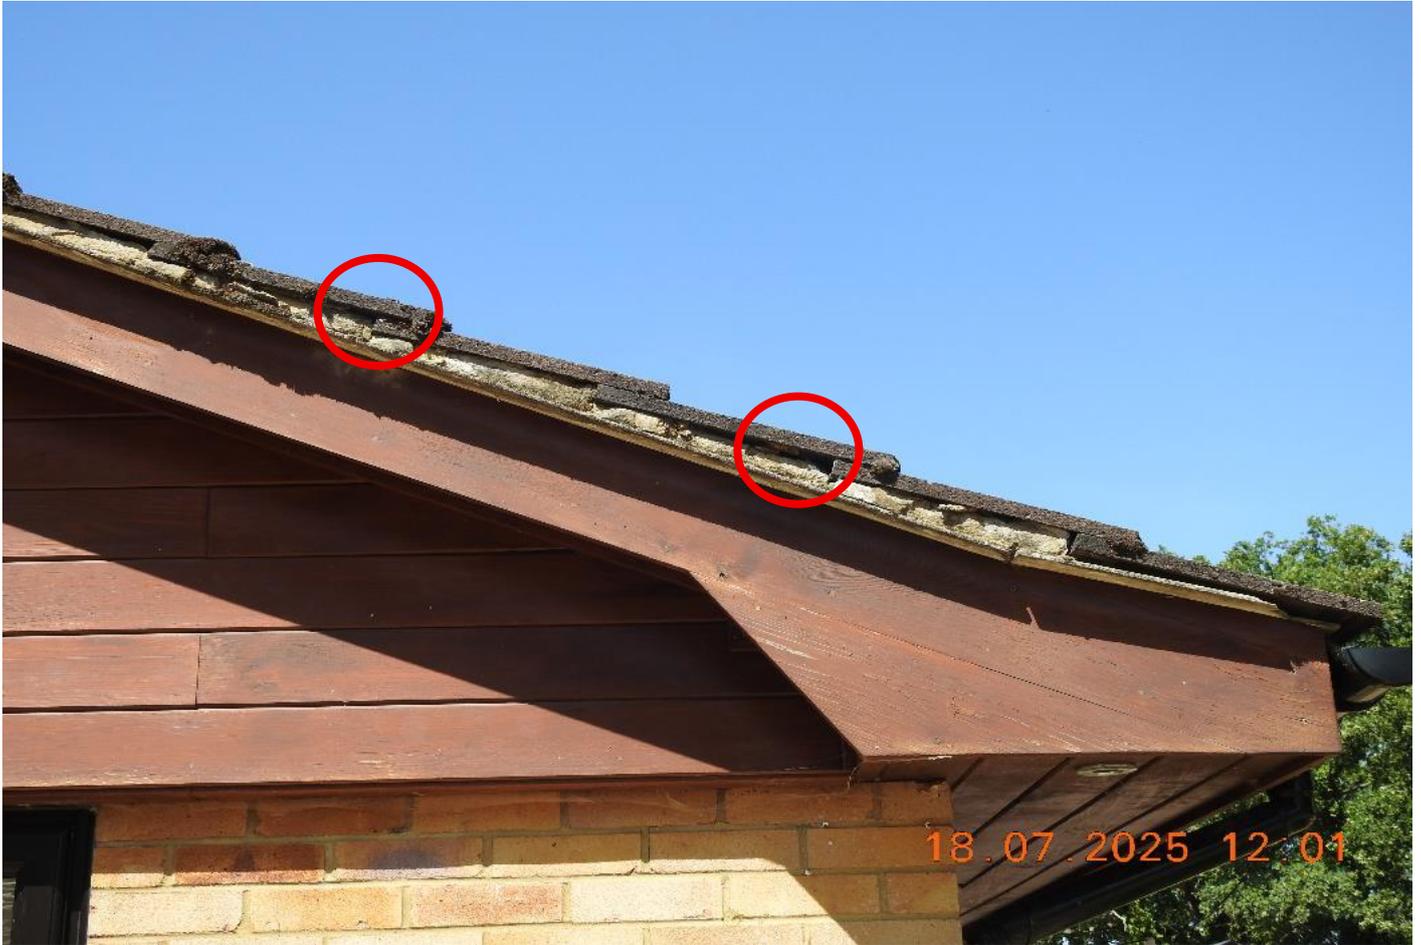
Right hand side of southeast gable end - potential emergence points; holes below roof tiles due to missing mortar.

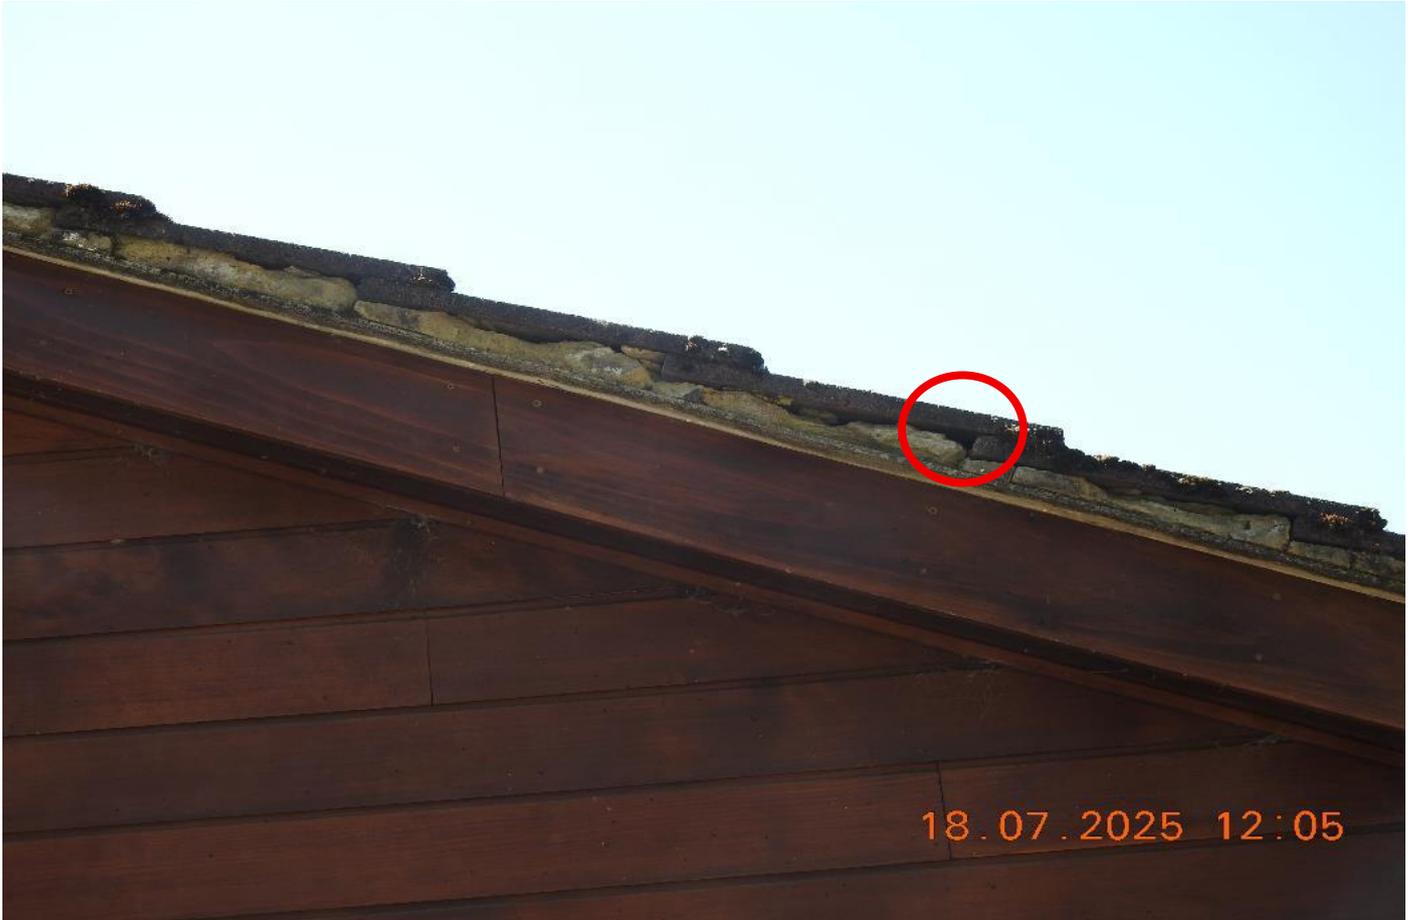
Right hand side of northeast gable end - potential emergence point; hole below roof tile due to missing mortar.

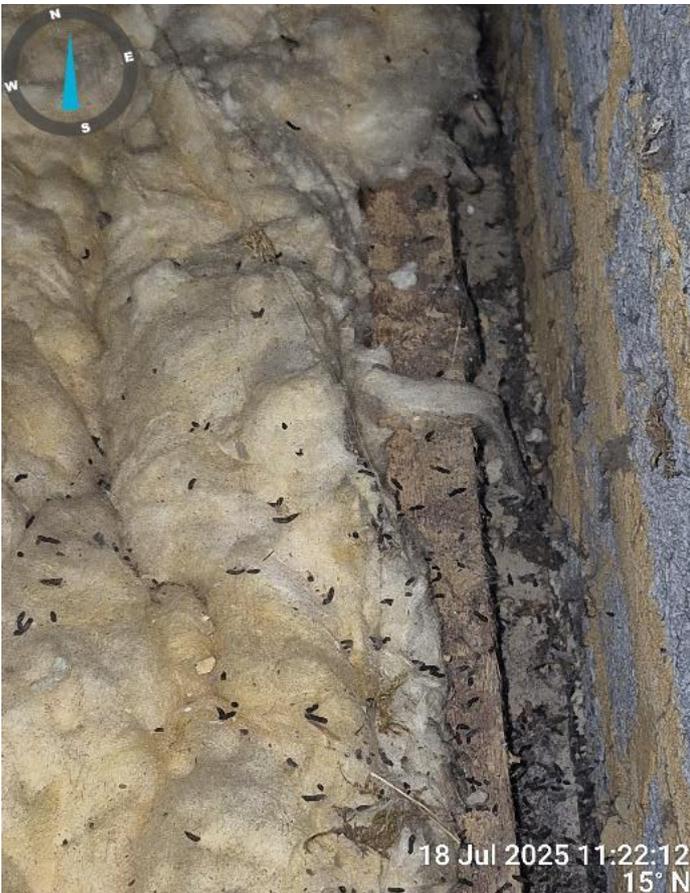
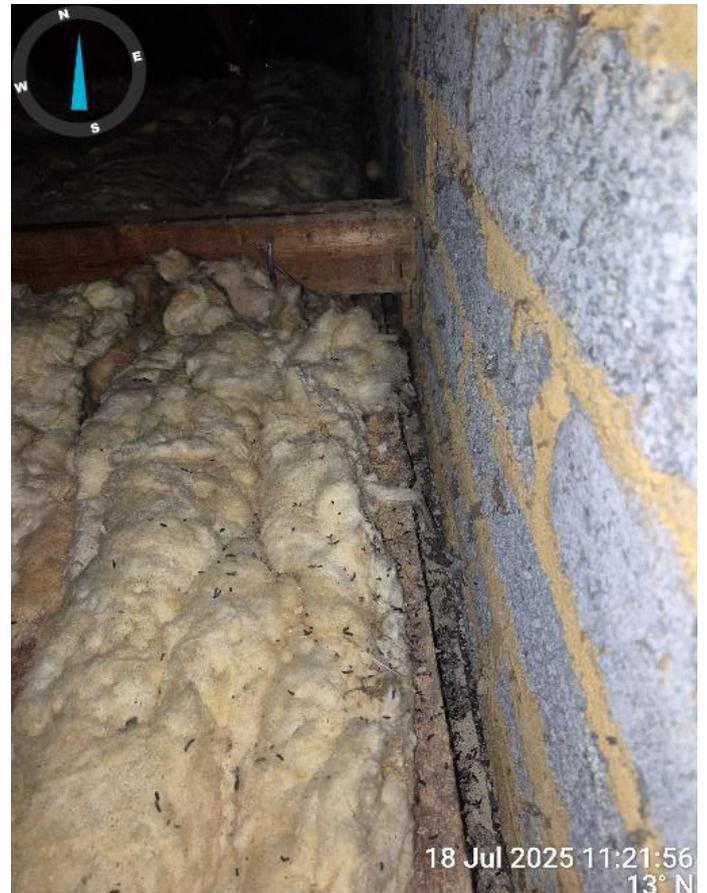
Left of southeast gable end wall.

Right of southeast gable end wall.

Approx. 250 individual droppings at the base of the southeast gable end wall; approx. 150 were to the left, and approx. 100 were to the right of the centre of the wall.

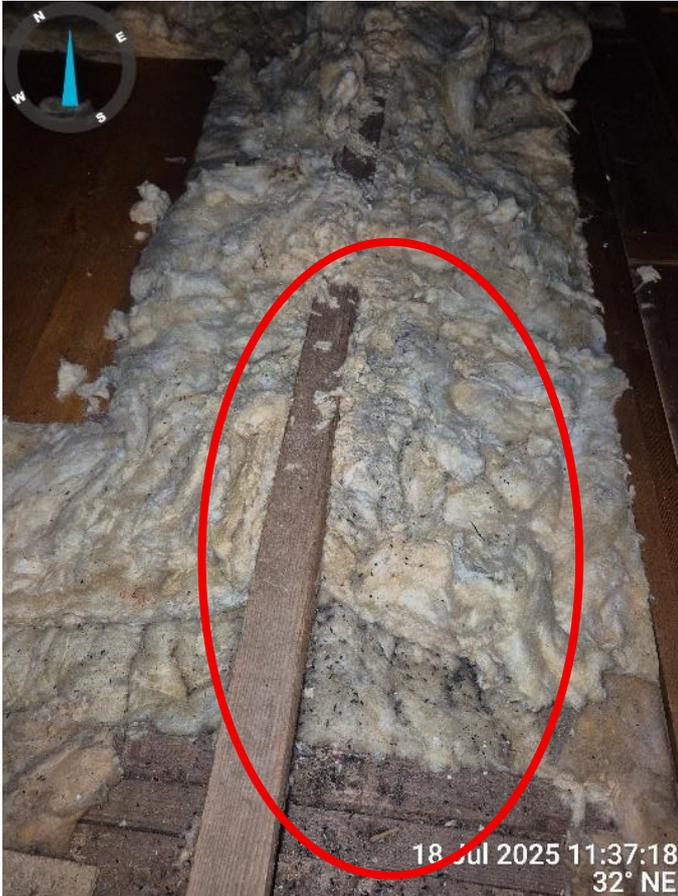
Approx. 30 individual droppings were on the insulation (circled), between 1 and 2m out from the northeast gable end wall.

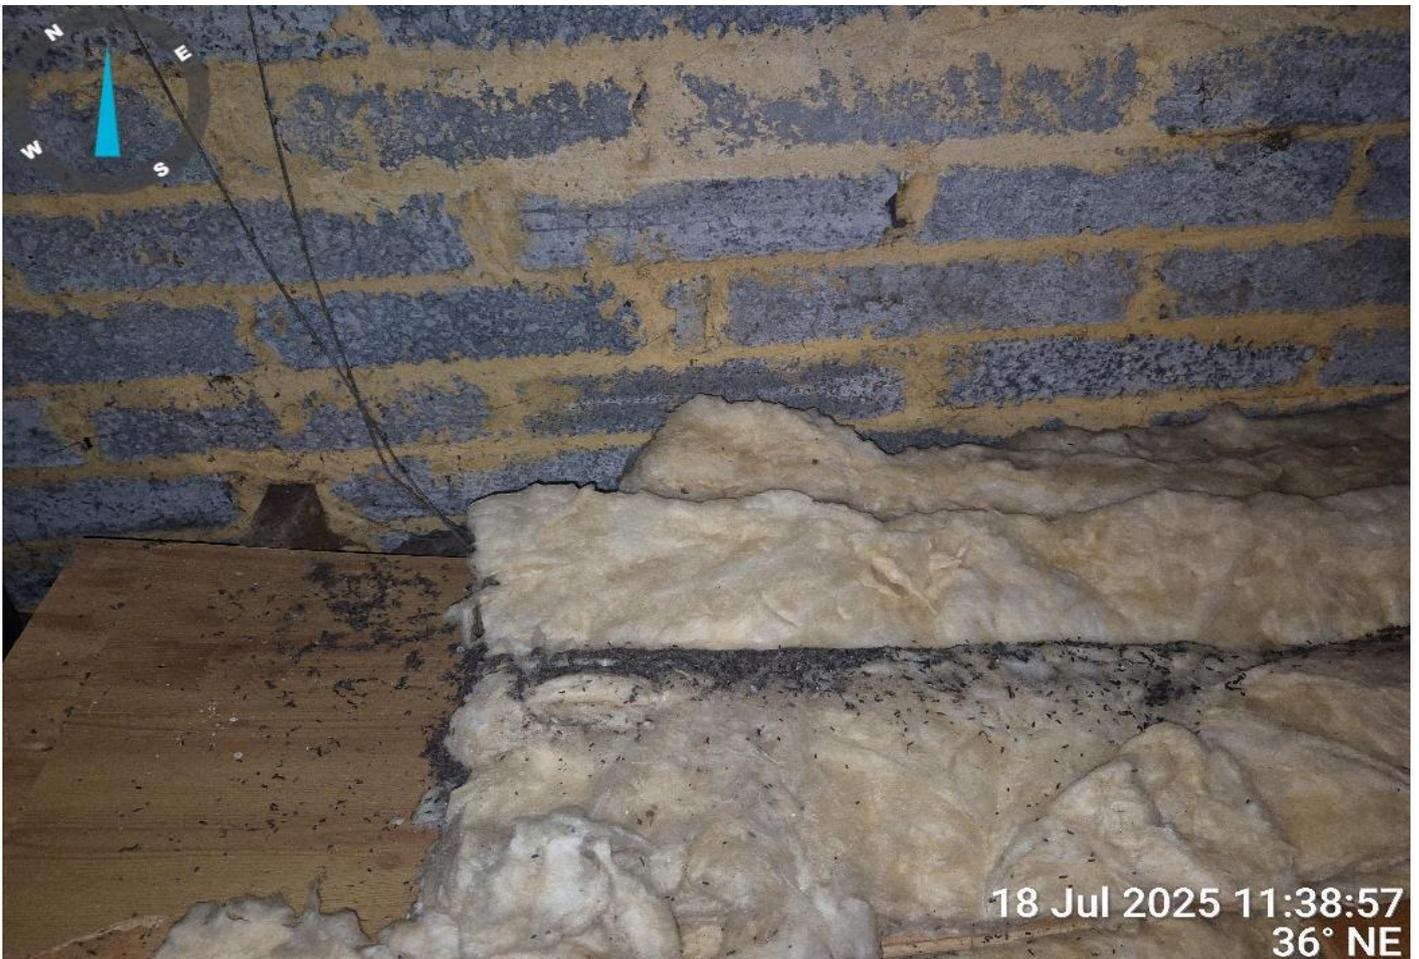
Approx. 100 droppings near the base of the northeast gable end wall, to the right. A few individual droppings were also on both gable end walls.

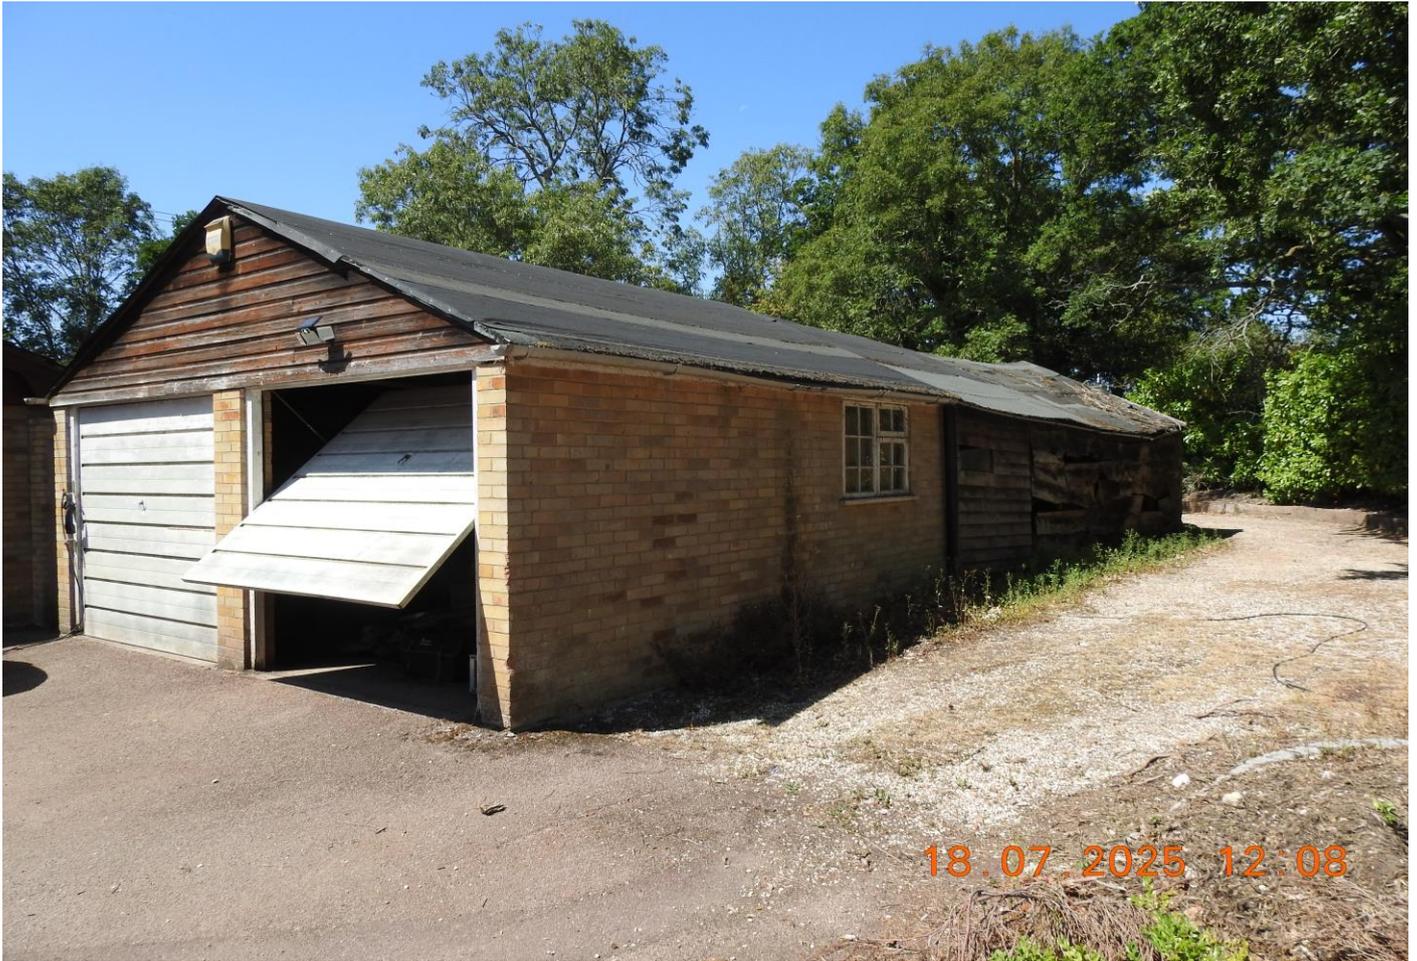
Garage; detached double garage with a pitched felt open roof and flush timber cladding above the doors- a timber dilapidated store is at the rear of the garage. No PRS are on the garage/timber store.
