# Hatch Farm

## **HERITAGE IMPACT ASSESSMENT**

JN2240

This Heritage Impact Assessment has been prepared to assess the potential impact to relevant built heritage assets arising from the proposed demolition of all extant buildings associated with Hatch Farm. These buildings are not identified as “Buildings of Traditional Local Character” in accordance with Policy TB26 of the MDDL, or “Locally Listed Buildings” in accordance with the Emerging Local Plan Policy DH5 which also states that “*All non-designated heritage assets are identified and recorded on the council’s website*”. The buildings at Hatch Farm are not identified in the Historic Environment Record. Four of the cluster of buildings which form Hatch Farm (the Farmhouse, Outbuilding, Large Barn and Threshing Barn) have been identified by the LPA as meriting further assessment in pre-application consultation.

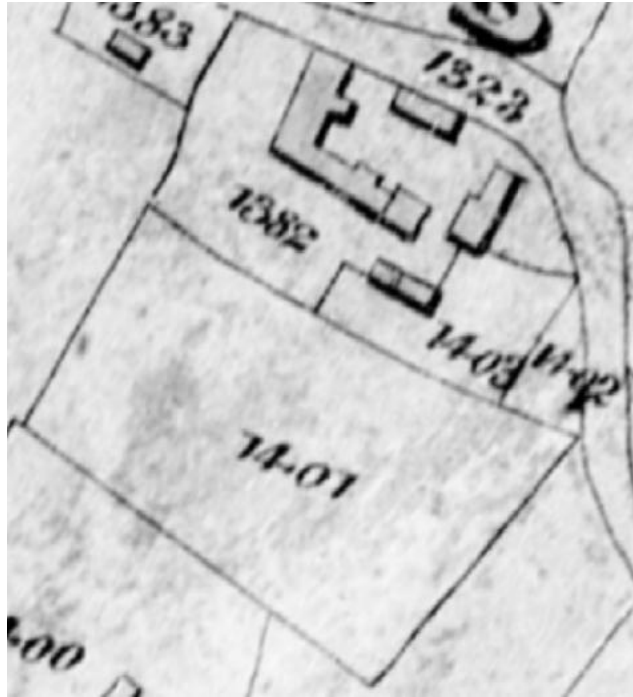
*Plate 1 - Tithe map of 1840 - extract depicting plots 1382, 1401, 1402 and 1403 which constituted the farmstead - the land farmed by this farmstead was largely to the east and north-east of Mill Lane*

- 4.31. The Shelter Shed is built against a wall along Mill Lane. It is depicted in the 1840 Tithe map (**Plate 1**) and from the 1872 OS onwards, two extensions either side are also depicted (**Plate 7**). The extension adjacent to the Threshing Barn is depicted as doubling in depth from the 1967 OS maps onwards (**Plate 8**), and this is the arrangement observed during the Site walkover.
- 4.32. The wall along Mill Lane is built of brick, with the Shelter Shed(s) built as a lean-to structure. The roof is now of corrugated iron, and likely a replacement of the original.

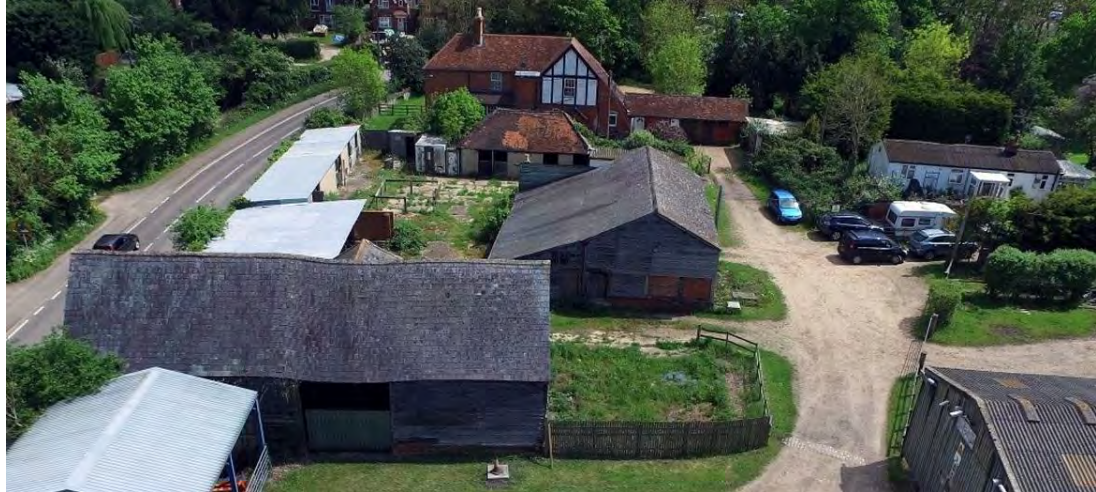
*Plate 3 – Hatch Farm – historic farmstead core (in 2016/2017 sales brochure<sup>8</sup>)*

- 4.1. The extant historic farmstead at Hatch Farm is the latest stage of an original farmstead of which only the farmhouse survives. It consists of a group of buildings of different dates, and built in different materials and styles. The buildings are currently in separate residential, agricultural and commercial uses, and include a core of historic farmstead buildings.

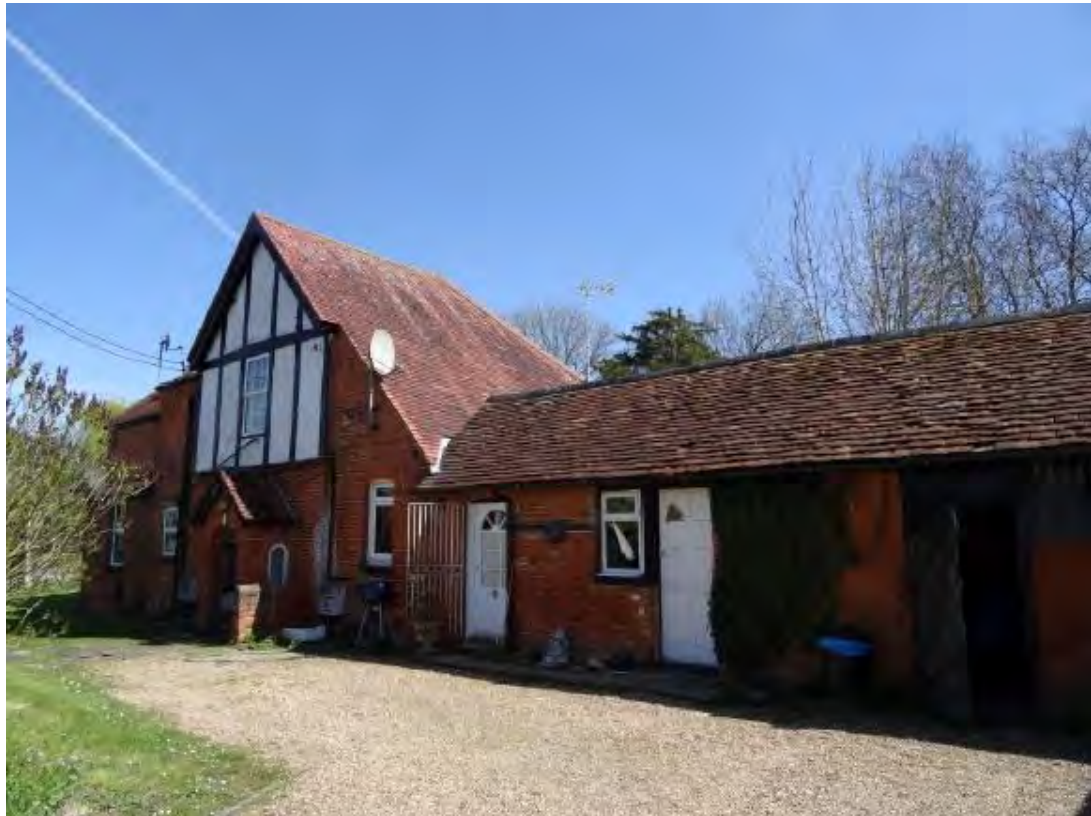
*Plate 4 - Hatch Farmhouse – north-western elevation (in 2016/2017 sales brochure<sup>11</sup>)*

- 4.6. Although it is not possible to establish with certainty whether this is the building depicted in earlier maps, it is possible the farmhouse is depicted as early as in the John Roque's 1752-54 and Thomas Pride's 1790 maps (not included in this report). Those earlier maps also depict a second, separate, building at a perpendicular angle to the south-west (no longer extant), and possibly a contemporary barn.

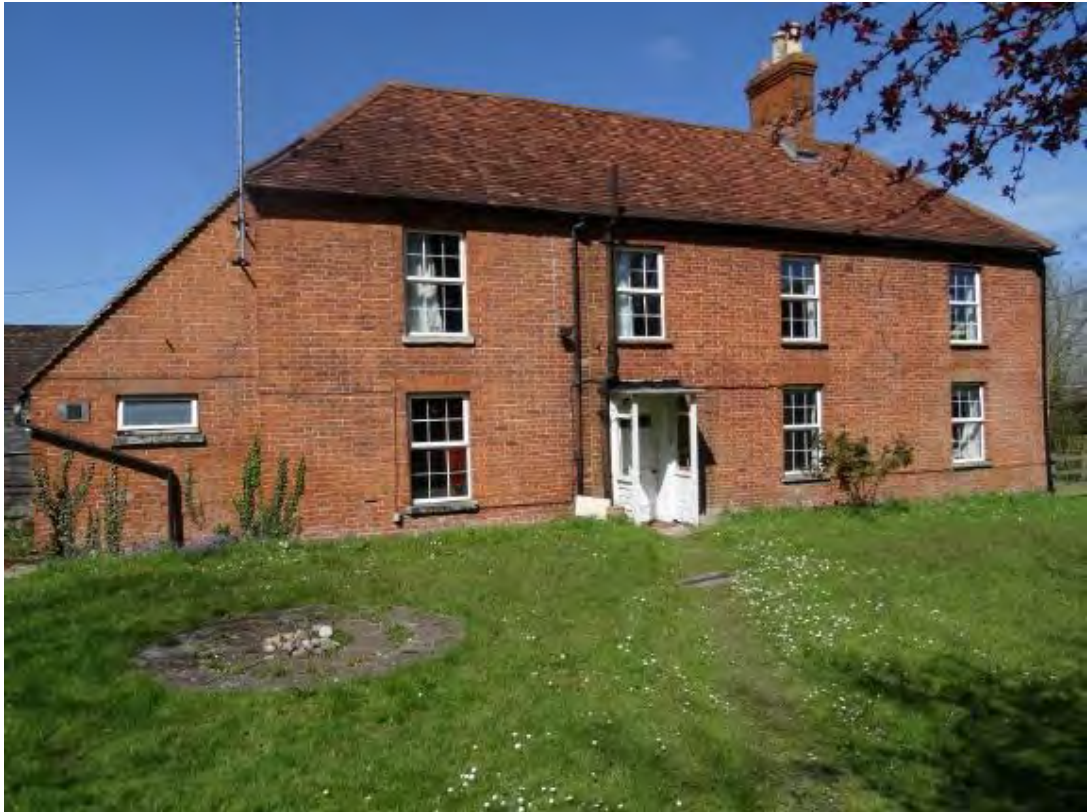
*Plate 5 - Hatch Farmhouse - south-eastern elevation (in 2016/2017 sales brochure<sup>12</sup>)*

- 4.11. The south-eastern elevation (**Plate 4**) presents as a regular façade, with seven 12-light sash windows (one to each bay on each storey), with flat brick lintels and stone sills. Access (to the upper floor of the building only) is through an open porch over the entrance, on the third bay from the left. This elevation fronts onto the road (albeit now separated by mature tree line) and presents a polite “Georgian-style” façade. There are casement windows, on to each storey, on the north-eastern (side) elevation – closest to the road side -, which has a similar style, however without brick lintels or stone sills.

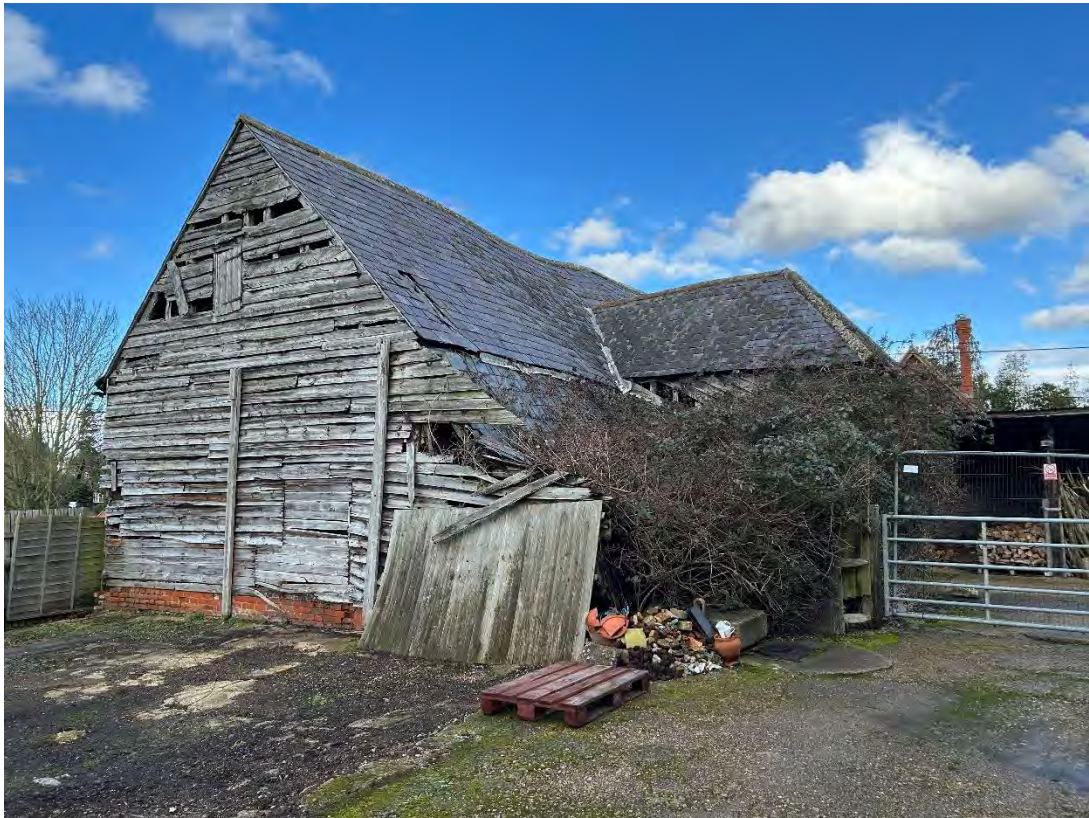
*Plate 10 - Threshing Barn viewed from south*

- 4.24. The Threshing Barn is a timber framed building on a brick plinth, timber clad all around, and with a gabled slate roof (**Plate 9**). The plan consists of four bays open on the third bay from the north-west, with a hip porch over the opposite, farmyard-facing, side. The plan does not appear to have experienced any significant changes since its construction, however, it may have been originally connected to a separate structure adjacent to its south-western (side) elevation which is apparent in historic mapping (**Plates 9 and 10**) but is no longer extant.
- 4.25. The interior of the building was not accessible at the time of the walkover due to being deemed an unsafe structure, although glimpsed views of the roof structure using a combination of queen and raking struts were possible from the entrance (**Plate 10**), possibly indicating partial rebuild of the roof structure.

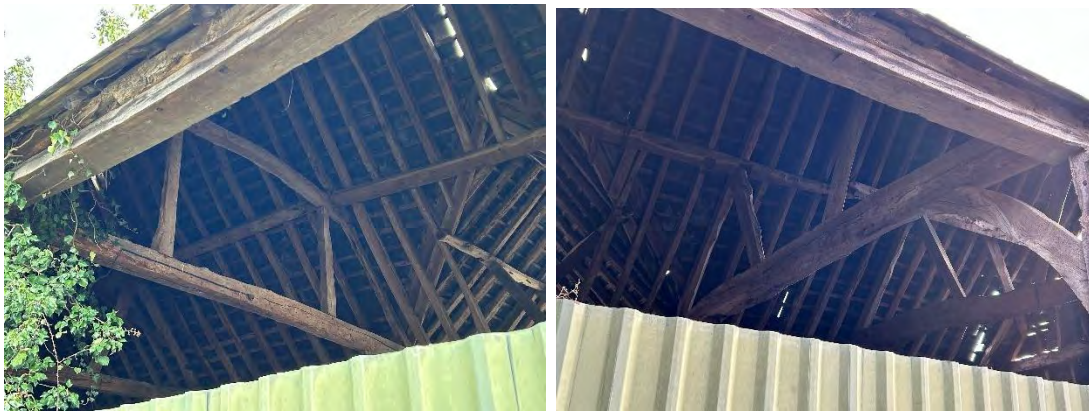
*Plate 11 - View of interior of Threshing Barn with combination of queen struts (left) and raking struts (right)*

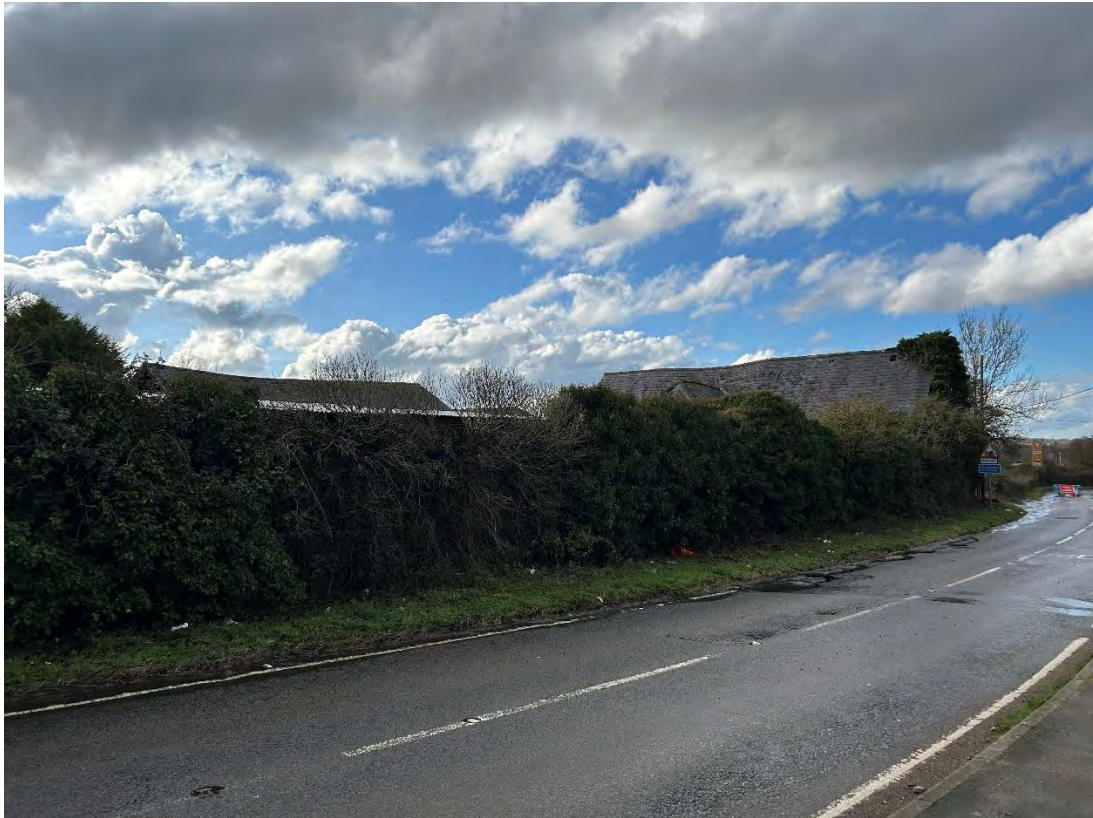
*Plate 12 - Threshing Barn viewed from Mill Lane, looking south-west*

- 4.26. The Threshing Barn is located at the entrance to the farmyard, adjacent to and perpendicular with Mill Lane and the Large Barn and Shelter Sheds, forming one end of the loose arrangement. The Threshing Barn is the most prominent building of the farmstead both in views looking out of the settlement (**Plate 11**) and on the approach (**Plate 17**), where glimpses of top stages of the Large Barn and Hatch Farmhouse are also possible.

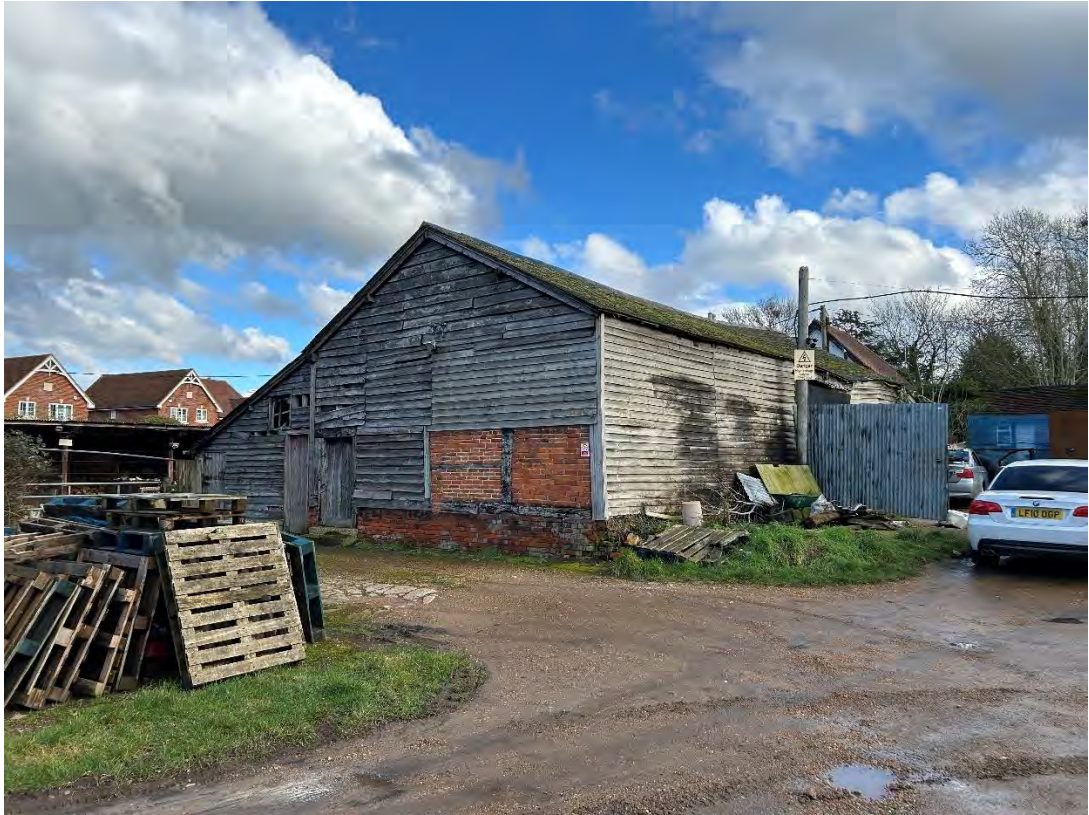
*Plate 13 - Large Barn to north-west of Hatch Farmhouse, view looking west*

- 4.28. The Large Barn is timber-framed, mostly, but not exclusively, with brick infill to lower level and timber-clad to upper level. It has a plain tile gabled roof with cat-slide to north-north-east over an extension of the building (**Plate 12**). There are also doors to each of the building areas on the north-west elevation. The building is currently in use as a car repair workshop, with entrance retained in central bay to the south-west. The interior shows evidence of multiple phases of alteration and repair of both walls and timber roof structure, with some original materials and features surviving (**Plate 13**).

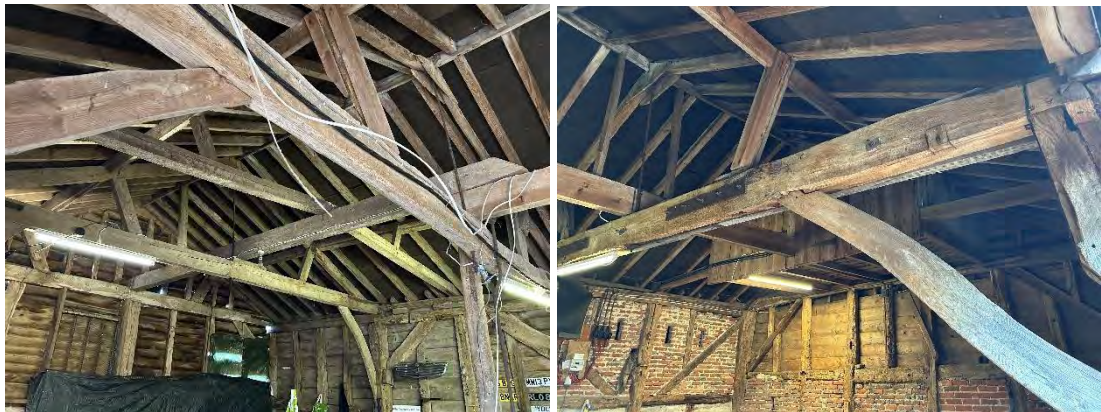
*Plate 14 - Large Barn - interior*

- 4.30. The original function is not known, but given original plan as well as some of the apparent features which partly survive in the interior including slits for ventilation, it is possible it may have originally been a cart shed with an entrance facing away from the courtyard and towards the access to the farmstead courtyard from Mill Lane for easy access to farm, and a second entrance

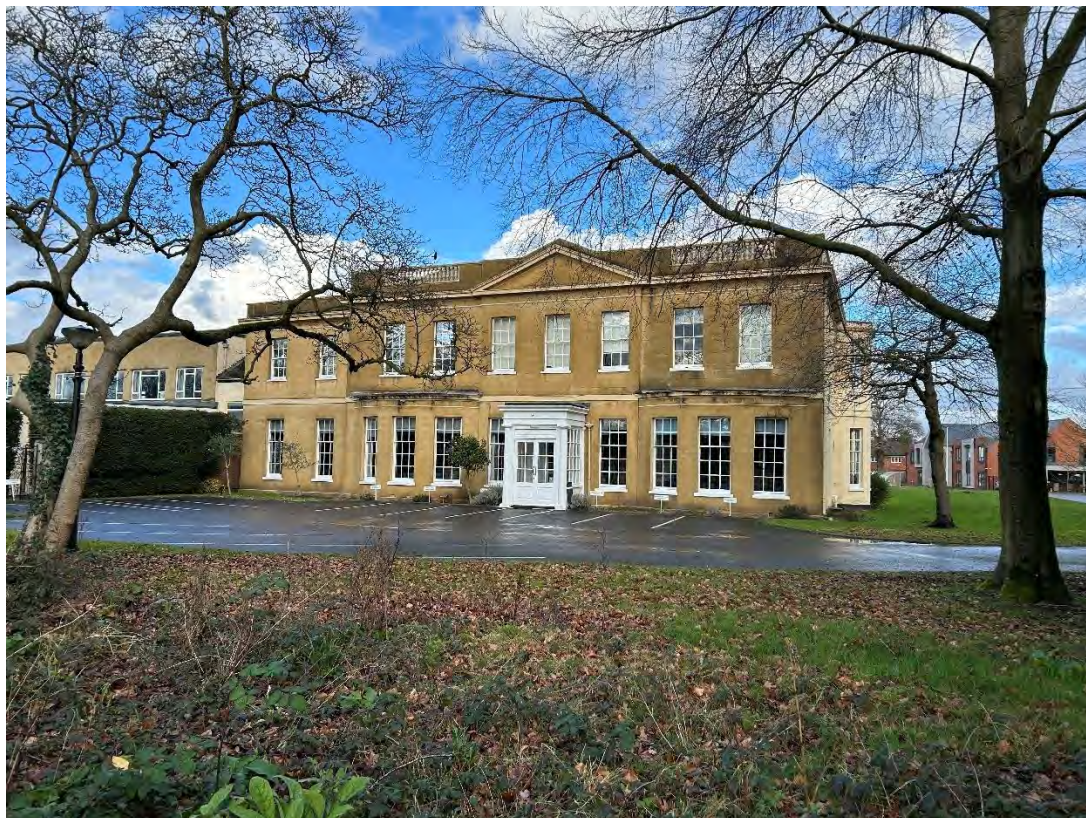
Plate 15 - Berkshire Masonic Centre (Sindlesham Hall)

- 4.54. The key elevations of the building address Mill Lane to the south-west and Mole Road to the south, with the elevation fronting onto Mill Lane being the main façade (**Plate 15**). The key elevations are separated from the road by car parking and access, with a small grassed area adjacent to the building to the south-east, and a mature tree lined boundary behind low wall to the road side.

- 4.58. There is no inter-visibility or known historic or functional association between Berkshire Masonic Centre (Sindlesham Hall) and Hatch Farm buildings proposed for demolition, and the buildings at Hatch Farm do not make any contribution to the architectural or historic interest of Berkshire Masonic Centre (Sindlesham Hall). Therefore, the demolition of Hatch Farm buildings within the Site would cause no harm to the significance of Berkshire Masonic Centre (Sindlesham Hall).

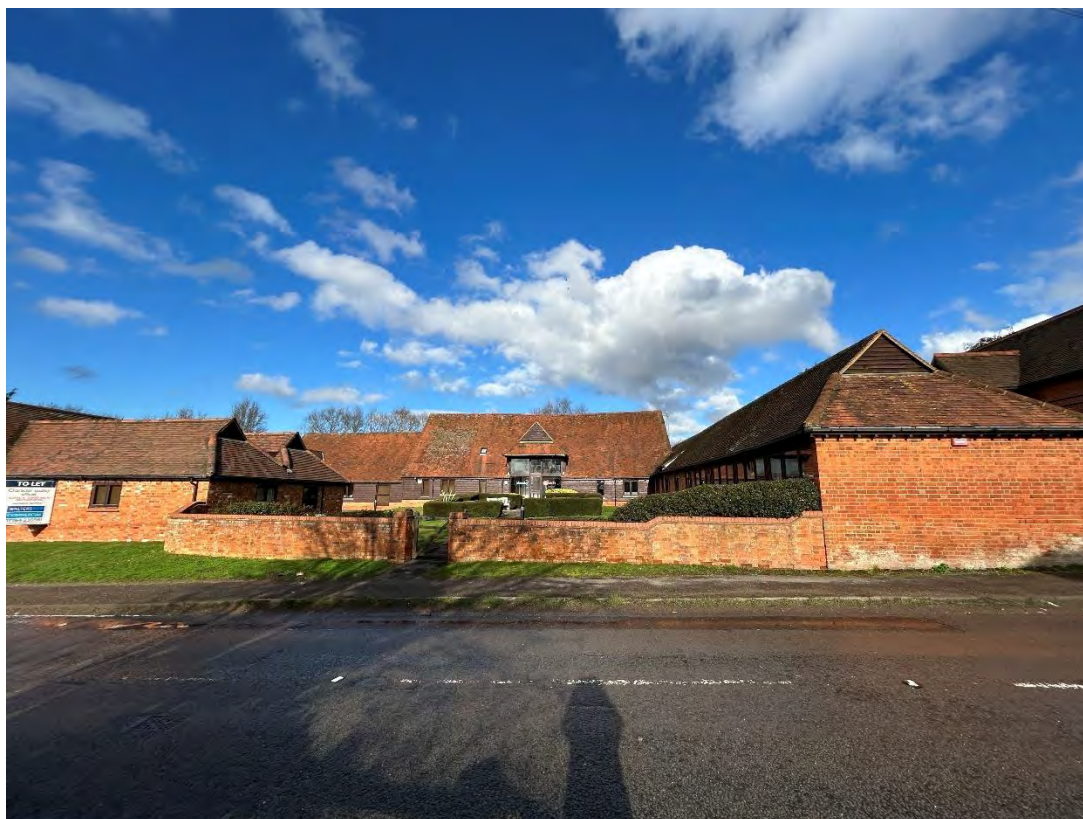
*Plate 16 - Converted range on northern side of Mill Lane*

- 4.65. The range of buildings forms a courtyard and is inward-looking. The courtyard and views into the courtyard from Mill Lane form its immediate setting.

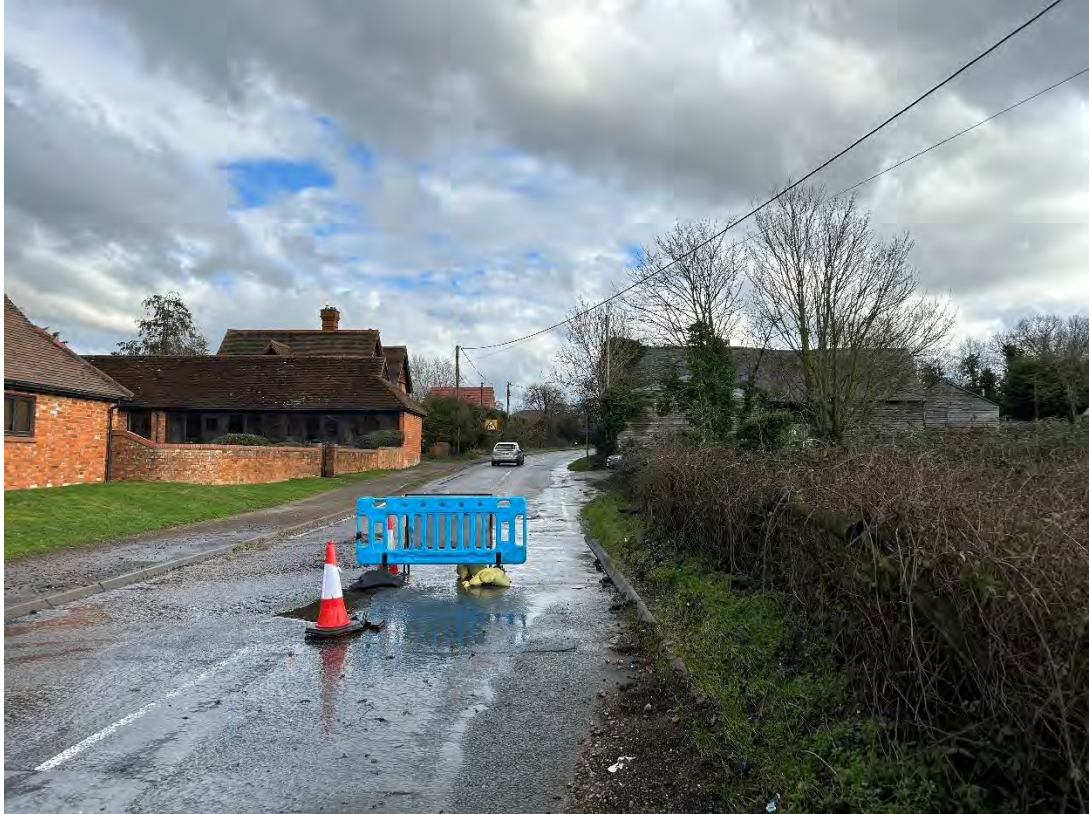
*Plate 17 - Converted range of former agricultural buildings to north of Mill Lane (left) and Threshing Barn to south (right)*

- 4.66. Although offset from Hatch Farm as it fronts a separate access to what was a separate historic holding, this range of converted brick buildings roughly corresponds with the wooden elevation of the Threshing Barn on the opposite side of the road, marking the current edge of the road side settlement (**Plate 17**). These kinetic views on the approach to the settlement will be severely limited other than in winter when trees are not in leaf, and the auditory experience of this edge of settlement is significantly affected by the proximity of the M4 motorway.
