## Preliminary Ecological Appraisal and Roost Assessment

71 Dorset Way, Wokingham, RG41 3AL

This report is prepared to inform a planning application with the Wokingham Borough Council. The proposal is described as: Extension of the dwelling and constructure of an additional garage building in the front garden.

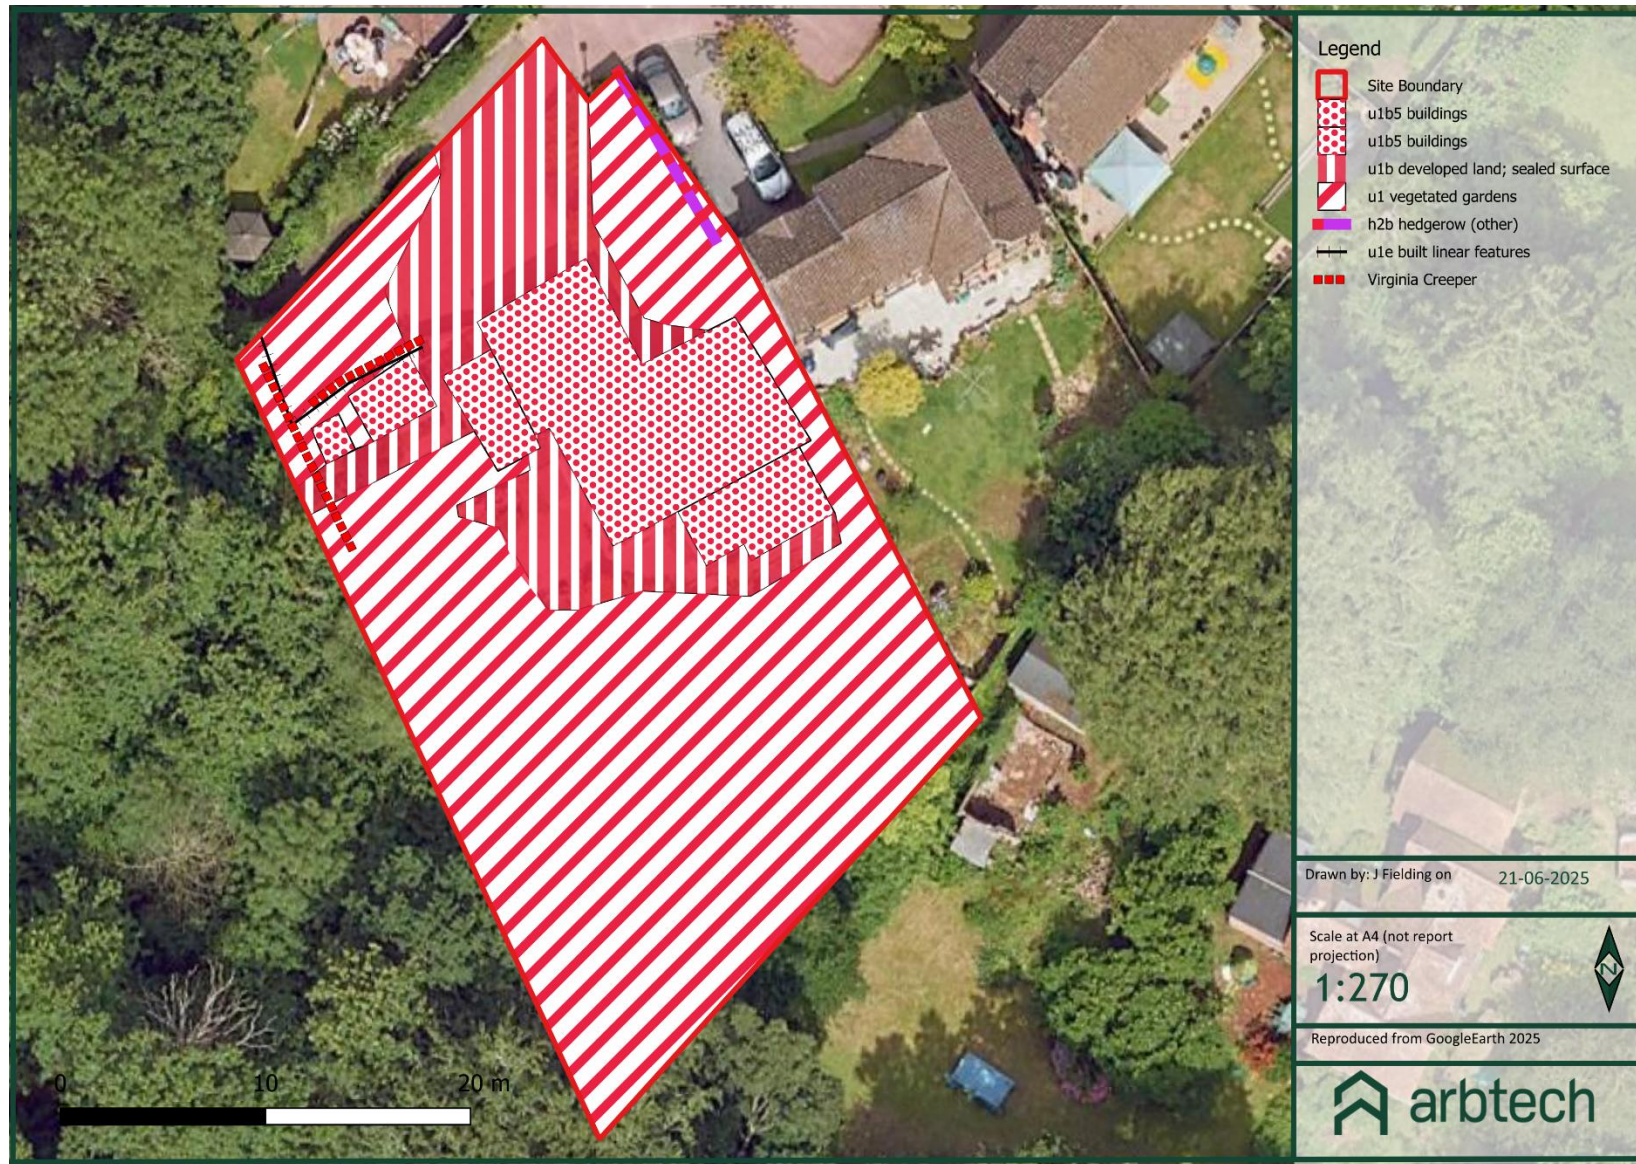
## Appendix 1a: Habitat map

| Summary of Survey<br><br>Findings<br><br>(UKHab codes used) | <b>Site Context</b><br>The survey site is centred on National Grid Reference SU 79186 68140 and has an area of approximately 0.09ha.<br><br>The site comprises one dwelling (B1), associated outbuildings and sheds (B2, B3) and a vegetated garden with scattered trees. It is situated within a suburban area within the town of Wokingham. There are scattered trees within the site and extending into the local garden landscape. Aerial imagery shows the local landscape to have a woodland character, with a large woodland called Fox Hill Woodland to the west and directly immediate to the west perimeter of the garden. Water bodies can be found nearby, such as a stream that runs through Fox Hill Woodland as well as numerous ponds and a lake in the golf course to the west, the closest being 0.7km away. Such features likely enhance the area for a variety of species, including bats, amphibians and reptiles.<br><br>The habitats are common and widespread and have a relatively low ecological value. No protected plant species were recorded during the survey, however invasive Virginia creeper was noted along the site’s western boundary.<br><br><b>On-site habitat descriptions</b><br><u>u1b5 – Buildings</u><br><u>u1b – developed land; sealed surface</u><br><u>u1e – Built linear features</u><br><u>u1 – urban garden</u><br><u>h2b – species-poor hedgerow</u> |

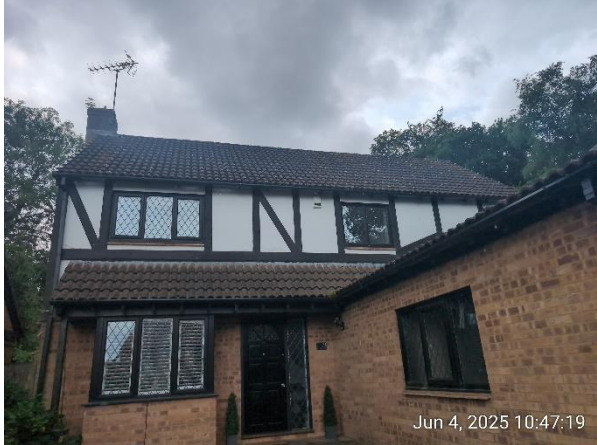
| <p>A photograph showing the northern elevation of a two-story house. The house has a dark tiled roof, a chimney on the left, and a front door with a small porch. The upper floor has white walls with dark timber framing. The lower floor is made of light-colored brick. A timestamp 'Jun 4, 2025 10:47:19' is visible in the bottom right corner.</p> | <p>A photograph showing the northern garage extension of the house. It features a light-colored brick wall, a dark wooden garage door, and a window. A timestamp 'Jun 4, 2025 10:47:15' is visible in the bottom right corner.</p> |

| | <p>Buildings and trees to be impacted by the proposed development are assessed for their suitability to support roosting bats below. No evidence of roosting bats was identified on or within B1, B2 or B3.</p> <p><i>Building B1 (Figure 1 – 9)</i></p> <p>B1 is a two-storey, brick-built building (Figure 1) with multiple extensions, including a northern single-storey garage and a southern UPVC/glass conservatory. The building features a mock-tudor façade, which appears in good condition with no gaps or cracks. The brickwork and rendering around the building appears in excellent condition with no gaps or cracks in which bats can roost. There are wooden soffits and bargeboards which are in good condition. The roof of the main section of B1 is pitched and gabled, and clad in concrete roof tiles which appear in good condition with no gaps or cracks suitable for bats. The roof of the garage extension is also clad in concrete roof tiles which also appear in good condition with no suitable roosting features.</p> <p>There is one loft space within the interior of B1, and one garage interior.</p> <p><i>Loft Space 1 - L1 (Figure 8)</i></p> <p>It is constructed from modern timber beams, including the ridge beam, rafters and purlins. There are wooden boards and areas of mineral wool insulation, and the loft is lined with bitumen felt which appears in good condition with no gaps or cracks suitable for bats. There are cobwebs along the ridge which may suggest a lack of recent bat roosting activity here.</p> <p>No bats or evidence of bat occupation (e.g. droppings, oil staining, etc.) was identified on or within L1.</p> <p><i>Garage space G1 (Figure 9)</i></p> <p>There is a small garage space on the northern end of B1, which has a false ceiling with a small interior space. This area lacks any notable bat roosting features.</p> <p><i>B1 Suitability Assessment</i></p> <p>Given the good condition of the building and lack of roosting features, B1 has been assigned a <b>negligible</b> habitat value for bats.</p> <p><i>Building B2 (Figure 9 – 10, Appendix 4)</i></p> <p>B2 is a single storey garage building with corrugated fiber roofing. It has a metal garage door on the eastern elevation and metal guttering. It appears to be in good condition with no notable roosting features.</p> <p><i>B2 Suitability Assessment</i></p> <p>Given the good condition of the building and lack of roosting features, B2 has been assigned a <b>negligible</b> habitat value for bats.</p> <p><i>Building B3 (Figure 11 – 12, Appendix 4)</i></p> |

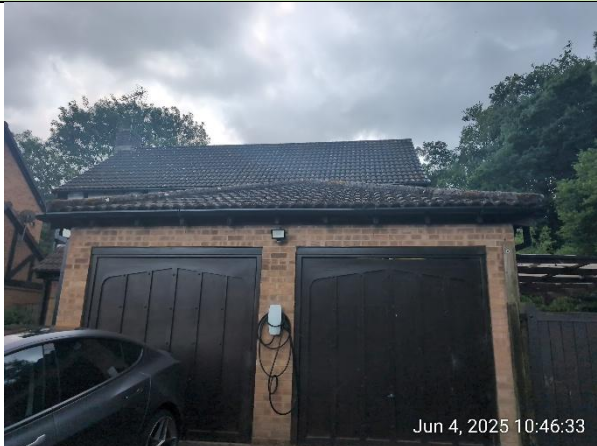
| <p>A photograph showing the northern garage extension of the house. It features a light-colored brick wall, two dark wooden garage doors, and a car parked in front. A timestamp 'Jun 4, 2025 10:46:33' is visible in the bottom right corner.</p> | <p>A photograph showing the southern elevations of the house. It features a two-story house with a dark tiled roof, a chimney, and a large glass conservatory on the right. A timestamp 'Jun 4, 2025 10:42:33' is visible in the bottom right corner.</p> |
