# 3 Somerset Close

## Bat Roost Assessment

June 2025

Report Ref: DFA25046

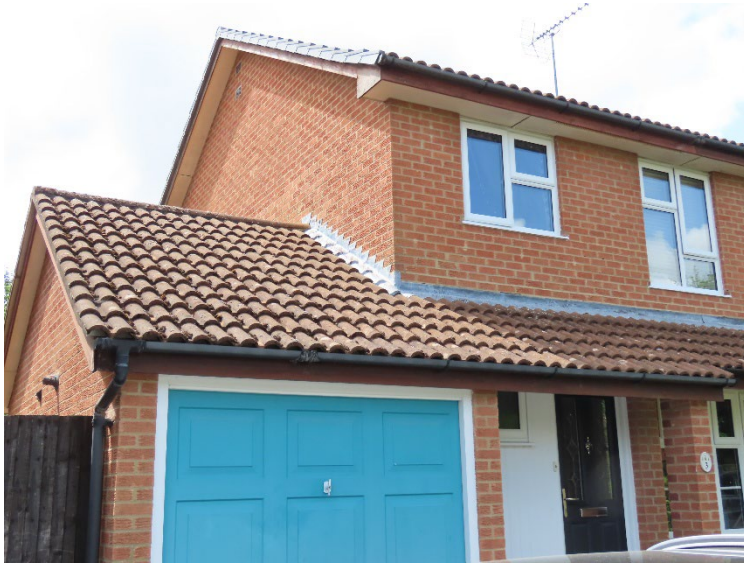
- 4.2.2 The roof is of a gable design with the ridge line running more or less north to south; a lower gable roof is present on the garage (Plate 1). A single storey shed roof runs along the front of the dwelling that contains an inaccessible void (Plates 2 & 3). A heating vent exits through the south western aspect of the roof. There are no hanging tiles on any aspect of the dwelling.

Plate 1. General view of the front of the property.

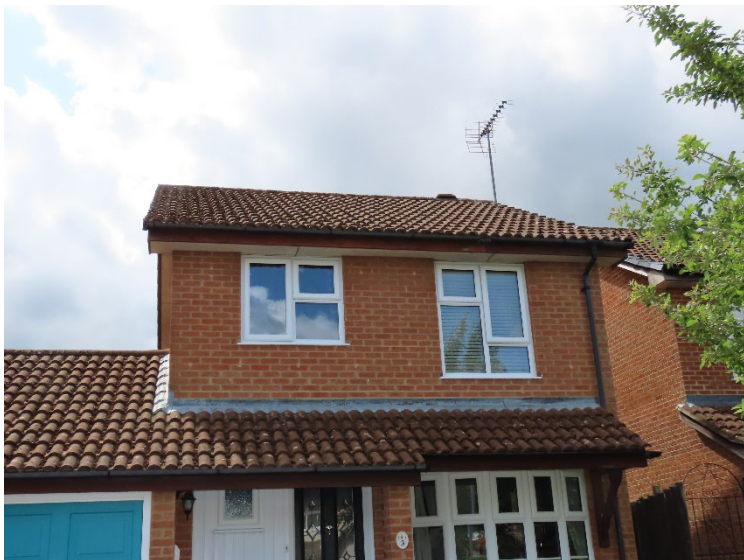
Plate 2. General view of the shed roof at the front of the property.

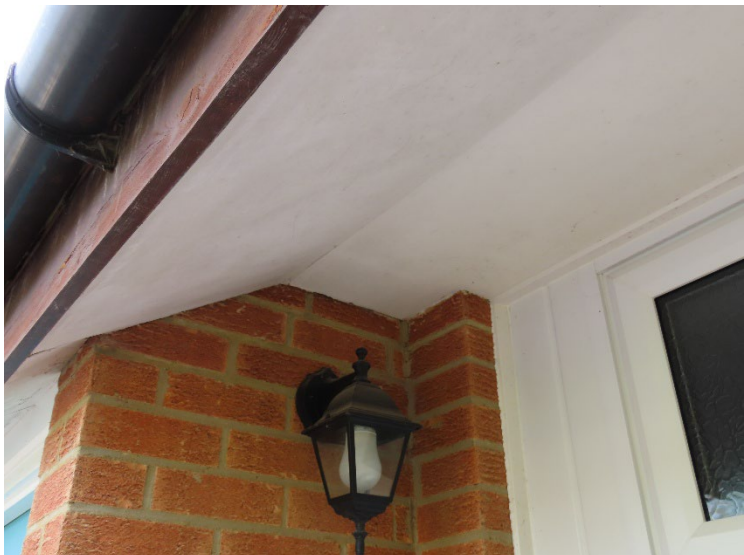
Plate 3. View of the sealed void space.

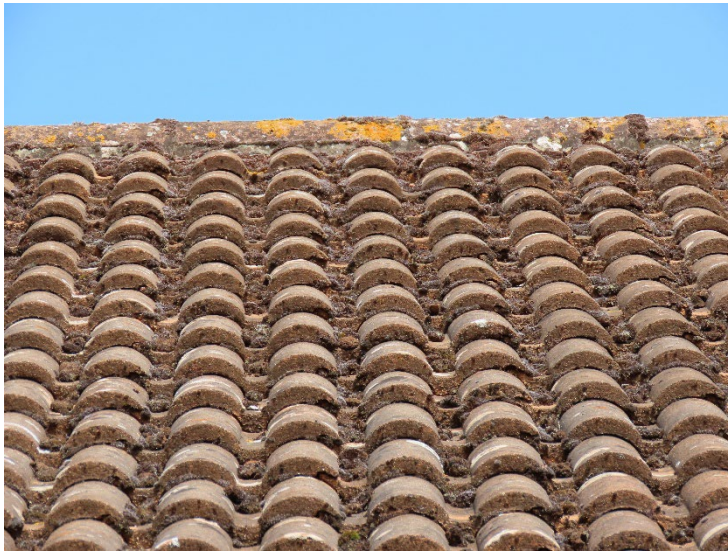
- 4.2.3 The roof of the house is finished with Spanish style, interlocking, concrete tiles which support a moderate build-up of moss. The tiles are good condition with no broken or loose tiles noted (Plate 4). The ridge lines are intact, as is the lead flashing around the heating vent.

Plate 4. Typical view of the roof tiles.

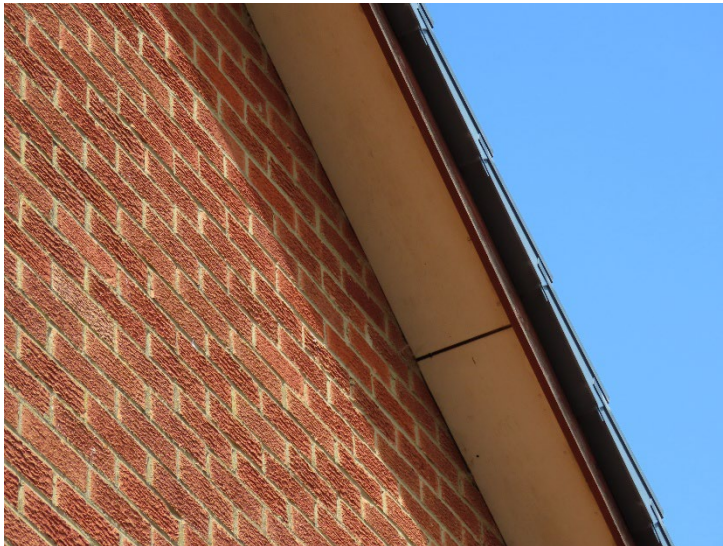
- 4.2.4 The soffits are constructed from concrete boards, whilst the fascia are wooden (Plate 5). They are in good condition. There appears to be a gap between the juncture of the soffit boards, however, there is a lining board behind which eliminates any potential ingress points. There is a negligible gap between the soffit and adjoining brick work.

Plate 5. Typical view of the soffit and fascia.

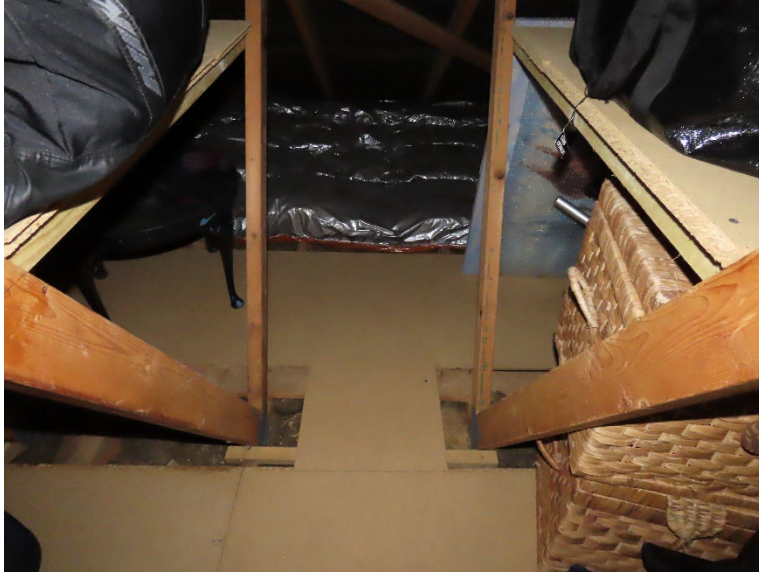
- 4.2.6 Internally, the trusses are of a Fink design. Nail plates are present at the major junctions eliminating any potential gaps. A moderate build-up of cobwebs is present around the junctions and throughout the void spaces in general, suggesting a lack of bat activity (Plates 6 - 7). No staining or scratch marks were noted along any of the beams, and

Plate 7. General view of the void space.

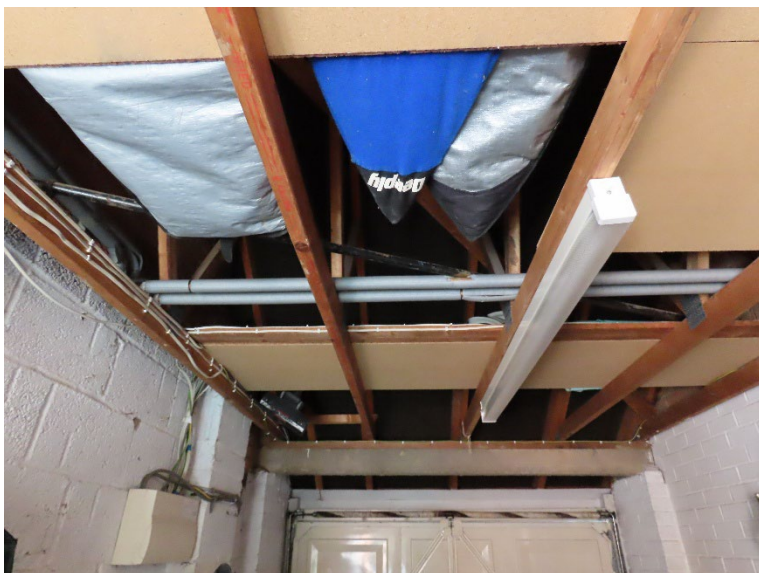
- 4.2.7 The roof lining is intact throughout. The gable end walls are constructed from breezeblock, with the occasional area of missing mortar which is typical. However, none of the resulting gaps was deemed of sufficient size or depth to offer potential roosting opportunities. A grilled vent is located on the southern wall.
- 4.2.8 The roof void within the garage is open and exposed, although a roof lining is present (Plate 8).
- 4.2.9 No evidence of bat activity was encountered within the roof void of the house was noted.

Plate 8. General view of the internal void space of the garage.
