Heritage Assessment- Garden Room and WC:

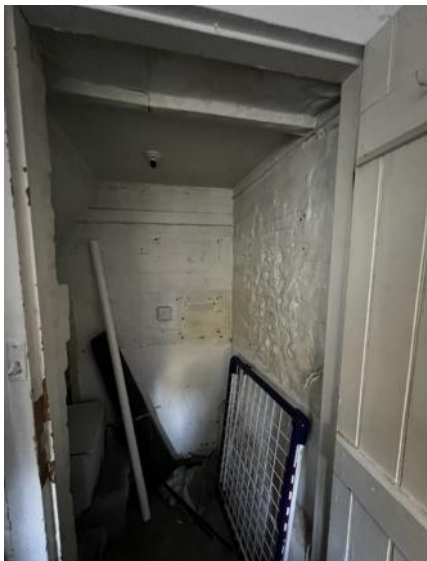
Existing under side of staircase

**WC:** The small WC at the rear of the house has poor finishes and requires the owner to step up through a steep step. A new WC will be proposed under the staircase, which will be slightly larger and accessible without steps, as the floor finish will be level with that of the garden room.

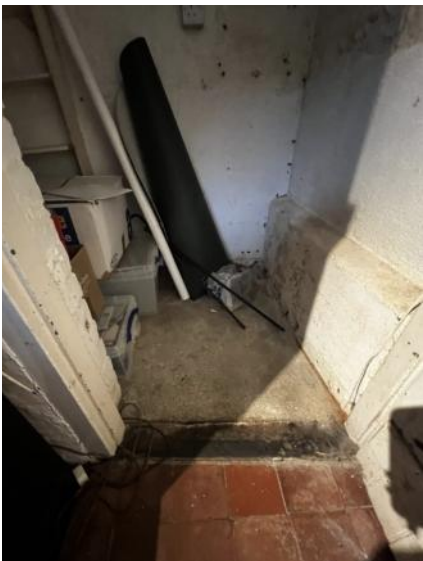
The existing garden room forms part of a two-storey rear extension added in the late 20th century. Due to the nature of the extension, it holds no historical value and is not in keeping with the style or character of the original house. The floor is tiled with a poor finish, and the walls are painted brick, revealing what appears to have been the original garden wall.

Presumed garden wall showing brick infill

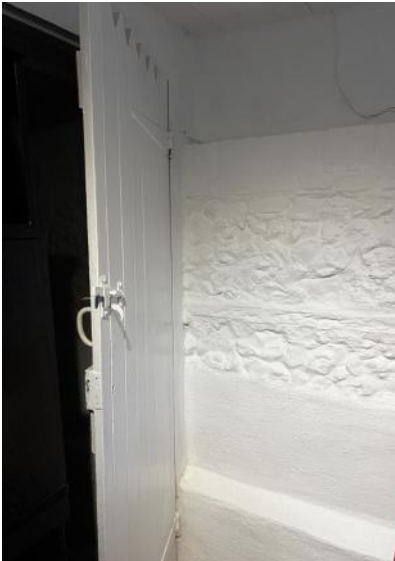
Presumed garden wall in garden extension

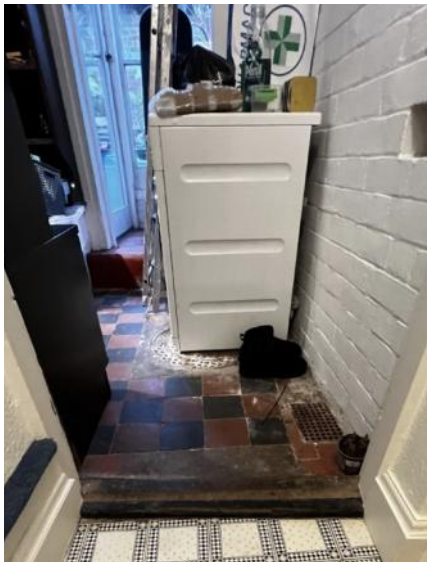
Floor finish and view to courtyard

**Floor:** the proposals will include the existing concrete floor to the garden room with a new insulated floor enabling the floor level to be retained

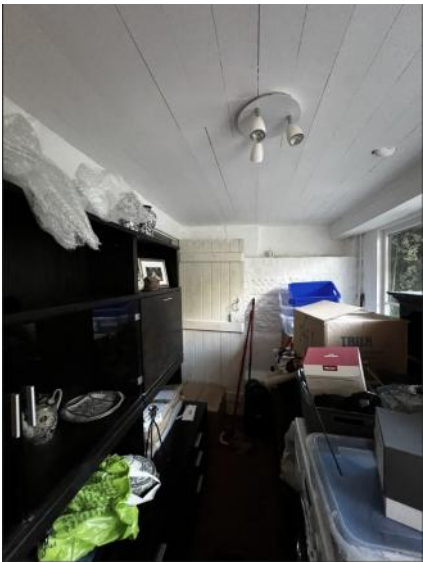
Existing garden room

**Garden Room:** We propose to slightly extend this room to align with the two-story extension. The extension will only slightly extend the existing single-story structure—roughly 300mm to the side of the gable end and 1159mm to the opposite side. Additionally, the new glazing will be contemporary, distinct from the original house, yet lightweight through the use of structural glass.

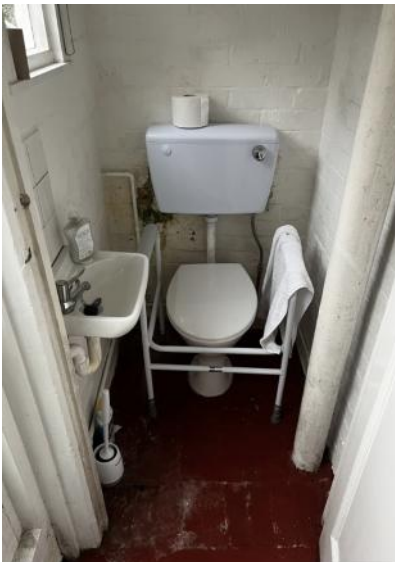
To the rear of the garden room is a small WC within a single-storey tiled extension, set at a higher level than the rest of the house. The step up into the WC is steep, and the floor is finished in painted concrete. Garden access is via a single glazed door, with a sash window occupying the rest of the garden-facing wall.

Existing ground floor WC
