Heritage Assessment- Bathrooms

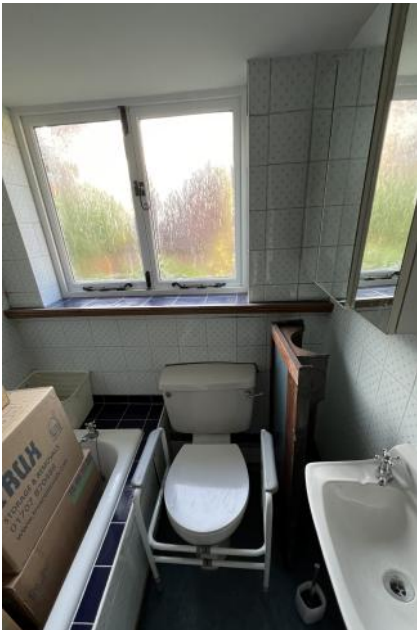
Right bathroom

There are two bathrooms in the first floor which are part of the existing late addition flat roof extension, they are both at lower level than the rest of the first floor and require stepping down in order to access them. The ceilings are very low and both feature a bath tub. The external wall is presumed to be a thin layer of brick.

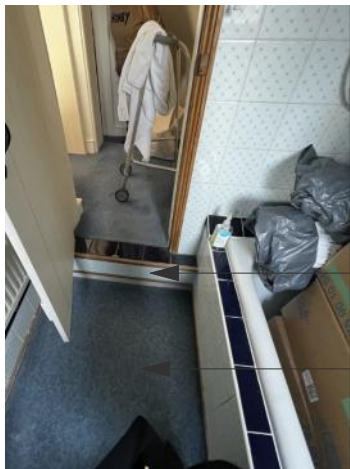
Existing 250mm rise step to access rear bathroom  
Existing floor deck to be raised to match rear bedroom level and eliminate step  
Existing step to access left bathroom from staircase. Proposed partition to close this doorway and make sure the stair lift chair can rest against it.

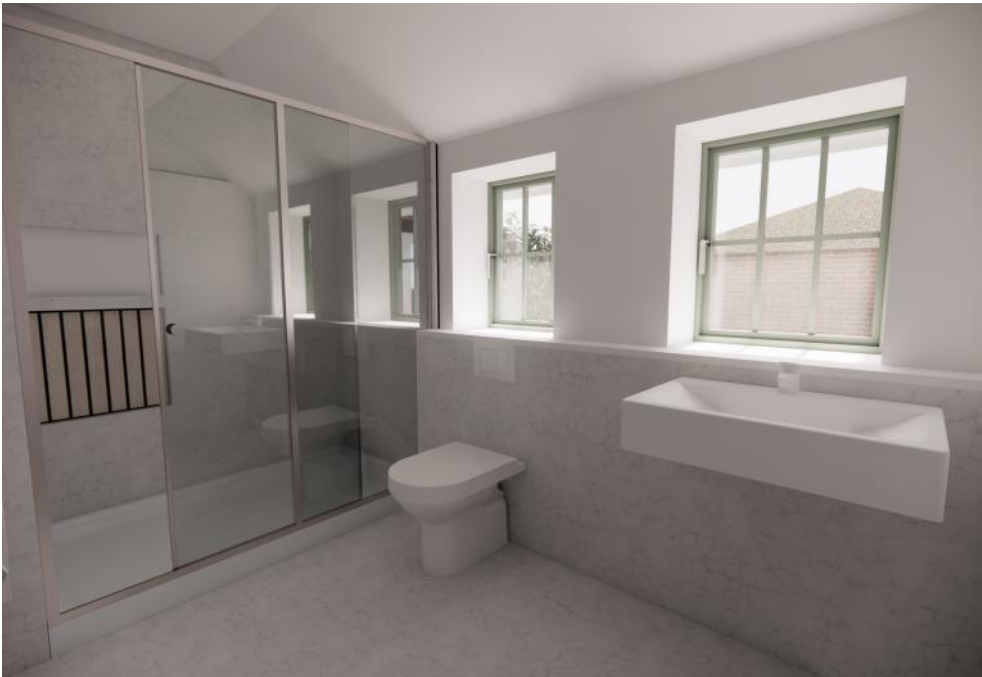
Proposed large bathroom with walk-in shower and raised ceiling

**Bathroom:** We propose to merge the two existing bathrooms into one larger bathroom, allowing for a spacious walk-in shower. Additionally, we will rebuild the external wall, which is currently an uninsulate thin layer of brick, of poor qaulity, to create an insulated wall and straighten it to match the angle of the new extension. This adjustment will cause the wall to shift slightly from its original alignment, but only by a small amount.

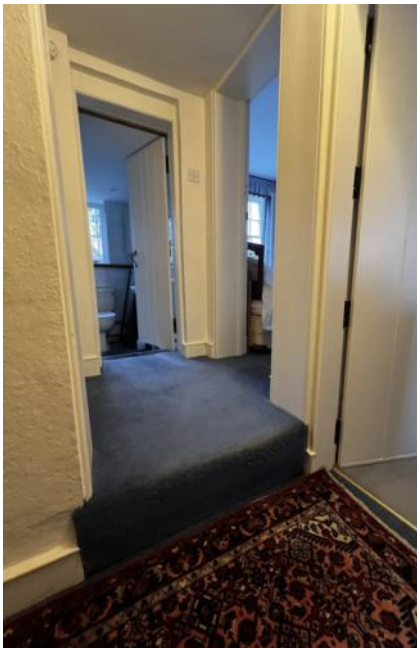
Existing steep step into rear bedroom and bathroom

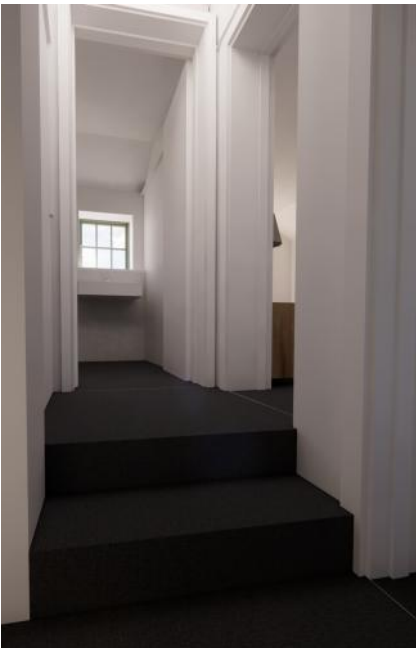
Proposed adjusted step and flush floor finish
