Heritage Assessment- Front Rooms and Staircase

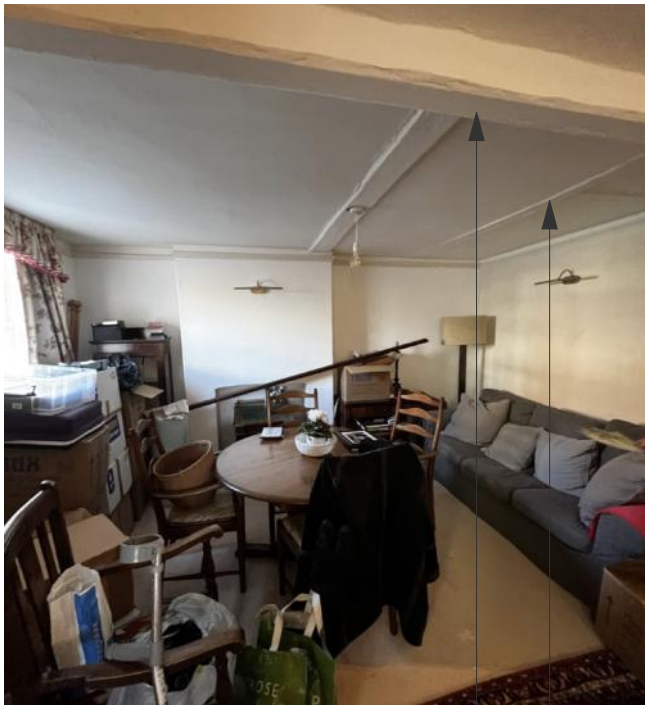
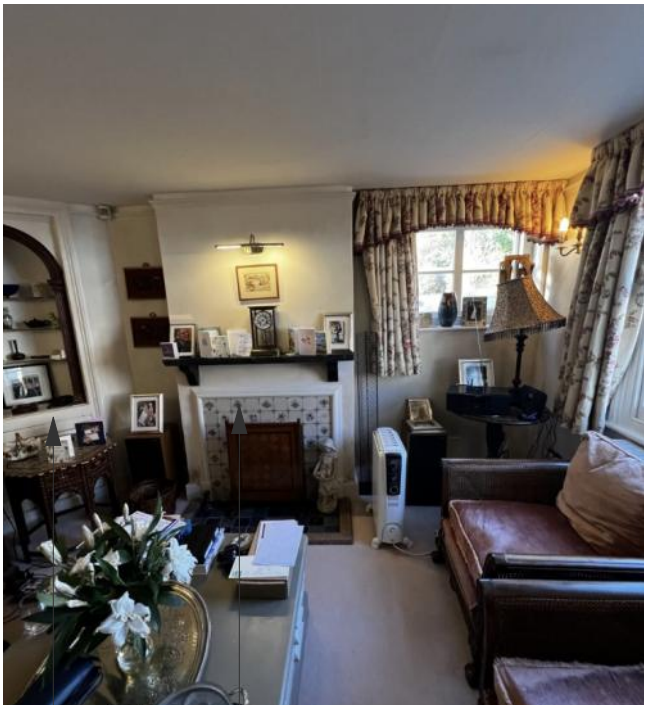
The house features two front receptions rooms with a fireplace each side. Both fireplaces are no longer in use. There are exposed timber joists to the ceiling which have been painted over and a central access door to the rear. Additionally, it is possible to see what is the presumed location of the original staircase and partitions from the cuts in the ceiling.

The existing staircase is carpetted, with timber hand railing to one side and is presumed to have been added as part of the later addition flat roof extension.

- Tiled fireplace
- Alcove detail. Presumed location of original fireplace
- Presumed location of 18th century staircase
- Original timber joists painted white. Presumed location of partition that separated the two front rooms.

The two front rooms are part of the original house, and no structural works or changes are proposed, apart from replacing the existing carpet with a hard floor finish. Additionally, we may improve the glazing by introducing either secondary glazing.

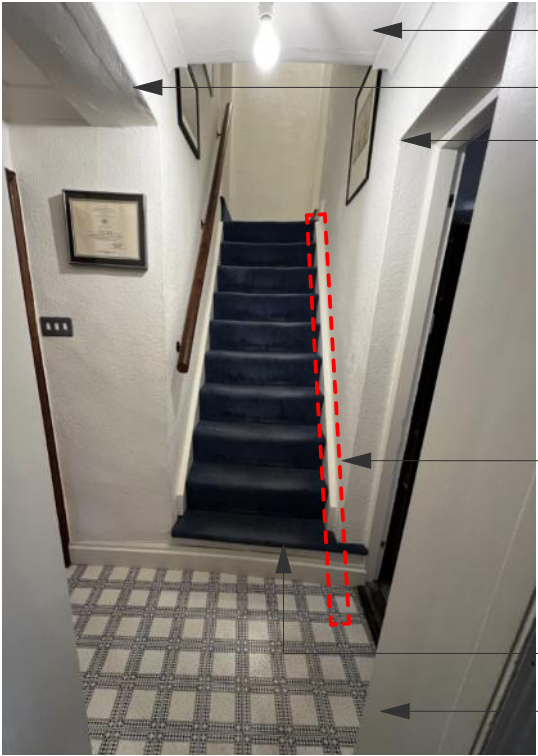
The existing staircase will be retained, with the addition of a stairlift to aid mobility for the current owner. Efforts were made to improve the steepness of the stairs, but due to the staircase's position and lack of space, the best course of action was to retain the existing staircase and add a stairlift.

We propose to raise the floor deck of the rear bathroom to improve headroom in the ground-floor garden room and to address the existing level difference on the upper floor, where there is a steep step to access the rear bedroom, with an additional steep step leading to the adjacent bathroom. By raising the floor deck to match the rear bedroom's height, we will create a continuous floor throughout this part of the building while preserving the existing structure of the bedroom and only altering the floor structure in the bathrooms.
