# WWII Pillbox at Nine Mile Ride Finchwood Park (Hogwood) Berkshire

Management Plan

Document Ref.: 218332.01  
Application Number: O/2014/2179 (Hybrid/Outline)  
May 2025

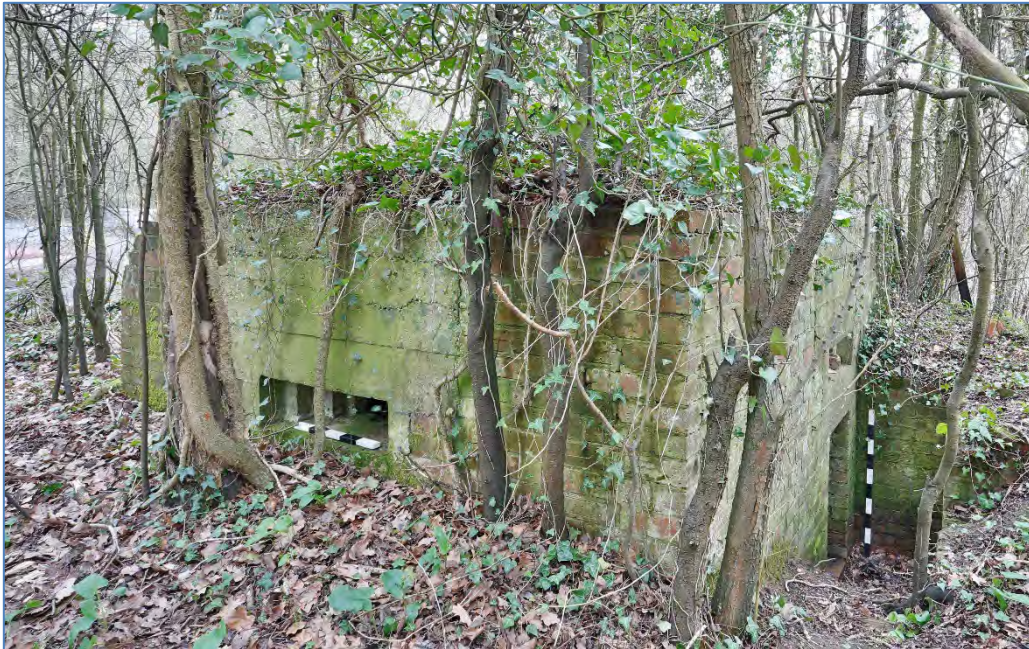
**Front cover** Northern view of the pillbox and the western entrance

- 2.4.2 The pillbox appeared to be in good condition, although the structure was partially obstructed by vegetation at the time of the recording. The structure is partially sunk into the ground, overlooking the junction with Park Lane and Nine Mile Ride.

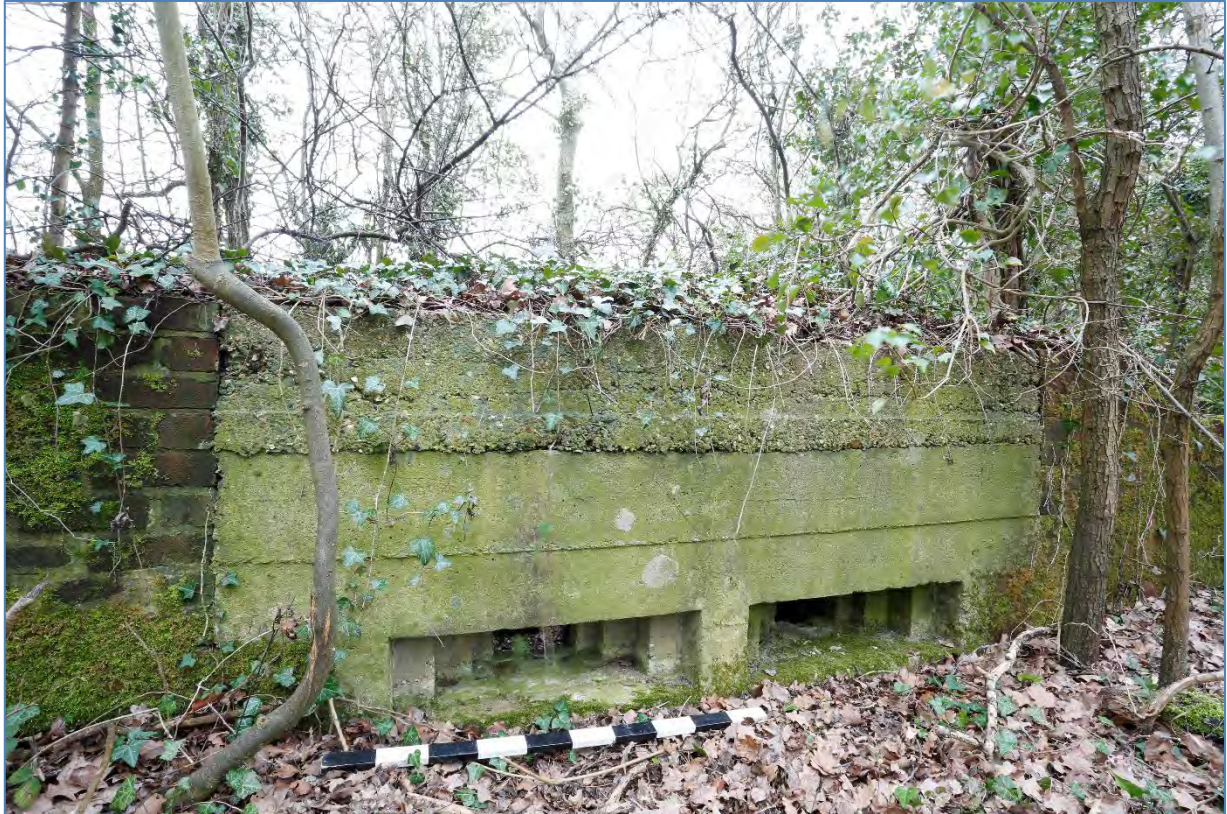
- 2.4.4 Construction is of concrete and brick. The walls of the pillbox measure 0.61 m (2 ft) thick and a flat shuttered concrete roof measuring 0.3 m (1 ft) thick provides protection from above. The floor is made from a concrete slab of unknown thickness. Within the centre of each wall there is a precast concrete embrasure loophole, although the eastern wall has a double one covering the road junction (**Photo 1**). The external loopholes are positioned just above ground level and each of them consists of a narrow rectangular opening (0.76 m x 0.25 m) whose jambs step in regularly in three sections yielding a narrower internal rectangular aperture (0.18 m x 0.16 m).

Photo 1: Southern elevation with double loophole (March 2019)

- 2.4.5 The southern wall contains a small circular iron vent grille towards the eastern end and above the loophole. The grille is attached to a ceramic pipe which provides additional ventilation to the interior.

- 2.4.7 A fragment of a flameproof asbestos shutter with a rusted iron hinge attached was found in the southern loophole, these could have been raised in the event of an attack by infantry or tanks equipped with flamethrowers. An iron screw picket for holding barbed wire was also found nearby.

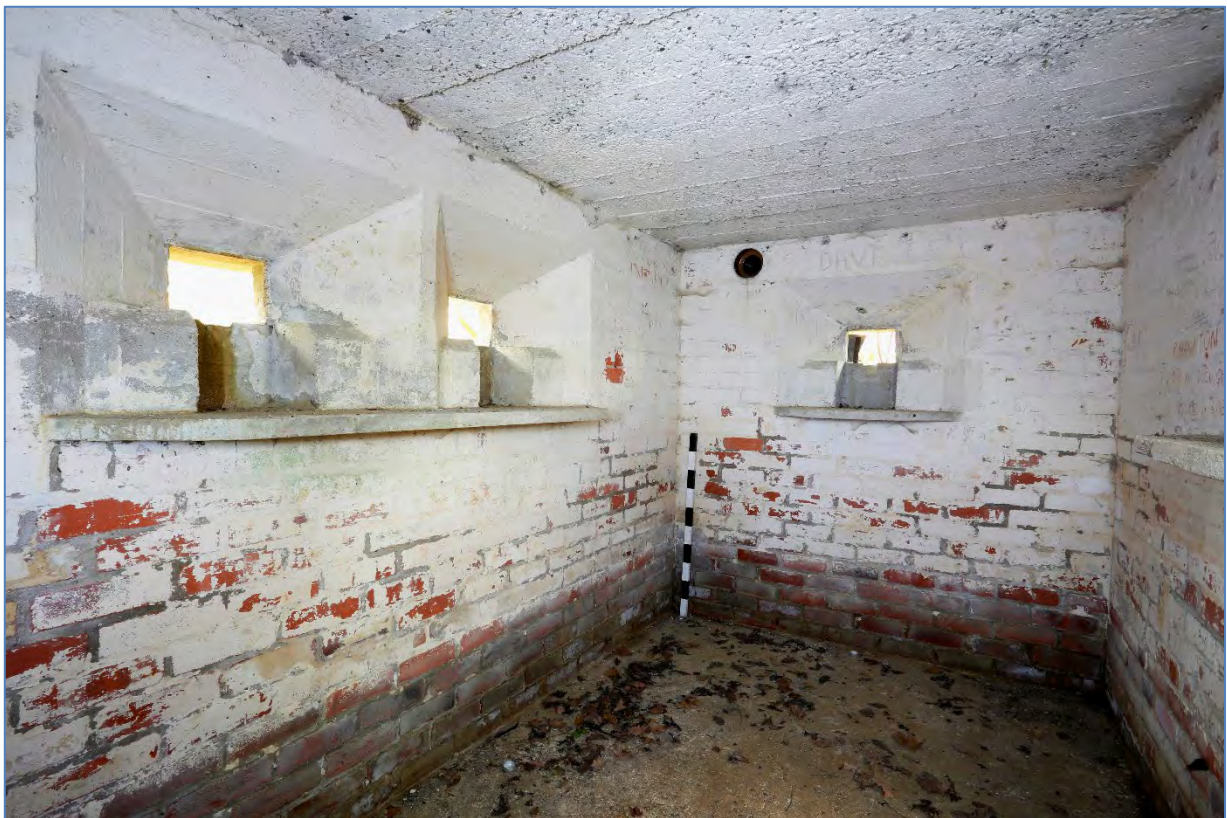
Photo 2: Interior of the pillbox, view of the eastern and southern walls (March 2019)

- 2.4.8 The internal chamber measures 3.51 m (11 ½ ft) in length, 1.91 m (6 ¼ ft) in width and 1.98 m (6 ½ ft) in height (**Photo 2**). The ceiling and walls are coated with lime wash which has subsequently weathered away in places. Each embrasure loophole comprises splayed lintel and jambs, and a projecting shelf-like sill with canted corners which supports short chamfered plinths immediately underneath and to each side of the actual loophole to hold rifles and/or light machine guns.

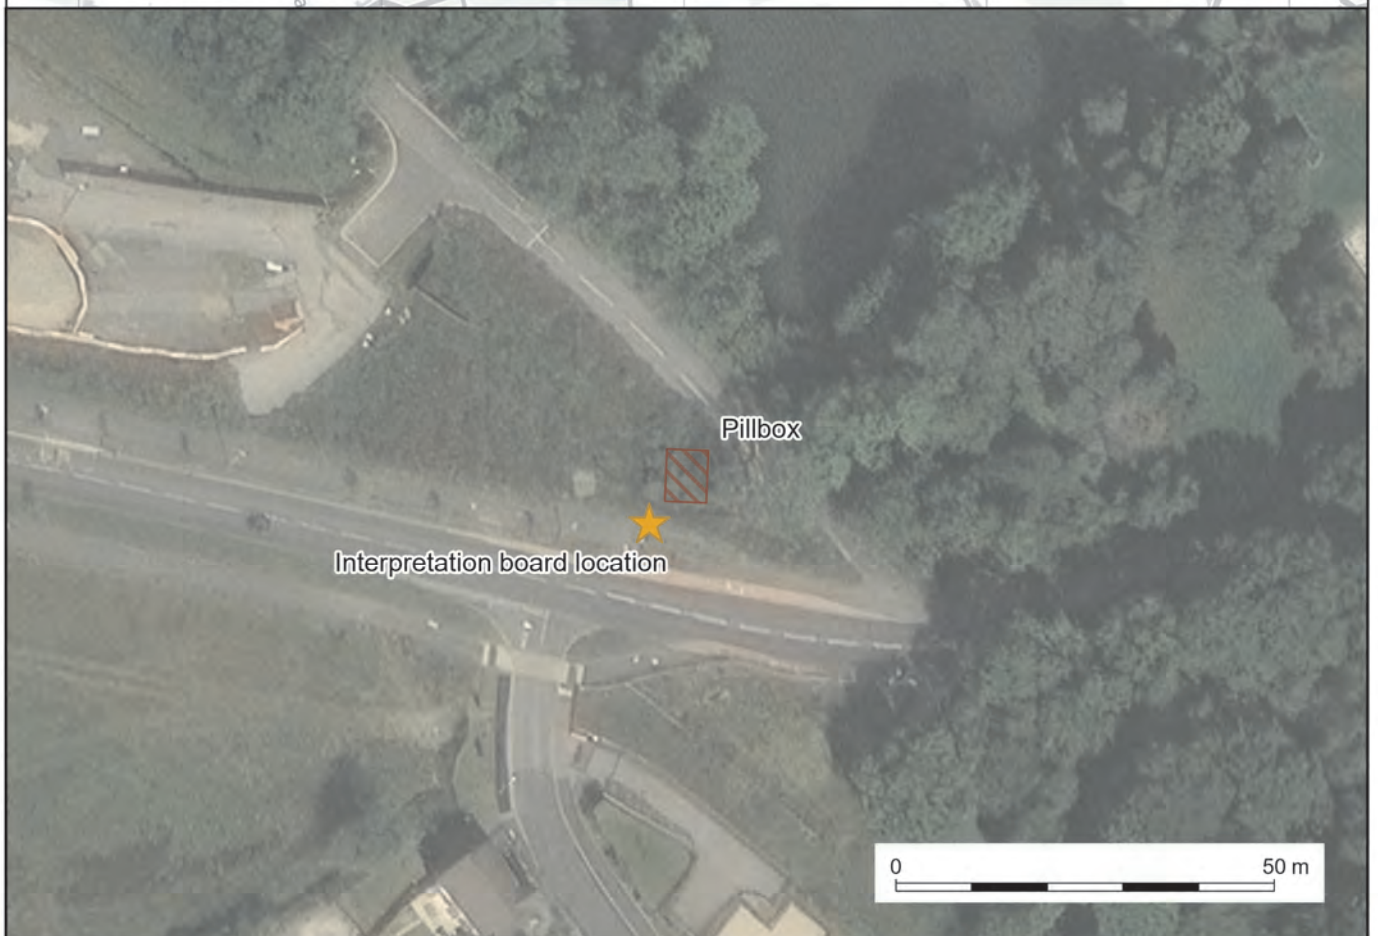
**Figure 1** Location of pillbox and proposed interpretation board

- 3.5.6 An interpretation board should be erected at the location and orientation indicated on Figure 1.
- 3.5.7 The condition of the board should be reviewed annually and cleaned if needed. The need for a new panel should be reviewed after 10 years.
- 3.5.8 Opportunities to promote public understanding of the pillbox and the wider Second World War history of the area should be considered.
