**PHASE 2  
GROUND INVESTIGATION REPORT**

**LAND ADJ. TO STATION ROAD AND WELLINGTON ROAD, WOKINGHAM, BERKSHIRE  
RG40 2AE**

**WOKINGHAM HOUSING LIMITED**

| Report Reference: GWPR2800/GIR/November 2018 | | Status: FINAL |

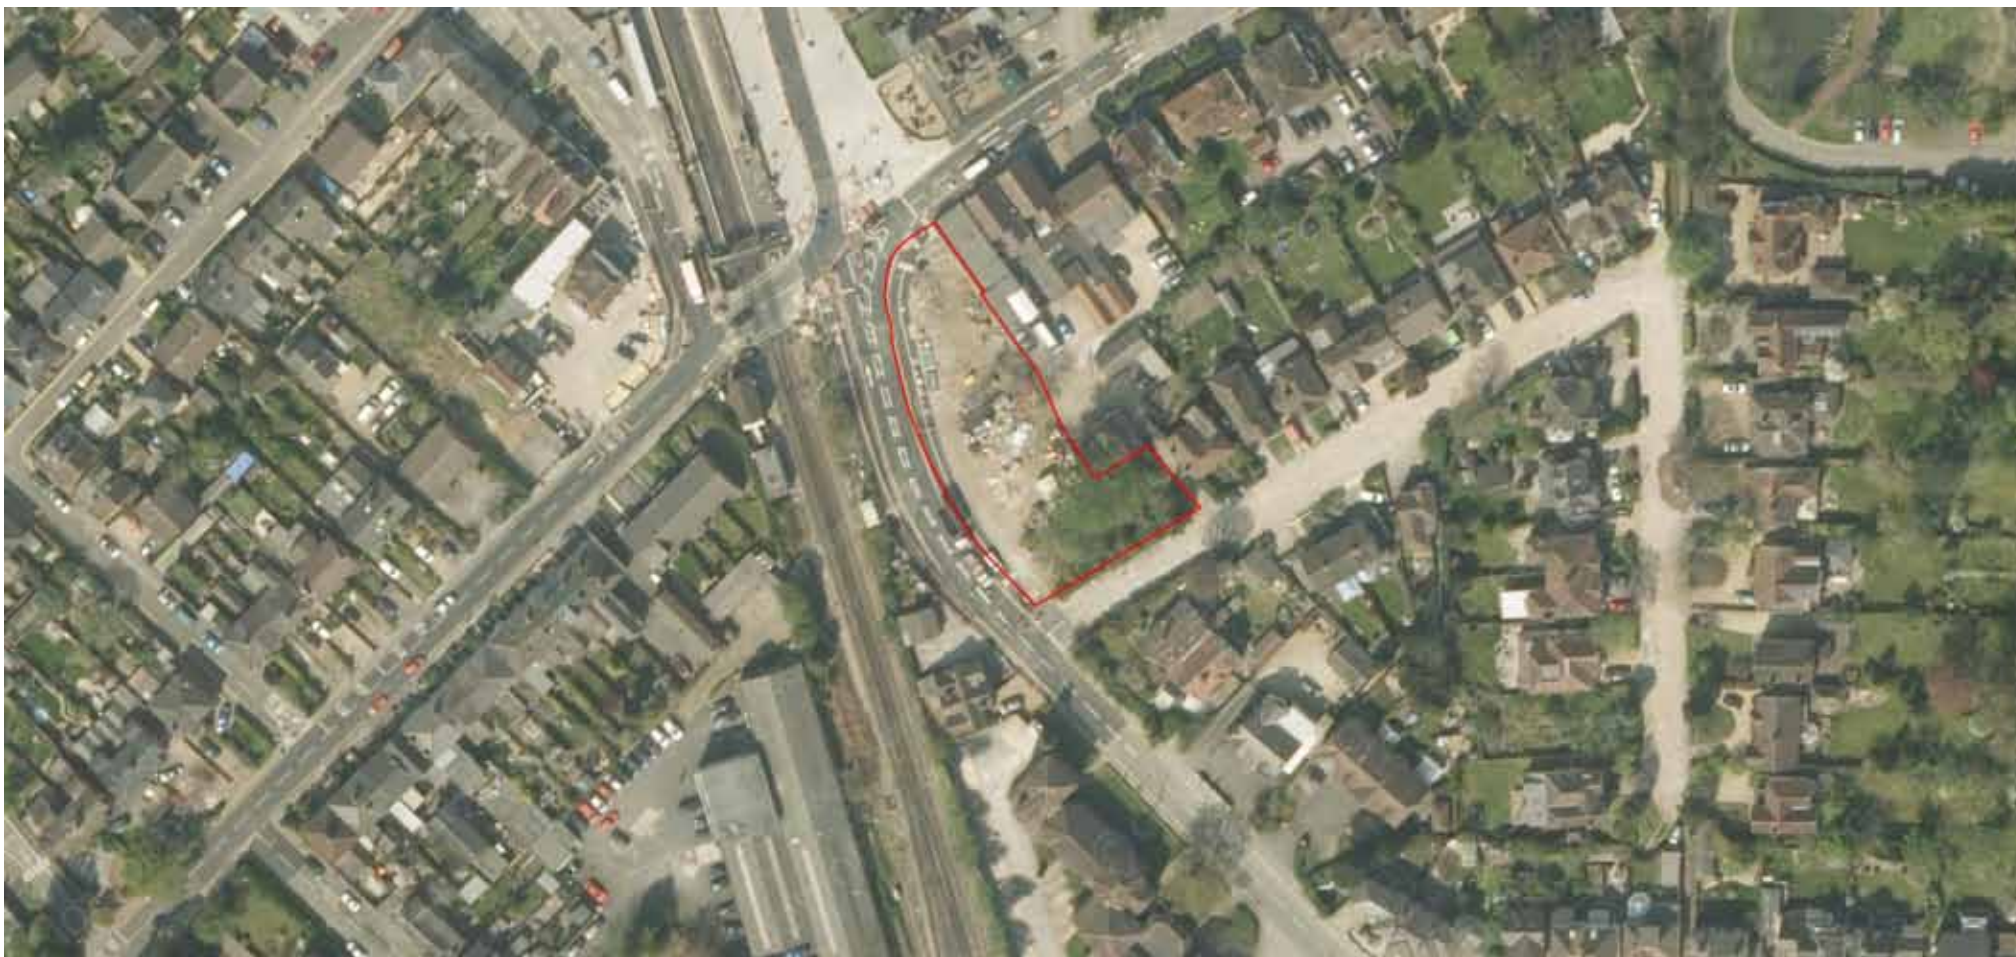
Figure 3

APPROXIMATE SITE BOUNDARY

A Site Walkover was undertaken on the 10<sup>th</sup> October 2018. A description of the site, as noted during the Site Walkover, is tabulated below and overleaf. An aerial view of the site showing an approximate site boundary is given within Figure 3.
