PRELIMINARY ECOLOGICAL APPRAISAL (DBW) AT WYCHWOOD HOUSE FINCHAMPSTEAD

Prepared for:
KRT Property & Steel Ltd
Winchester Road
Basingstoke
Hampshire
RG21 8UQ

20 June 2025

Ref: SPH/NP/PEA-25/20.05

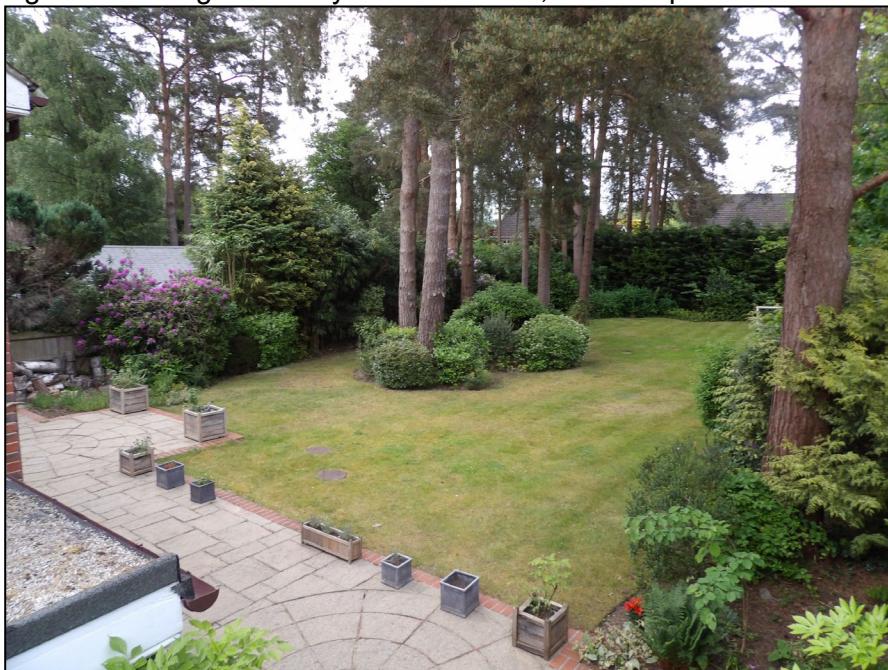
The application site comprises a detached, two storey brick-built property with detached garage. The remainder of the site comprises a paved parking area/driveway to the front with lawn surrounded by hedgerows and a rear garden that is mainly laid to lawn, with patio area and mature trees/shrubs/hedgerows throughout, see Figure 3 below. The site itself offers suitable foraging and commuting habitat for bats and there is excellent ecological connectivity to the wider landscape which provides further foraging, commuting and roosting opportunities for a wide range of bat species.

Figure 3. Rear garden. Wychwood House, Finchampstead. 20.05.25

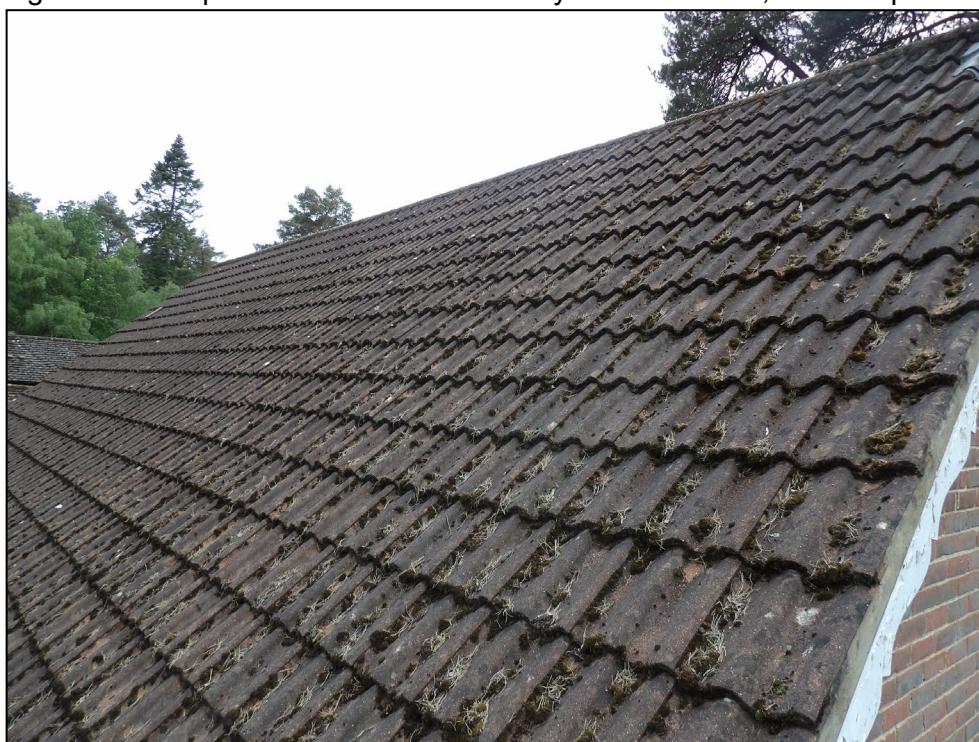
The property is a detached, brick-built two-storey building that is in a good condition externally. The cross-pitched roof is covered in interlocking tiles, all of which are well fitted, see Figure 4 below. The majority of the ridge tiles are well sealed however there is missing mortar from a small section by the chimney stack, see Figure 5 on page 9. The verges are well sealed with no missing mortar (see Figure 6 on page 9) as is the lead flashing around the chimney stack. There are gaps within the soffits and missing mortar on the right front gable end (see examples at Figure 7 on page 10) which could be used by crevice dwelling bat species or afford access into the building for bats. At the side of the property is a single storey section of the property with pitched roof to the front and flat roof behind, the roof and ridge tiles are all close fitted with no gaps (see Figure 8 on page 11) however, on the rear elevation, the gaps where a brick had been removed has been temporarily sealed, see Figure 9 on page 11. The bitumen felt covering the flat roof section is well fitted with no rip or tears and the soffits and fascias are tight to the wall with no gaps.

Figure 4. Example close fitted roof tiles. Wychwood House, Finchampstead. 20.05.25

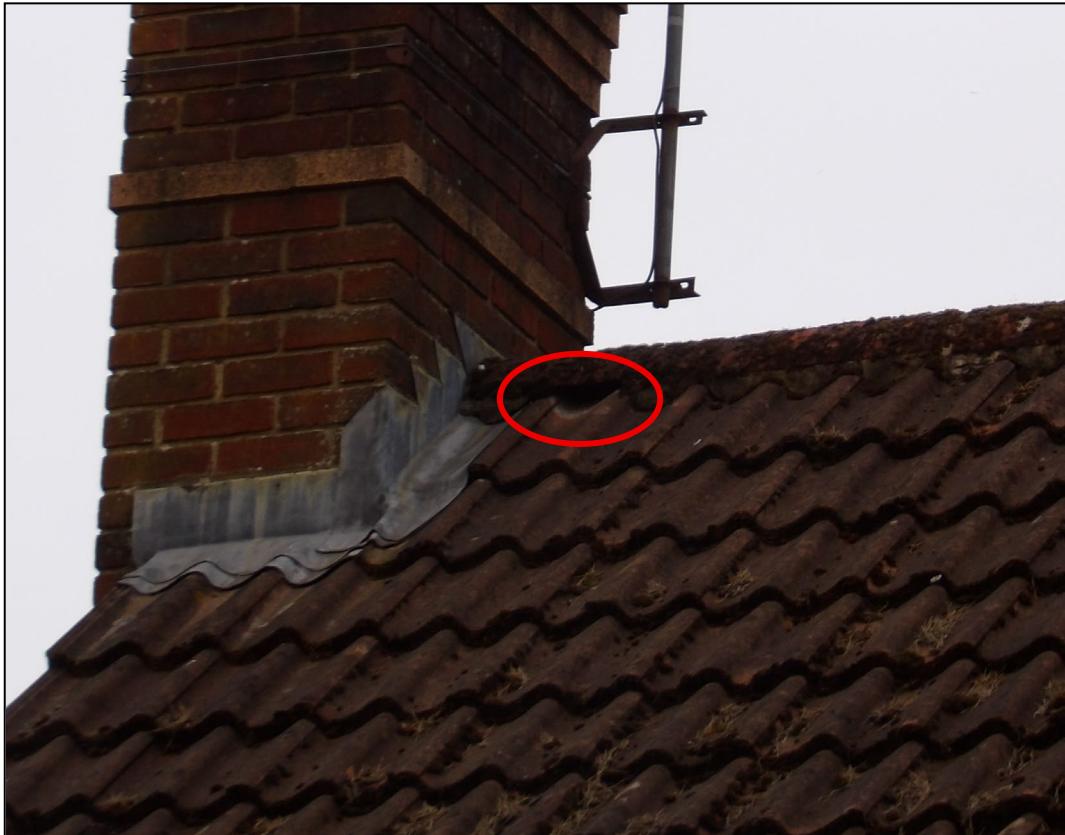
No bats or evidence of bats was recorded externally on the property although there were gaps within the soffits/mortar and in the wall on the property which could provide potential roosting opportunities for bats externally or provide access into the building for roosting bats.

Figure 5. Missing mortar from ridge. Wychwood House, Finchampstead. 20.05.25

Based on the Bat Workers Manual and the Bat Surveys Good Practice Guidelines, three dusk emergence surveys need to be undertaken on the property. Two of the surveys must be completed between May and August and a minimum of 21 days must be left between each survey. The surveys are required to assess the current status of roosting bats, in order to inform appropriate mitigation for the proposed works.

Until the activity surveys have been conducted and the findings are known, no further work must be undertaken to the loft/roof.

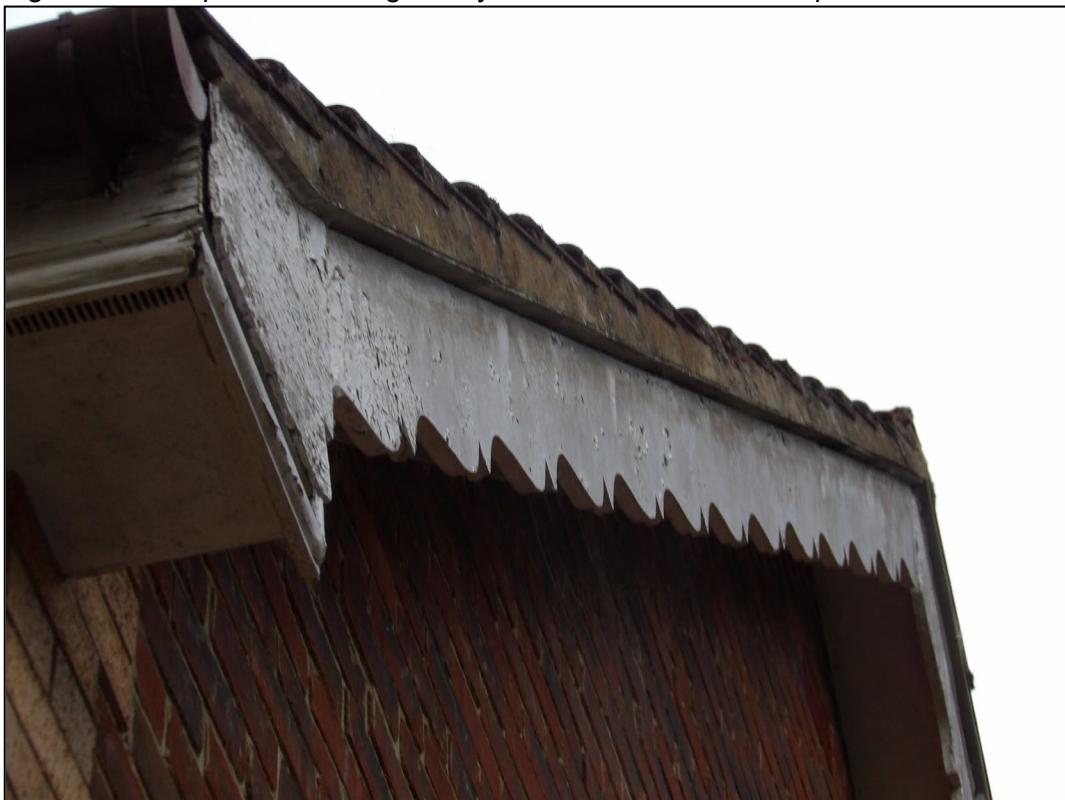
Figure 6. Example sealed verges. Wychwood House, Finchampstead. 20.05.25

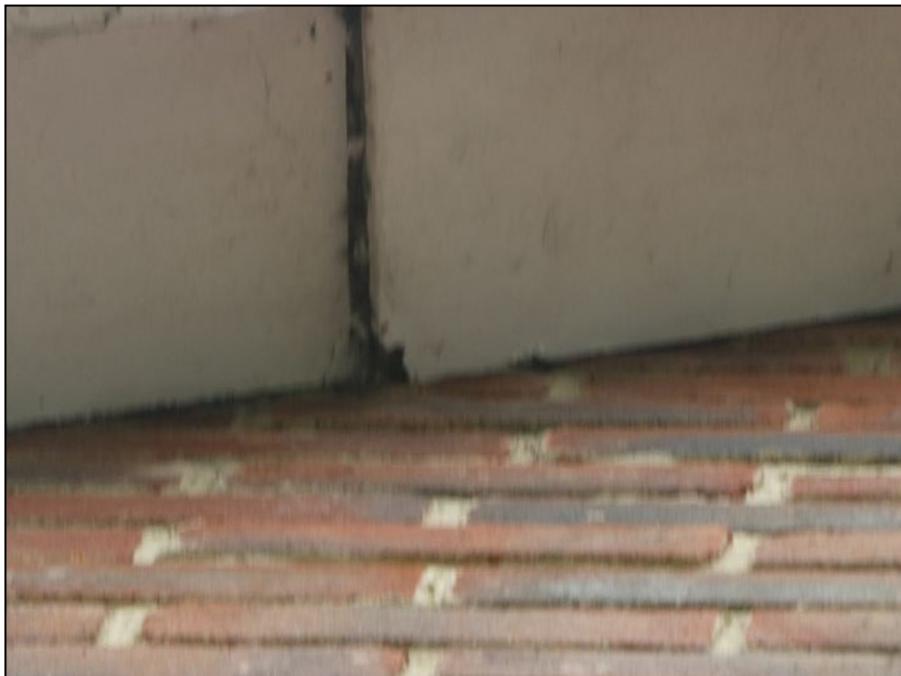
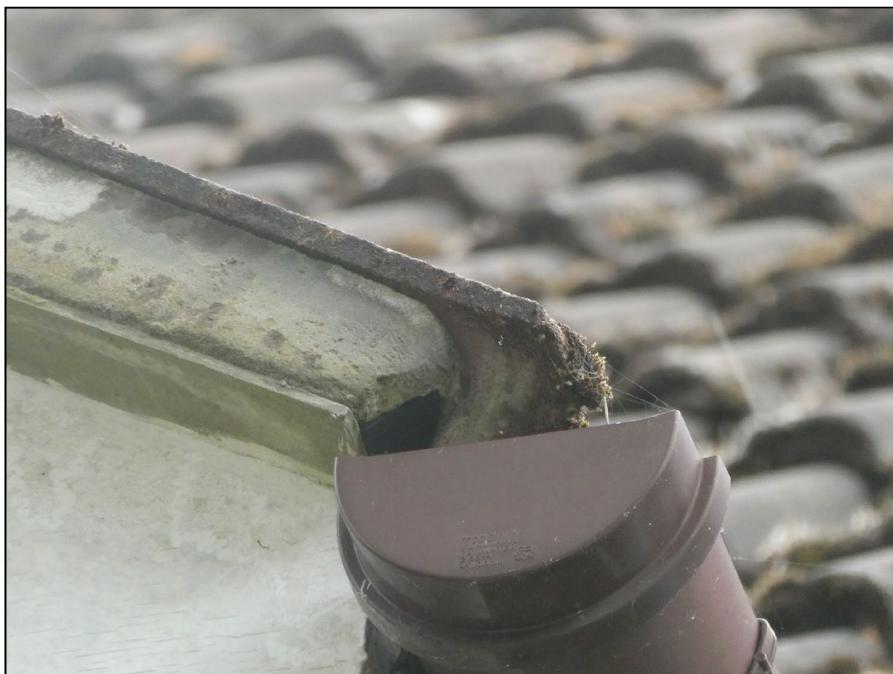
Figure 7. Gaps with soffit and mortar on property. Wychwood House, Finchampstead. 20.05.25

The property is in a good condition externally and internally. There are gaps within the soffits, missing mortar and a missing brick and these features could be utilised by crevice dwelling bats species or allow access into the building for bats. The droppings (confirmed by DNA analysis to be those of the BLE bat) were recorded within both lofts of the property, indicating that BLE bats are or have been using the building to roost. Recent works including the boarding of both loft spaces may have inadvertently covered any further droppings and the number of bats using the lofts spaces or status of the roosts cannot be determined without further survey effort.

The features identified will require 4 survey positions, 3 equipped with bat detectors and all 4 with night vision cameras in order to cover all the potential bat roosting features.

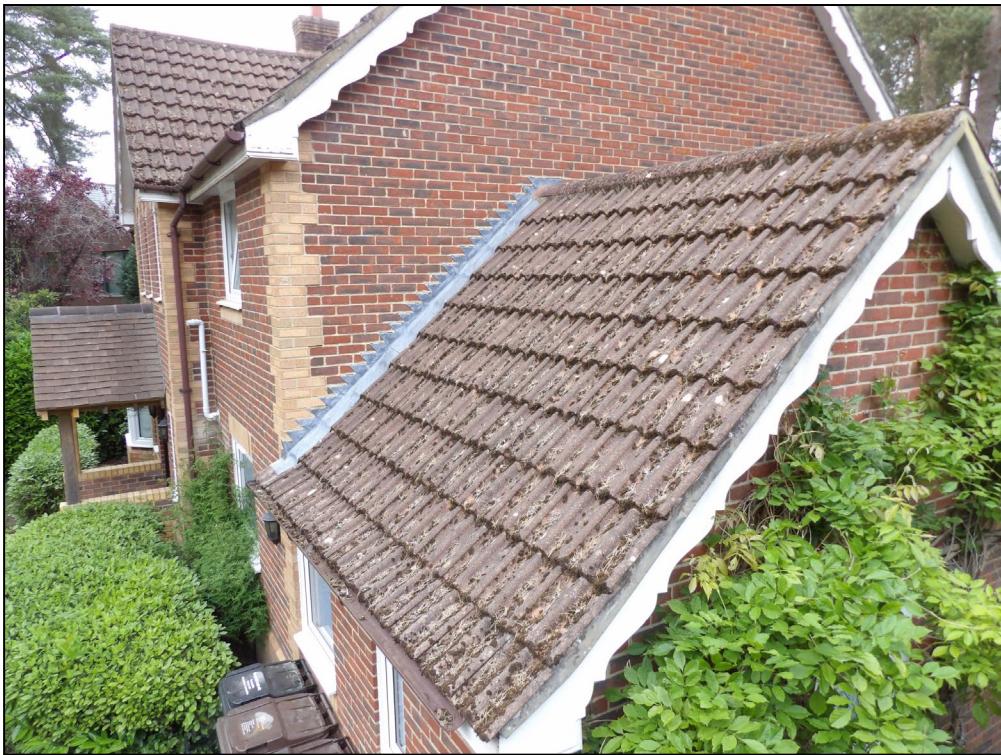
Figure 8. Example sealed roof and ridge tiles on single storey section of the property. Wychwood House, Finchampstead. 20.05.25

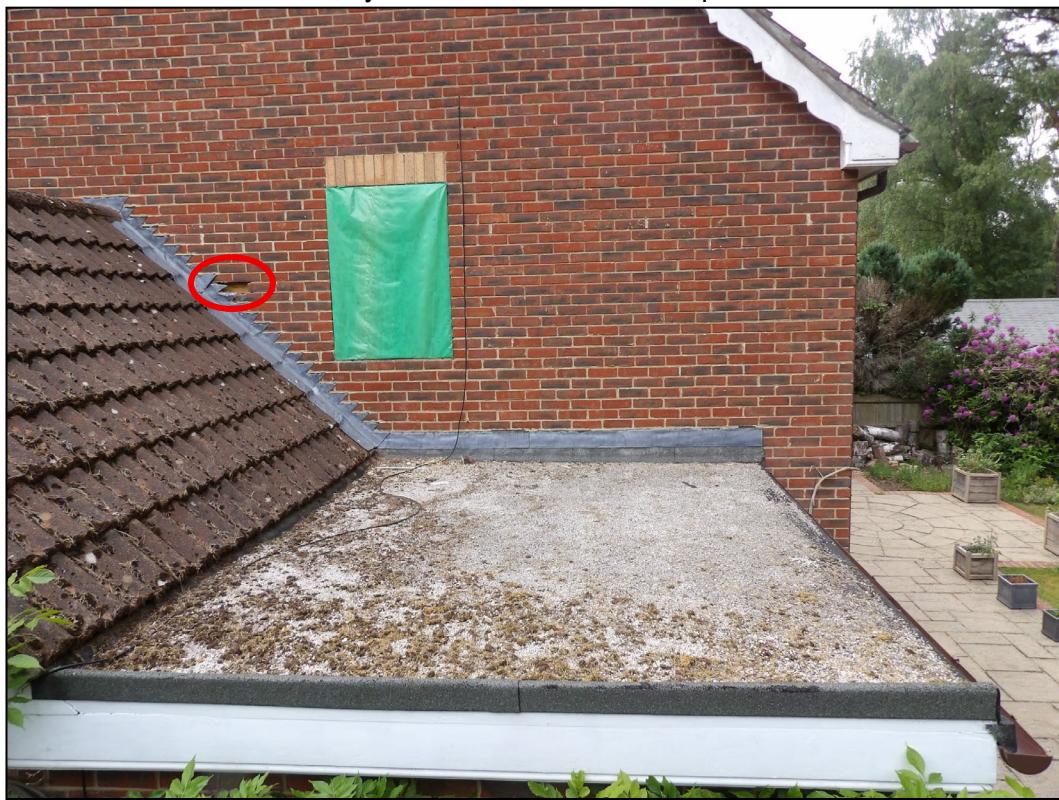
Figure 9. Temporary sealing of removed window and gap where the missing brick was and rear flat roof section. Wychwood House, Finchampstead. 20.05.25

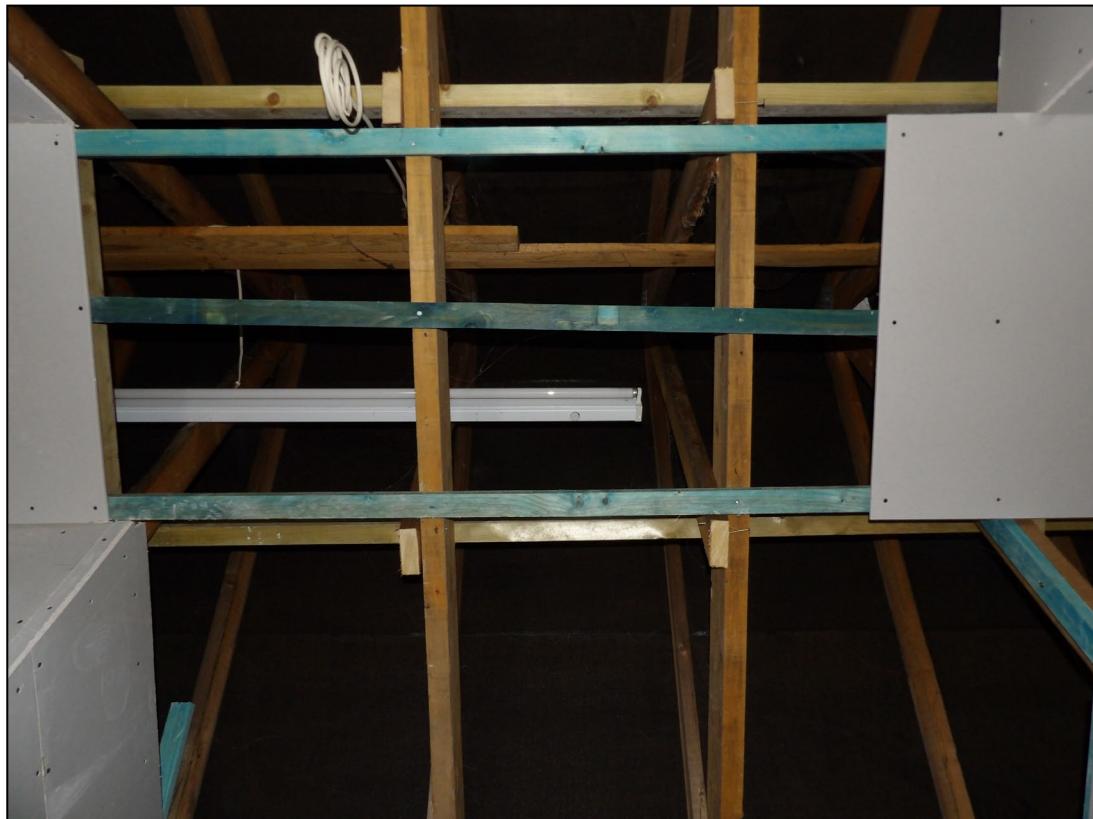
The property's suitability to support roosting bats was assessed and potential roost features identified during both preliminary inspections. In addition, during the 2024 survey, a number of bat droppings were recorded within both loft spaces of the property, indicating that bats are or have been using the building for roosting. DNA analysis of the droppings confirmed them to be those of the brown long-eared (BLE) bat, see Appendix 1. Activity surveys were recommended in line with best practice however they were not conducted in 2024 due to a language barrier and the homeowner not being resident in the UK.

Following the survey conducted in June 2024 internal works to the loft space of the property ceased as requested with the main loft space being left partially boarded and insulated, see Figure 10 below. The tiles are lined with bitumen felt and what could be seen appeared to be in a good condition, see Figure 10 below. No bat droppings were observed in the loft space.

Figure 10. Example of main loft space. Wychwood House, Finchampstead. 11.06.24
