# MEMORANDUM

| <b>Address:</b> | The Old Cottage, Pearson Road, Sonning, RG4 6UH. | | |
| <b>Proposal:</b> | Application for submission of details to comply with the following condition of planning consent (232278) dated 9/1/2024. Condition 4 relating to structural repairs safeguarding special architectural or historic interest. | | |

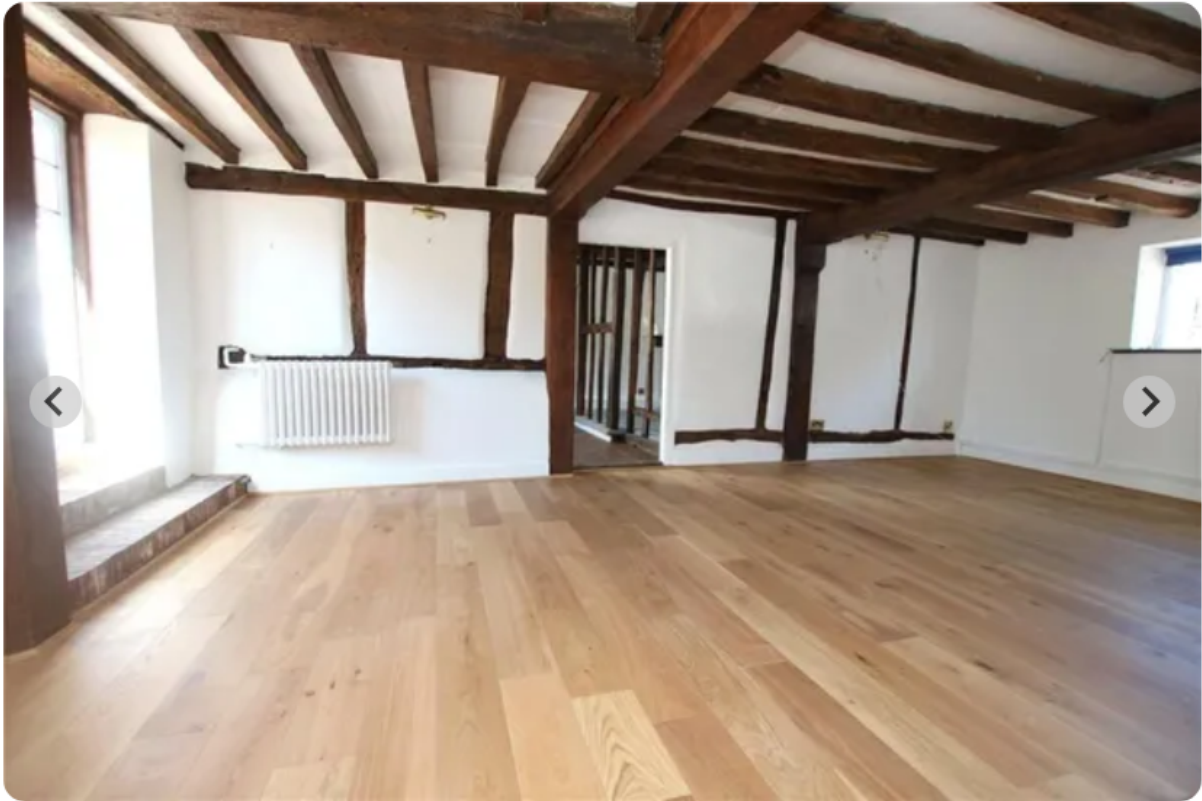
Image from 2022 Sales particulars on The Move Market website showing the front ground room to eastern end – front to right

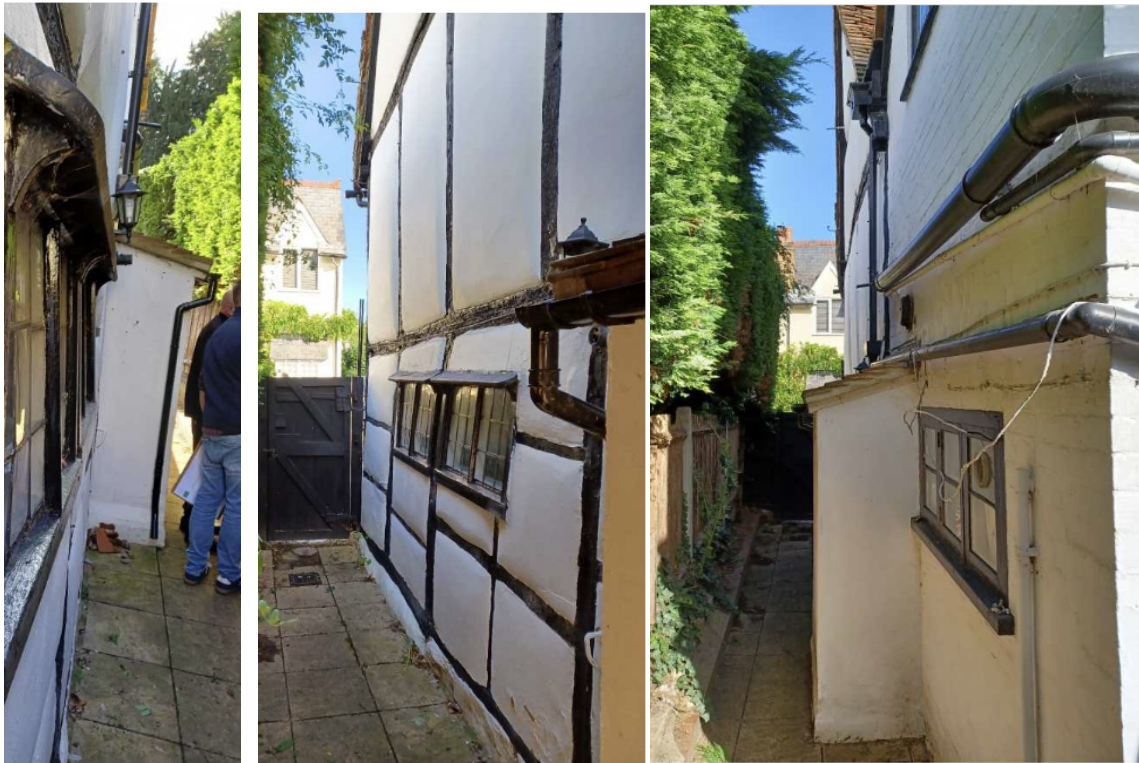
Western end gable, with far-right image being of the boiler extension.

The western gable contains bulbous painted cement-rendered panels externally, with exposed brick infill internally at first-floor and attic levels. Consent was given only for the removal of the non-breathable modern render and its replacement with a breathable finish following timber repairs and installation of external insulation. Although the original render made it difficult to determine the underlying material, the method statement suggests masonry infill at ground-floor level, likely consistent with the upper floors. If so, these panels should be retained.

The proposed demolition of the modern boiler extension also falls outside the approved works and cannot be considered under Condition 4. A separate listed building consent or a certificate of lawful works would be required.

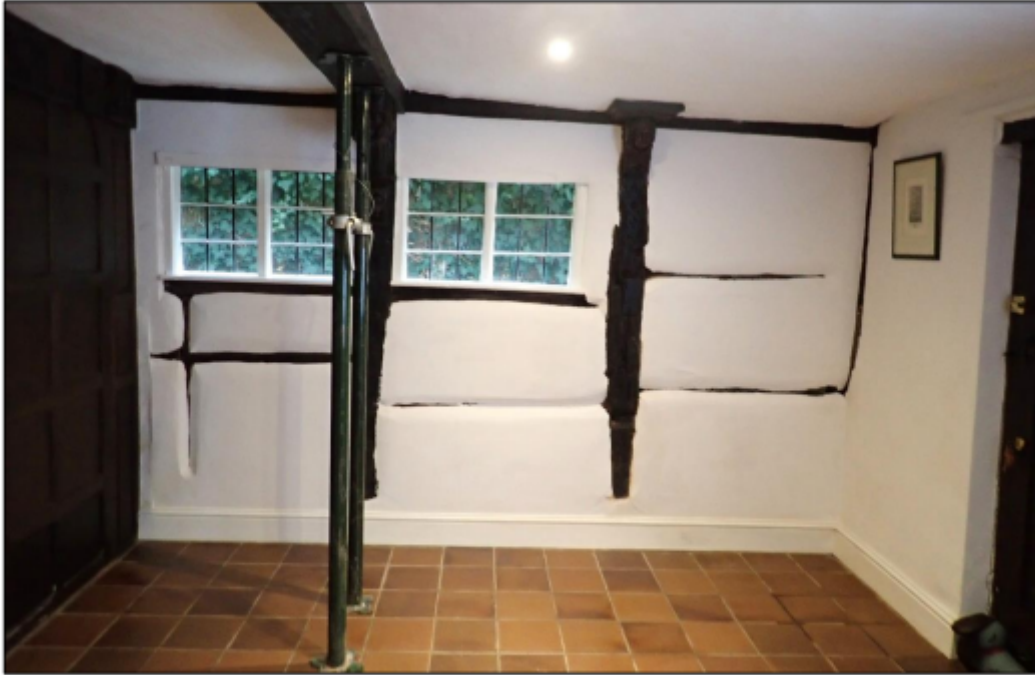
Figure 28. General view of the west wall from the Dining Room.

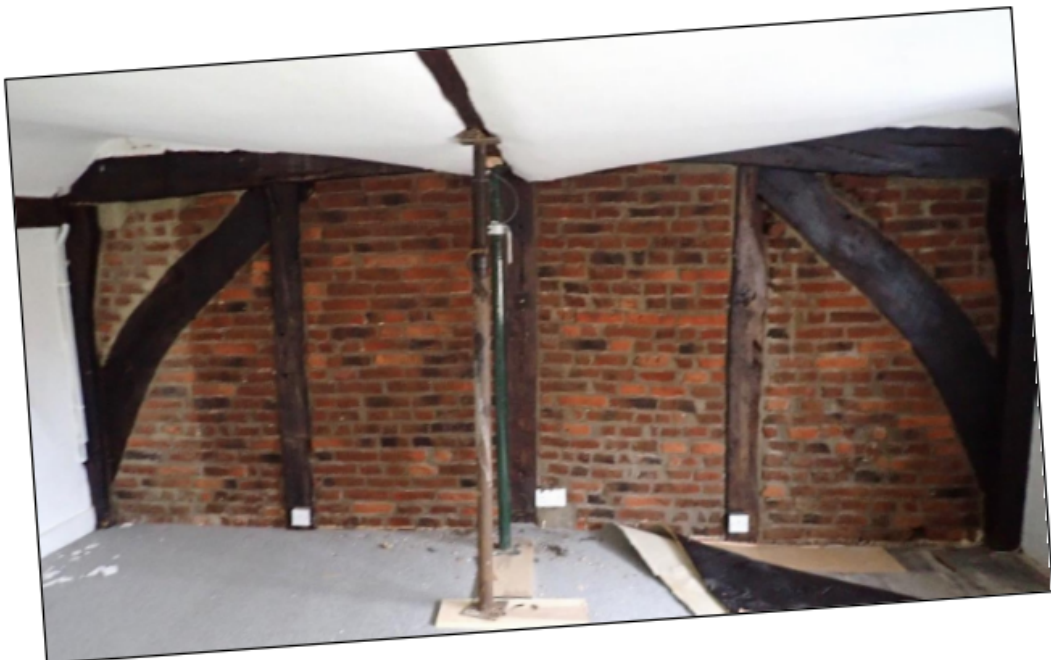
Figure 37. General view of the west wall on the 1<sup>st</sup> floor.

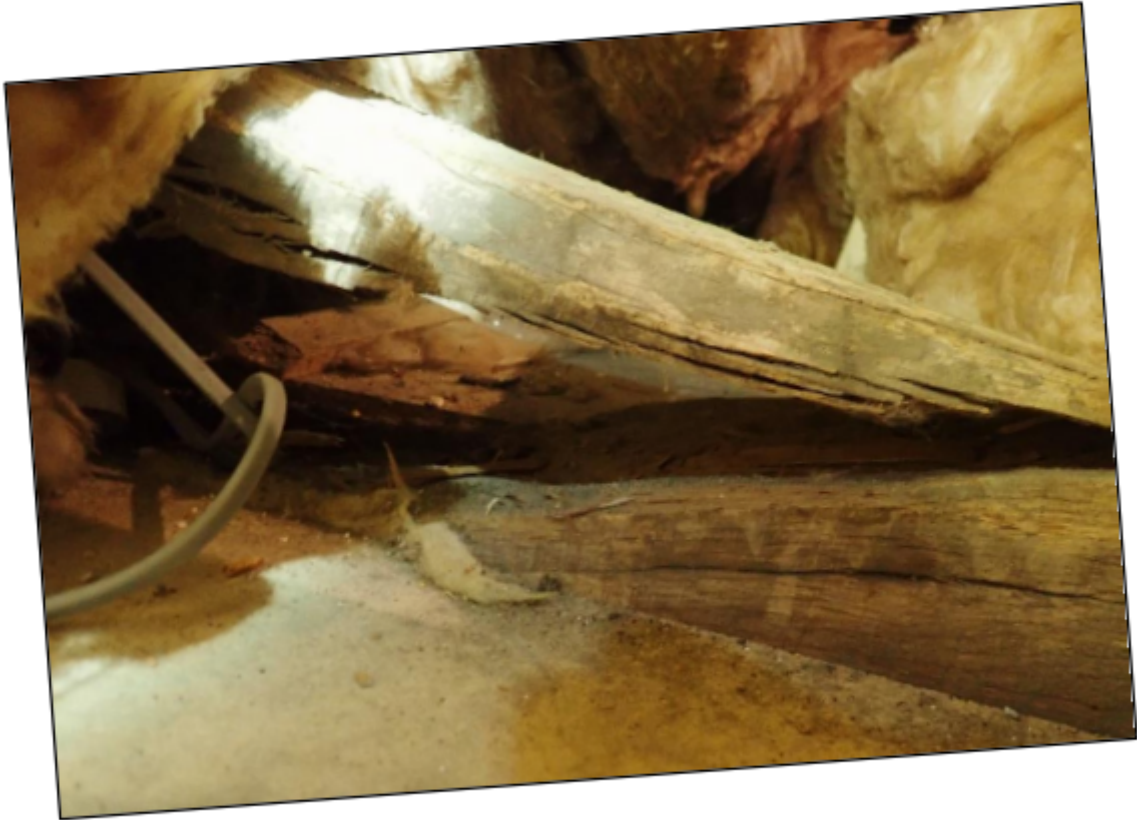
The proposed removal of ground-floor masonry infill and the associated need to prop the gable also raises structural risks. The structural engineer's report identified the dropped first-floor ceiling beam, which has separated from the gable wall, but this was not included in the approved scope of works. Further intervention may require additional consent.

Figure 43. View of the fracture in the 1<sup>st</sup>-floor ceiling beam

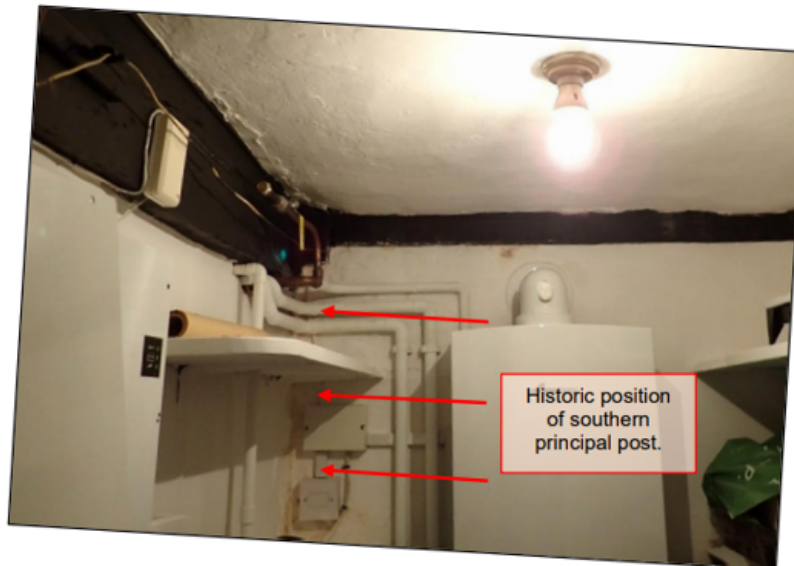
- ix. By looking in the south-west corner of the utility room it was apparent the lower section of the southern principal post has been removed from below the end-girt at some point in time (Fig. 36).

Figure 36. South-west corner of the Utility Room.

Regarding timber repairs, the proposal includes removing—rather than reinstating—the historic horizontal rail and vertical studwork below the end girt, replacing them with new studs aligned to those above. No justification is provided for altering the historic arrangement instead of replicating it.

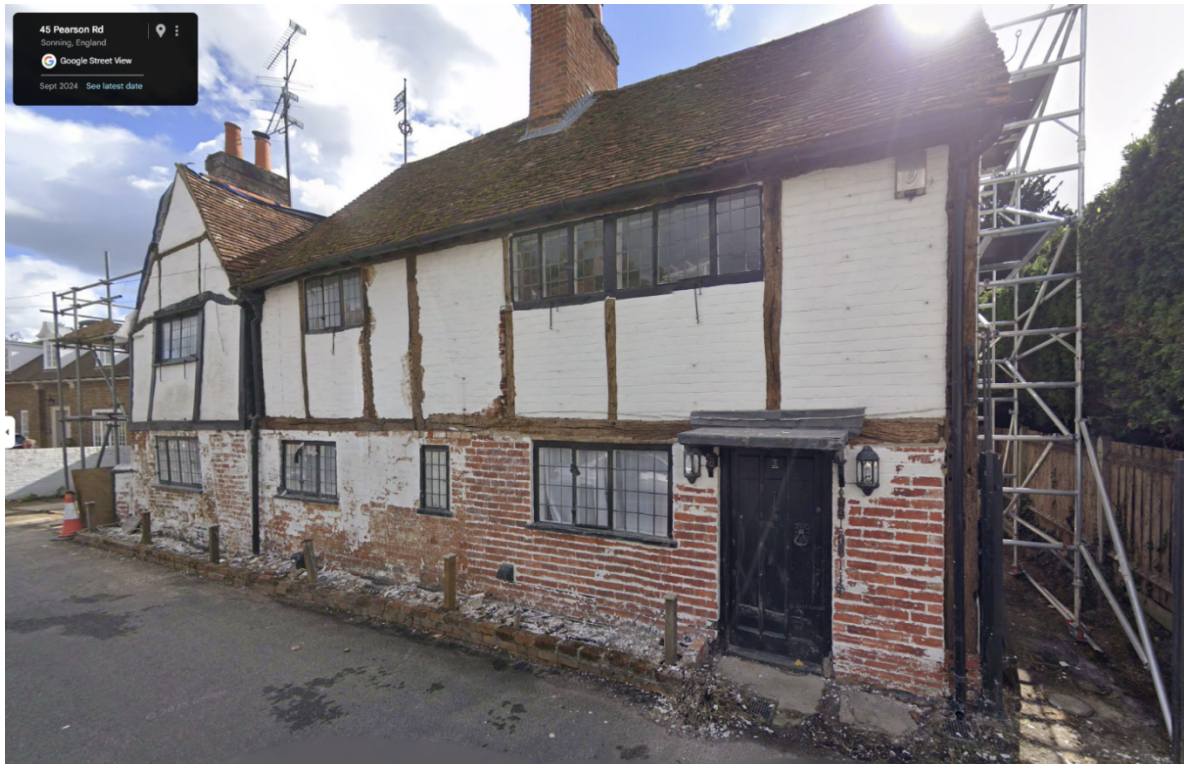
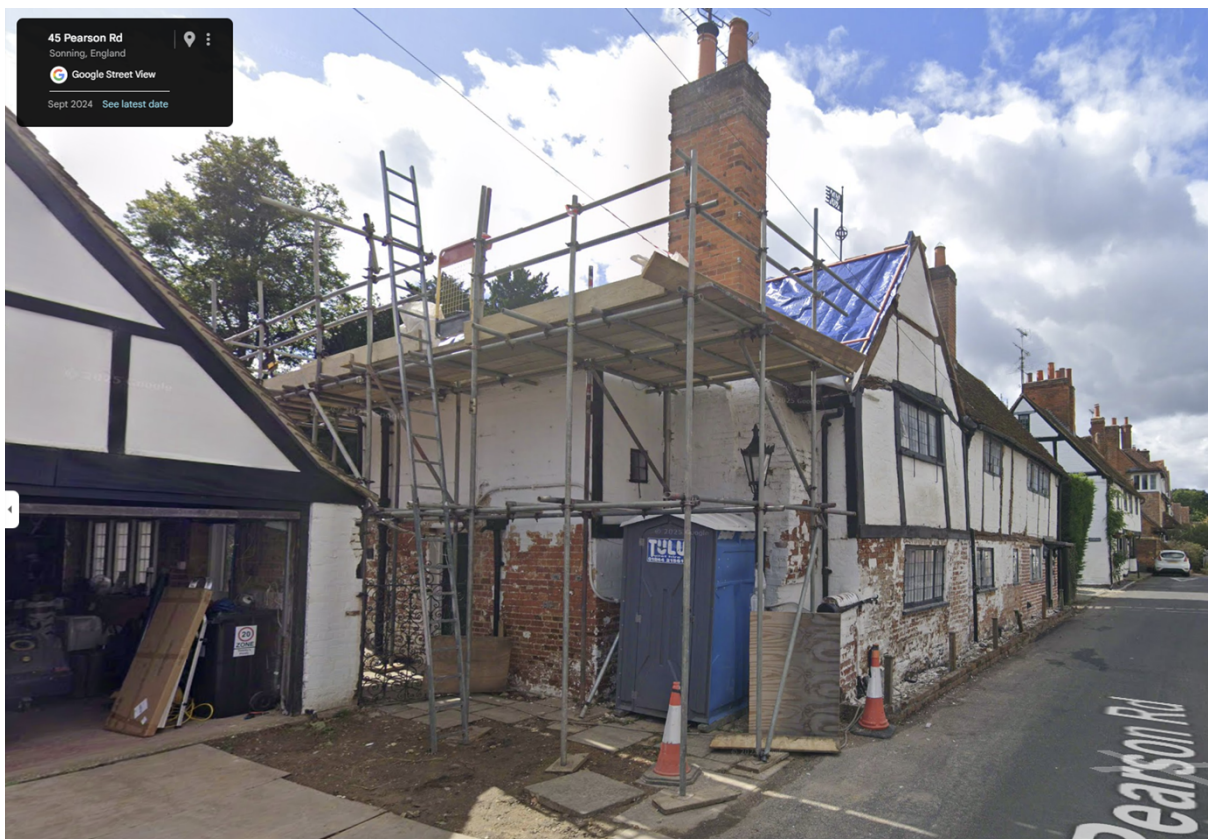
Above images from Google Street View

It is noted with respect to condition 3 of consent 232278, relating to removal of modern render and paint, was discharged in July 2024, and Street View images from September 2024 indicate significant progress. Condition 5, concerning external insulation, has not yet been discharged, though the current submission includes elements relating to this work. This raises concern given the exposed and potentially vulnerable condition of the timber framing and brickwork, particularly on the northern elevation.
