**WINDWHISTLE  
READING ROAD  
ARBORFIELD  
READING  
BERKSHIRE  
RG2 9HN**

**ECOLOGICAL SURVEY REPORT (BATS)**  
(Preliminary Roost Assessment/DBW)

**Prepared for:**  
**Mr D RAMKALI and Mrs J. NASH.**  
**Date: 12/3/25.**  
**Ref: NWP/ESR-12/3/25.**

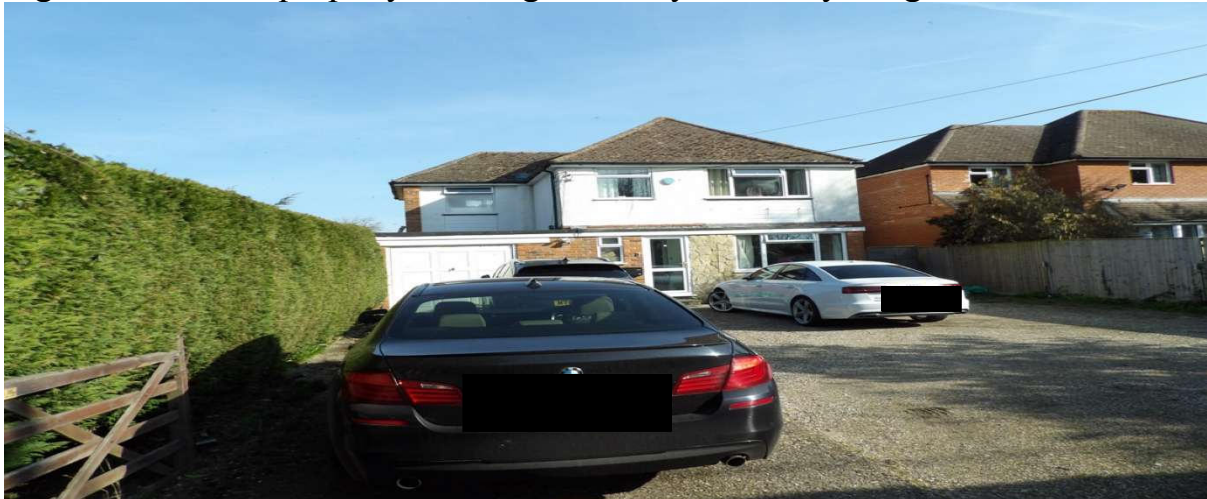
Immediately to the front of the property is a gravel driveway and parking area. There is a maintained mature hedge forming one boundary whilst a close board fence forms the boundary on the opposite side. Figure 1.

Figure 1. Front of property showing driveway/boundary hedges and fence.

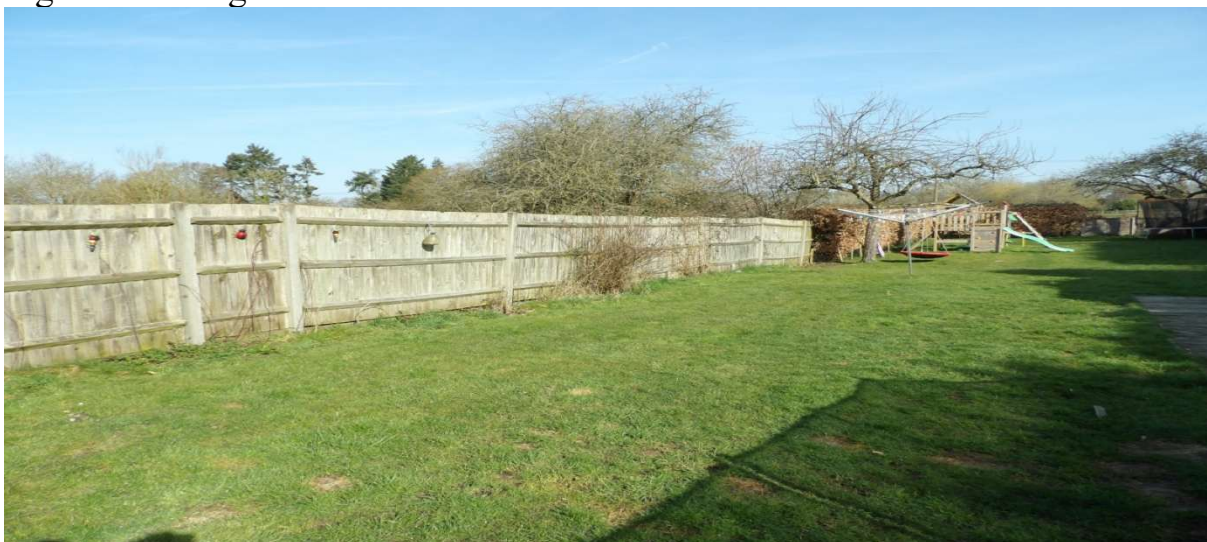
To the rear of the property is an area laid to lawn, bordered with a hedge on one side and close board fence on the other. There is a swimming pool. Figures 2/3. There is farmland adjoining.

Figure 2. Rear garden.

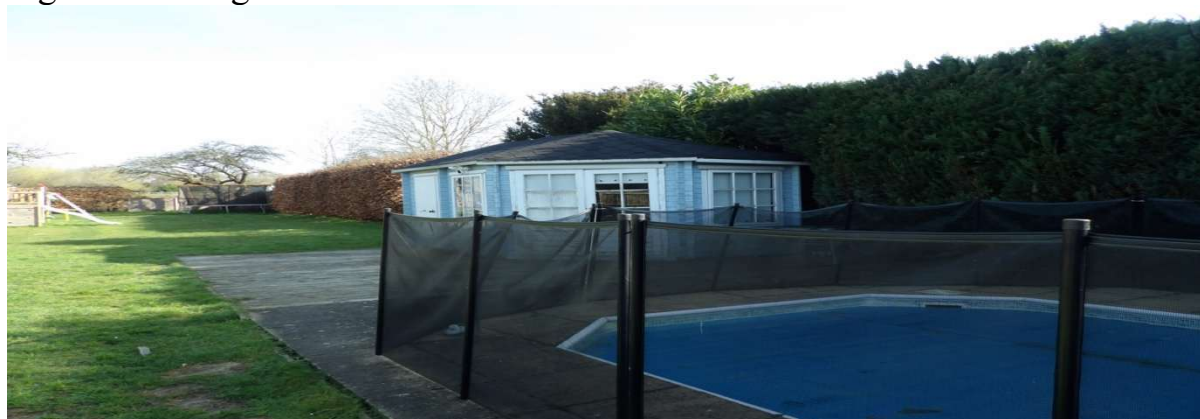
Figure 3. Rear garden.

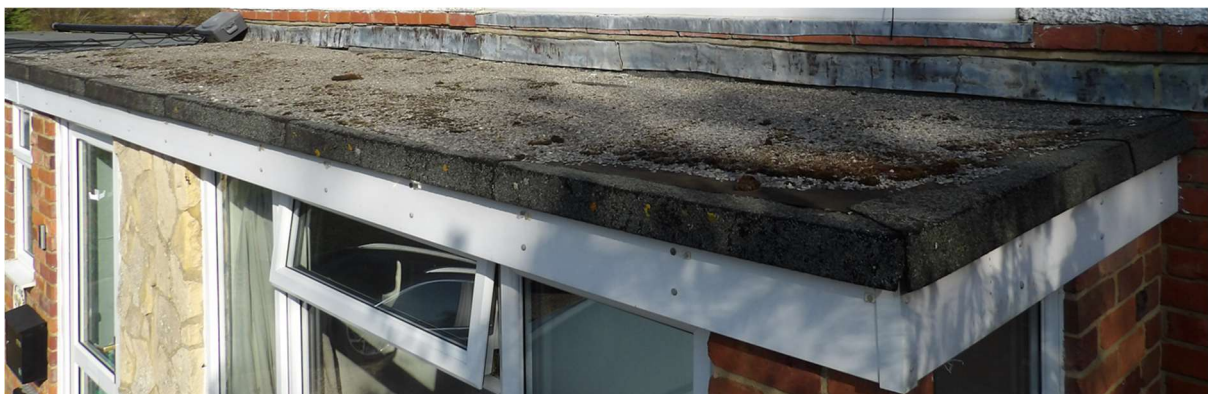
Figure 1. Flat roof extension.

To the front is an extension with a flat roof covered in a composite material, (bitumen felt) it was close fitting to the soffit boards, it was in good condition with no rips or tears. Figure 1.

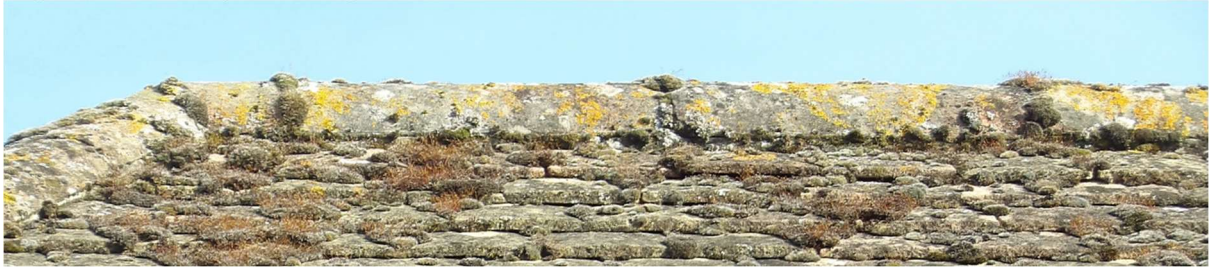
Figure 2. Example of ridge tiles.

The ridge tiles on the dwelling were in good condition with no significant missing mortar that bats could exploit. Figure 2.

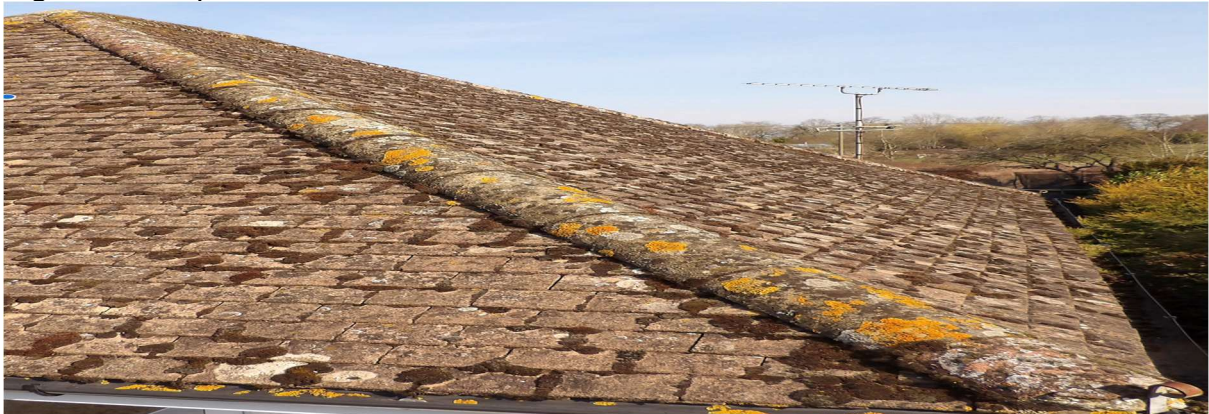
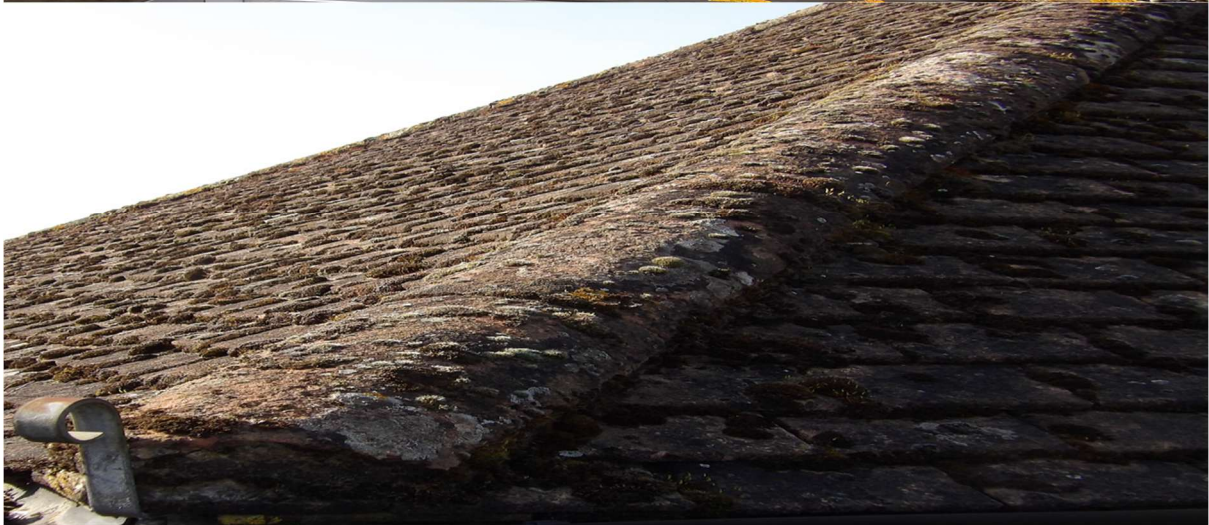
Figure 3/4. Hip Tiles.

The hip tiles were in good condition with no significant missing mortar that bats could exploit. Figure 3/4.

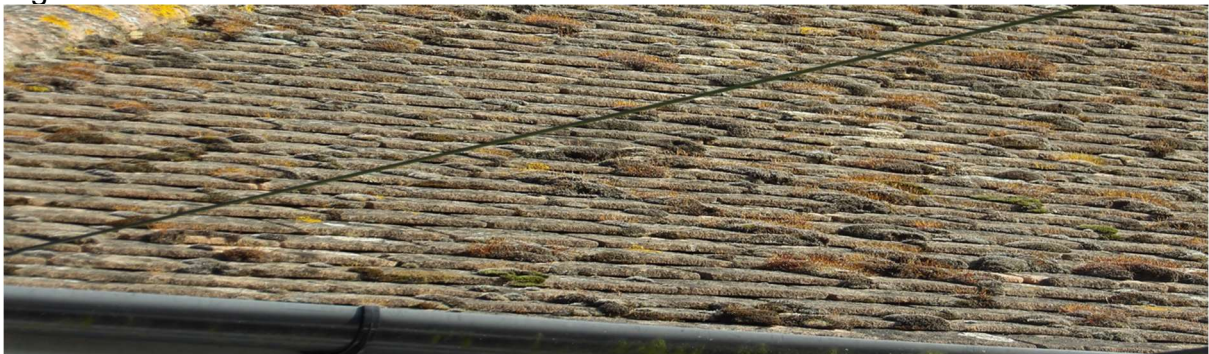
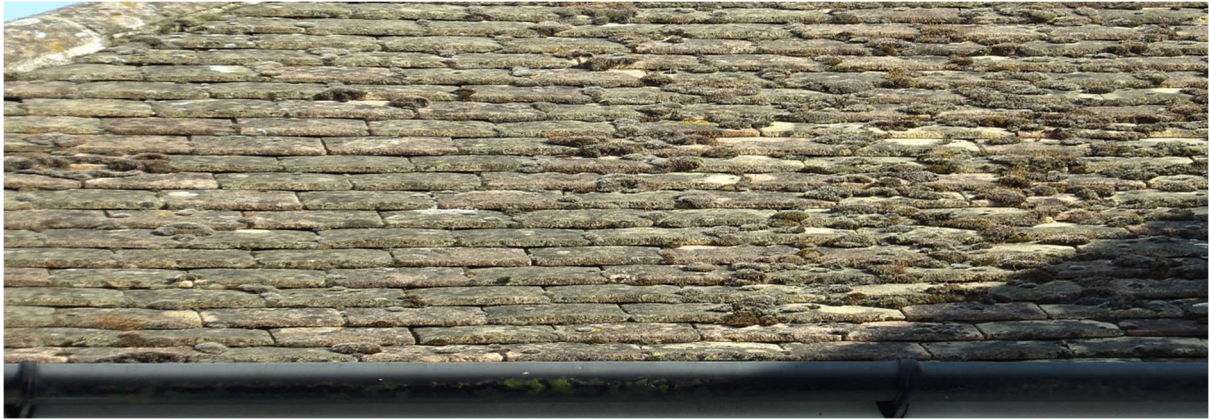
Figure 5/6. General tiles.

The tiles covering the roof were in good condition, close fitting with no visible broken/slipped/missing tiles visible. Figure 5/6.

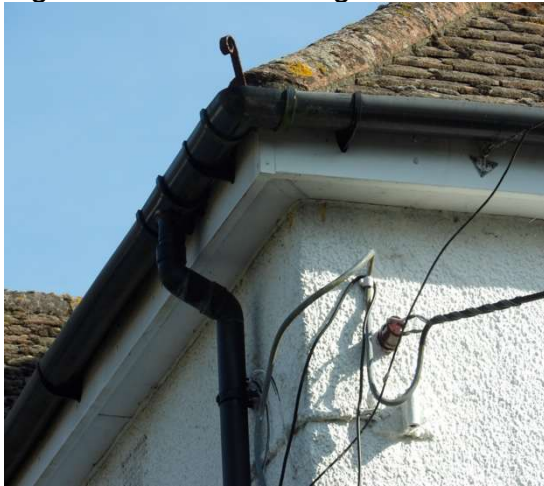
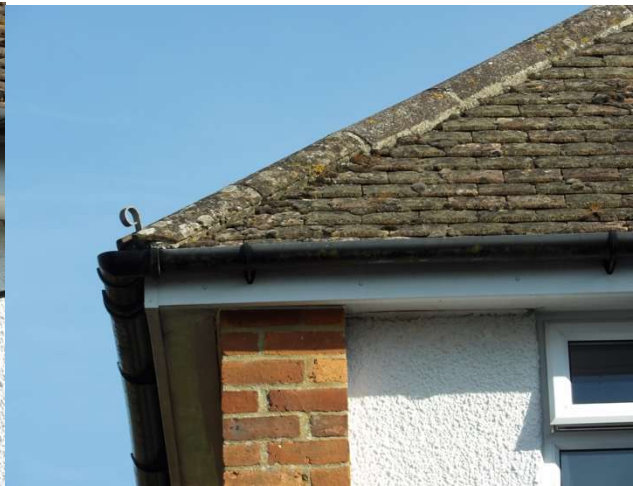
The U.P.V.C soffits and fascias on main dwelling are all in good condition, close fitting to the walls with no splits or significant openings. Figure 9/10.

Figure 9/10. Close fitting U.P.V.C soffits and fascias.

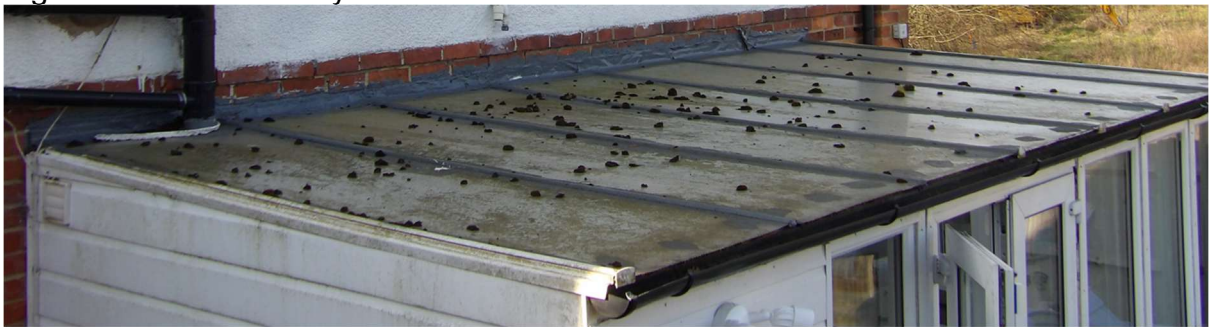
Figure 11. Conservatory.

The conservatory had a corrugated plastic roof. Figure 11.

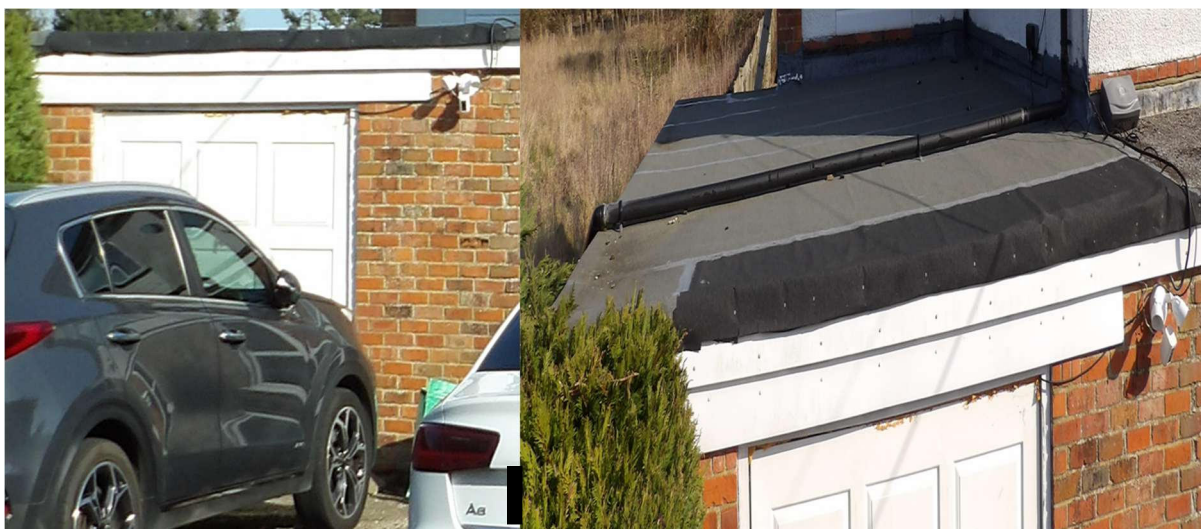
Figure 13. Garage roof.

The Garage is of brick construction with a flat roof, Figure 12.

The composite covering was in fair condition. Figure 13.

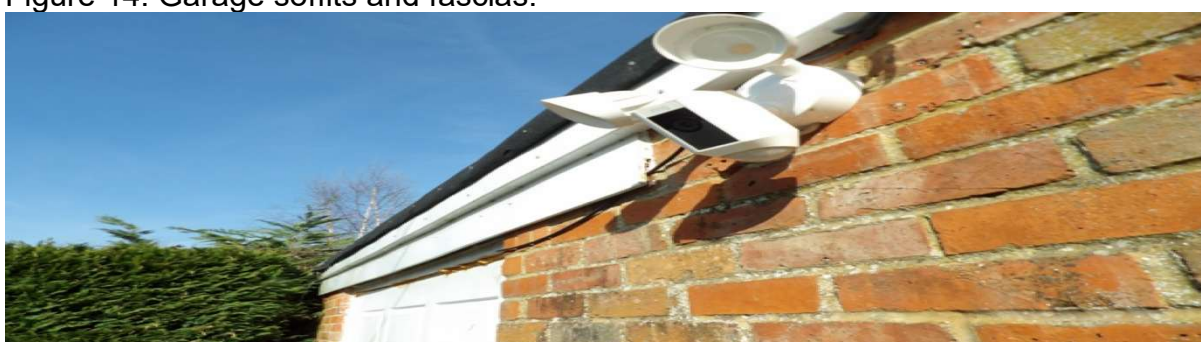
Figure 14. Garage soffits and fascias.

The soffits and fascias were U.P.V.C, all in good condition, close fitting to the walls with no significant splits or openings. Figure 14.

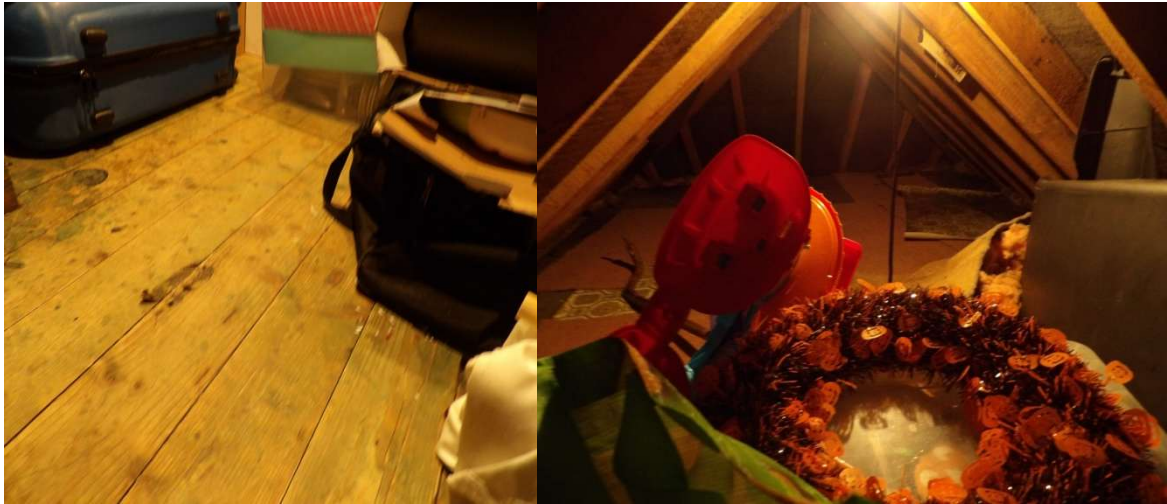
The loft was lit, it was boarded and insulated, figure 1.

Figure 1. Example of boarding.

Figure 2. Example of personal possessions.

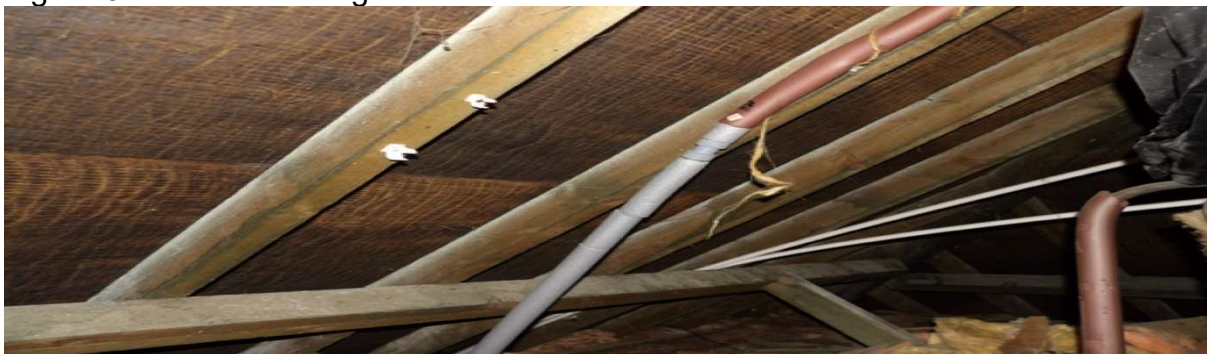
The roof tiles were lined with a bitumen felt, it was in good condition with no visible rips/tears. Figure 3.

There was no light ingress.

Figure 3. Bitumen felt in good condition.

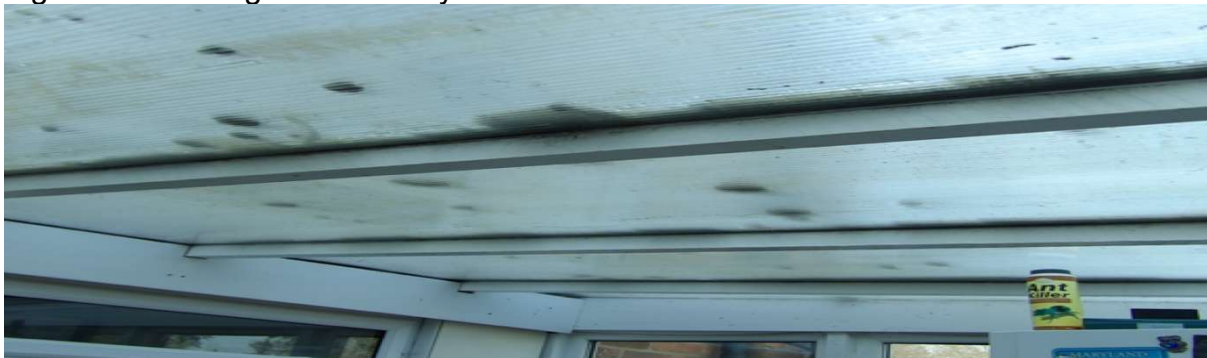
Figure 4. Showing conservatory roof.

The conservatory had a corrugated plastic roof. Figure 4.

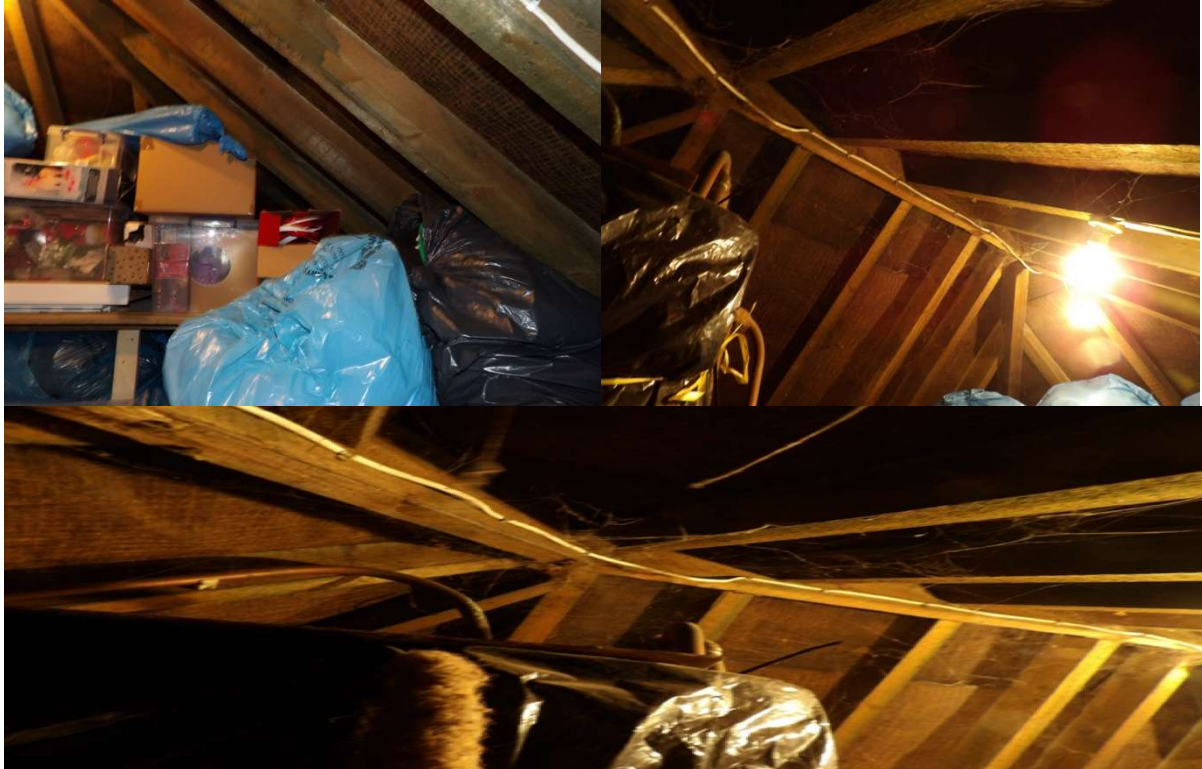
Figure 7/8/9.

Figures 7/8/9. Show roof structure and general condition.
