## Preliminary Roost Assessment

62 Clifton Road, Wokingham, Berkshire, RG411NE

This report is prepared to inform a planning application with Wokingham Borough Council. This proposal can be described as "upward extension above garage".

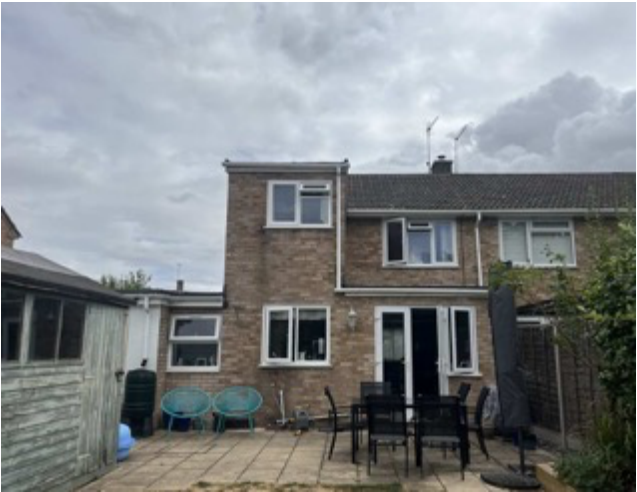
Building B1, western elevation

B1 is a residential dwelling. Its primary structure features a pitched roof with interlocking concrete tiles, metal soffits and uPVC windows and doors. It features a single-storey side extension to the north with a bitumen felt roof, which will be undergoing an upward extension.

Due to its modern construction, B1 was seen to be well-sealed with no obvious gaps or crevices externally. The internal void was seen to be well-sealed and offers no suitable crevice or void habitat for roosting bats. The building was assessed to have negligible habitat value for roosting bats owing to a lack of features.

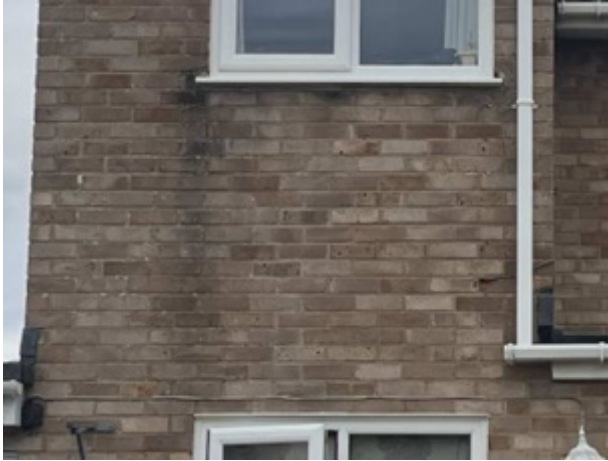
| Walls | Brick | <p><b>Condition/description</b></p> <p>All brickwork across elevations was deemed to be in good condition with no cracks or crevices within the brick and no areas of missing mortar.</p> <p><b>Suitability/access/evidence of bats</b></p> <p>No suitability for roosting bats was identified on the walls.</p> | <p><i>B1 walls, western elevation</i></p> |

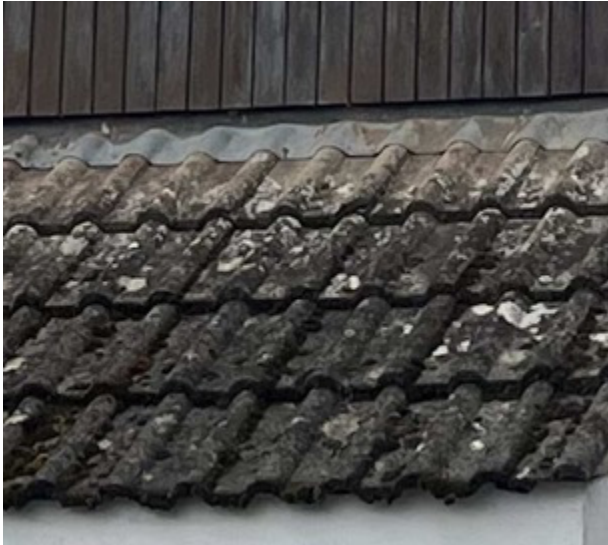
| Roof | Interlocking tiles<br>Bitumen felt | <p><b>Condition/description</b></p> <p>The interlocking roof tiles across all elevations were seen to be in good condition with no areas of lifting or crevices under which bats could roost. All mortar was equally in good condition, with no gaps or crevices present.</p> <p>The bitumen felt of the flat roof, where the extension will be taking place, was seen to be in good condition, with no areas of lifting present under which bats could roost.</p> <p><b>Suitability/access/evidence of bats</b></p> <p>No suitability for roosting bats.</p> | <p><i>B1 roof, eastern elevation (above porch)</i></p> |

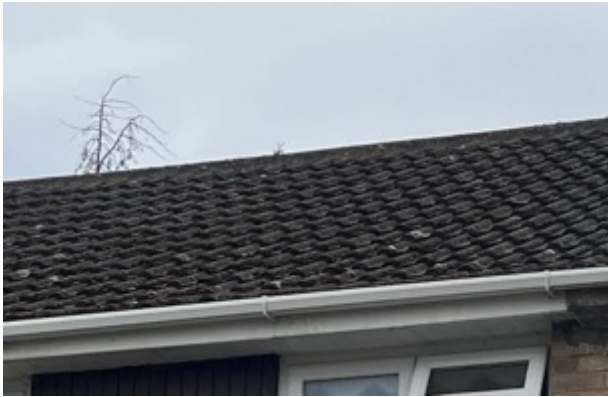
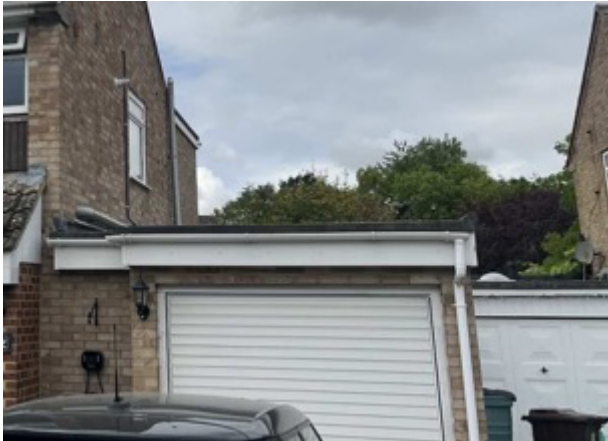
| | | | <div><p><i>B1 roof, eastern elevation</i></p><p><i>B1 roof, flat roof section above garage, subject to upward extension</i></p></div> |

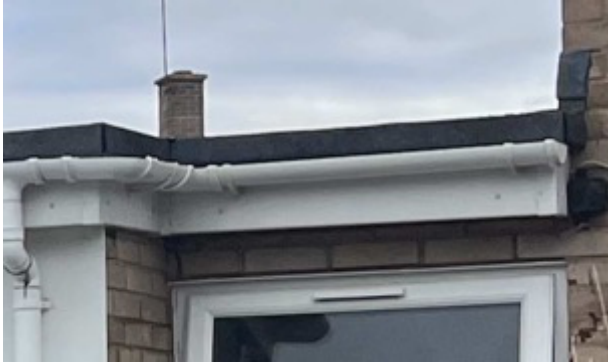
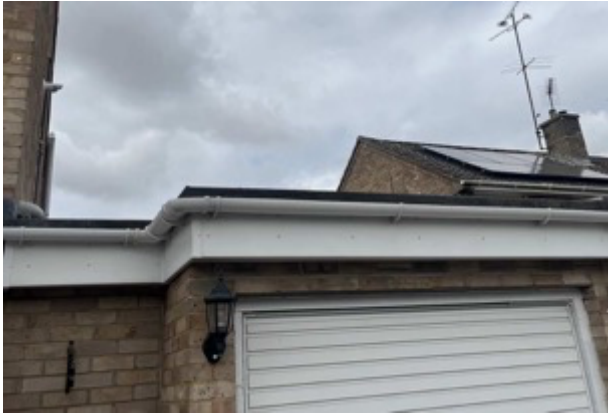
| Eaves | Metal | <p><b>Condition/description</b></p> <p>The eaves were closed, featuring metal soffit boxes on all elevations.</p> <p><b>Suitability/access/evidence of bats</b></p> <p>All soffits were observed to be well-sealed and gapless, offering no suitability for roosting bats.</p> | <div><p><i>B1 eaves, western elevation (garage)</i></p><p><i>B1 eaves, eastern elevation (garage)</i></p></div> |

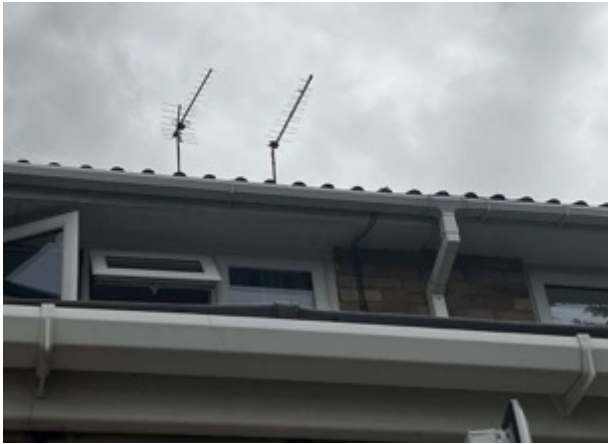
| | | | <p>B1 eaves, western elevation (main dwelling)</p> |

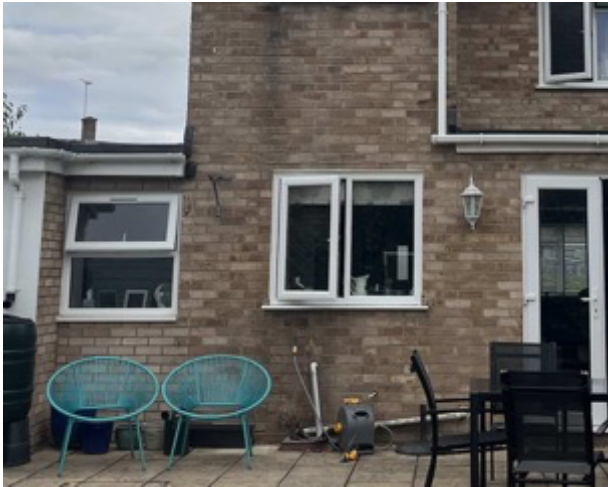
| Windows | uPVC | <p><b>Condition/description</b></p> <p>The windows and doors of the building are made from uPVC.</p> <p><b>Suitability/access/evidence of bats</b></p> <p>All are tightly fitting, with no gaps or crevices where bats could roost between the walls and frames.</p> | <p>B1 window / doors frames and lintels, western elevation</p> |

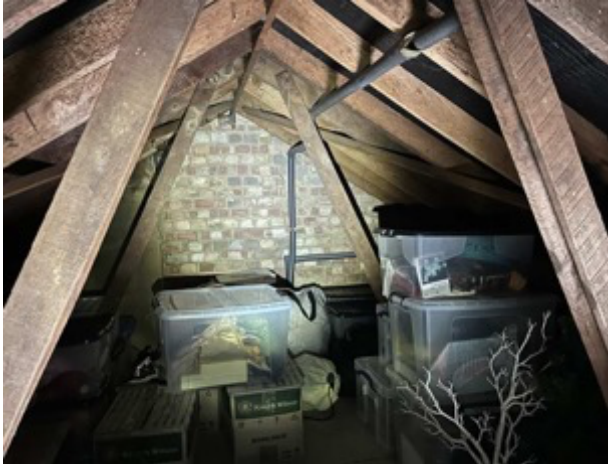
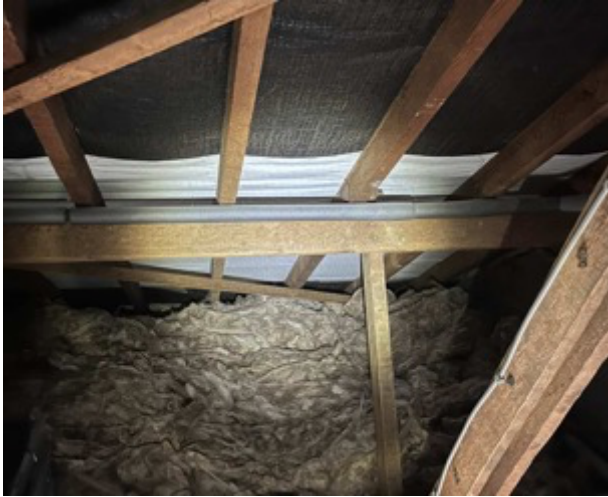
| <p>Internal void 1</p> | <p>Timber rafters.<br/>Bitumen felt lining.<br/>Brick partition walls</p> | <p><b>Condition/description</b></p> <p>The timber rafters were seen to be in good condition with no areas of splitting wood or crevices where bats could roost, though small gaps present between the bitumen felt roof lining and timber rafters could be utilised by roosting bats.</p> <p><b>Suitability/access/evidence of bats</b></p> <p>No suitable roosting crevices or points of access were noted at the time of survey, and no areas of light ingress were noted. No evidence of rodents was found, further indicating that no hidden or concealed access points are present within the loft. No evidence of bats was found (i.e. feeding remains, droppings or staining).</p> | <div data-bbox="1361 164 1966 630"></div> <p data-bbox="1361 643 1664 667"><i>B1 internal void 1, facing south</i></p> <div data-bbox="1361 691 1966 1189"></div> <p data-bbox="1361 1201 1657 1225"><i>B1 internal void 1, facing west</i></p> |

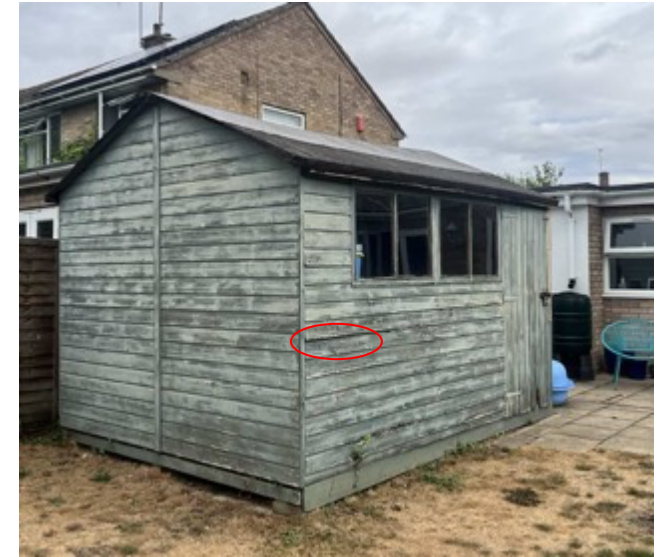
*Building B2, southwestern elevation, facing northeast*

B2 is a timber shed located to the west of B1. One small area of lifting was observed underneath the wooden cladding on the southern elevation; however, the crevice was deemed superficial upon further investigation (measuring less than 1cm in depth), and therefore unsuitable for roosting bats. Overall, the building was seen to lack the traditional features that would typically provide suitable roosting opportunities for bats and is likely to be subject to temperature fluctuations due to the nature of the construction materials (timber and glass), creating an unstable thermal environment that does not support bats roosting. No suitable gaps were observed during the survey. Therefore, B2 is assessed as having negligible value for roosting bats. B2 will be retained in line with development plans.
