**RE: Riverways Farm, Twyford, RG10 9RY – Winter Groundwater Monitoring**

Omnia were commissioned by David Wilson Homes Southern to undertake winter groundwater monitoring within five (5no.) installed wells across the site in order to assist with the drainage strategy. The following letter report presents the information obtained from the winter groundwater monitoring works.

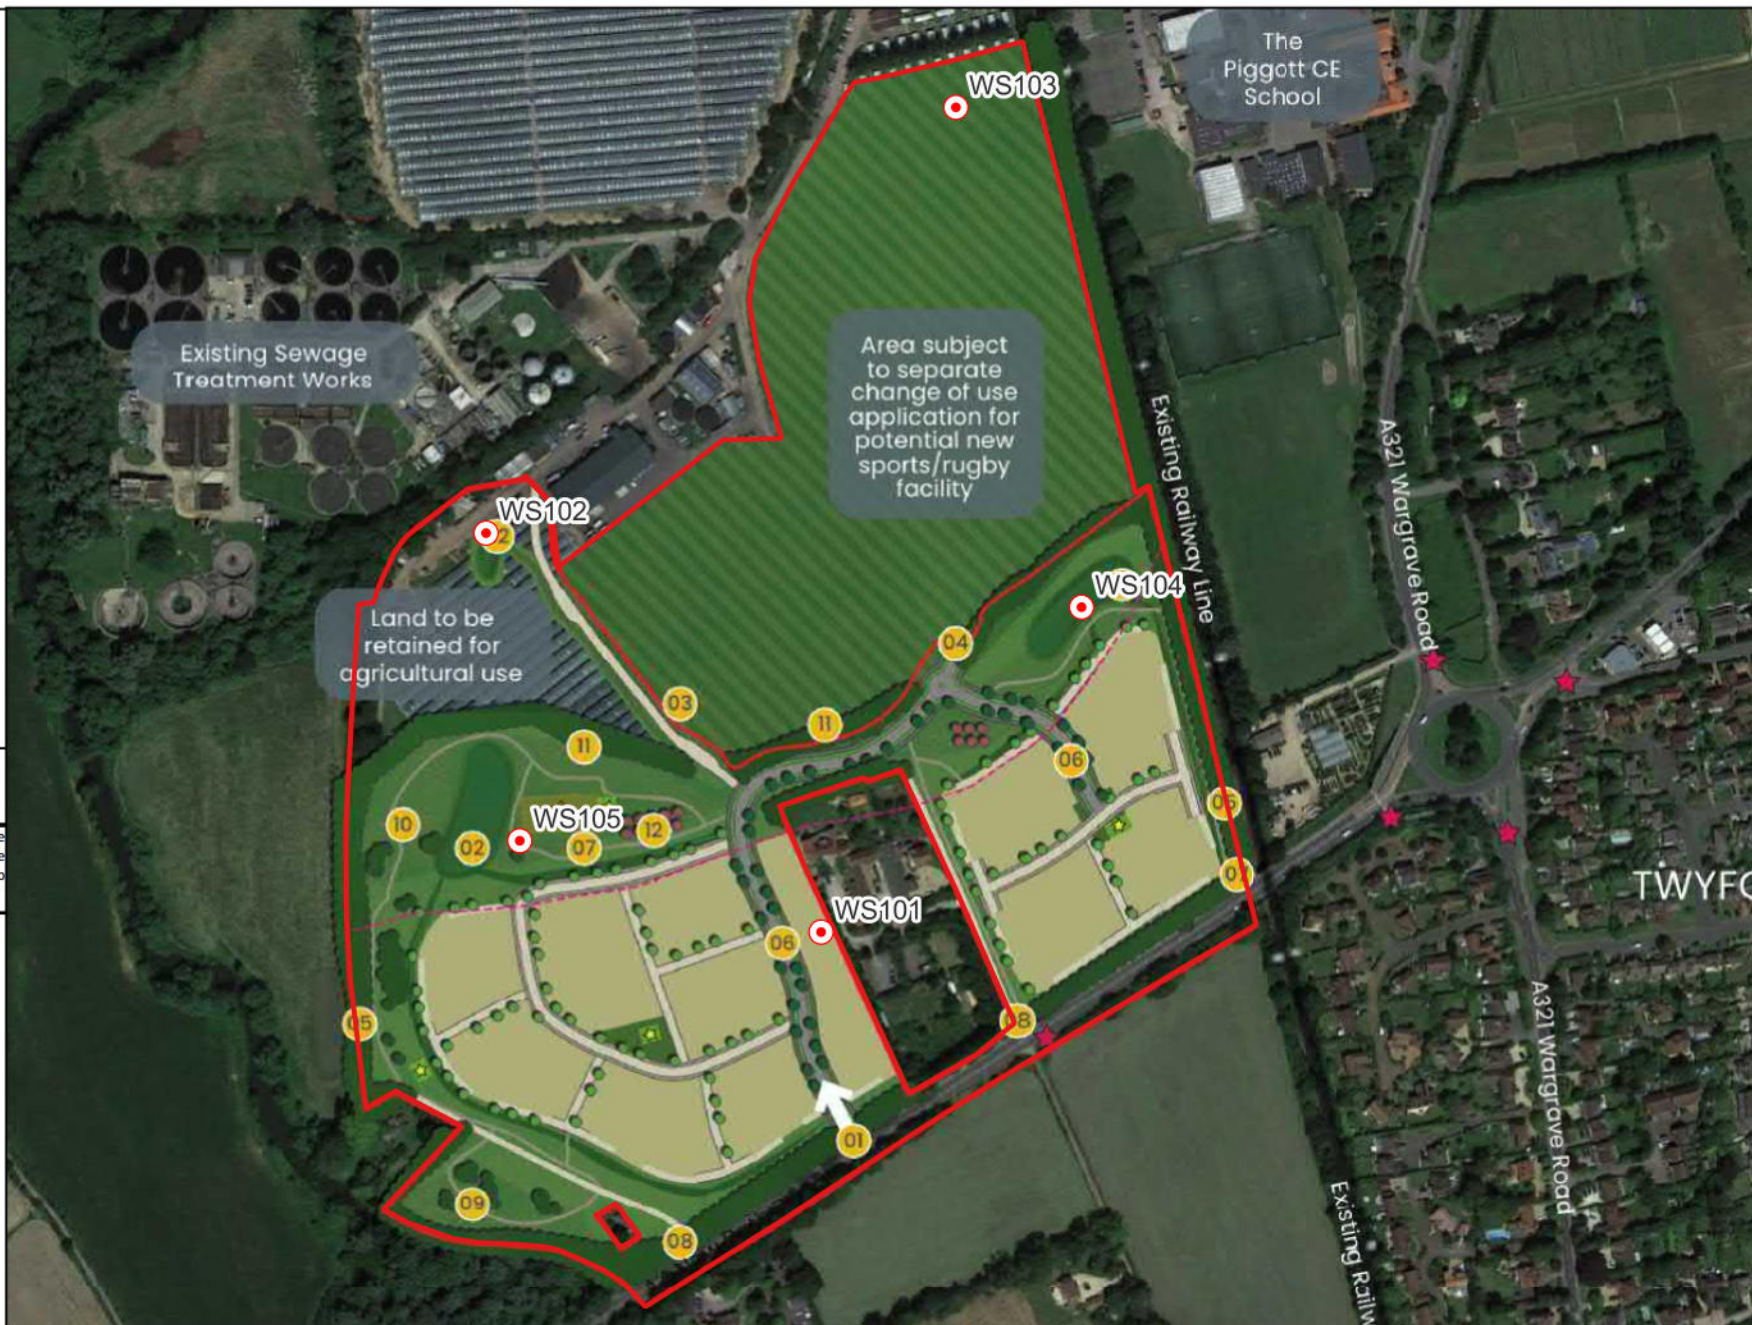
Drawing Title:  
Figure 3.0  
Intrusive Location Plan

Locations of the groundwater monitoring installations have been denoted on Figure 3.0 appended to this report.

- Groundwater Monitoring Locations
- Site Boundary

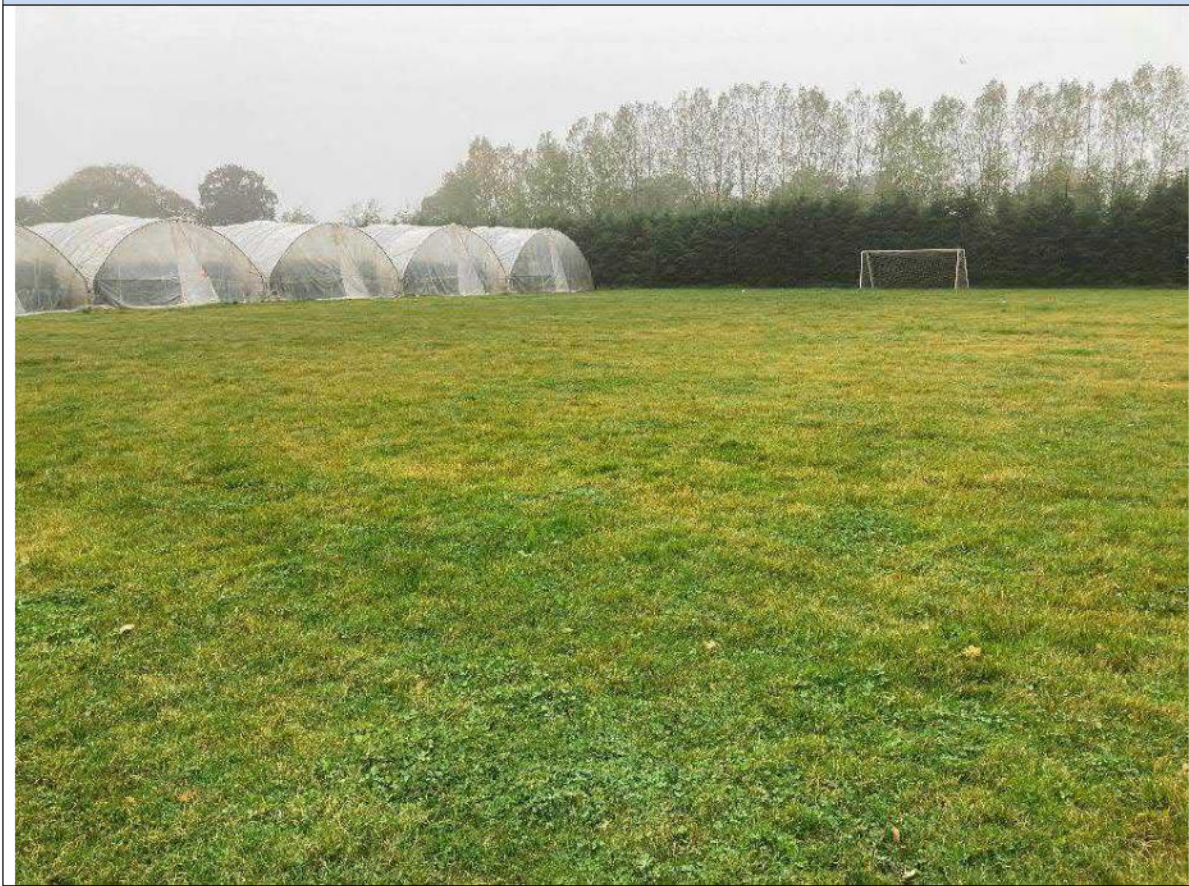
**Photograph 1 – WS103 location within fruit farm (facing west)**

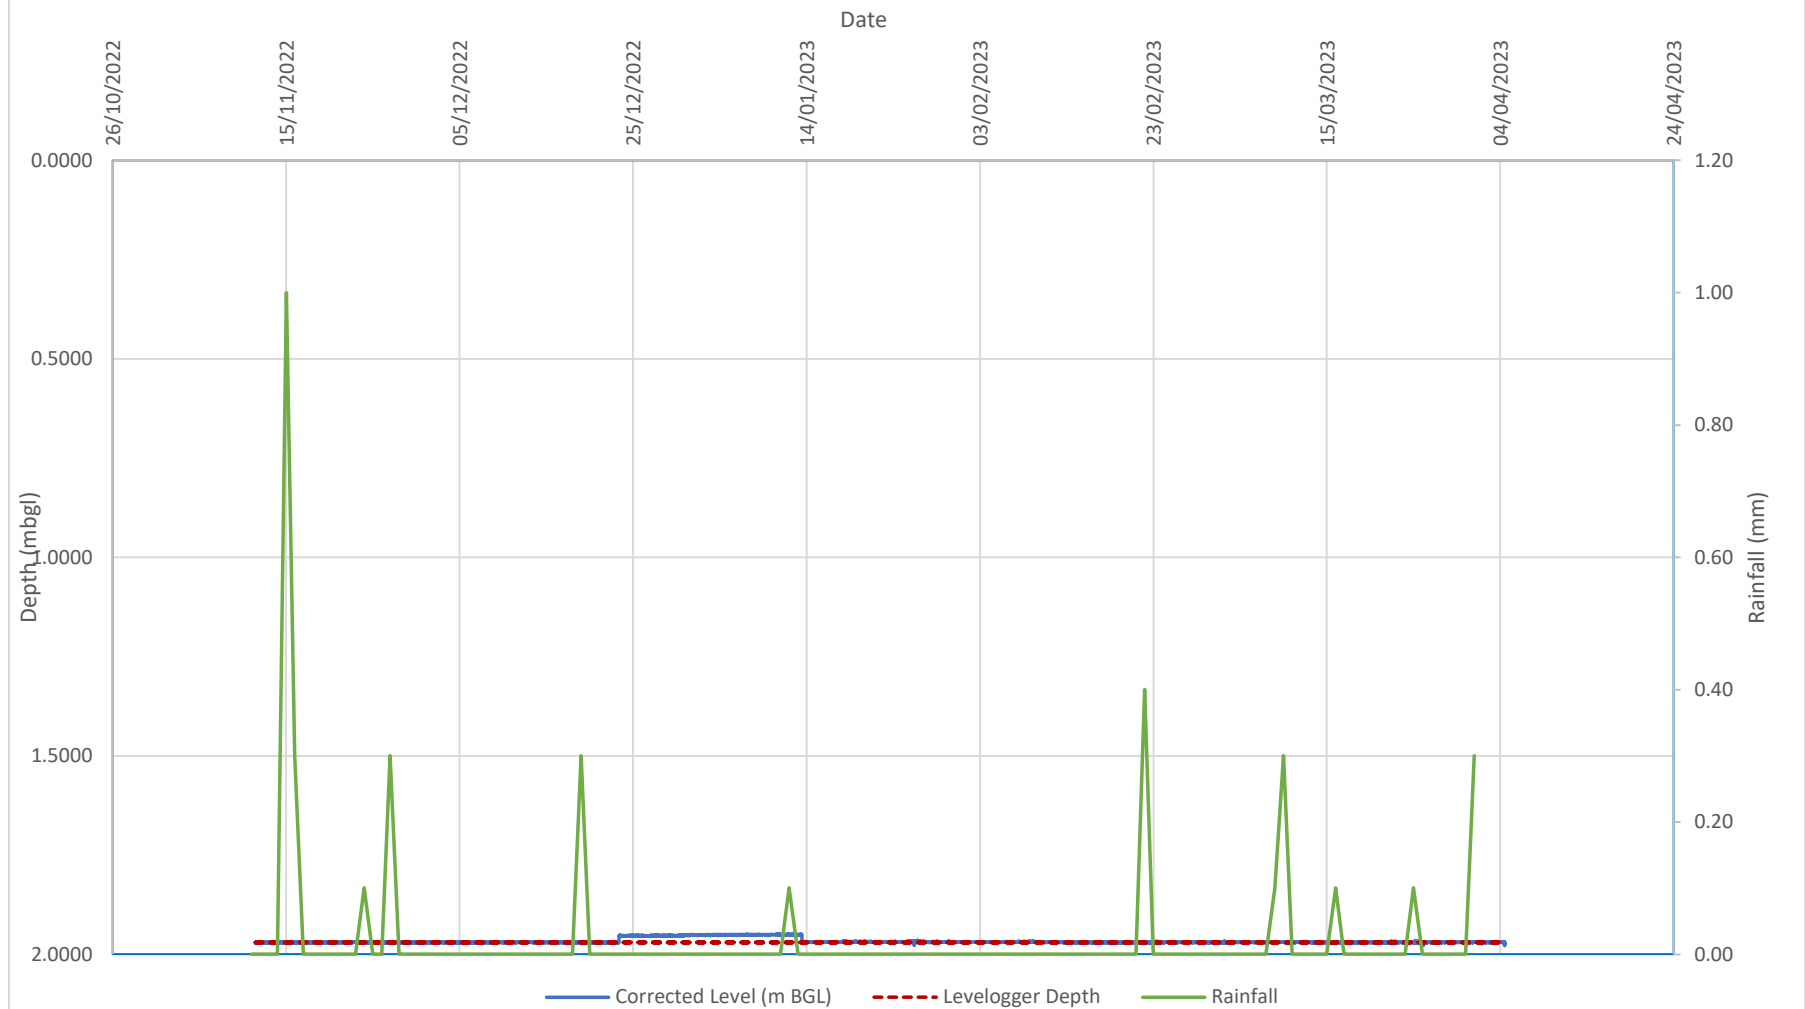
# WS105 Groundwater Level (mbgl)

| Location | Shallowest Groundwater Level (m bgl) | Deepest Groundwater Level (m bgl) | Date of Shallowest Groundwater Level | Date of Deepest Groundwater Level |
|---|---|---|---|---|
| WS105 | 1.94 | 1.97 | 13/01/2023 | 11/2023, 02/2023-04/2023 |
