# MEMORANDUM

| <b>Service</b> | WBC Ecology | <b>App No:</b> | 242953 |
| <b>Address:</b> | The Horns Inn, Crazies Hill, Wargrave, RG10 8LY. | | |
| <b>Proposal:</b> | Full application for the proposed change of use of part of the upper floor to guest accommodation (Use Class C1) and part to flexible Class C1 and E use; erection of a replacement gazebo with PV panels, removal of decking and 2 no. existing sheds and erection of 1 no. shed, plus landscaping and external alterations to the building including changes to fenestration and erection of a single storey canopy roof to the side. | | |

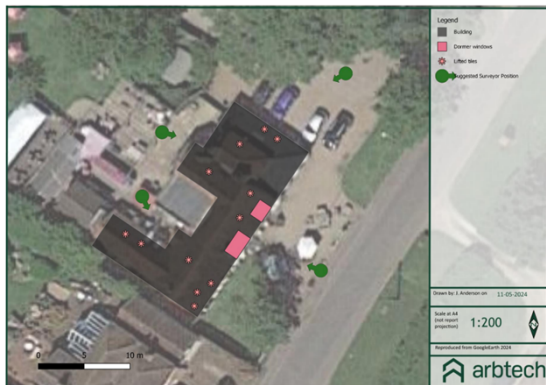
Appendix 1: PRA plan

The Preliminary Roost Assessment (PRA) recorded a complex roof structure, the majority of which is clad in clay tiles, and the lower half of the eastern extension is clad in slate tiles. There are numerous chimneys on the building. According to Arbtech's Ecologist, the site is located in a semi-rural part of Reading surrounded by large arable fields and woodland pockets. Owing to the surrounding mature trees and the proximity of a water body to the southwest of the sit the onsite habitat value for bats is assessed as optimal. Two large and two small loft spaces were surveyed in the pub/restaurant building B1. Numerous raised or missing tiles on the southeast, north elevation provide gaps which crevice-dwelling bats could exploit. The sub roof on the northeastern elevation had areas of cracked slate tiles which provide potential roosting features for crevice-dwelling species. The temperature

and relative humidity of the cellar and loft spaces are recorded in PRA Appendix 4. It appears that Arbtech did not complete a roost assessment for the barn.

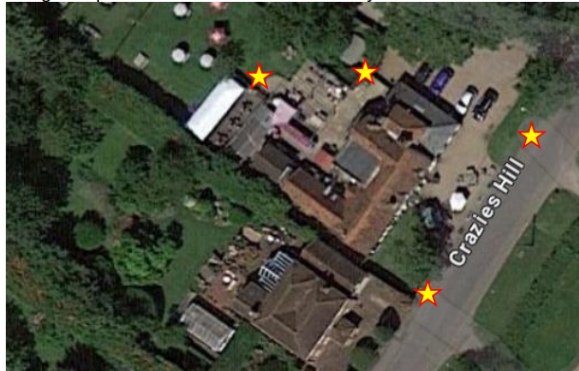
Arbtech state that four surveyors are required to provide full coverage of the building. For the emergence survey Chase Ecological consultancy's surveyors were not located in the car park opposite the northeastern slate-clad elevation and 1 was positioned further to the northwest beyond the gazebo further from the rear of B1. Chase Ecology's surveyors were equipped with EMT 2 Pro/Nightfox infrared cameras and no additional static cameras appear to have been used, survey locations added or amended following recording Common pipistrelle emergence on the 2<sup>nd</sup> survey on 10 August. Emergence Survey Section 5 Phase 2 Activity Survey does not make clear which bats were recorded, observed or filmed.

Google Map View to show locations of surveyors.

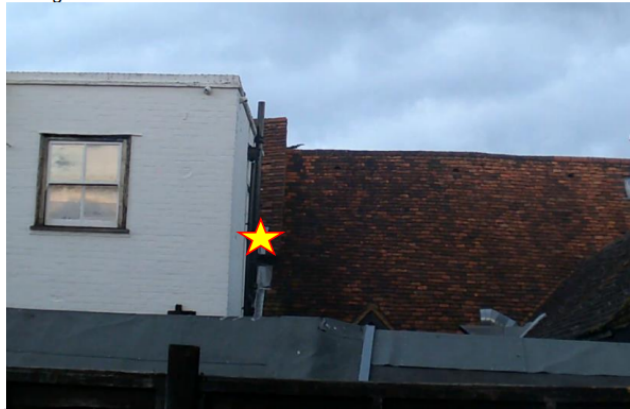
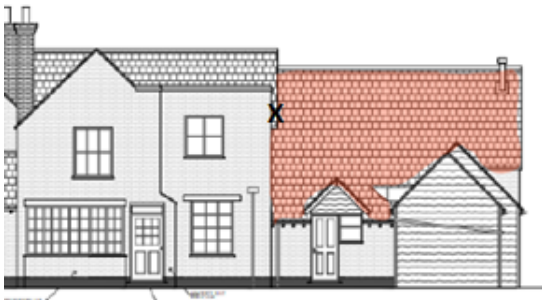
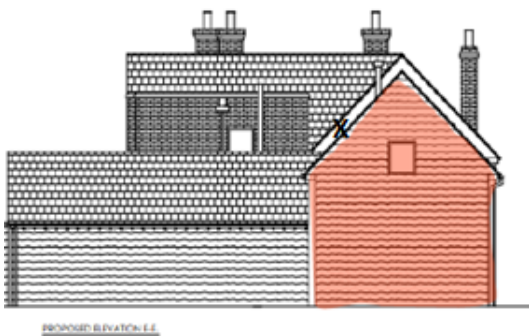
Emergence Two

During the nocturnal bat emergence surveys undertaken on 14/07, 10/08, and 02/09/2024 a maximum count of two single Common pipistrelle bats were recorded emerging from Roost 1 - South/West gable claddings/eaves; and Roost 2 – Common Nort/East facing lower roof coverings.

The Emergence Survey Report proposes that no European protected species licence will be required if the avoidance measures in appendix 1 are maintained at all times. The red zone on the rear northern elevation is shown adjacent to but not to include the “*Nort/East facing lower roof coverings*” shown in the photograph of emergence point two. The red zone shows the northwest facing barn roof which extends well below the Emergence point 2 identified by the yellow star on the lower part of the rear elevation slope of the main roof. I therefore disagree that not undertaking works in the proposed red zones will avoid disturbance, impacts or modification the Bat Roost 2. As a result, the application and emergence survey fail to demonstrate that there would be no requirement for a Europeans protected species mitigation licence.

I request that the Emergence Survey Report is corrected and also updated to take account of direct and indirect impacts of the development proposals to install first floor ensuite bathrooms adjacent to Roost 2. In addition, the revised assessment must take into account the ventilation for the ground floor toilets and first floor kitchen shown the slate roof and west-facing tiled roof above, as shown in Proposed Elevation B-B.

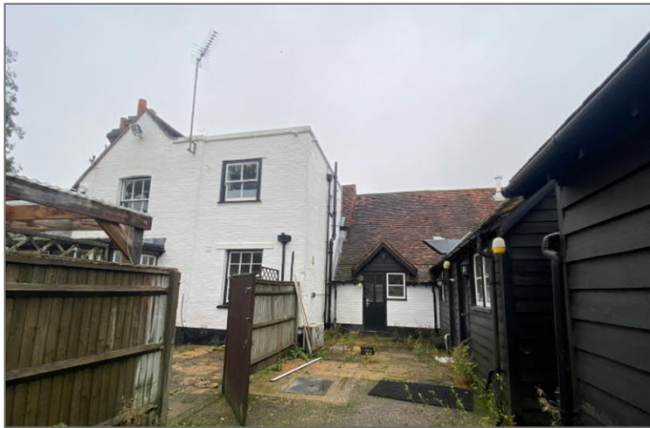
Image 22: North elevation of Barn and service yard

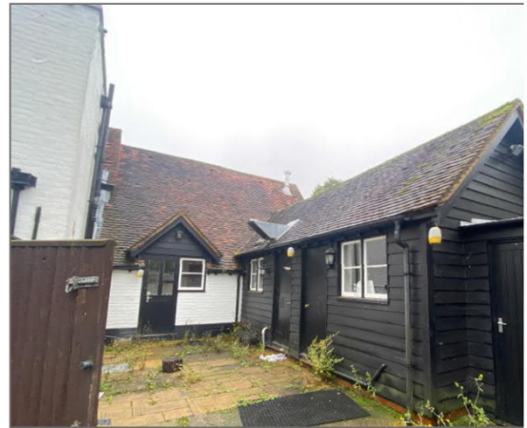
Image 23: View southwest of Kitchen and service yard

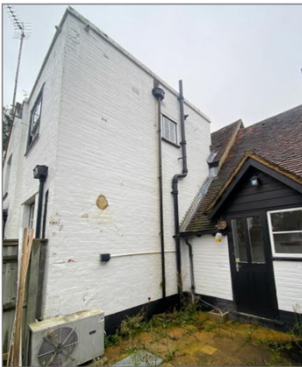
Image 25: West elevation of C20 extension
