## Bat Scoping and Emergence Report

**Arborfield House, Reading**

**28<sup>th</sup> September 2022**

**Project No: P4932**

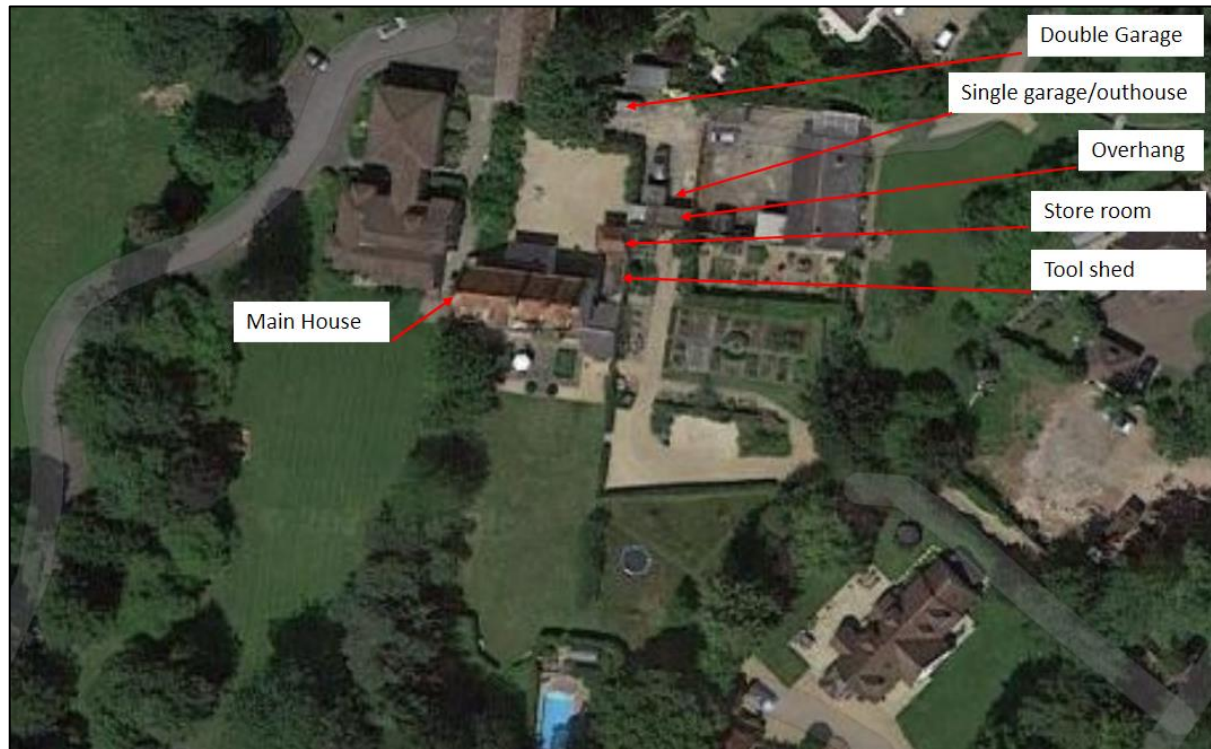
**Figure 1.** Aerial image of Arborfield House, Reading, with the surveyed buildings labelled for the purposes of this report.

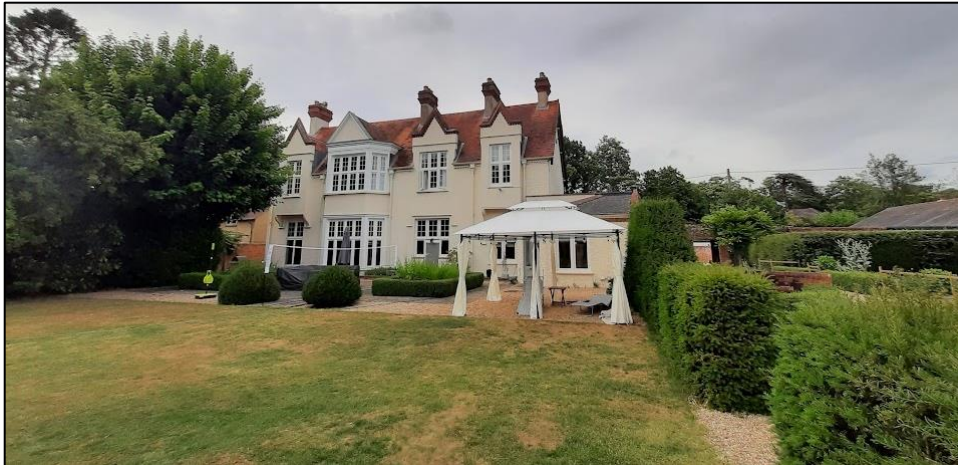
**Photograph 1.** The southern elevation of Arborfield House which is brick built and supports a hipped, gabled roof. Note the surrounding gravelled and hard-standing areas surrounding the property.

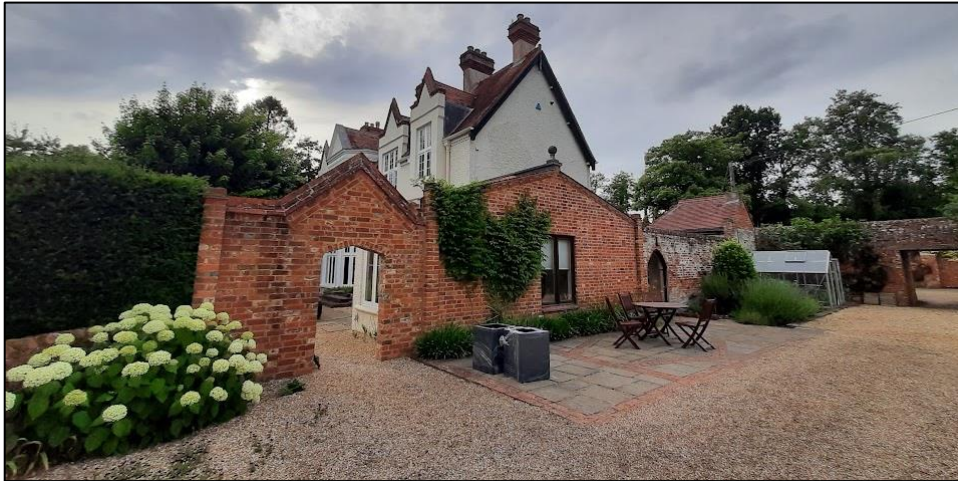
**Photograph 2.** The eastern elevation of Arborfield House. Also shown is the brick wall leading to the overhang (right side of image) and the southern and eastern aspect of the store, with a pitched roof.

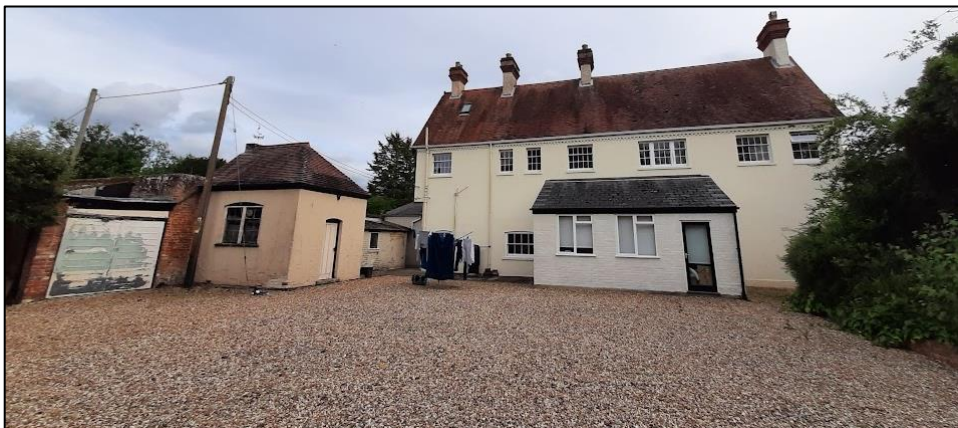
**Photograph 3.** The northern elevation of Arborfield House showing the single storey extension. Note the surrounding gravelled and hard-standing areas. Also shown are the north and western aspects of the store, with a pitched roof, hipped roof and the single garage/outhouse (to the left of the image).

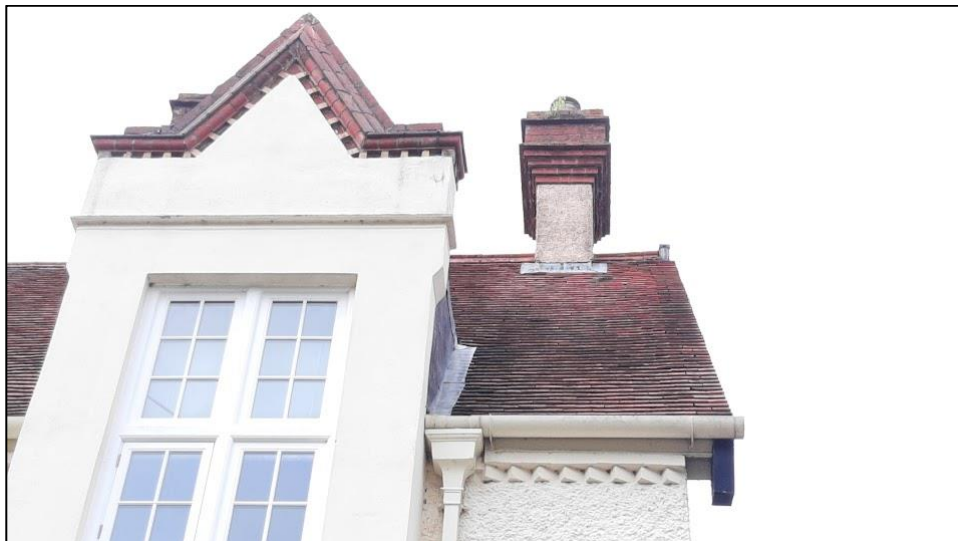
| Building section/<br>Tree | Description of features | Assessment of roost suitability<br>(Collins 2016) |
|---|---|---|
| Main House - exterior | <p>The property is well-maintained and in use as a dwelling. It has a rectangular footprint, with a small single-storey single-pitched rear (northern) extension covered by a slate roof. The property is two-storey and supports a pitched gable-ended roof covered in clay-tiles. The walls, which are brick-built and rendered/painted, are in a good state of repair, with no cracks or gaps identified. The slate tiles across the roof of the extension are tightly-fitted with no lifted tiles or naturally occurring gaps identified. However, moderate numbers of external crevice features were identified under the clay roof tiles and the lead-flashing, creating potential bat access into suitable roosting features between the tiles and the internal sarking boards which line the loft void of the main house. The wooden soffits and fascia boards were tightly fitted across the building.</p> <p>No evidence of bats was identified during the external assessment.</p> | Moderate bat roost suitability |

**Photograph 4.** An example of the gaps identified across the roof of the main house providing suitable bat access and roosting opportunities.

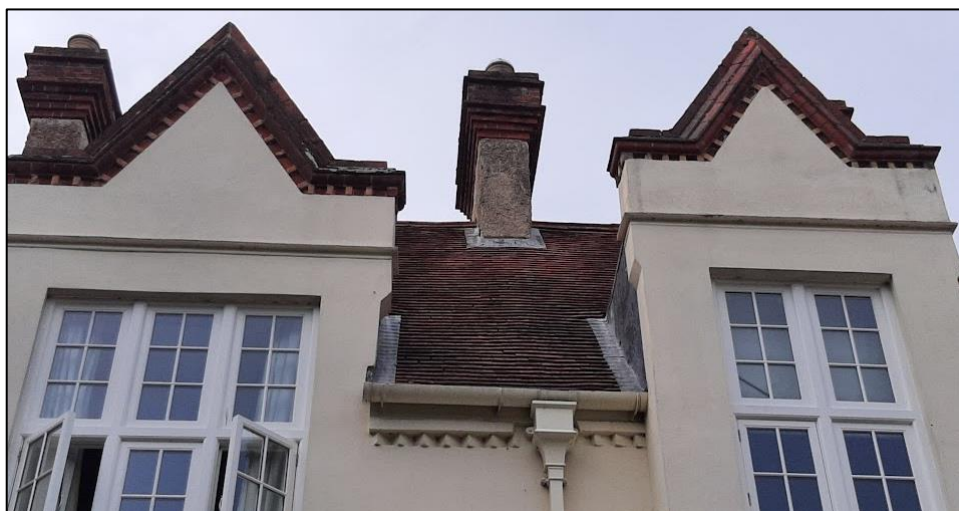
**Photograph 5.** An example of the gaps identified across the roof of the main house providing suitable bat access and roosting opportunities.

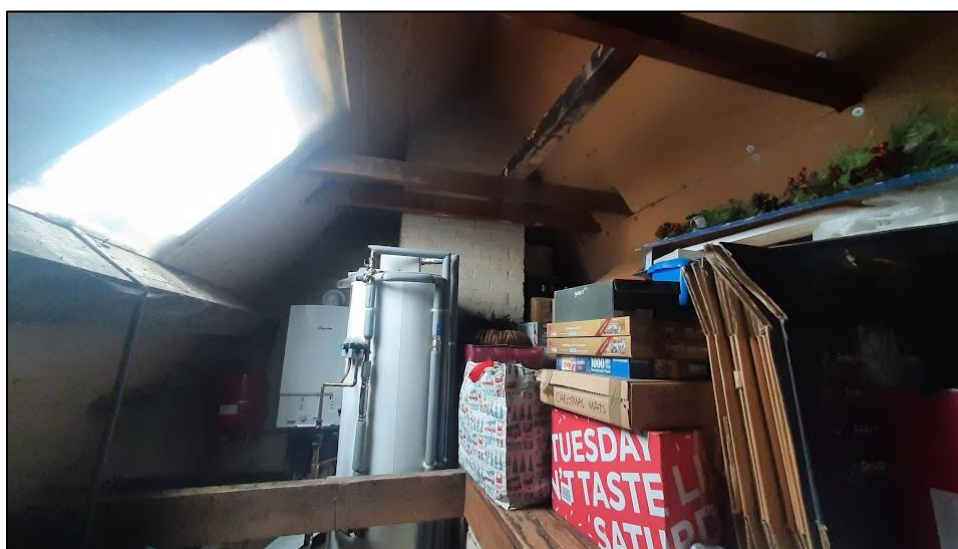
| interior | <p>The void is used for light-storage and there were no recent signs of disturbance. The space is timber-framed, lacking any cracks or crevices, has some exposed brickwork and timbers and is boarded with wood internally at ground and roof-level, with gaps showing the sarking boards lining the roof internally.</p> <p>Loft void two is a crawl space spanning the length of the northern aspect of the property at eaves-level and measures approximately 1.2m (w), 14m (l) and 1m (h). It is boarded at ground-level, with a timber-frame, exposed brickwork and insulation present between the rafters. The space is small and has a modern timber-frame which lacks any cracks or crevices.</p> <p>No evidence of bats was identified within either of the two loft spaces. However, evidence of previous use by nesting birds was noted.</p> | |

**Photograph 6.** Loft void one within Arborfield House.

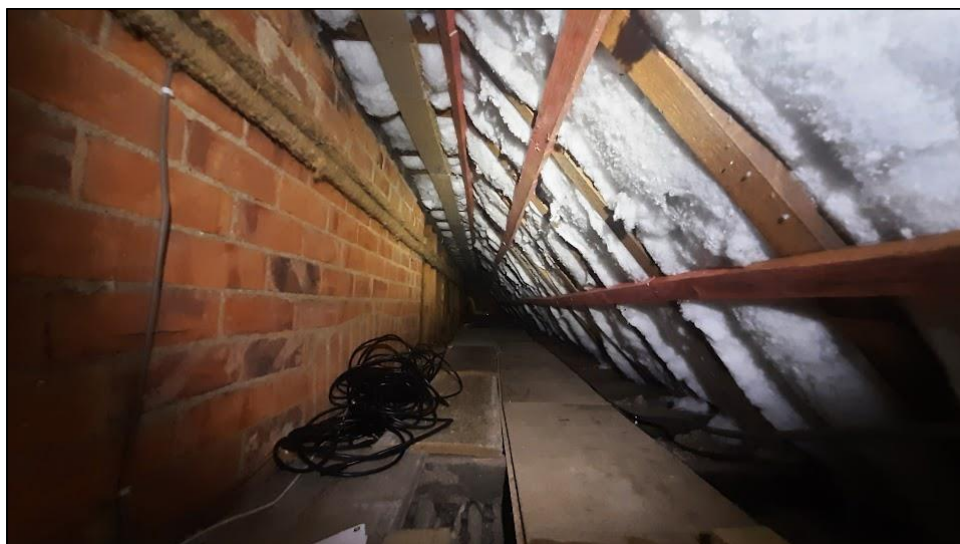
**Photograph 7.** Loft void two within Arborfield House.

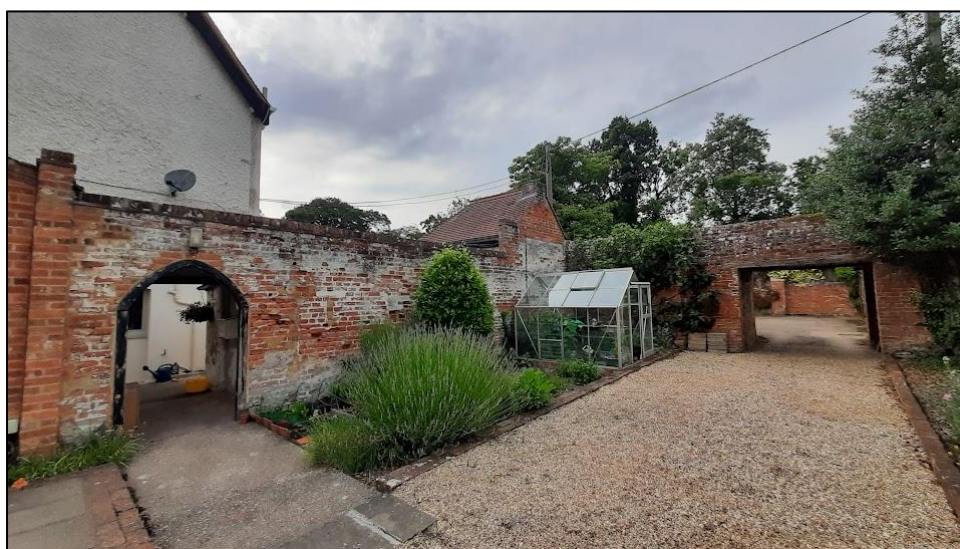
**Photograph 8.** The brick-built wall and southern aspect of the overhang.

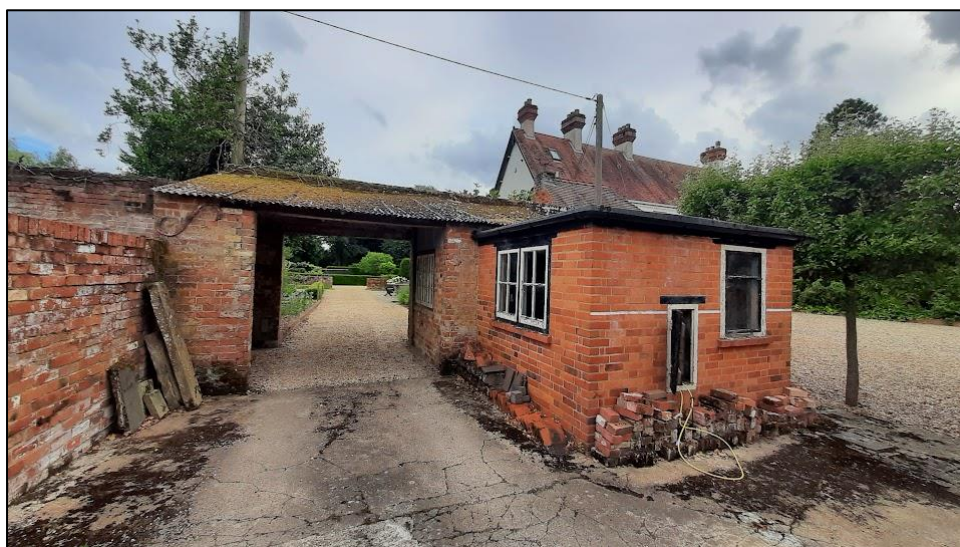
**Photograph 9.** The brick-built wall and northern aspect of the overhang. The northern and eastern aspects of the flat-roofed single garage/outhouse are also shown to the right side of the image.

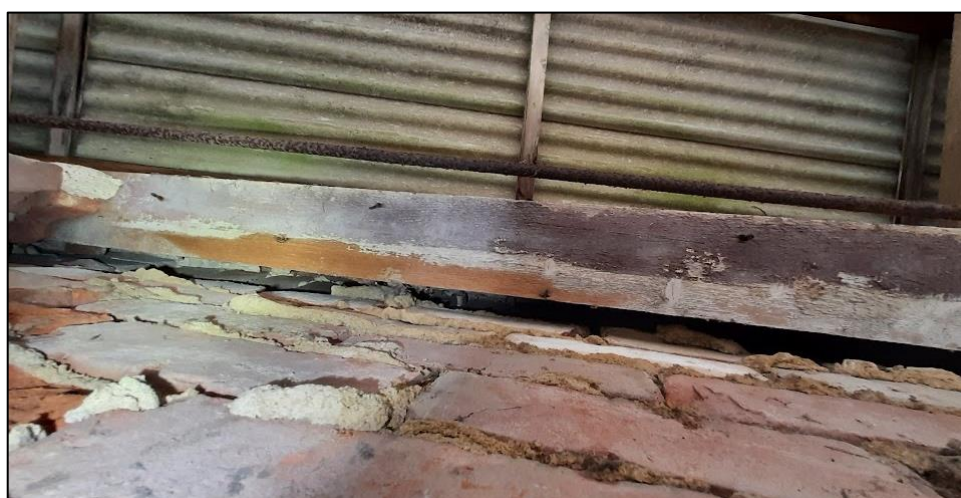
**Photograph 12.** The horizontal gap to the cavity taken. Picture taken from beneath.

A repeat endoscope inspection should be undertaken of the overhang prior to any works completed on this structure. If the store is due for demolition, the ceiling will be broken through carefully under bat licensed supervision to allow an internal inspection of this void prior to any work impacting the roof areas. All ridge, hip and verge tiles on the roof of the store and main house will be undertaken under the direct supervision of a Natural England Class 2 bat licence holder.

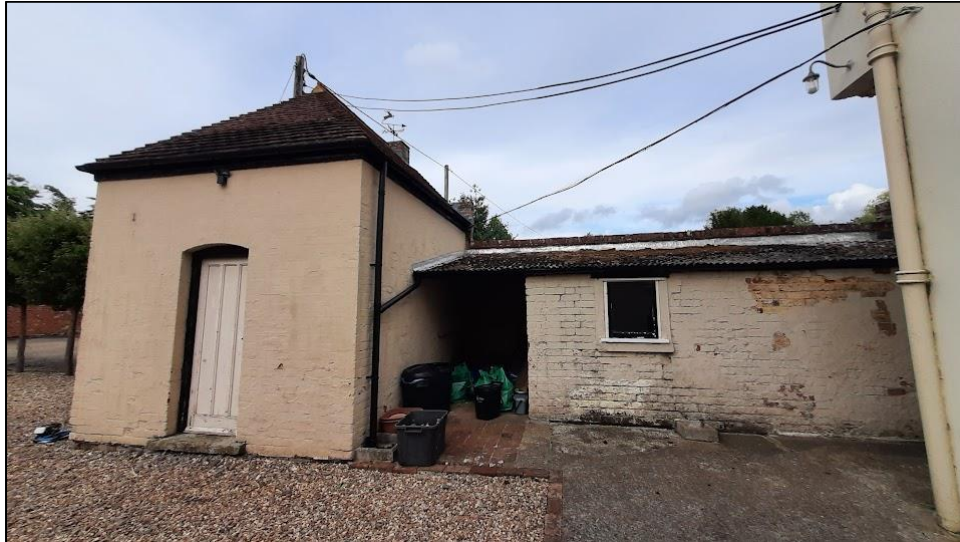
**Photograph 13.** The western and southern aspects of the store (left side of image) and the western aspect of the tool shed, with adjoining log store (centre and right side of image).

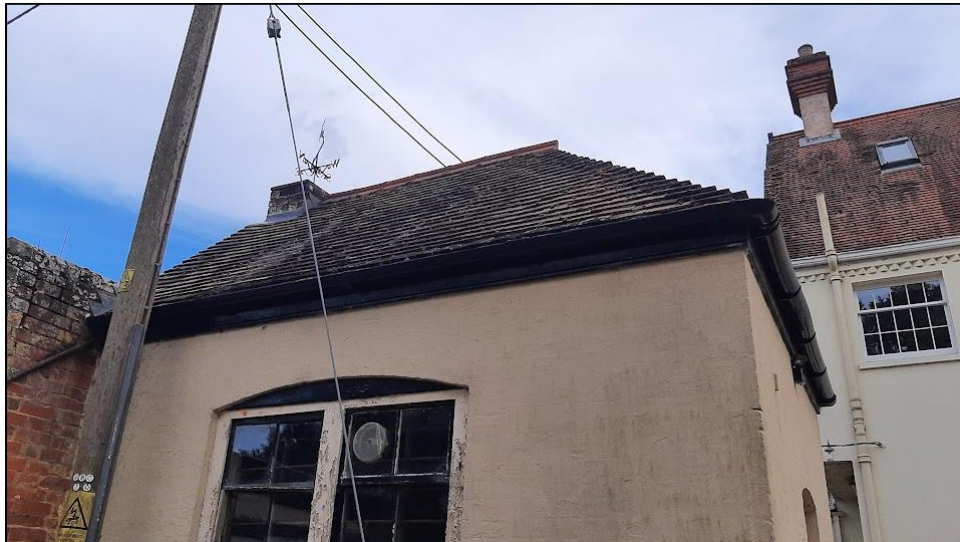
**Photograph 14.** The northern and western aspects of the store and its proximity to the main house.

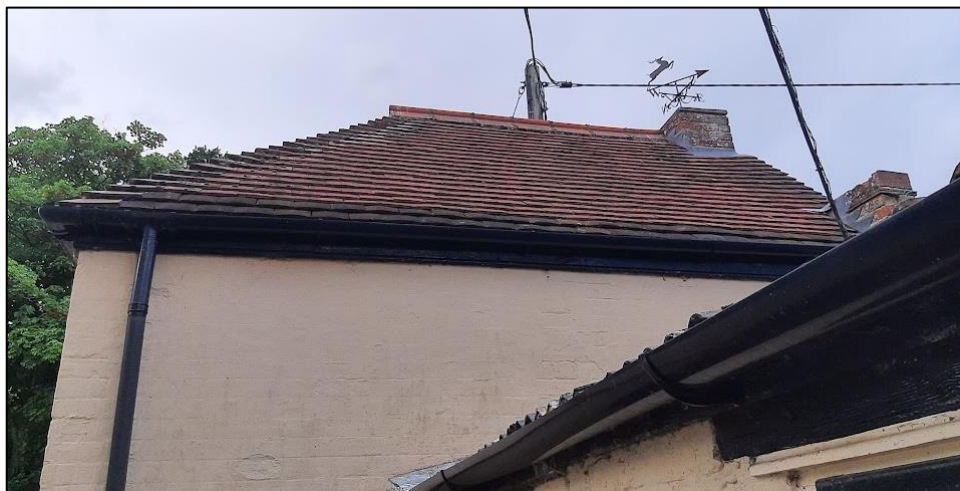
| The Store - external | <p>The store is a single-storey building which supports a pitched roof covered in clay-tiles with a gable-ended construction on the eastern aspect and hipped construction on the western aspect. The walls, which are brick-built and painted, are in a good state of repair, with no cracks or gaps identified. Low numbers of the clay tiles across the roof are lifted or have naturally occurring gaps creating external crevice features providing potential bat access into suitable roosting features between the tiles and the internal lining. The wooden soffit/fascia/barge boards were tightly fitted across the building.</p> <p>No evidence of bats was identified externally.</p> | Low bat roost suitability |

**Photograph 15.** An example of the gaps identified across the roof of the store providing suitable bat access and roosting opportunities.

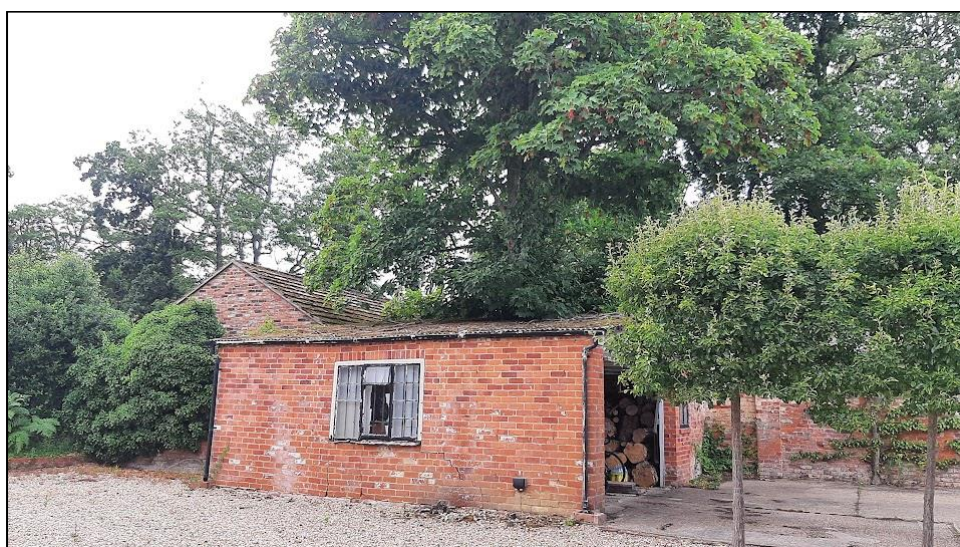
| Double garage - exterior | <p>The double garage is brick-built with a single-pitched corrugated chrysotile roof, a window on the southern aspect, an up-and-over door on the eastern aspect and an access door on the western aspect. The garage is displaying signs of severe structural deterioration in the form of large cracks noted in the brickwork, but no features were deemed suitable for supporting roosting bats.</p> <p>No evidence of bats was identified.</p> | Negligible bat roost suitability |

**Photograph 17.** The southern and eastern aspects of the double garage. Note the large cracks in the brickwork.

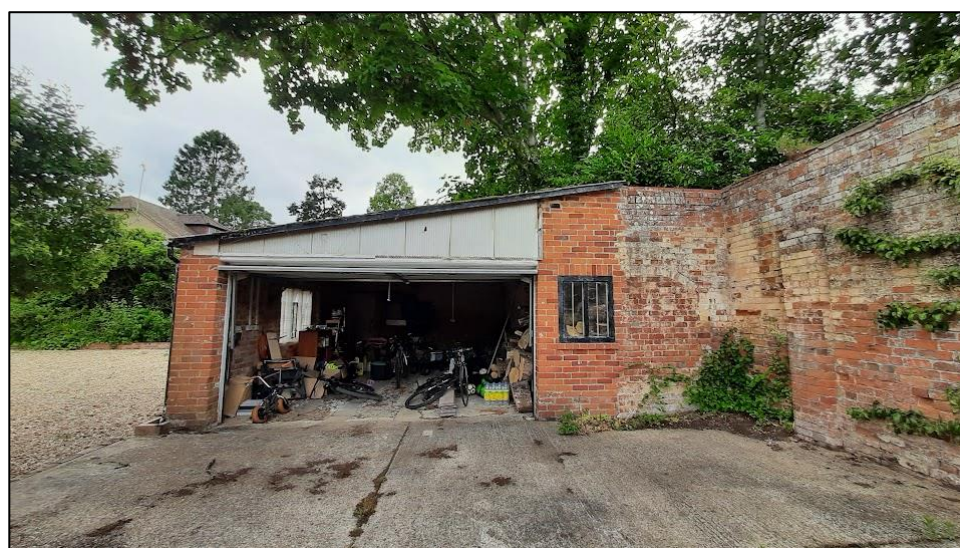
**Photograph 18.** The southern and eastern aspects of the double garage.

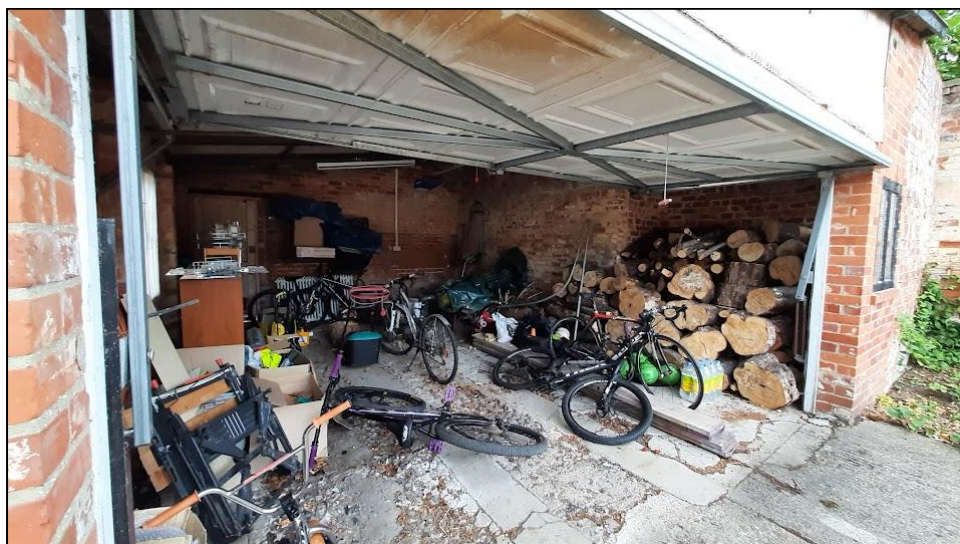
**Photograph 19.** The internal areas of the double garage facing north-west.

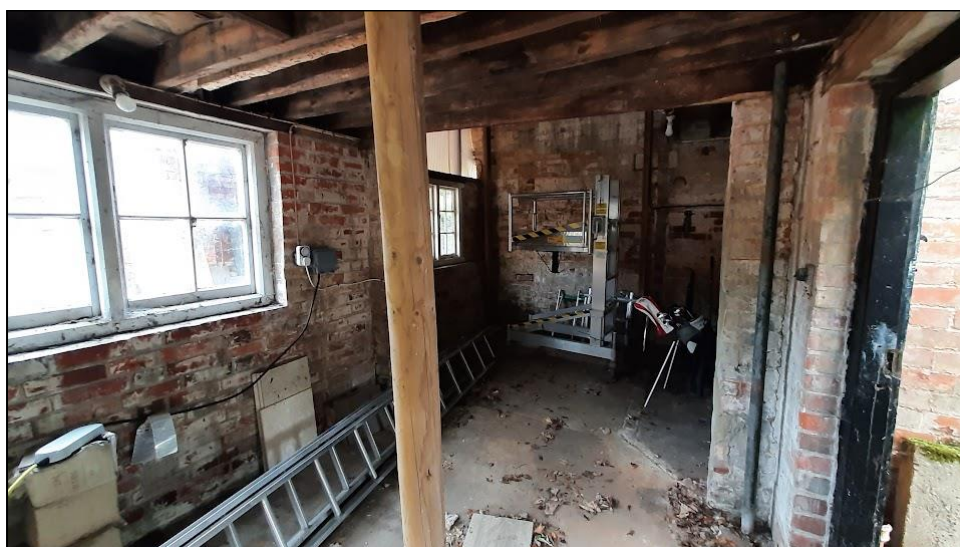
**Photograph 21.** The internal areas of the single garage/outhouse taken facing south.

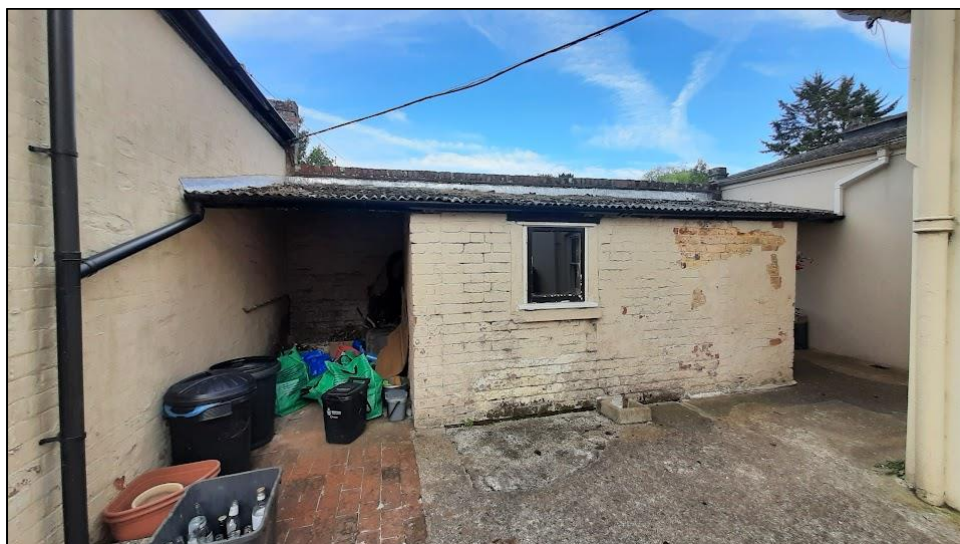
**Photograph 22.** The western aspect of the tool shed, with adjoining log store.

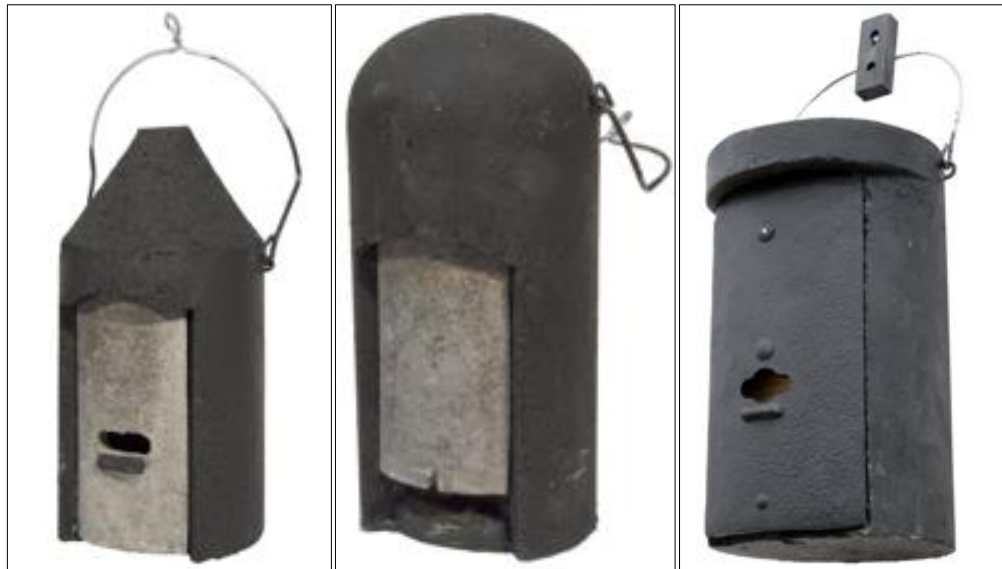
**Figure 1.** Left to right, the 2F, 2FN and the 1FS bat boxes produced by Schwegler. These and other brands are available at many on-line wildlife stores. These are constructed of ‘woodcrete’ (a mixture of cement and woodchip) and are designed to be durable and replicate the stable thermal properties of trees and buildings. They may be attached to trees or buildings.

Consideration should be given to the installation of bat boxes within the site, to provide suitable replacement roosting features should these be lost by the removal of these buildings. Bat boxes such as the Woodstone Bat Box are designed to be mounted on walls of buildings and provide a self-contained roost. Alternatively, bat boxes such as the 2F Schwegler Bat Box are designed for mounting on trees. Provision of four bat roost features made of woodcrete or similar within the site is considered a suitable level of compensation/enhancement, given the number of features potentially due to be lost. If it is concluded that these buildings will require removal, the measures below should be adhered to for any work impacting the store and overhang and on Arborfield House:

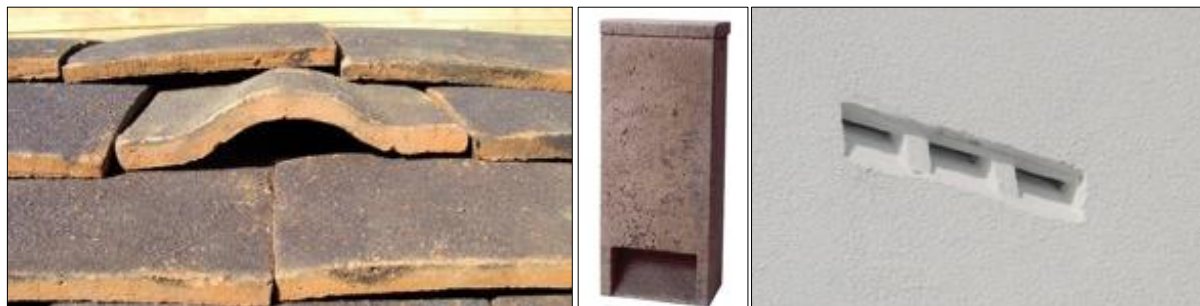
**Figure 2.** Examples of integral bespoke bat roosting features that may be incorporated into buildings during construction/renovation. From left to right: an example of bat access tile into loft space; the 2FR bat tube; and an example of 2FR bat tubes installed into a house wall in a series of three. Other brands and designs are available.
