## **PRELIMINARY ECOLOGICAL APPRAISAL (DBW) AT 33 STANTON CLOSE EARLEY**

**Prepared for:  
Mr S Mateen  
33 Stanton Close  
Earley  
Reading  
RG6 7DX**

**24 July 2025**

**Ref: SPH/NP/PEA-25/16.07**

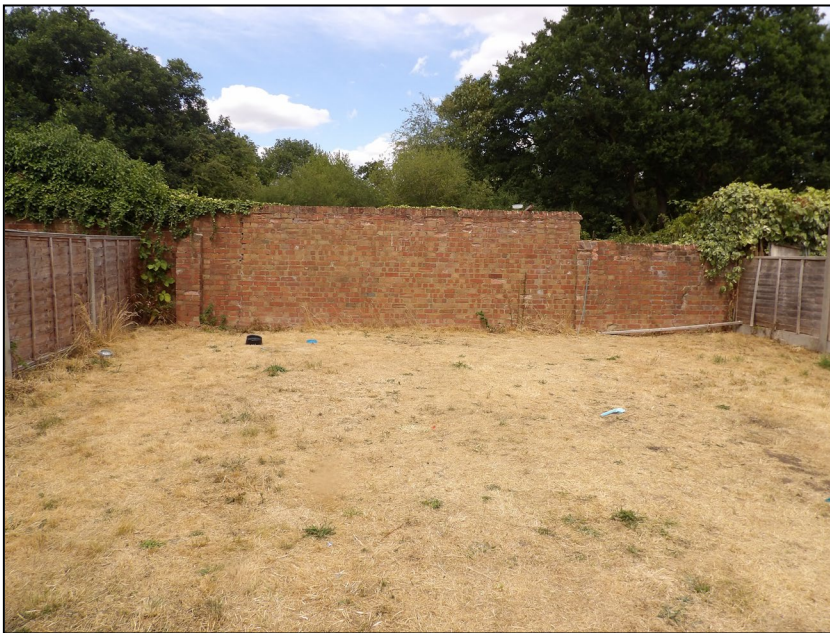
The application site comprises a semi-detached, 2 storey brick-built and part painted and rendered property with attached garage and rear single-storey extension and conservatory. The remainder of the site comprises a driveway/parking area to the front and a rear garden is laid to lawn, see Figure 3 below. The site offers no foraging or commuting habitat for bats, however there some ecological connectivity to bat foraging and commuting habitat in the rear of the site.

Figure 3. Rear garden. 33 Stanton Close, Earley. 16.07.25

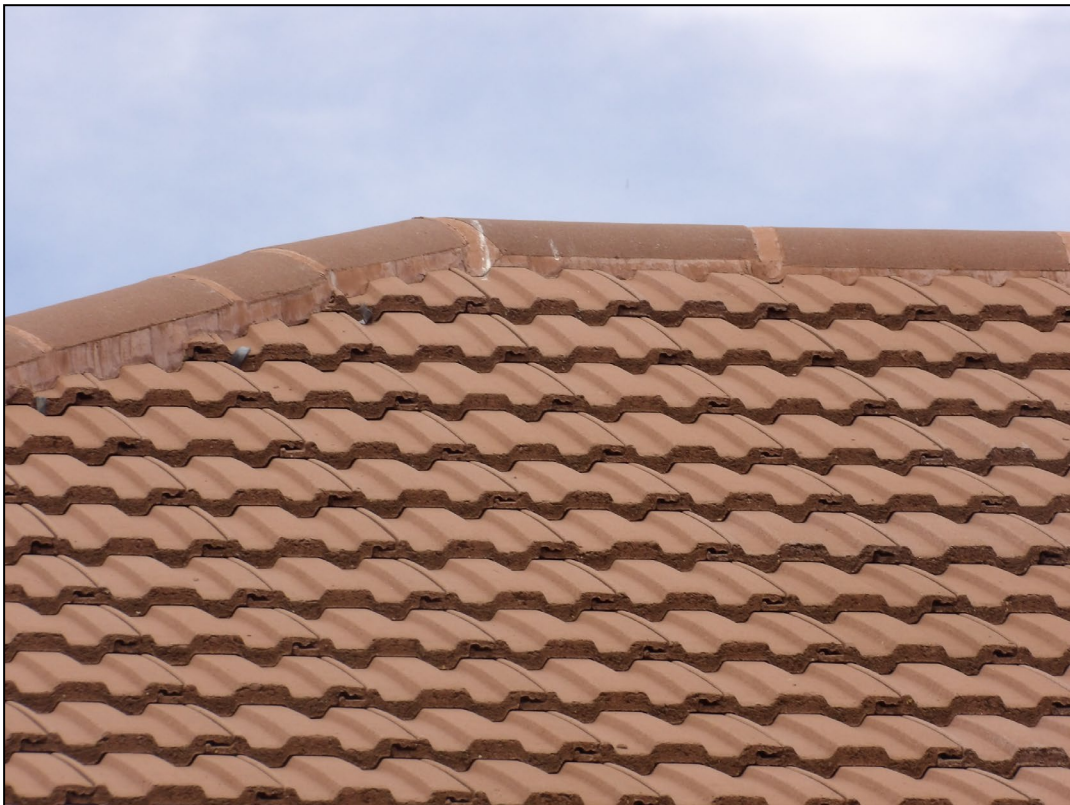
The property is a semi-detached, brick-built and part rendered/painted 2 storey building which is in a good condition externally. The hipped roof is covered in interlocking tiles, none of which are broken or missing, see Figure below. The ridge and hip tiles are firmly cemented with no missing mortar or gaps that crevice dwelling bat species could exploit, see Figure 4 below. The lead flashing around the shared chimney stack is flush (see Figure 5 on page 9) and the uPVC fascias and soffits are tight to the wall with no splits or gaps and offer no roosting opportunities for bats, see Figure 6 on page 9. To the rear is a mono-pitched extension and conservatory, see Figure 7 on page 10. The roof of the extension is covered in well fitted tiles with no gaps, it is firmly affixed to the main dwelling and the verges are sealed, as are the fascias, see Figure 8 on page 10. The uPVC and glass conservatory on dwarf brick wall with Perspex roof (see Figure 9 on page 11), offers no roost potential due to the construction materials, light ingress and poor thermal properties.

Figure 4. Example of interlocking roof and sealed ridge/hip tiles. 33 Stanton Close, Earley. 16.07.25

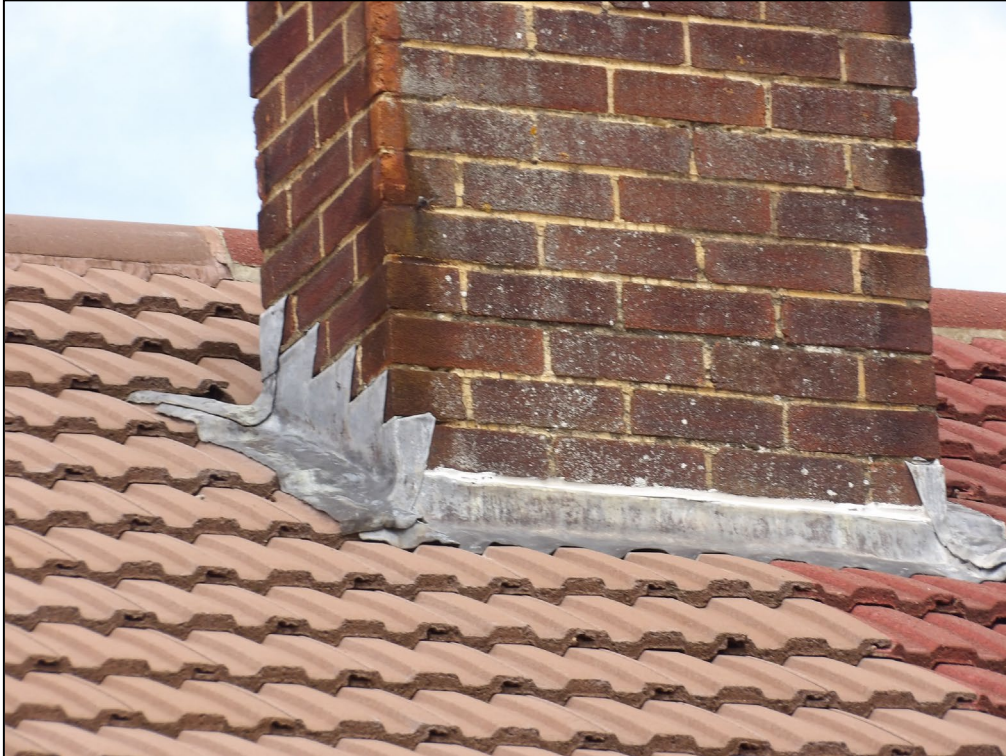
Figure 5. Example of sealed lead flashing. 33 Stanton Close, Earley. 16.07.25

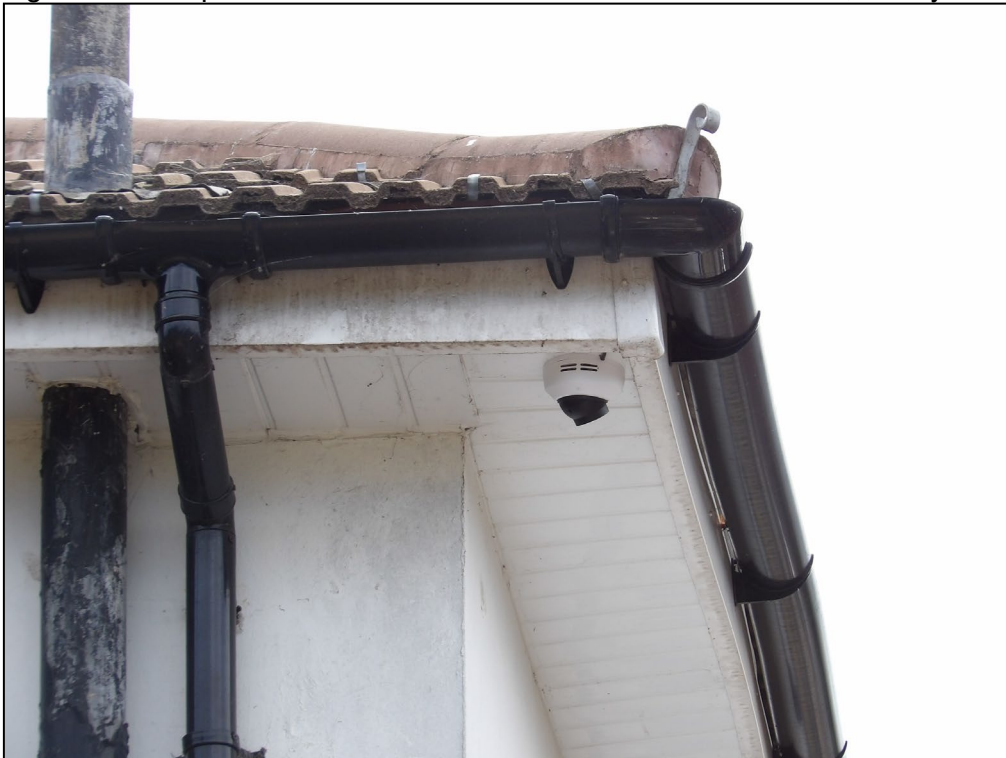
Figure 6. Example sealed uPVC soffits/fascias. 33 Stanton Close, Earley. 16.07.25

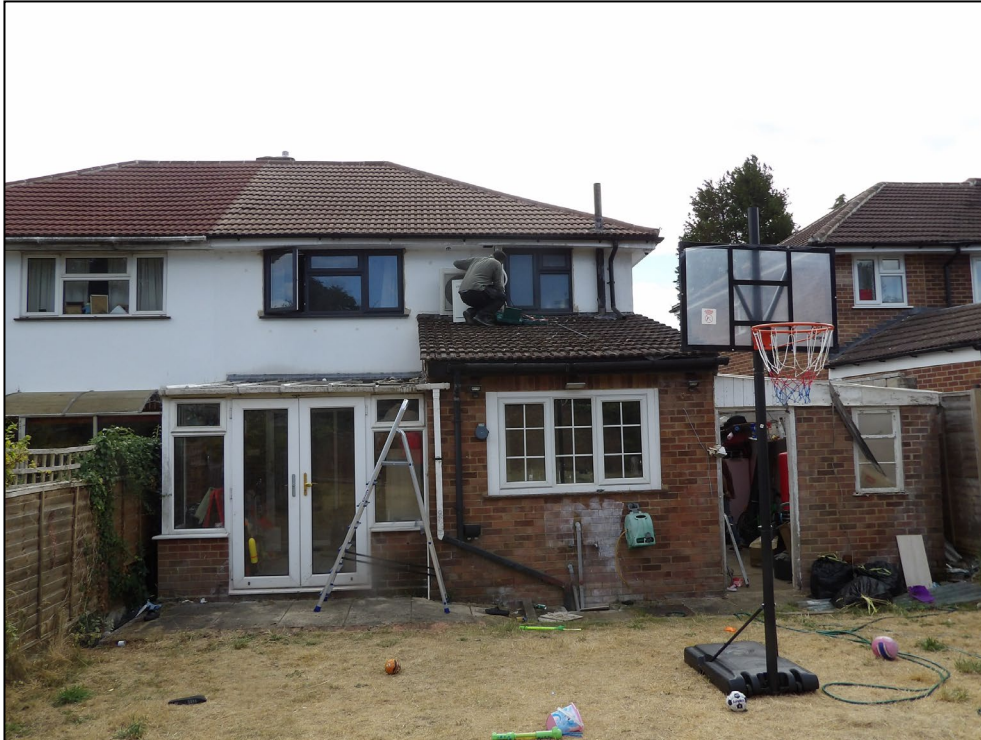
Figure 7. Rear view of property and extension and conservatory. 33 Stanton Close, Earley. 16.07.25

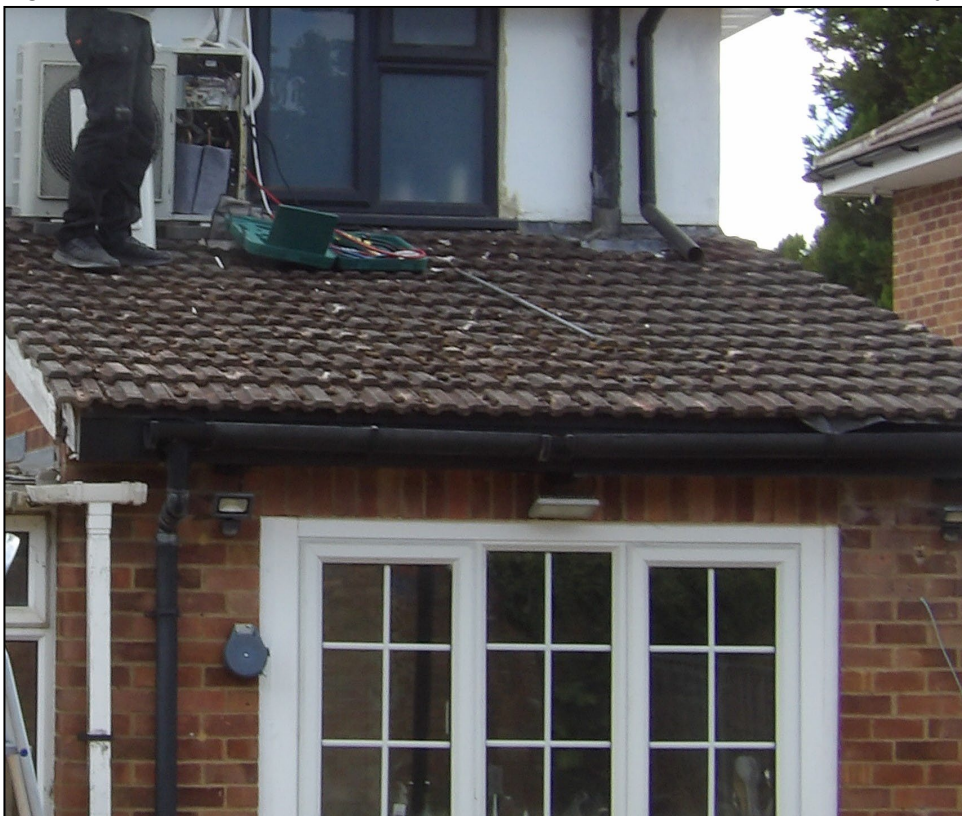
Figure 8. Roof of rear, mono-pitched extension. 33 Stanton Close, Earley. 16.07.25

There was no access to the roof void in the rear, mono pitched extension but given the good condition of the roof tiles externally, this was not thought to be a significant constraint to the survey.

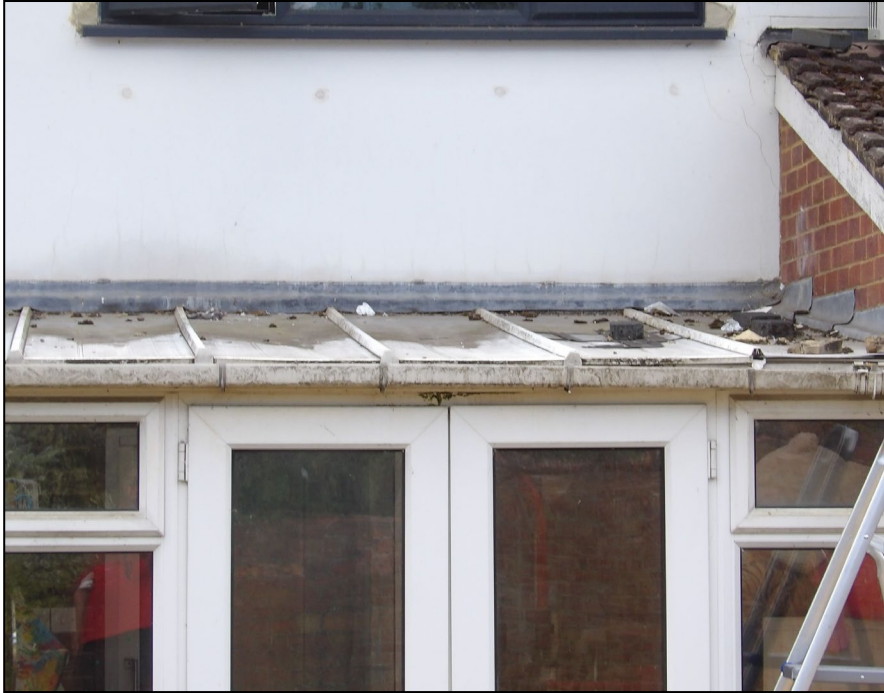
Figure 9. Perspex roof of conservatory. 33 Stanton Close, Earley. 16.07.25

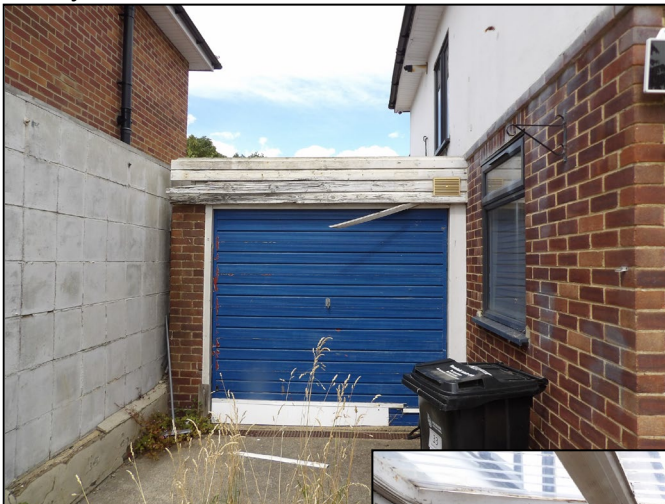
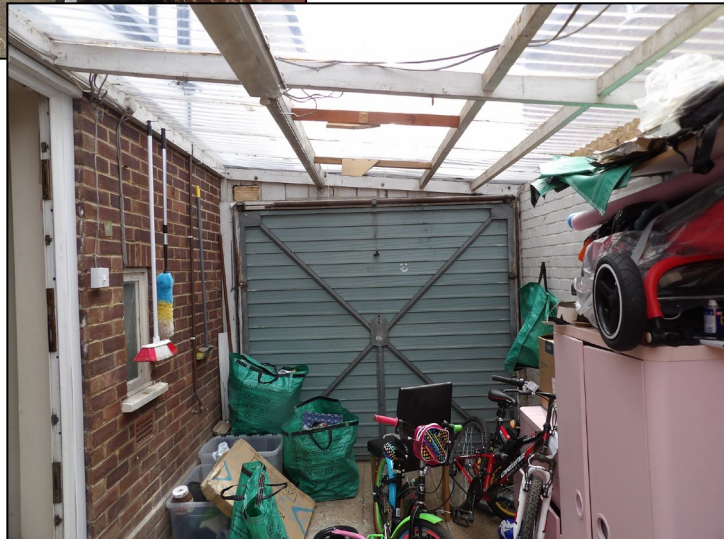
On the western elevation is the attached garage, see Figure 10 on page 11. The roof is covered in corrugated Perspex sheets, and due to the construction material and light ingress, this building offers no roosting potential, see Figure 10 on page 11.

Figure 10. Garage and internally view of corrugated Perspex roof. 33 Stanton Close, Earley. 16.07.25

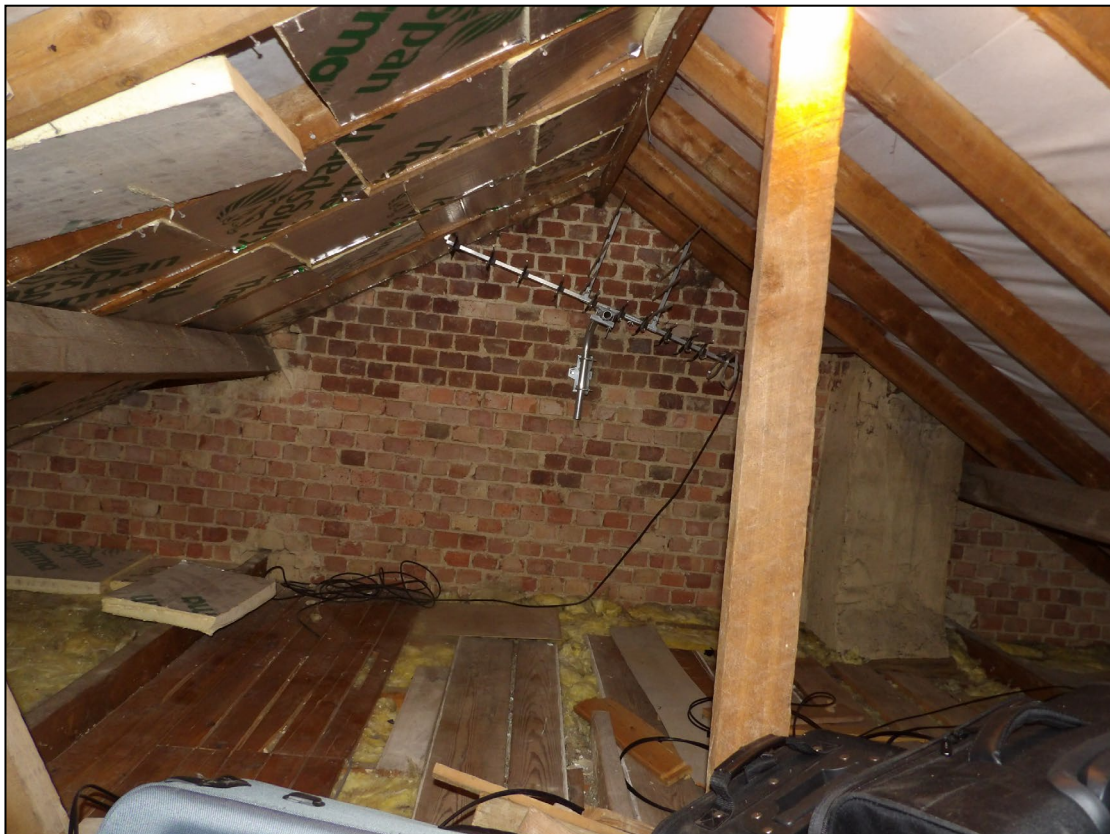
The loft of the property was accessed via a ladder and appeared to be in a good condition. The loft space was lit, boarded and insulated and the roof tiles are lined with a combination of insulation and membrane, see Figure 11 below.

No bats or evidence of bats was recorded during the internal of the loft and internally there appeared to be no roosting opportunities for bats within this space.

Figure 11. Example of loft space and insulation/membrane lining. 33 Stanton Close, Earley. 16.07.25
