10a Holmes Crescent  
Wokingham  
Berkshire  
RG41 2SD

## Preliminary Roost Assessment

Report ref.: R3124\_PRA\_a

**February 2026**

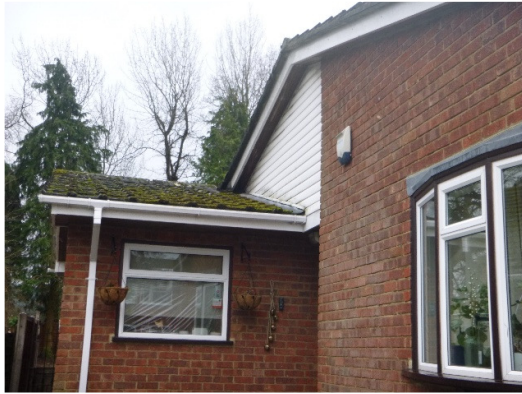
**5.2.2** The detached bungalow was of brick construction with PVC cladding along the side elevations on the southwest and northeast. The roof was pitched with two pitched roof side extensions and there was a detached single storey flat roofed garage to the southwest of the property (**Photographs 1 & 2**).

*Photograph 1. Side elevation, viewed from the southwest.*

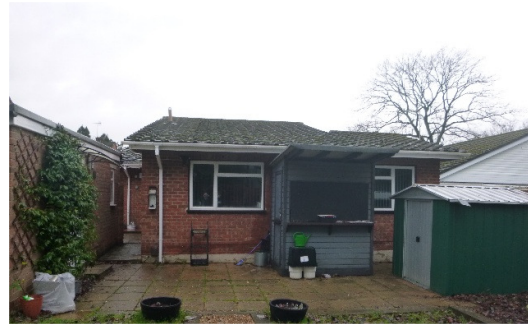
*Photograph 2. Rear elevation, viewed from the southeast.*

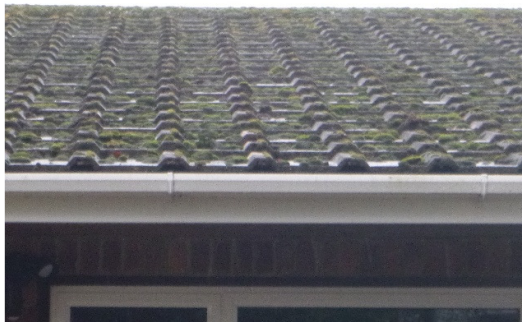
**5.2.3** The bungalow's pitched roof was covered by interlocking concrete tiles that were in place and tightly fitted (**Photograph 3**). The mortar along the ridge was intact however there was some crumbling mortar along the verge at the southwestern side and at the apex of the gable end extension along the southwestern elevation. The gaps were investigated from a ladder with an endoscope. The gaps in the verge mortar at the southwestern end went into the soffit box and showed no evidence of the presence of bats or historic use by bats (**Photographs 4-6; Target note 1**). The gap at the apex was shown to be of limited extent as it did not lead to any suitable crevices.

*Photograph 3. Tight fitting interlocking concrete tiles (rear southeast elevation)*

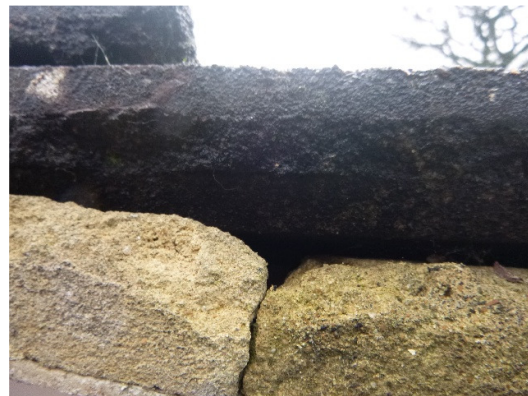
*Photograph 4. Verge mortar crumbling; when investigated with endoscope showed no evidence of use by bats (southwestern elevation).*

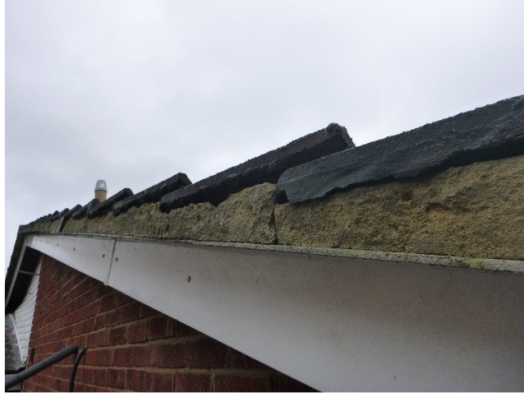
*Photograph 5. Crumbling mortar along the verge (southwestern elevation)*

**6.1.3** The crumbling mortar along the main verge and at the apex of the gable end on the southwest elevation were investigated with an endoscope which showed no evidence of use. The gaps along the verge lead directly into the soffits which were filled with fibreglass and no evidence of historic or current use by bats was evident. The gap at the apex was of limited extent unsuitable for crevice dwelling bats, such as the locally recorded common pipistrelle (*Pipistrellus pipistrellus*). The gap under the lead flashing along the rear of the property was inspected using binoculars and a high powered torch and deemed to be of limited extent.

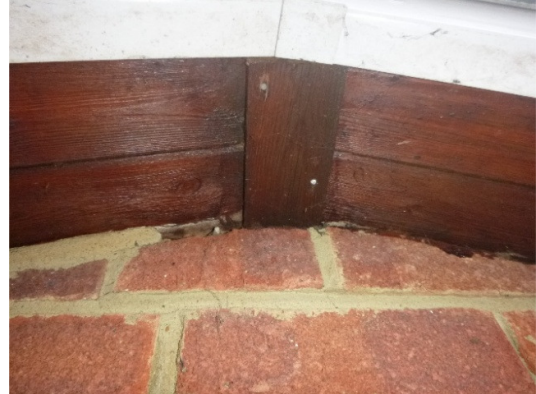
*Photograph 6. Crumbling mortar at the apex of the gable end extension which was of limited extent (southwestern elevation)*

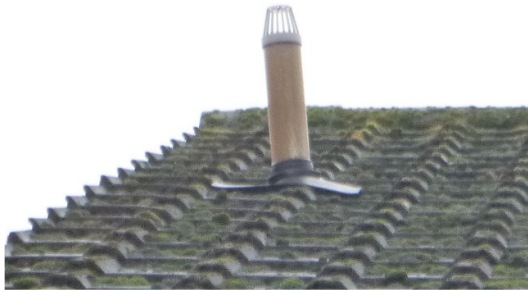
- 5.2.4** There was a gap under the plastic flashing around the flue pipe on the rear southeast elevation, however this was concluded to be of limited extent where the plastic was sat on top of roof tiles (**Photograph 7; Target note 2**). The soffits were well sealed throughout (**Photograph 8**).

*Photograph 7. Gap under lead flashing from flume pipe (front northwest elevation)*

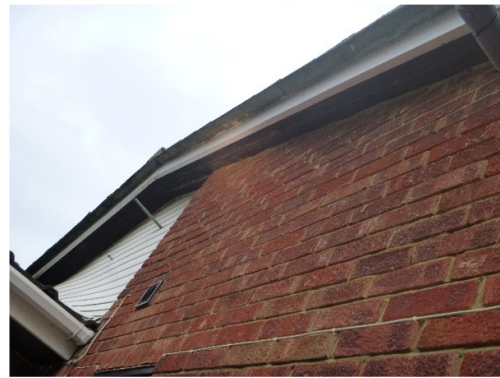
*Photograph 8. Sealed soffits throughout (northeastern elevation)*

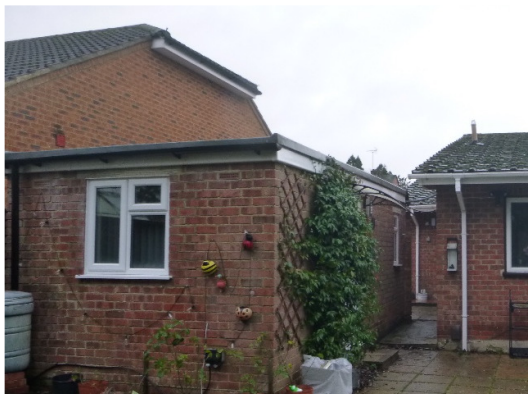
- 5.2.5** The detached converted garage had a flat roof that was lined with bitumen felt which was fully intact and had tightly fitted barge boards (**Photographs 9**).

*Photograph 9. Flat roof garage.*

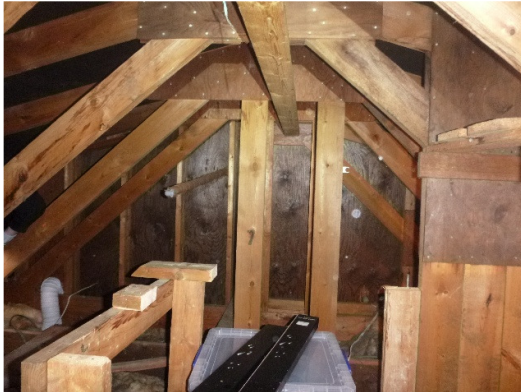
- 5.2.6** The building had one roof void that covered the main footprint of the property and was accessible via a ground floor loft hatch. The void was of trussed rafter construction with rafters and supporting trusses, and had an approximate floor-to-ridge height of 0.5 metres (**Photograph 10**). The ridge was lightly cobwebbed.

*Photograph 10. Trussed roof construction*

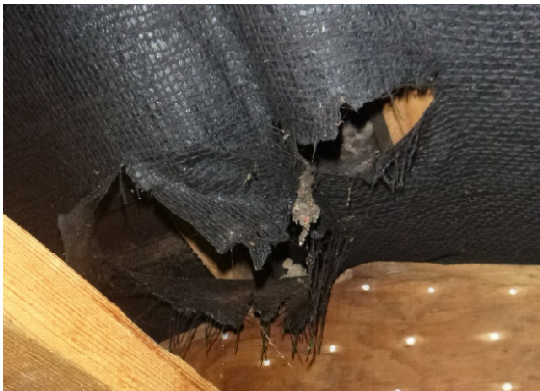
- 5.2.7** The roof was lined with bitumen felt. It was mostly intact with a small tear which had the roof tiles visible (**Photograph 11**; **Target note 3**). The floor was un-boarded with fibreglass insulation. The eaves were blocked and filled with fibreglass insulation down to the soffit (**Photograph 12**).

*Photograph 11. Tear in bitumen felt with tiles visible behind*

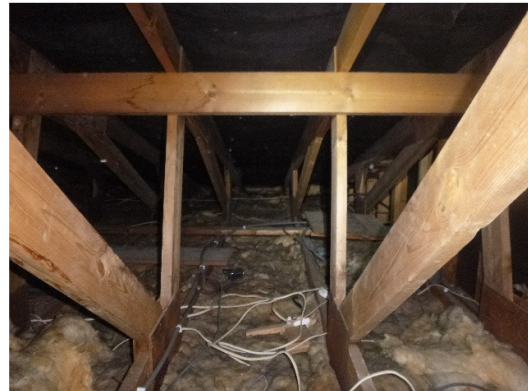
*Photograph 12. Roof lined with fibreglass*

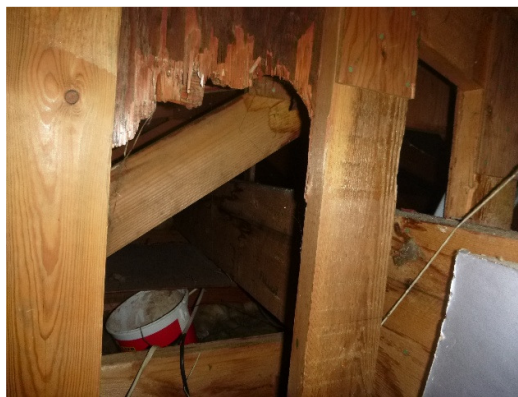
- 5.2.8** The gable ends were sealed with timber panels with no gaps or daylight visible (**Photographs 13**). At the two gable ends there were small inaccessible spaces behind some panelling which did have gaps around the edges so you could see the space behind (**Photographs 14**; **Target note 4**).

*Photograph 14. Inaccessible space behind the southwestern gable.*
