# LEVEL MONITORING

## for SMS (AVI, PRE)

**5 Sharpthorpe Close, Lower Earley, Reading, RG6 4DB**

| Report Date: | 29 November 2024 |

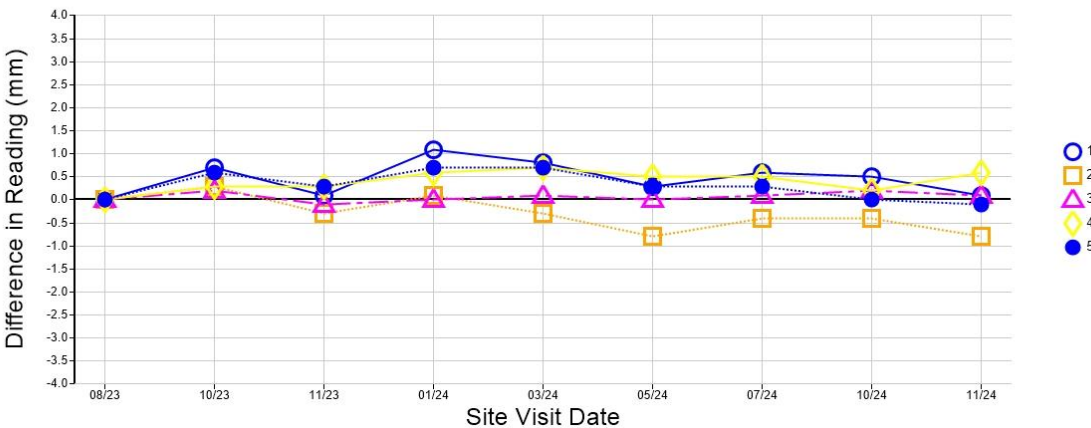
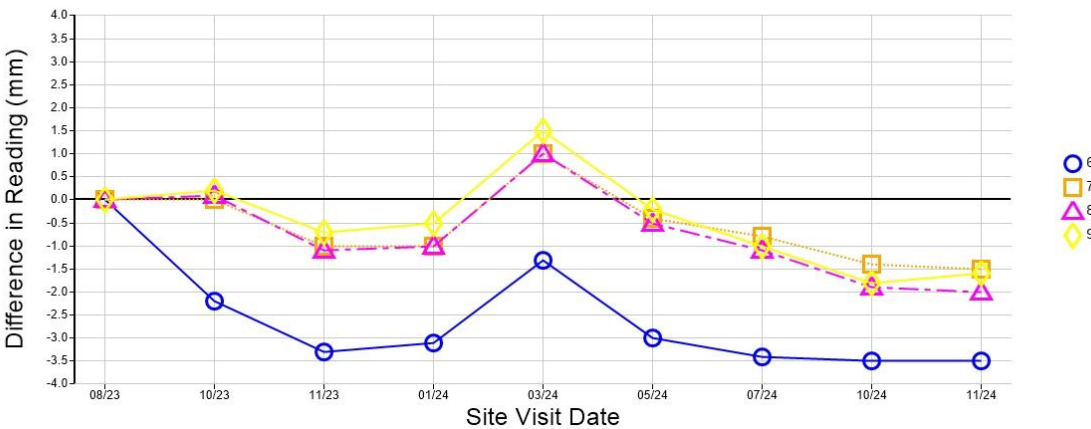
Level Monitoring Difference Graphs

The following graphs display the progressive movement that each Level Monitoring Station recorded at each separate site visit date to give an overall look at how much the property is moving.

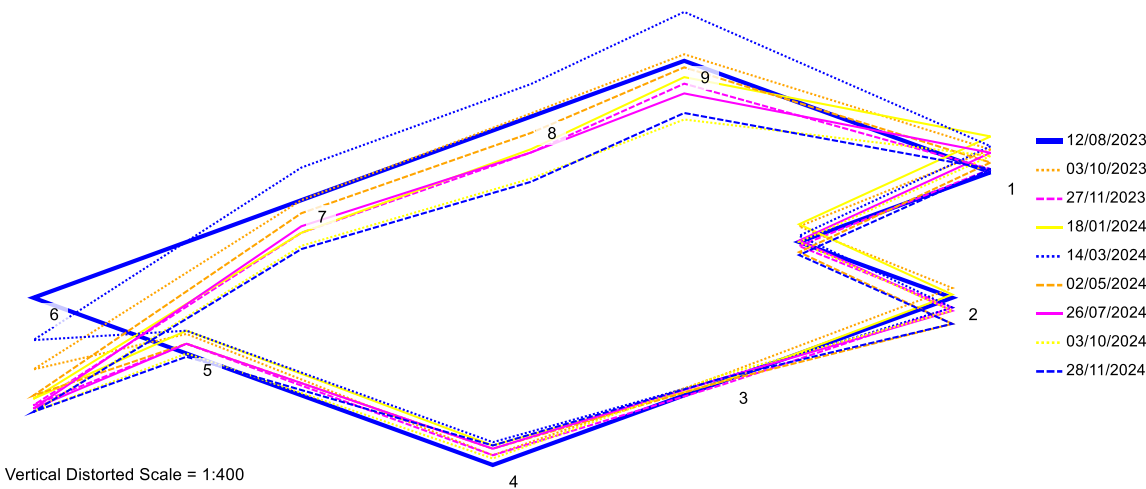
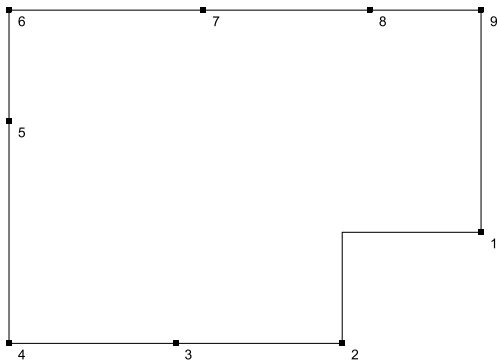
# Level Monitoring Displacement Map

The following image shows an isometric representation of the movement of the property, based on the Level Monitoring Stations that were installed.
