**SUBMISSION OF DETAILS TO COMPLY WITH CONDITIONS OF PLANNING  
PERMISSION 232278**

**Site Address:** The Old Cottage, Pearson Road, Sonning, Wokingham, RG4 6UH

**Proposal:** Application for submission of details to comply with the following condition of planning consent (232278) dated 9/1/2024. Condition 4 relating to structural repairs safeguarding special architectural or historic interest.

# MEMORANDUM

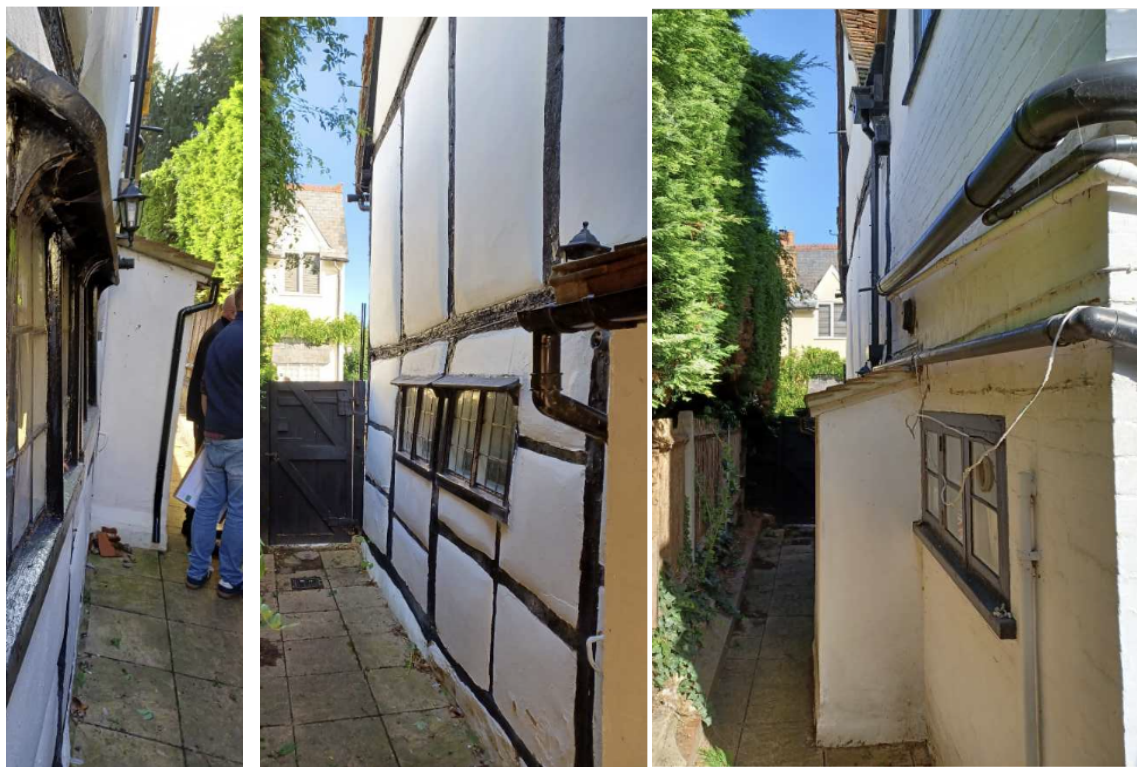
The western gable contains bulbous painted cement-rendered panels externally, with exposed brick infill internally at first-floor and attic levels. Consent was given only for the removal of the non-breathable modern render and its replacement with a breathable finish following timber repairs and installation of external insulation. Although the original render made it difficult to determine the underlying material, the method statement suggests masonry infill at ground-floor level, likely consistent with the upper floors. If so, these panels should be retained.

The proposed demolition of the modern boiler extension also falls outside the approved works and cannot be considered under Condition 4. A separate listed building consent or a certificate of lawful works would be required.

Western end gable, with far-right image being of the boiler extension.

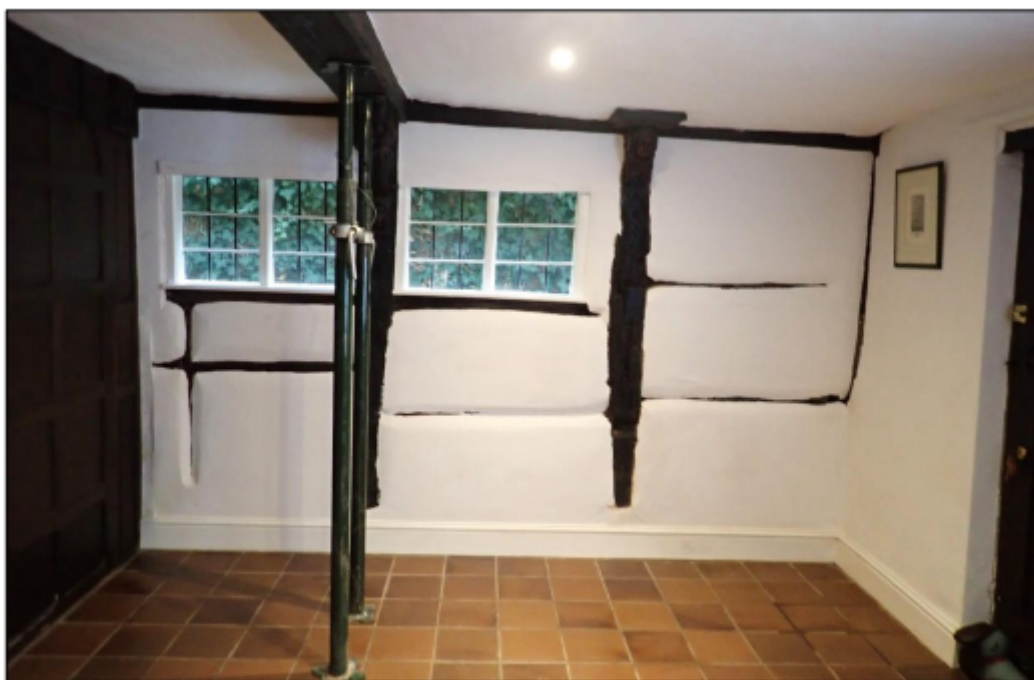
Figure 28. General view of the west wall from the Dining Room.

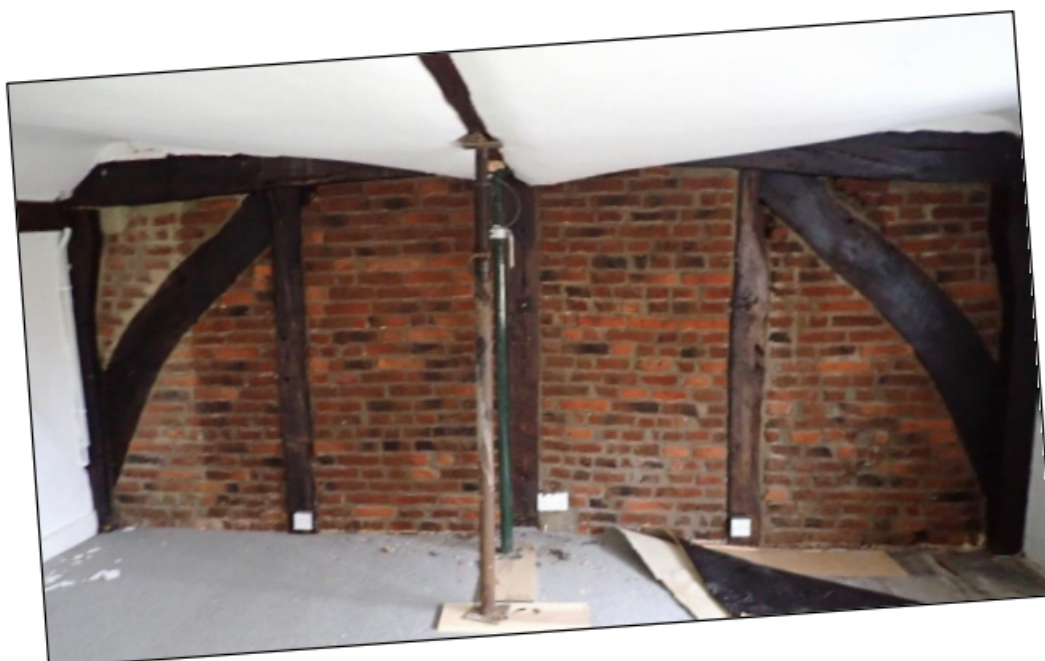
Figure 37. General view of the west wall on the 1<sup>st</sup> floor.

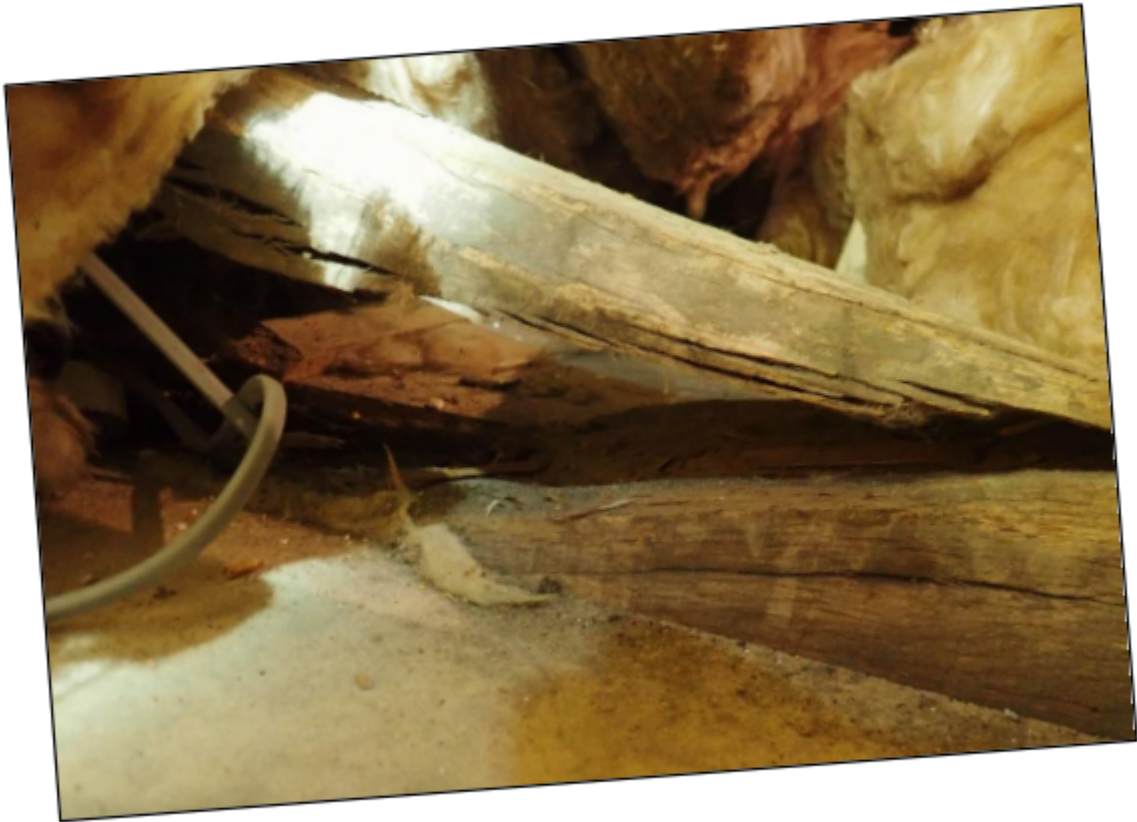
The proposed removal of ground-floor masonry infill and the associated need to prop the gable also raises structural risks. The structural engineer's report identified the dropped first-floor ceiling beam, which has separated from the gable wall, but this was not included in the approved scope of works. Further intervention may require additional consent.

Figure 43. View of the fracture in the 1<sup>st</sup>-floor ceiling beam

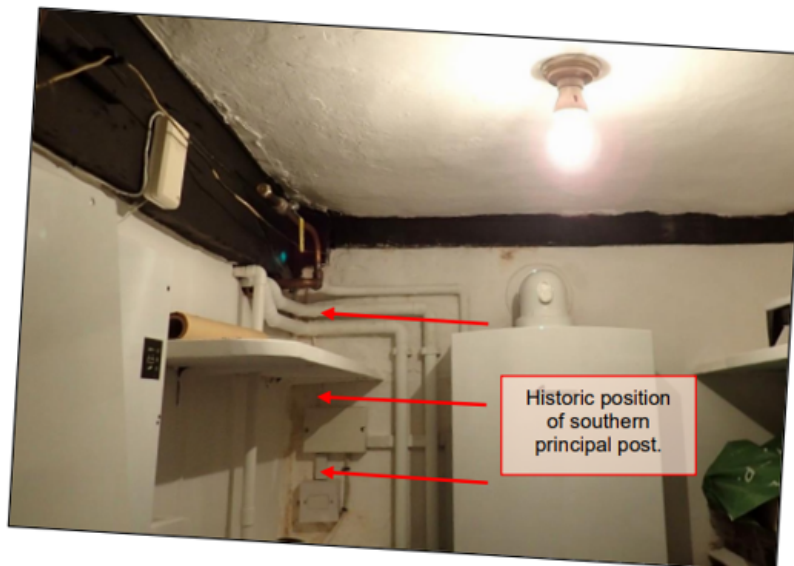
- ix. By looking in the south-west corner of the utility room it was apparent the lower section of the southern principal post has been removed from below the end-girt at some point in time (Fig. 36).

Figure 36. South-west corner of the Utility Room.

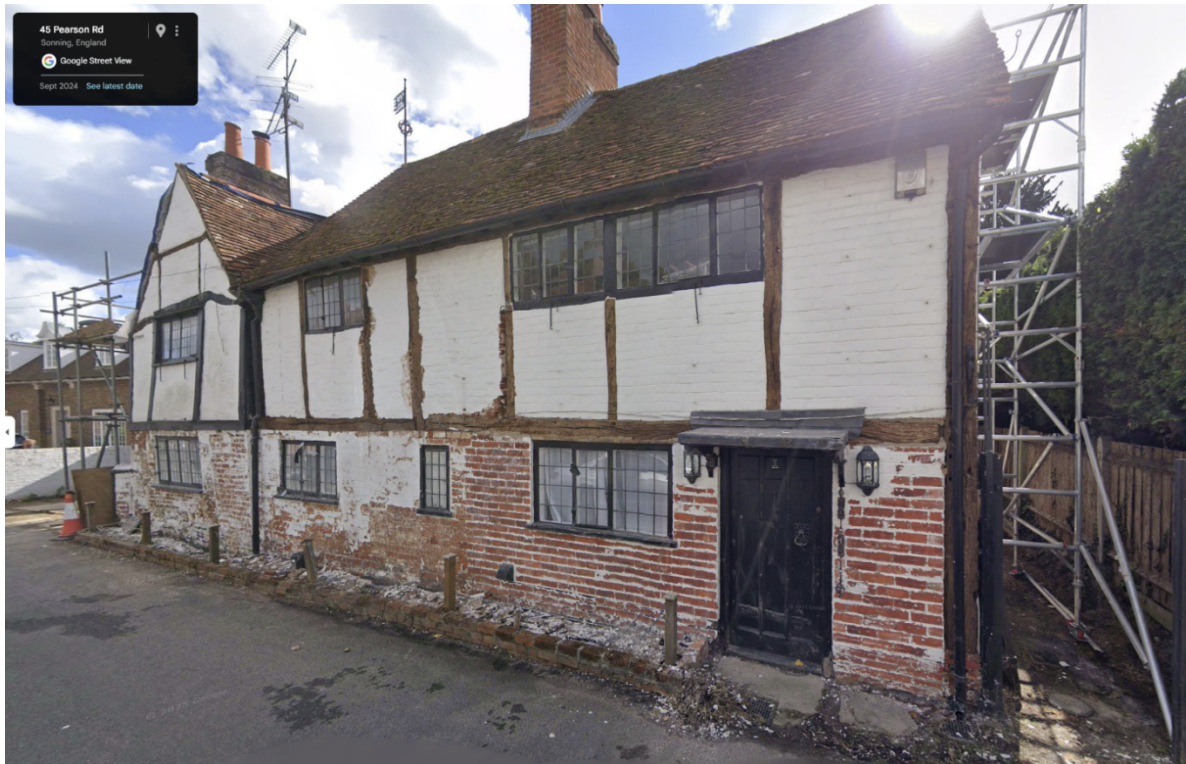
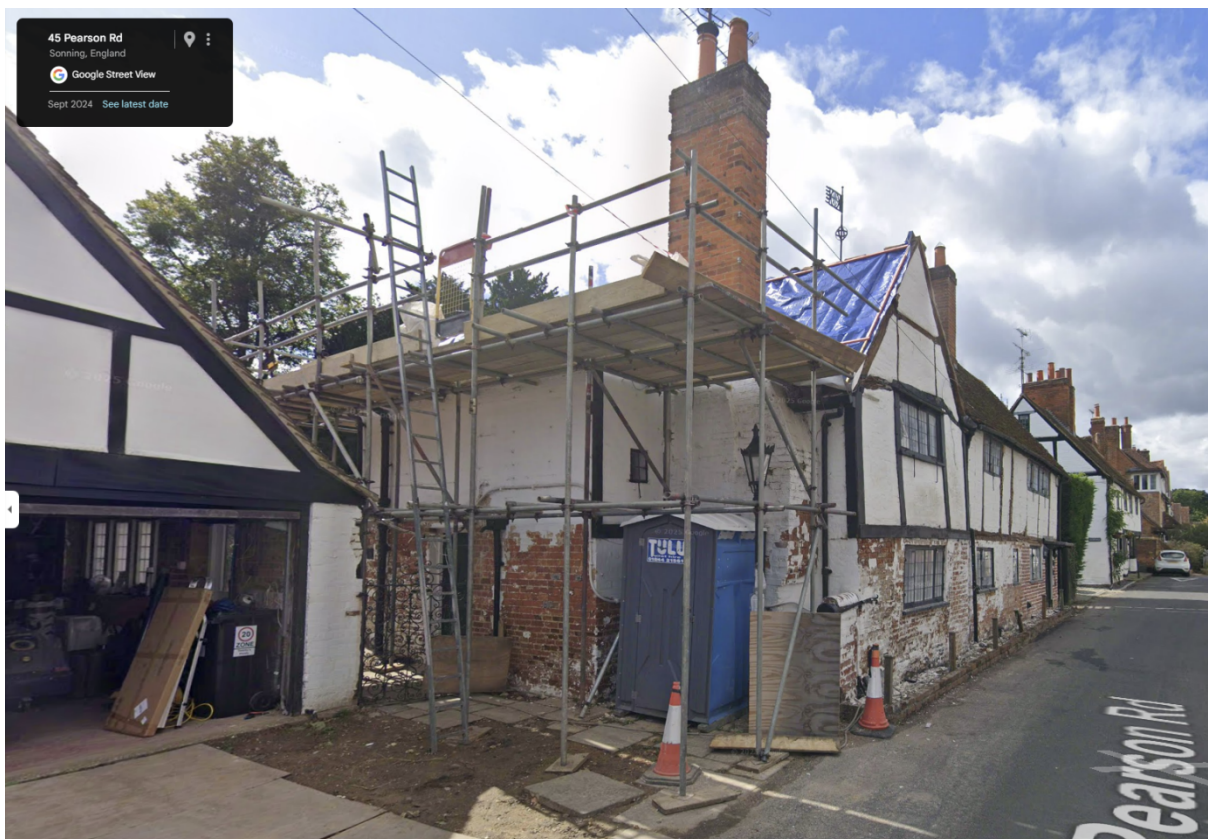
modern render and paint, was discharged in July 2024, and Street View images from September 2024 indicate significant progress. Condition 5, concerning external insulation, has not yet been discharged, though the current submission includes elements relating to this work. This raises concern given the exposed and potentially vulnerable condition of the timber framing and brickwork, particularly on the northern elevation.

Above images from Google Street View
