## PRELIMINARY BAT ROOST ASSESSMENT

**Property:** 14 Norfolk Close, Wokingham, RG41 3AF

**Date:** 30.01.2026

**Executive Summary:** A preliminary visual inspection of the roof structure was conducted to assess the potential for bat roosting activity prior to proposed side extension.

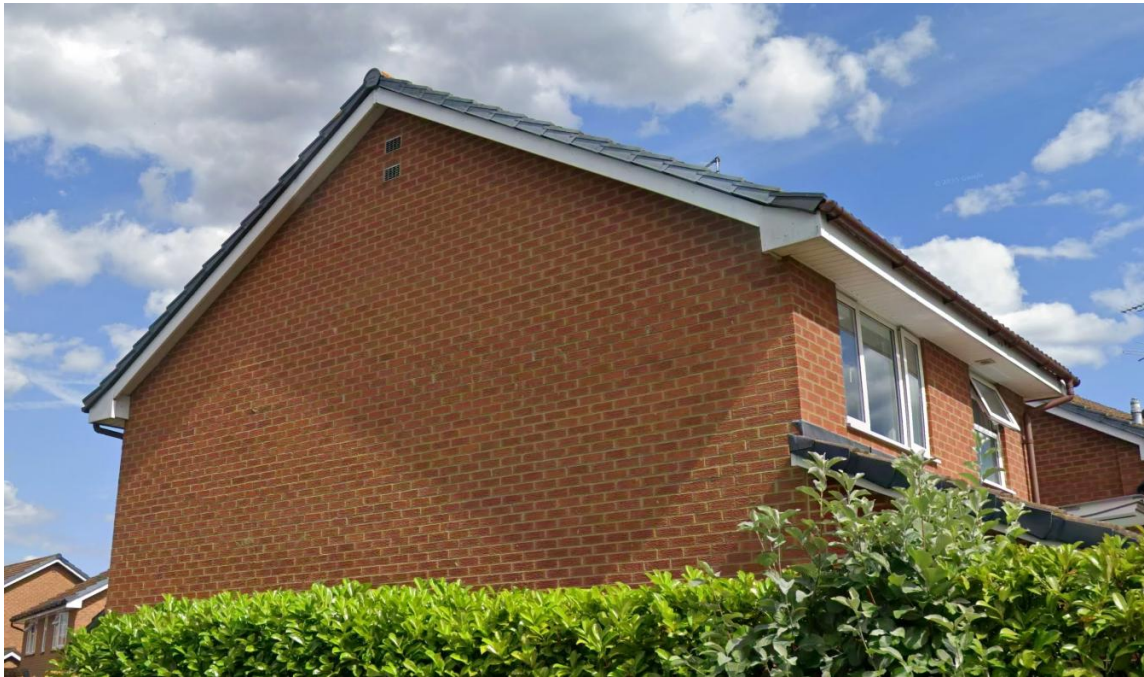
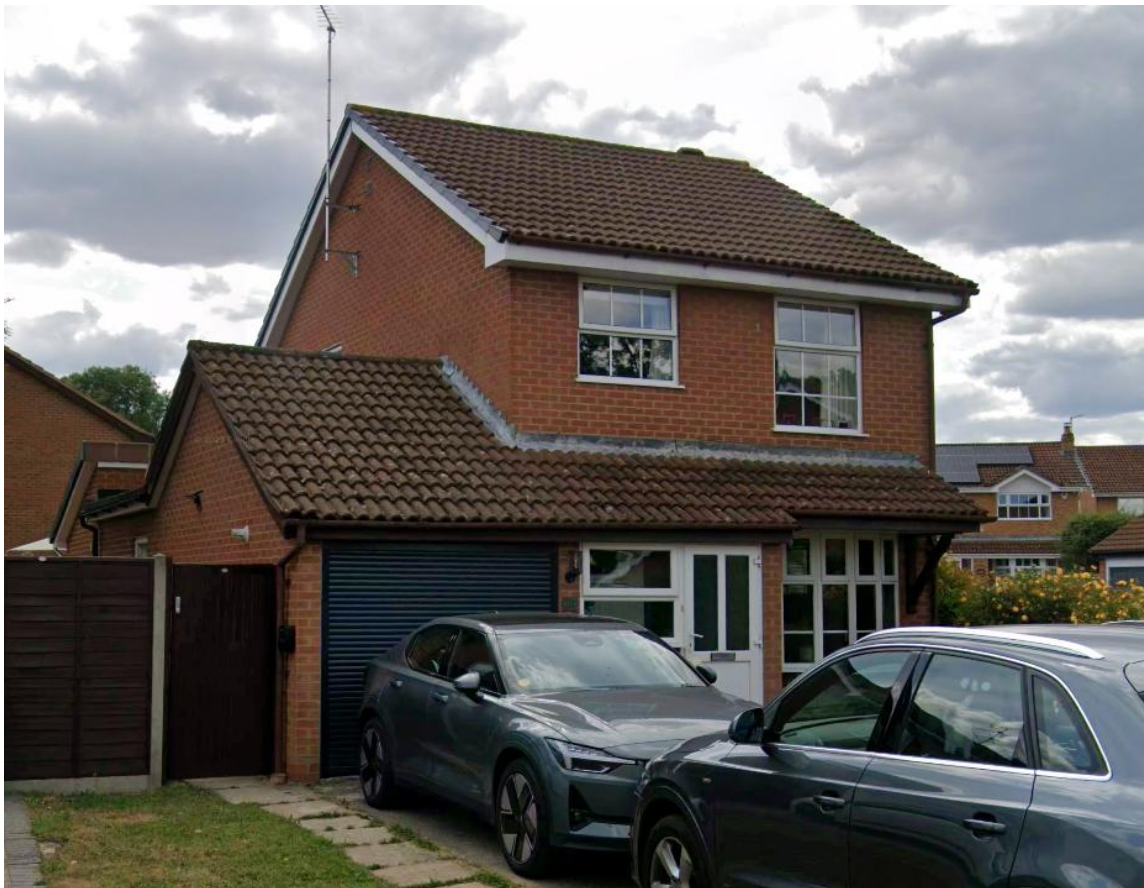
## APPENDIX 1: REFERENCE PHOTOS

- Roof covering appears well-maintained with no visible gaps or loose tiles
- Soffits and fascias are in good condition with no obvious entry points
- No bat droppings, staining, or other evidence of occupation observed
- No suitable crevices or voids identified that would provide roosting opportunities

**Assessment:** Based on the visual inspection, the roof structure shows negligible potential for supporting bat roosts due to the absence of suitable access points and roosting features.

**Recommendation:** Given the low potential identified, consideration should be given to whether a full emergence survey is proportionate to the level of risk.
